Thermal Evaluation of High Voltage Hermetic Motors Experiencing Recurrent Insulation Failures

H-P. Liu, J.D. Herbst, H.E. Jordan
Center for Electromechanics
The University of Texas at Austin
Austin, TX 78712

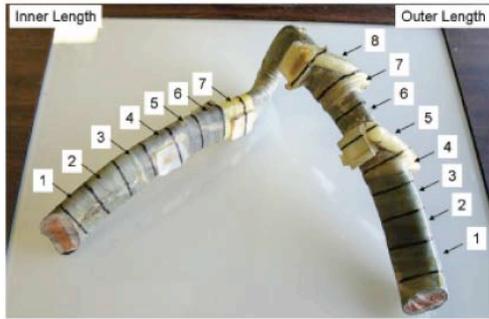
Figure 1. Stator coil dissection map

A thermally failed motor was examined by dissecting the stator coil end turn sections. The coil end turn was sectioned into multiple specimens and polished for visual inspection. Figure 1 shows the coil dissection map. Figure 2 displays the sectioned coil specimens. Discoloration of insulation is evident in figure 2, in which both the outside and inside coil sections show a dark ring adjacent to the conductors. Coil specimen one is nearest to the stator iron core and specimen eight is closest to the coil knuckle. As shown in figure 2, the insulation discoloration progresses through the full thickness of the ground wall insulation from specimen one to specimen eight. This appears to indicate that the coil temperatures increase as the coil extends away from the stator core.

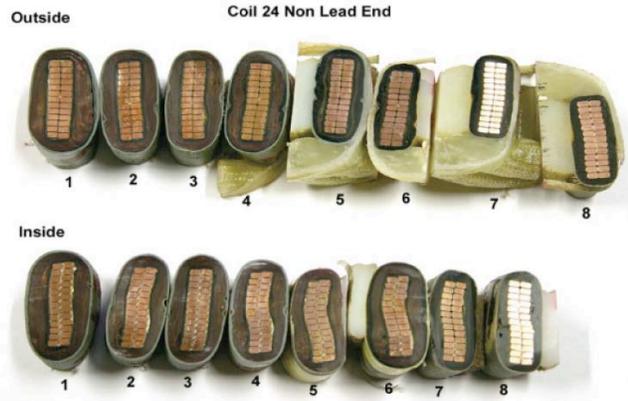
Figure 2. Insulation discoloration in specimens

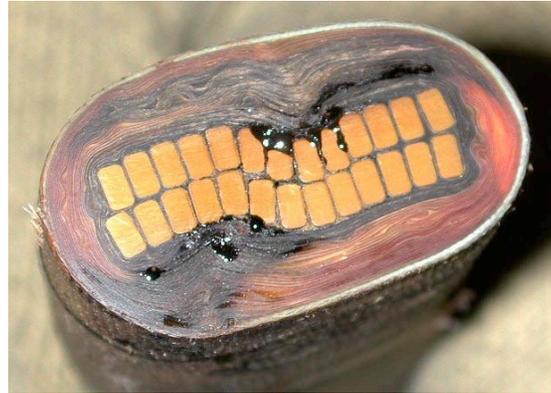
To qualitatively evaluate the effect of operating temperatures at the 155°C temperature rating, a small coil sample was heated to 155°C and a visual inspection was conducted. It was found that the sample showed signs of significant resin flow and a marked reduction in mechanical properties at this temperature. The reduced mechanical properties will make the coil more susceptible to insulation damage from relative motion, either from electromagnetic forces or mechanical vibrations. Figure 4 is a picture of this coil sample just after removal from the 155°C oven.

Figure 4. Coil removed from 155°C oven

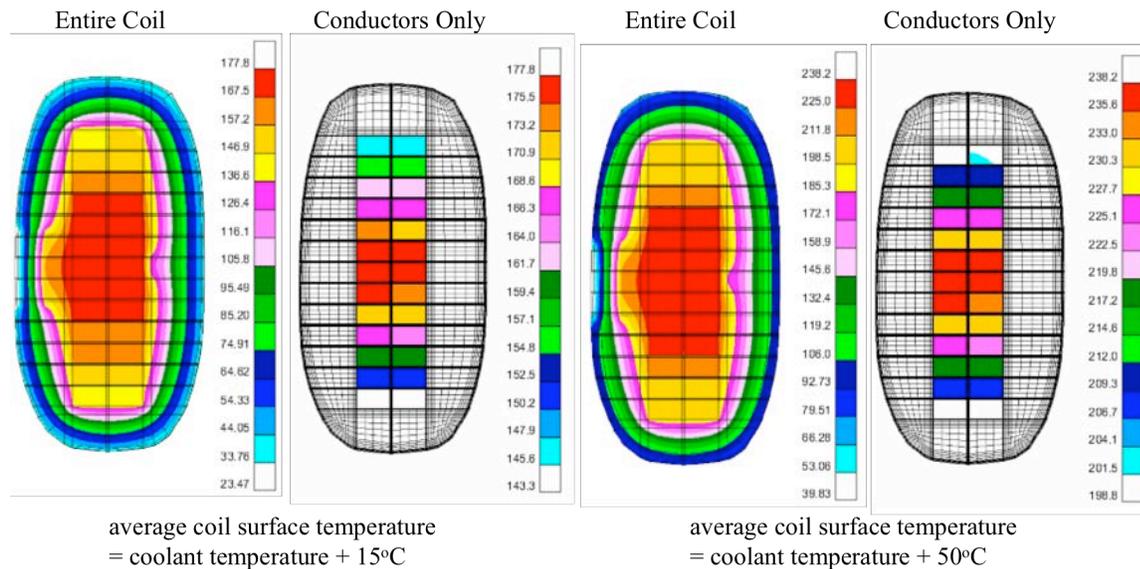
Two thermal analyses have been performed with a range of estimated convection heat transfer coefficients to match the predicted average coil surface temperature rises of 15°C and the presumed maximum coil surface temperature rise of 50°C. For the thermal model with two voids included (one void in the ground wall insulation and the other void adjacent to the conductors) and non-uniform conductor loss distribution considered, the predicted stator coil and copper conductor steady state temperature distributions at the full-load current are shown in figure 5. A convection heat transfer coefficient of 300 W/m²/K was used in the thermal analysis to make the predicted average coil surface temperature approximately 15°C higher than the coolant temperature, and the predicted maximum copper conductor and maximum turn insulation temperatures are 177.8°C. A convection heat transfer coefficient of 100 W/m²/K was used to make the predicted average coil surface temperature approximately 50°C higher than the coolant temperature, and the predicted maximum copper conductor and maximum turn insulation temperatures are 238.2°C. Both of these predicted maximum insulation temperatures exceed the insulation temperature rating of 155°C.

Figure 5. Predicted steady-state coil temperature distribution ($^{\circ}\text{C}$) in stator end turn coils at full-load current

As a response to the premature motor stator insulation failures, a new motor design was implemented which featured larger stator laminations, increased stator winding cross sectional area, and reduced current resulting in a 36% reduction in the stator winding current density at rated load. Considering differences in conductor volume and assuming equivalent conductor temperatures, the decreased current density results in a 41% reduction in the ohmic losses in the new motor stator winding. In addition to the electrical design changes, the cooling system was also improved by providing more uniform coolant distribution to the stator coil head regions, particularly to the region where most of the insulation failures occurred.
