INSULATOR TESTS IN A HIGH PERFORMANCE, SQUARE-BORE RAILGUN

D. A. Weeks and W. F. Weldon

Presented at the
Electromagnetic Launcher Association
Pomona, California

Publication No. PN-106
Center for Electromechanics
The University of Texas at Austin
Balcones Research Center
EME 1.100, Building 133
Austin, TX 78758-4497
(512)471-4496

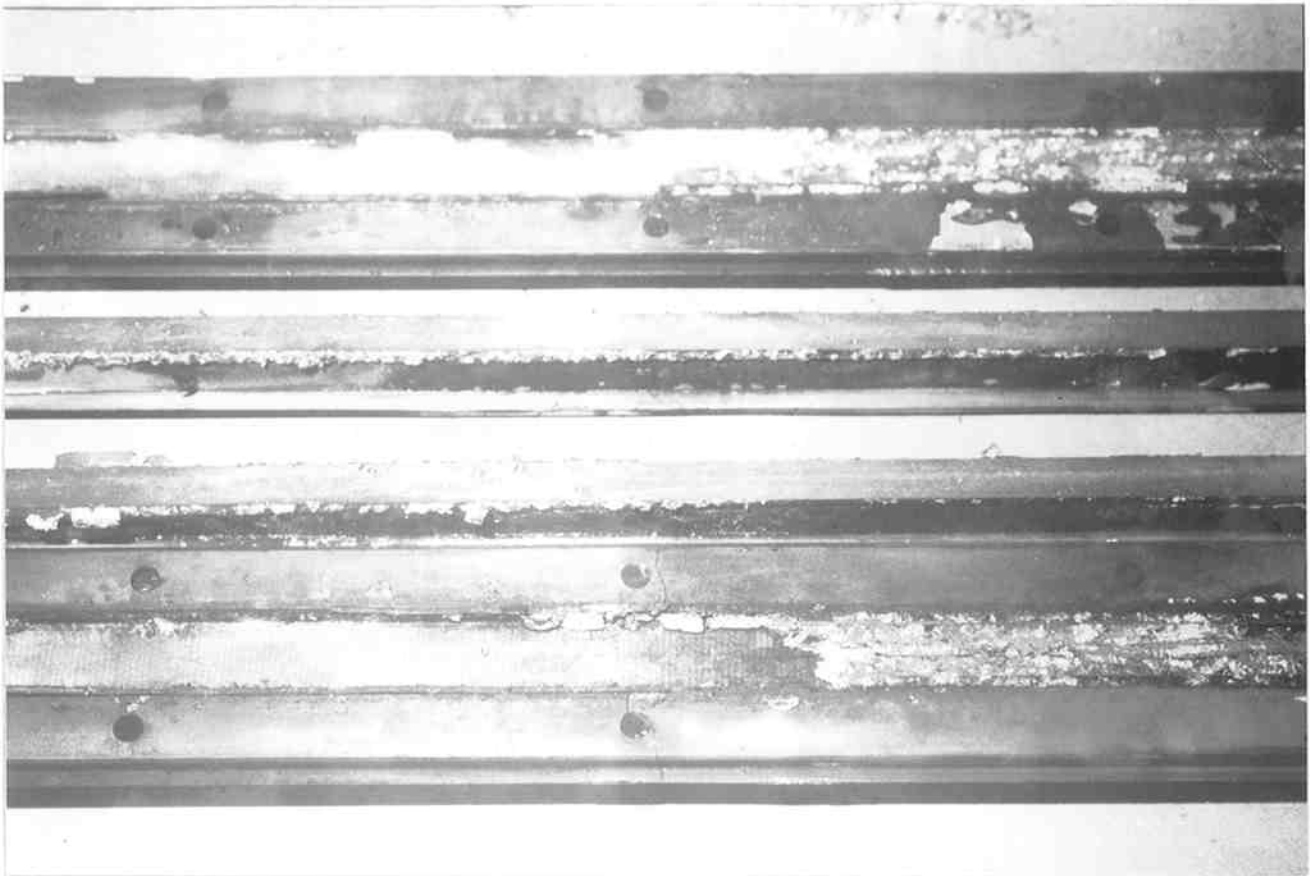
When soda lime glass was used as an insulator, the greatest damage occurred at the projectile location corresponding to peak current. Typically, a region approximately 25 to 40 cm (10 to 16 in.) long centered about peak current suffers major glass blowout (fig. 5). Often, a copper tint was observed on the glass after a shot. The copper tint appeared to be melted into the surface because it could not be cleaned off, so a scanning electron microscope (SEM) was used to verify this assumption (fig. 6). Under the magnification of the SEM, the glass no longer appeared to have a uniform coating of copper, but instead the surface is covered by scattered craters that are 1 to 10 microns in diameter. Additionally, the craters were often 10 to 20 microns apart and in several instances contained small spheres thought to be copper that condensed from the plasma armature. An analysis of the craters reveals that they were not formed by impact, but rather they melted into the surface of the glass.[5] Interestingly the craters are densely populated around the breech and the surrounding glass appears smooth. In the muzzle region, the craters are sparse and the surrounding glass appears coarse. During honing, the entire surface of the glass takes on the coarse appearance so it has been suggested that in the breech region where the arc dwells for a longer time, the glass melts. This also accounts for the greater density of craters in the breech area. In several instances, the SEM reveals cracks splitting craters in half, if the assumption that the craters are formed by molten copper from the arc is correct, then this indicates that the cracks form after the plasma and projectile pass by. In summary, the glass insulators do not survive for a second shot, yet they seem to stay intact while the projectile is passing, the insulators provide a witness plate for making observations of the plasma structure, and microspheres of copper are suspended in the body of the arc.

Figure 5. Soda lime glass insulator after 350 kA shot

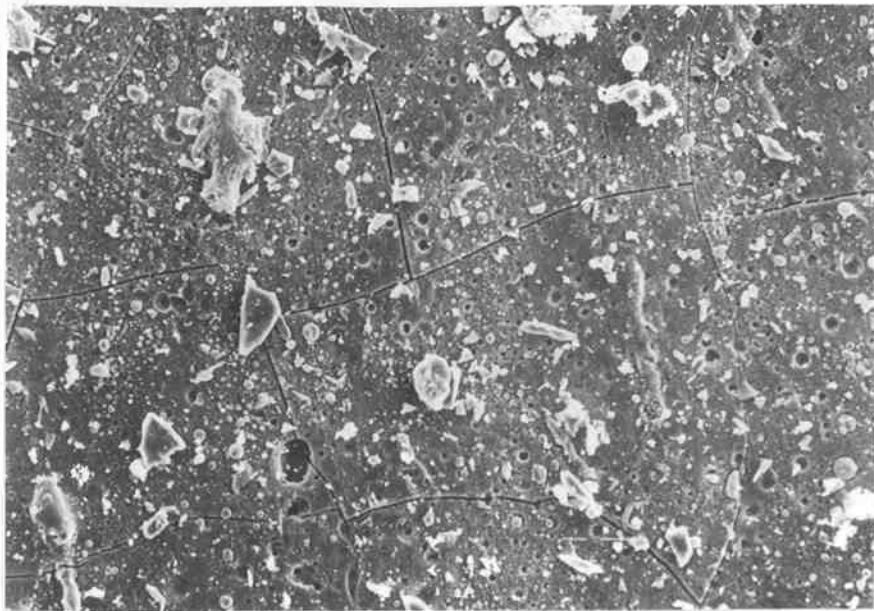
a. Breech region

Figure 6. Soda lime glass SEM photos (300x) after 350 kA shot

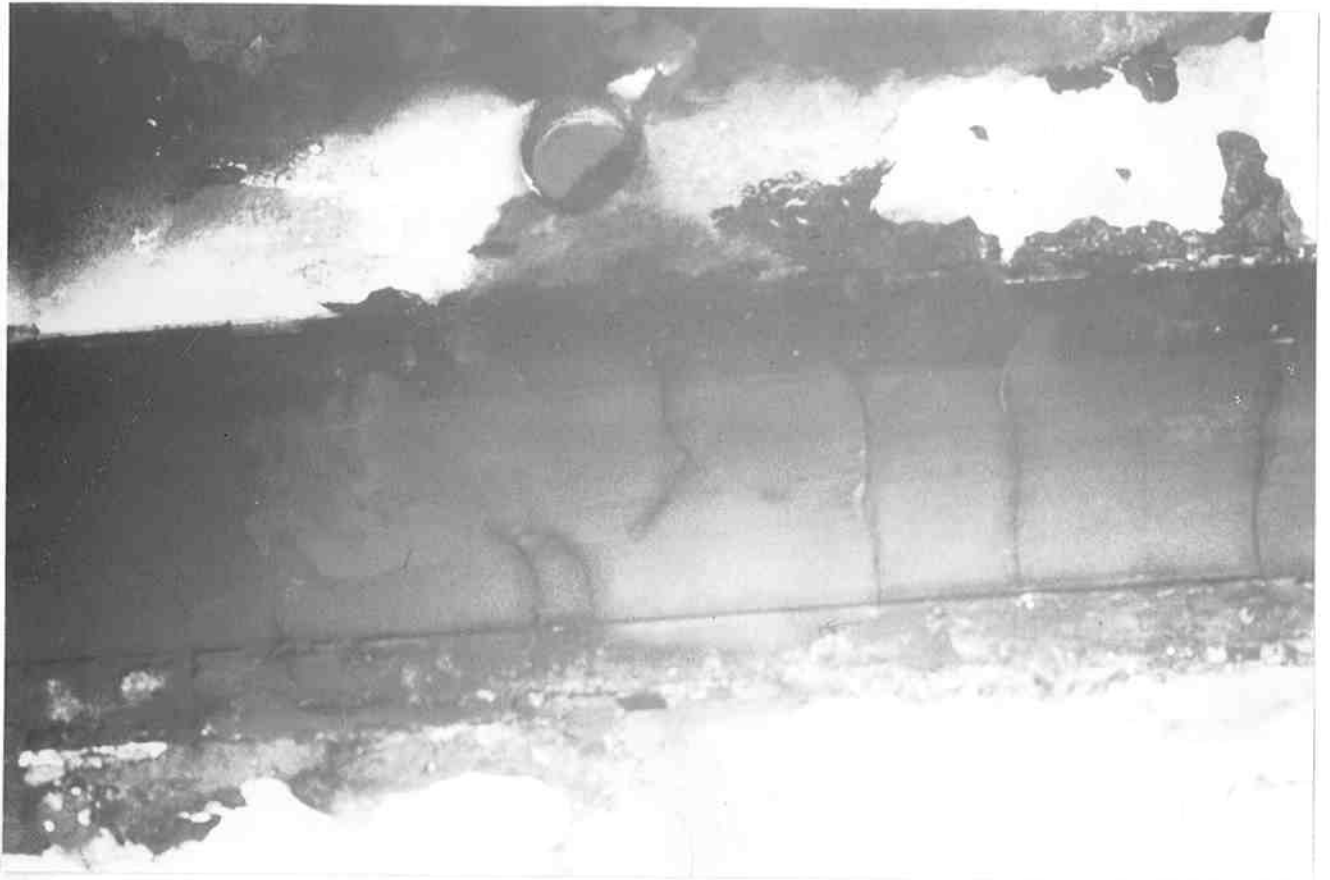
Polycarbonate was the next material tested as an insulator. Gun performance was similar to that obtained using glass and there were no regions where the polycarbonate was blown out of the sidewalls (fig. 7). However, it seems that there was more carbon soot after the polycarbonate test than there was after the glass test. A few gouges appear on the insulators which most probably occurred from the projectile tripping in the bore. Aside from this, the polycarbonate seems to be a good insulator with repetitive shot capabilities. The SEM revealed scratches that are

Figure 7. Polycarbonate insulator after 350 kA shot

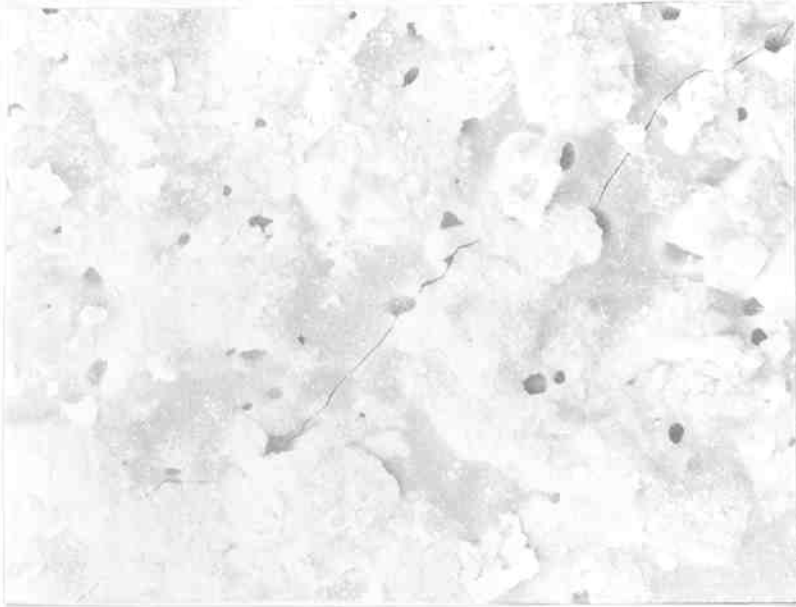
a. Breach region

textured surface of honed glass (fig. 8). The post shot appearance of the polycarbonate is smooth and features some craters indicating that the surface was probably melted by the arc.

Figure 8. Polycarbonate SEM (300x) after 350 kamp shot
