An Ethical Analysis of the MGPI Toxic Chemical Release in Atchison, Kansas 2016

Christopher Dean and Arianna Lim

ChE333T

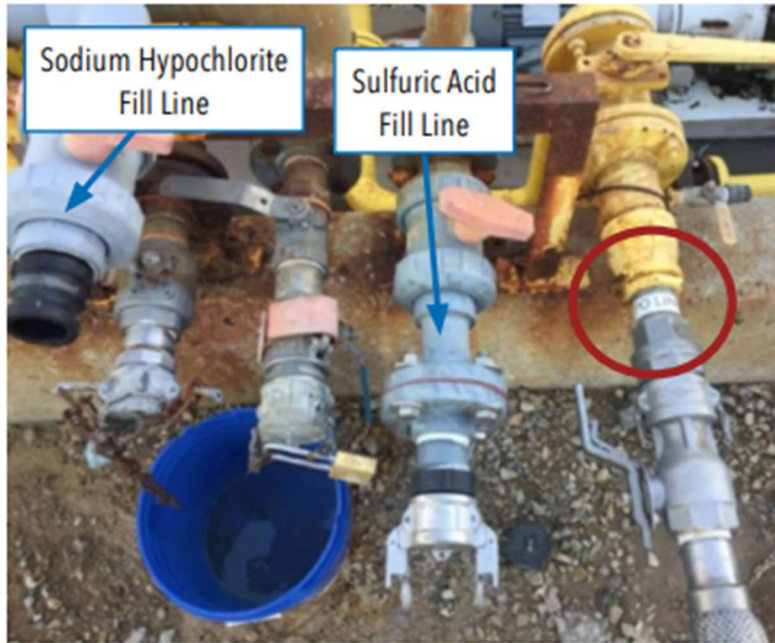
The fill line mix-up was most directly caused by MGPI plant violation of Chevron Phillips' sixth tenet in figure 2. The sodium hypochlorite and sulfuric acid fill line openings were

poorly labeled and crammed closely together, as seen in figure 3, creating the potential for the fill lines to be contaminated.

Figure 3. The fill lines involved in the incident lacked labeling and were only 18 inches apart. The red circle points out better fill line markings on the propylene oxide line near the connection point (CSB, 2017).

The CSB found that the two lines were only 18 inches apart and lacked pipe markers to identify intended fill line contents (2018). By failing to appropriately identify and separate the fill lines, MGPI's fill line system was compromised. Had MGPI placed pipe markers on all fill line connection points and separated the lines farther apart, it is likely that the truck driver would have readily identified which line to fill. Instead, he relied on tradition that only one fill line would be unlocked and ready to fill, which was not the case because the sodium hypochlorite cap had not been reattached after a prior delivery.

for safety modification suggestions, unlike before when they ignored recommended changes from PHAs in 2015. Additionally, they now require that fill line connection points have a minimum of three feet between each line to prevent proximity between incompatible chemicals. To improve the capacity to remotely stop unintended reactions like the one that occurred, more alarms and emergency shutdown devices were implemented. To protect operators from being suddenly overwhelmed with gas vapors, ventilation design changes were made in the control room to prevent flow of chemical vapors from outside. Lastly, to make it impossible to connect the incorrect chemical to a fill line, MGPI and Harcros coordinated uniquely shaped transfer equipment for each hose and line (CSB, 2017).
