**Experimental Testing of a Steel Gravity Frame with a Composite Floor
under Interior Column Loss**

Thesis

The University of Texas at Austin

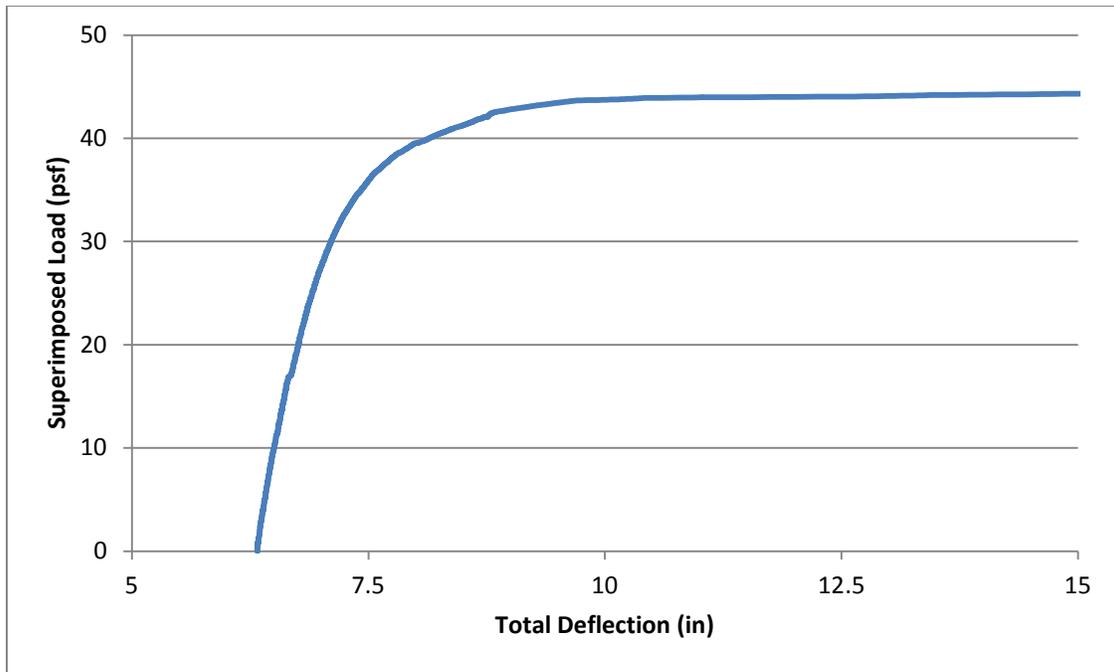
Figure 4-10: Test 4 Superimposed Loading

Figure 4-10 shows the deflection versus applied water load in Test 4. After the nuts and bolts were removed from the structural steel framing connections, the structure sagged to a deflection of 6.32 inches before additional water loading was applied. The floor system deformed at a steady rate for 1 inch of deflection over 35 psf of superimposed load before substantial softening began.

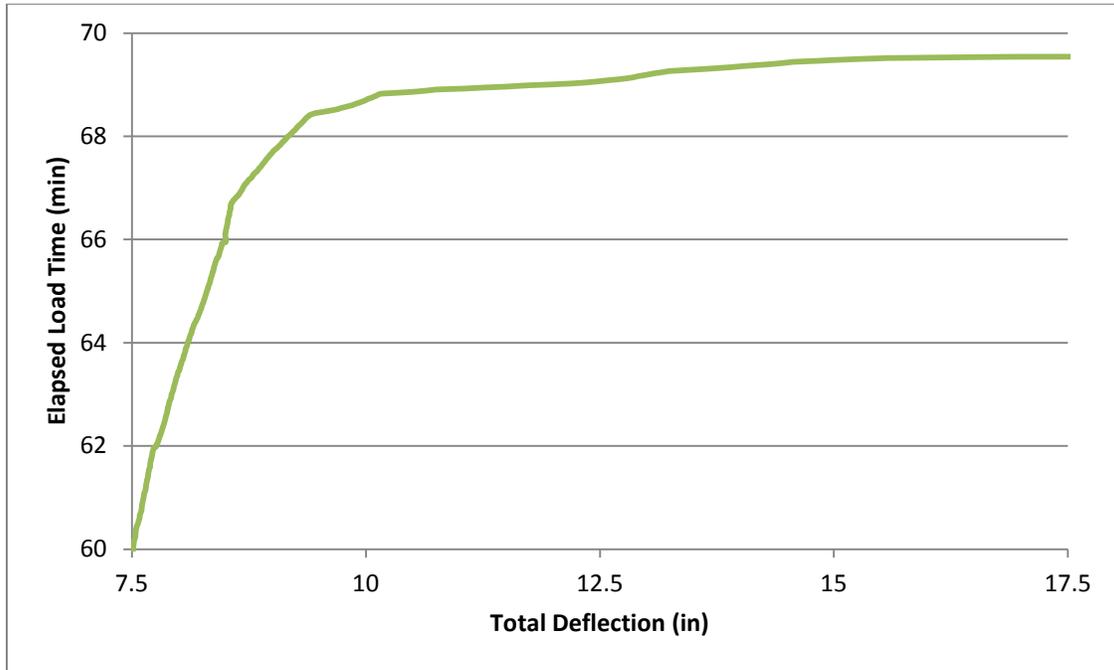
Figure 4-11: Test 4 Deflection vs. Time before Collapse

Figure 4-11 depicts the deflection of the specimen versus time in the last ten minutes before collapse. In these ten minutes, the structure deformed an additional ten inches. The softening began at a total deflection of about 7.5 inches and an applied load of 35 psf. Although the loading continued, the high rate of deformation over time indicates that the structure was unable to reach static equilibrium at these higher loads.

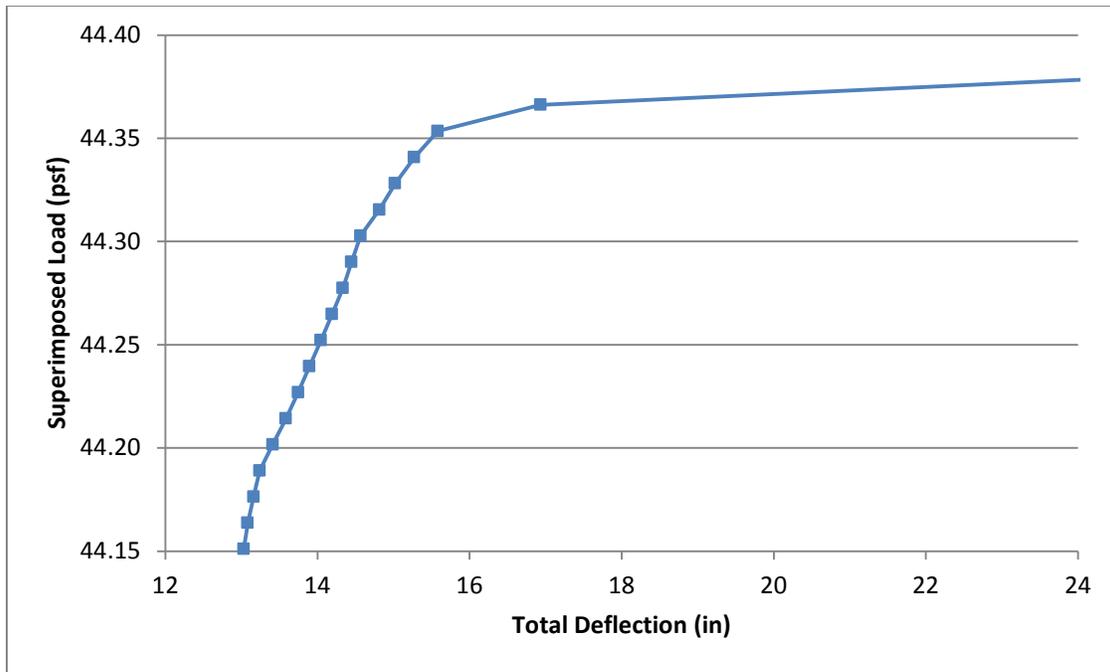
Figure 4-12: Failure of Test Specimen

Figure 4-12 shows the measured deflection versus load in the final seconds before collapse. The data points shown in the plot are one second apart. The floor system continued to deform at a steady rate until the deflection reached 15.6 inches. At this point, the structure collapsed. The superimposed load at the time of failure was 44.3 psf, but the actual failure load may be closer to 35 psf based on the rapid movement of the structure during this period of loading. Water was being pumped onto the structure continuously through the time of collapse; the high rate of displacement over time suggests that the structure was unable to stabilize under the additional load. The total collapse load of the floor specimen with no connections in the steel framing may be approximated as 155 psf including the self-weight of the specimen and the loading buckets.

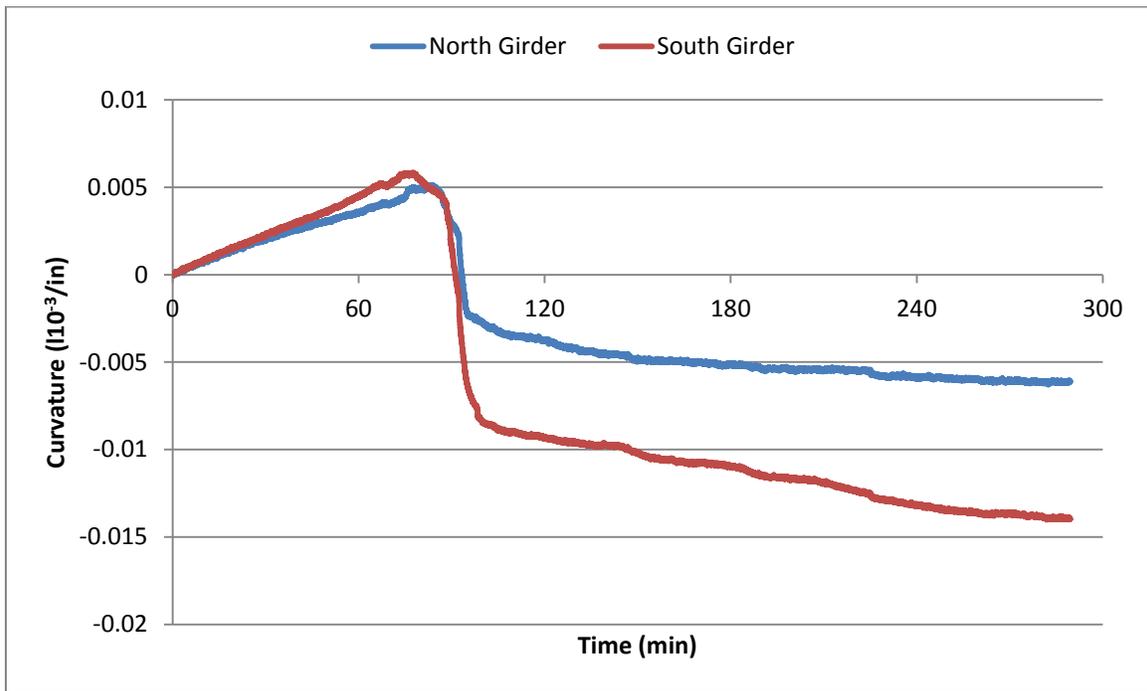
Figure 4-30: Curvature in Girders vs. Time in Test 3

Softening was observed in the load-deflection plot around a load of 50 psf. In Figure 4-29, the curvature abruptly begins to drop off. When the curvature is plotted against time, the change in behavior is especially evident.

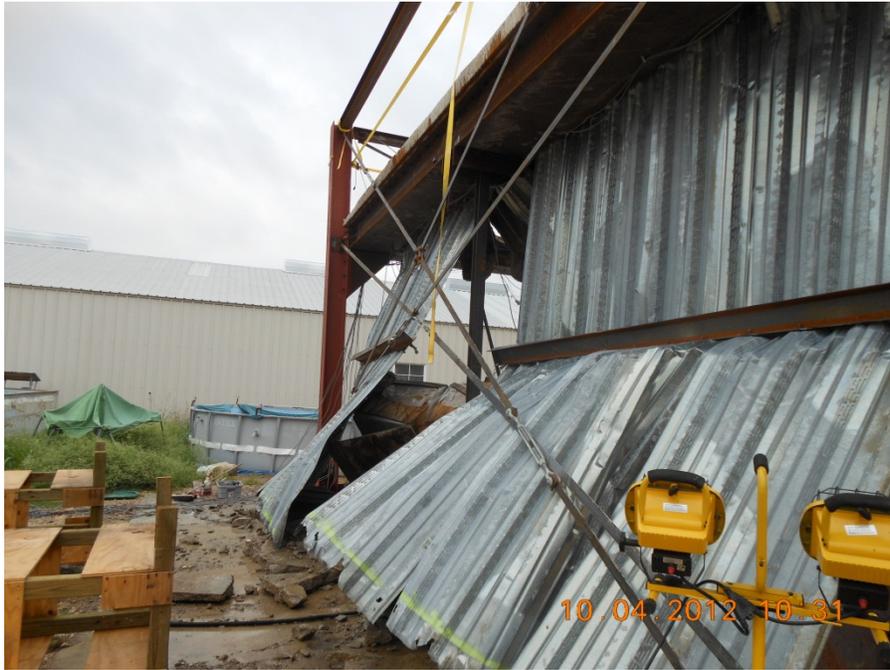
Figure 4-58: Corrugated Decking after Collapse

initiated by tear out at a longitudinal seam of the corrugated steel decking. Collapse was essentially instantaneous after this failure.
