Photographic field reconnaissance of bayous between Green Lake and Mission Lake in the Guadalupe River Estuary

Ben R. Hodges¹

Center for Research in Water Resources
The University of Texas at Austin

February 25, 2013

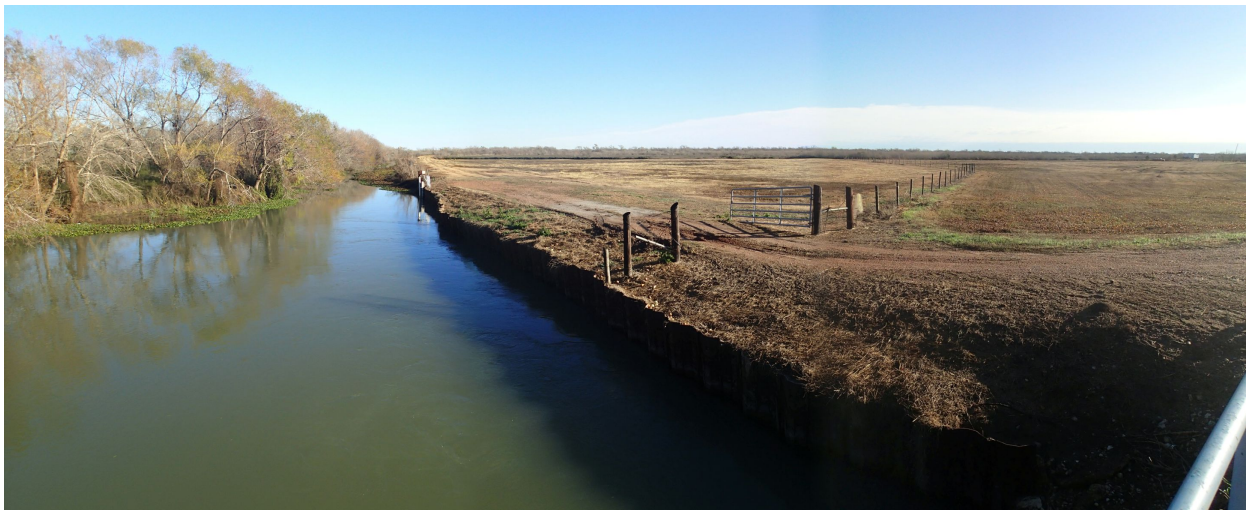
Figure 7. Freshwater diversion canal (wp03) looking downstream from gate structure. High banks require extreme flows to connect with the upstream reaches of Schwings Bayou. Composite panorama photo using DoubleTake software distorts linear relationships. Photograph by Ben R. Hodges, ©2013. File wp003 bNNetoS DiversionChannelFromUpstreamGate p028to030.

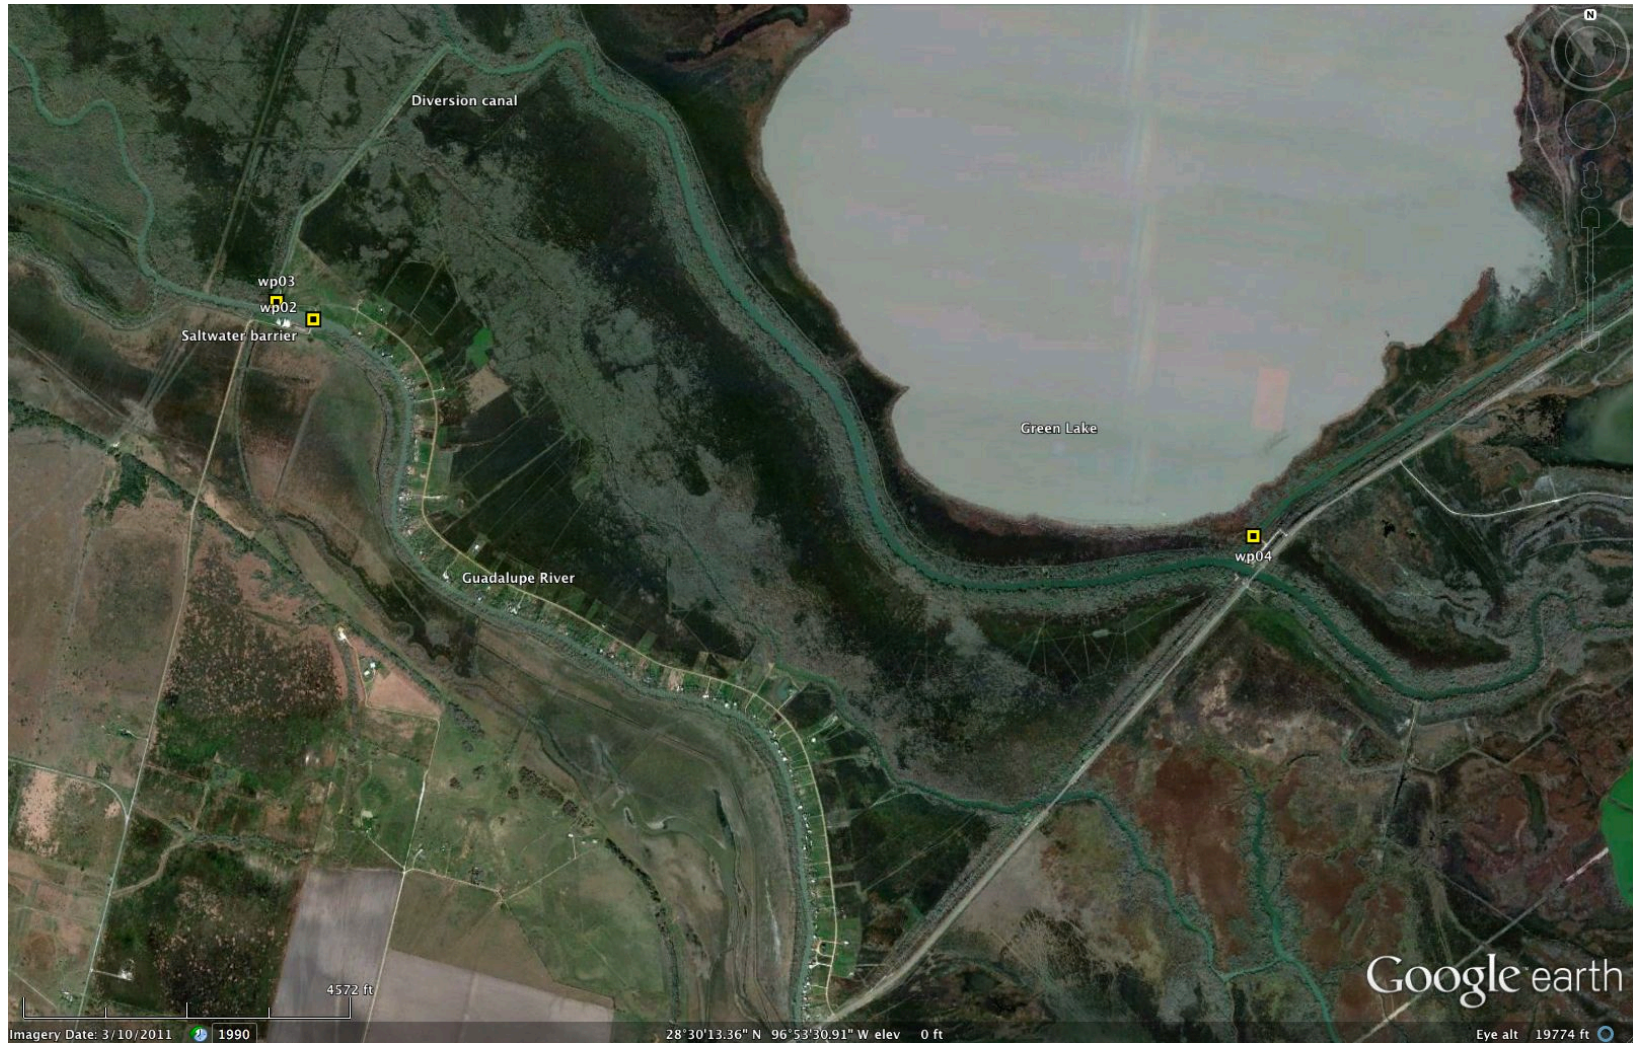
Figure 8 shows the upstream section of the freshwater diversion canal that winds around the west side of Green Lake. Between the diversion canal and the Guadalupe River are creeks that are the upper end of Schwings Bayou. Note that nowhere in this area does Schwings Bayou form a surface water connection with the diversion canal or the Guadalupe River at normal bankfull levels. Near wp04, shown in Figure 8, the diversion canal splits with the southern branch being the start of Hog Bayou, and the northern branch (closer to Green Lake) providing the diversion canal that feeds Goff Bayou and the industrial canals east of the Victoria Barge Canal.

Figure 8. Upstream portion of diversion canal, which runs around the southern boundary of Green Lake. Note the lack of any surface water connection from the diversion canal to the Schwings Bayou exiting through the lower side of the figure. However, the diversion canal does have a direct connection (right side of frame) that leads to Hog Bayou and Alligator Slide Lake. Imagery from Google Earth dated 3/10/2011.

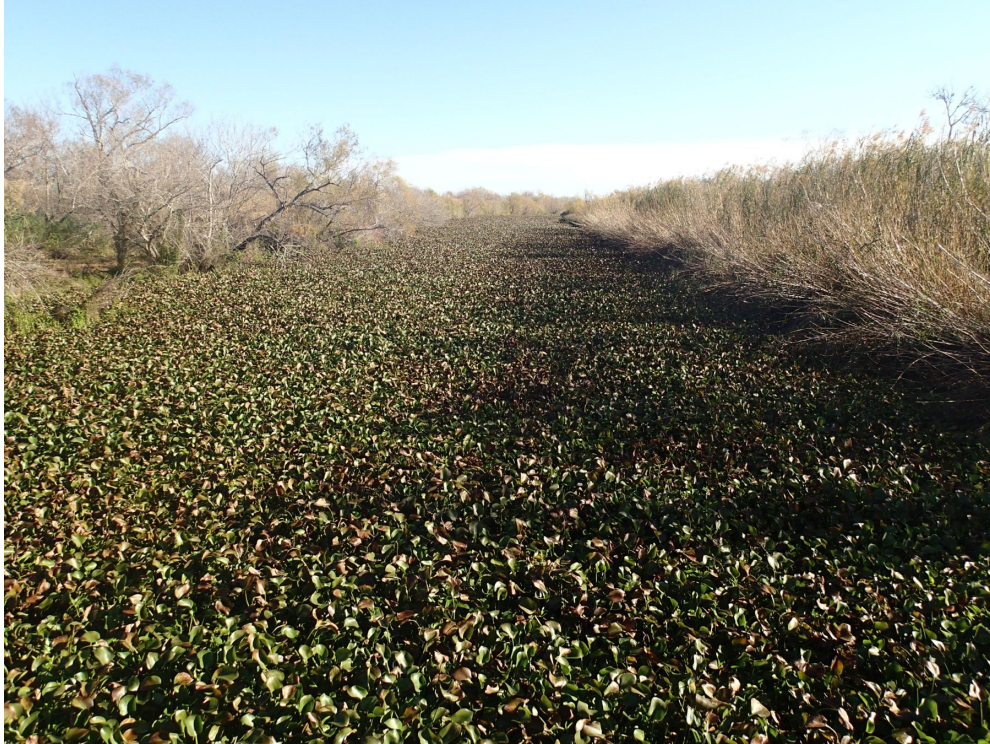
The connection between Hog Bayou is shown in greater detail in Figure 9. Figures 10 and 11 show the view upstream and downstream on the diversion canal at wp04 on the morning of January 10, 2013. The channel was completely blocked with plants (apparently water hyacinth), in both directions. Figure 12 shows the water level gage at the bridge. During our visit to the bridge, a worker from GBRA came by to make a water depth measurement.

Figure 10. Downstream view of diversion canal from bridge that is accessible off TX-35 (wp04). Canal is completely choked by floating plants (appears to be water hyacinth). Photograph by Ben R. Hodges, ©2013. File wp004 bENE BridgeOverDiversionChannel i032.

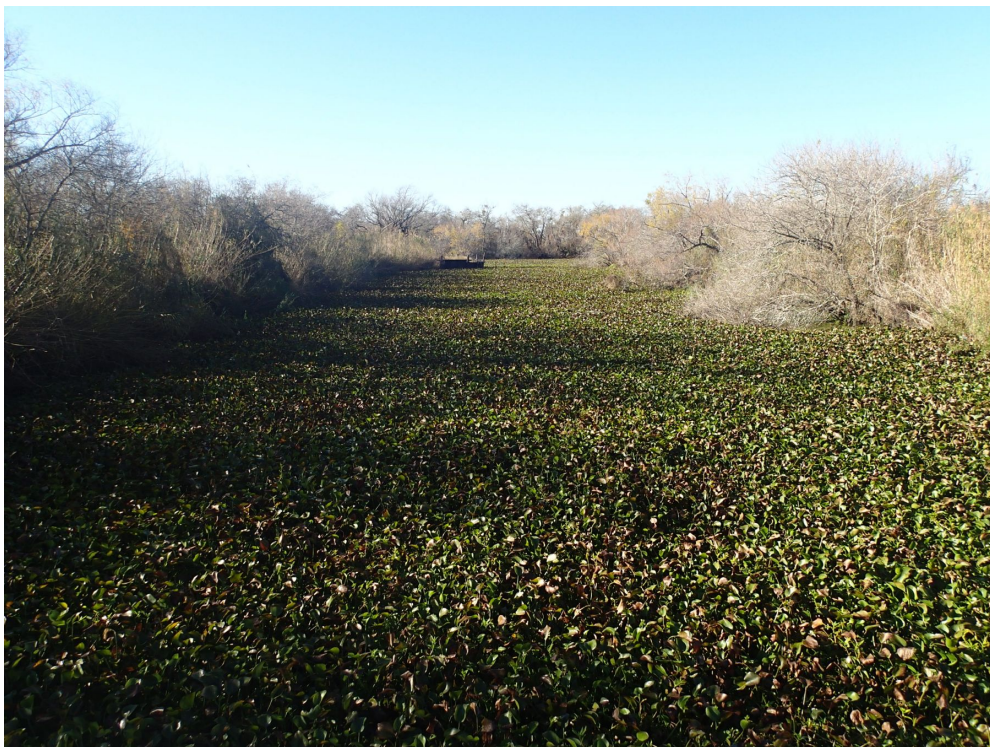
Figure 11. Upstream view of diversion canal from bridge that is accessible off TX-35 (wp04). Canal is completely choked by floating plants (appears to be water hyacinth). Photograph by Ben R. Hodges, ©2013. File wp004 bNNE BridgeOverDiversionChannel i033.

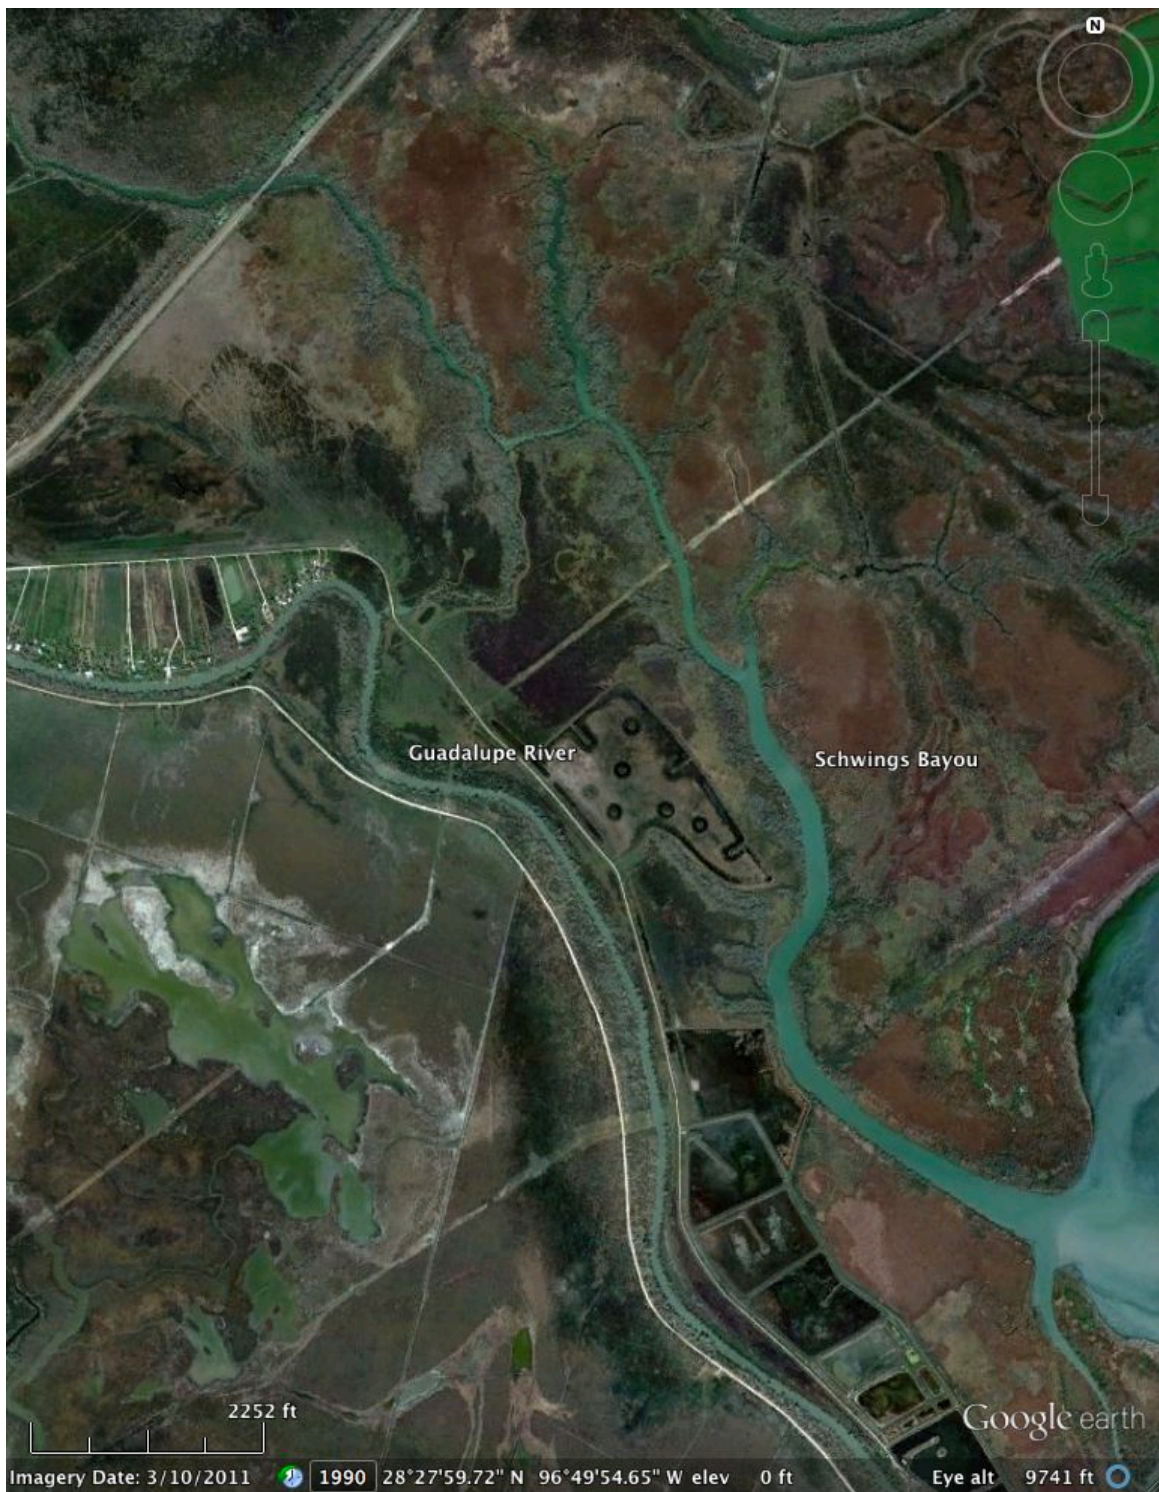
Schwings Bayou is shown in Figure 14. None of this color from Alligator Slide Lake is seen in Schwings Bayou outside of a narrow connection to Mamie Bayou on the right branch, just barely visible in Figure 14. Detailed review of Google Earth (not shown) indicates that Schwings Bayou is also connected to the Guadalupe River near the loop in the river south of TX-35.

Figure 14. Schwings Bayou. Note that this bayou does not have a surface water connection to either the Guadalupe River upstream of the salt barrier or the diversion canal. There is apparently a culvert connection near the river bend. There are no significant blockages for upstream exchange of marine water. Imagery from Google Earth dated 3/10/2011.

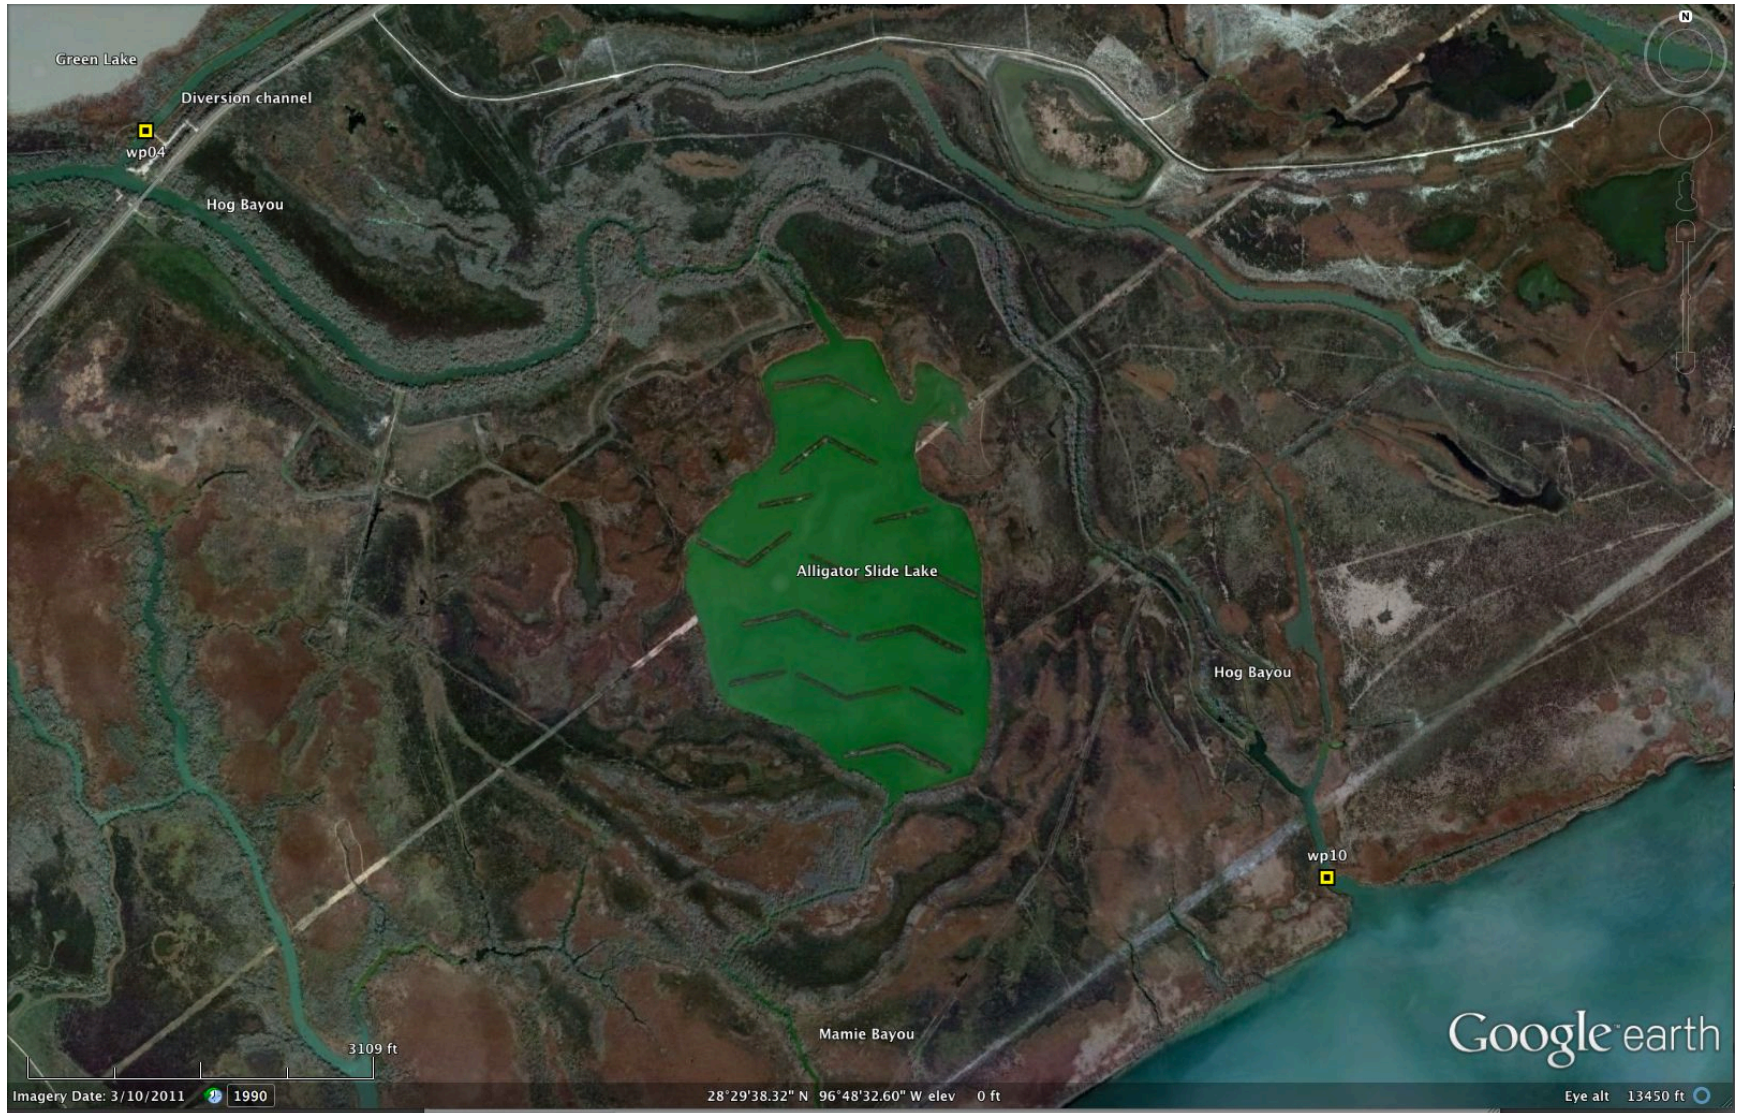
Figure 15. Hog Bayou is directly connected to the diversion channel, and feeds Alligator Slide Lake through an obstruction (see Figure 16).

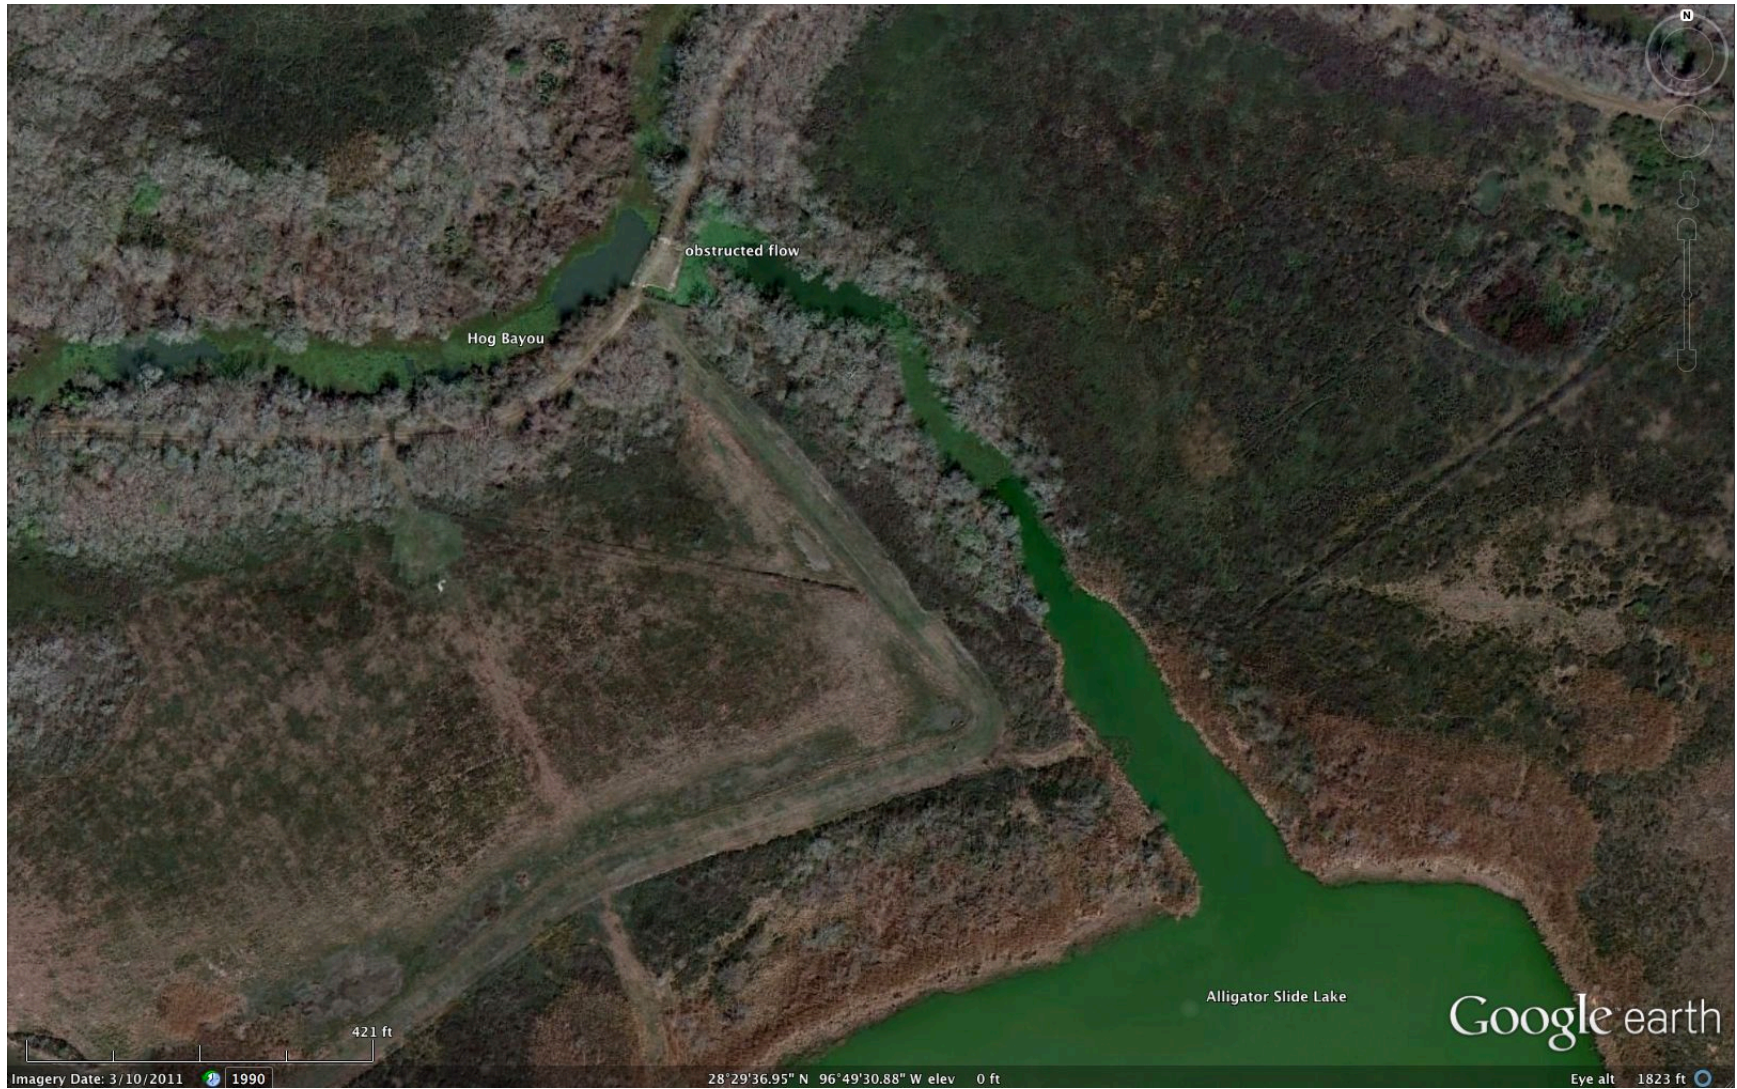
Figure 15 shows that Hog Bayou connects with the upper end of Alligator Slide Lake, but as shown in Figure 16, this connection is at least partially obstructed. From the satellite photos it is not clear whether the obstruction is a bridge or a road with culverts.

Figure 16. Obstructed flow connection between Hog Bayou and Alligator Slide Lake. The nature of the obstruction is not clear from the image.

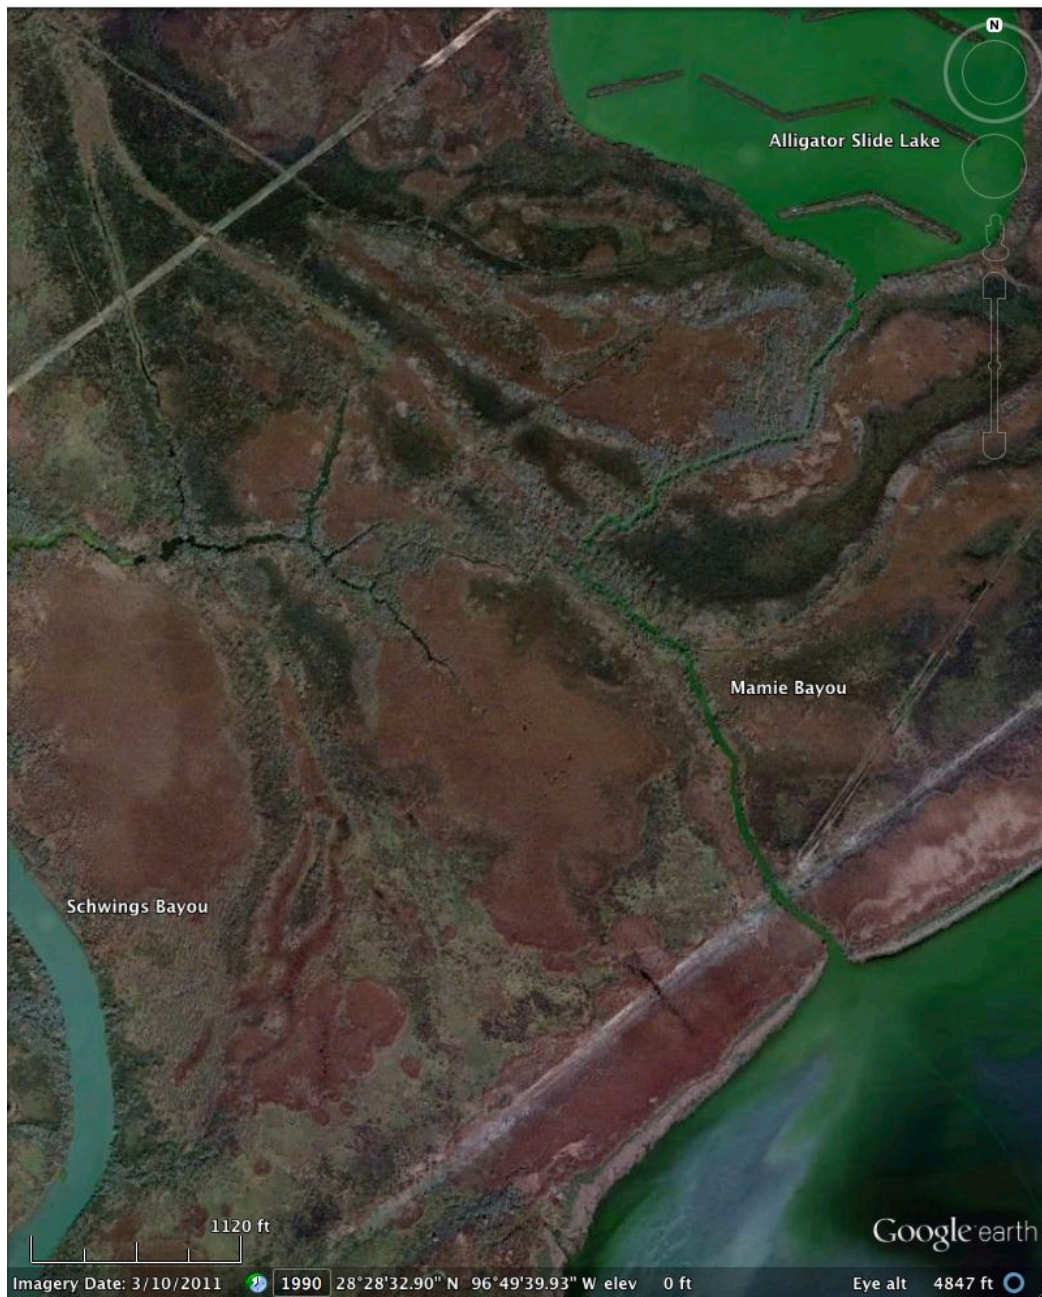
Figure 17 shows that Mamie Bayou provides a clear connection from the south end of Alligator Slide Lake and the north side of Mission Lake. There is a narrow connection between Mamie Bayou and Schwings Bayou, but it is not clear whether this has a preferred flow direction. From the satellite photographs, the connection appears to be minor.

Figure 17. Mamie Bayou, which connects to Alligator Slide Lake and has a very minor connection with Schwings Bayou. This small bayou appears the only relatively unobstructed connection between freshwater and marine water. The color indicates the high algal productivity in the lake is passing through the bayou into the bay. Imagery from Google Earth dated 3/10/2011.

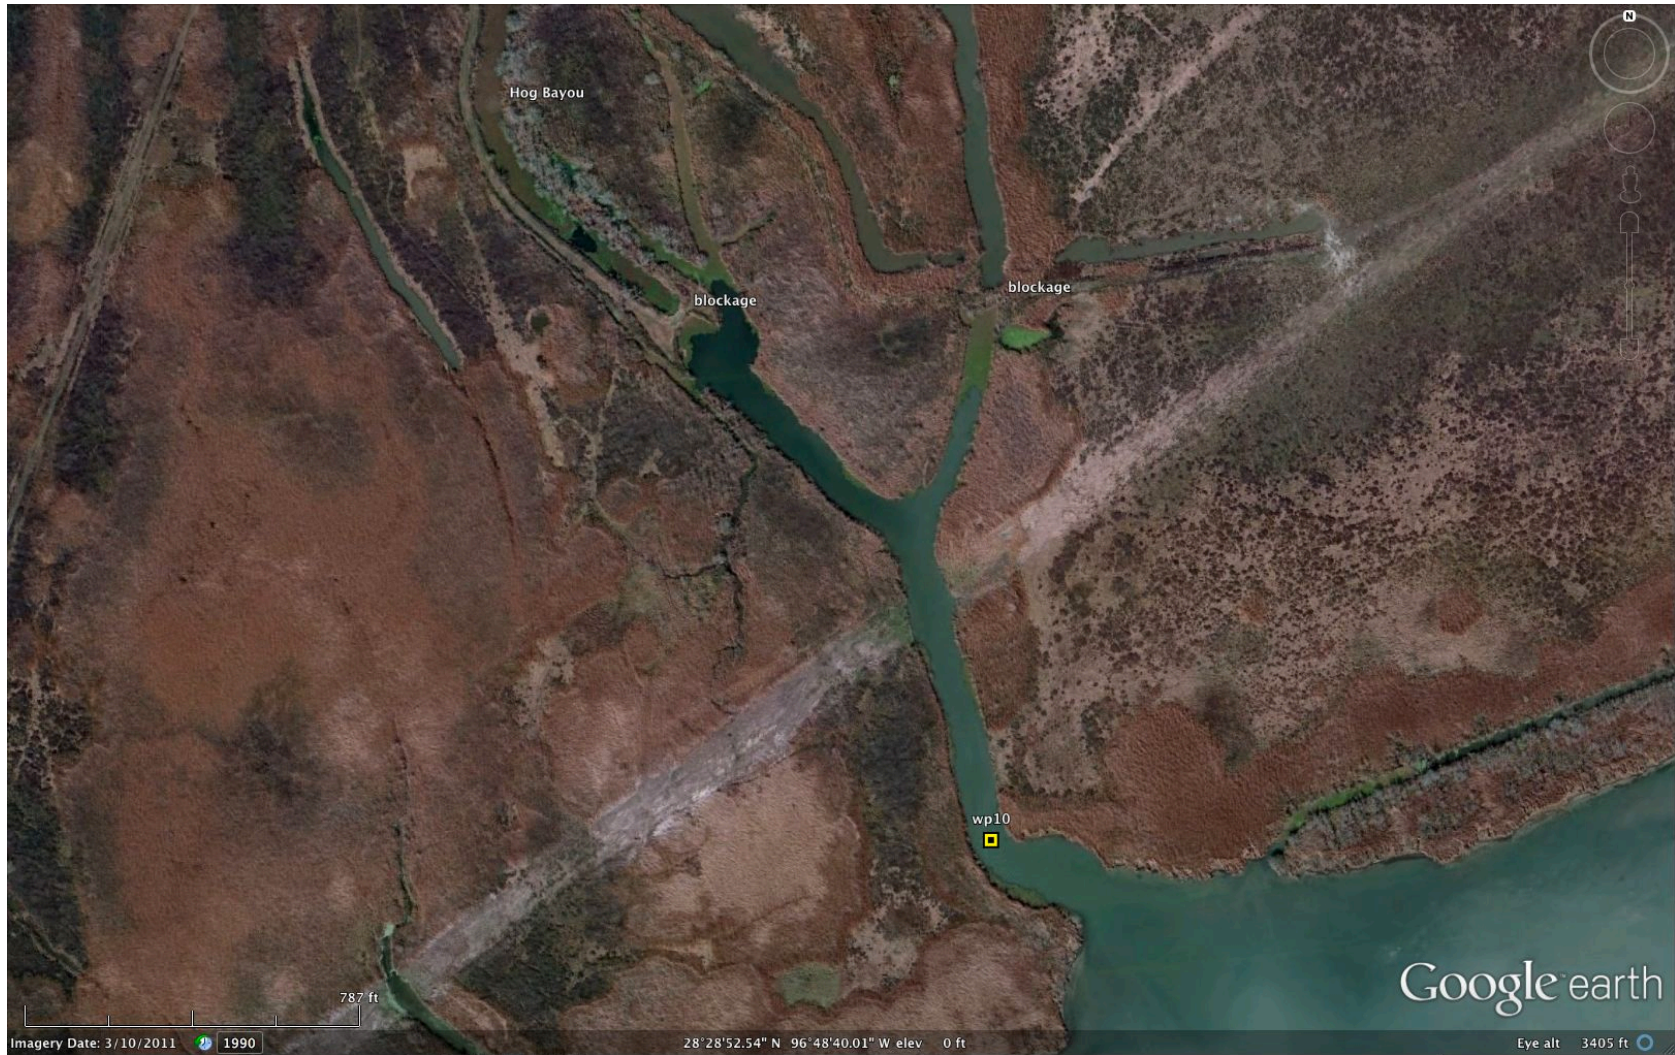
Where Hog Bayou connects with the estuarine waters of Mission Lake (Figure 18), the bayou has been blocked by revetments. It is not clear from these photos whether there are any gates or culverts providing connectivity between the fresh water on the upstream side and the marine waters on the downstream side. Figure 19 shows that the mouth of Hog Bayou was choked by plants on January 10, 2013. Figure 20 shows that the Hog Bayou entrance south of the plant mats was relatively clear.

Figure 18. The mouth of Hog bayou is blocked so that the marine waters do not appear to have a significant exchange with the upstream freshwaters. It is not clear whether there are gates on these blockages. Note the dramatic change of water colors at the blockage indicating flow stagnation and development of plant mats (likely water hyacinth). Imagery from Google Earth dated 3/10/2011.

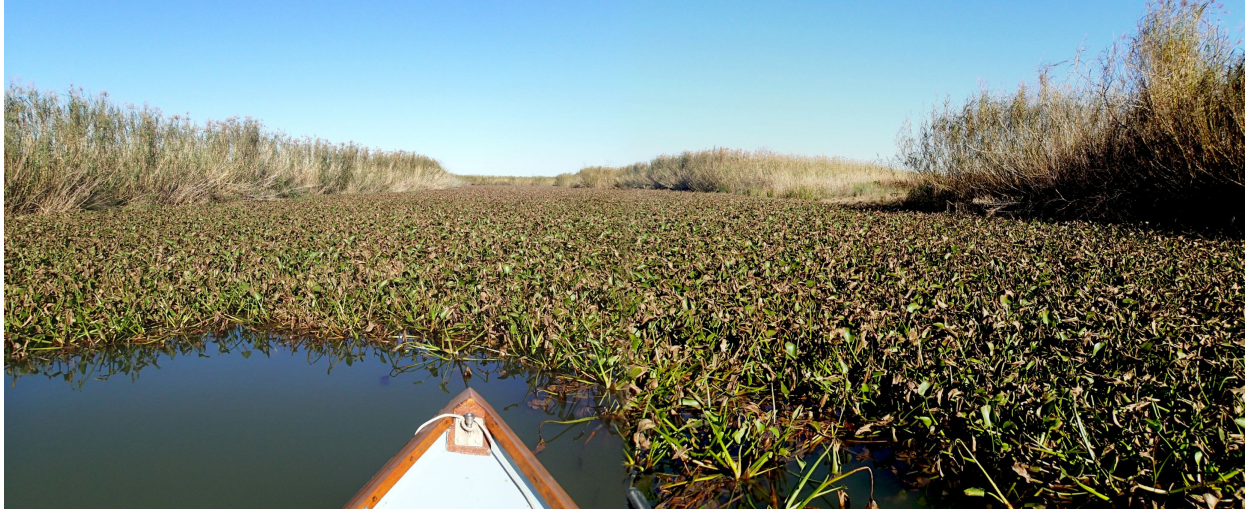
Figure 19. Mouth of Hog Bayou (wp10) choked by plants. Composite panorama photo using DoubleTake software distorts linear relationships. Photograph by Ben R. Hodges, ©2013. File wp010 bNWtoN HogBayouMouth p068to069

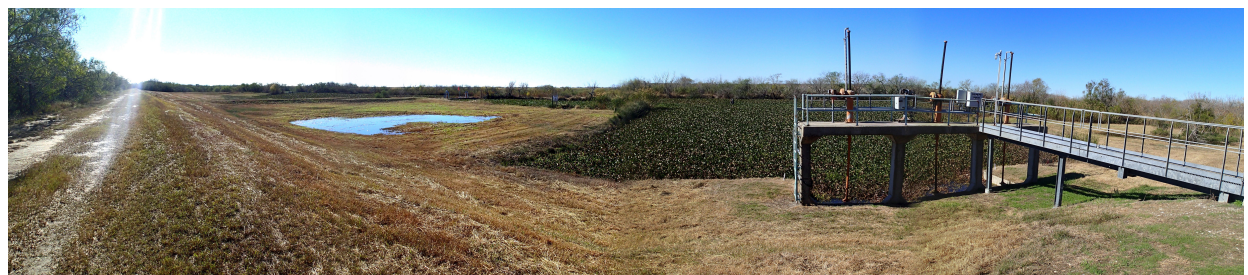
Figure 24. Panoramic view from south to west of Goff Bayou and the gates connecting the bayou to the industrial canals on the opposite side of the Victoria Barge Canal. Goff Bayou is entirely choked with floating plants (appears to be water hyacinth). In center of the photo are the downstream gates at wp14. Composite panorama photo using DoubleTake software distorts linear relationships. Photograph by Ben R. Hodges, ©2013. File wp013 bStoW GoffBayouGates p086to089.

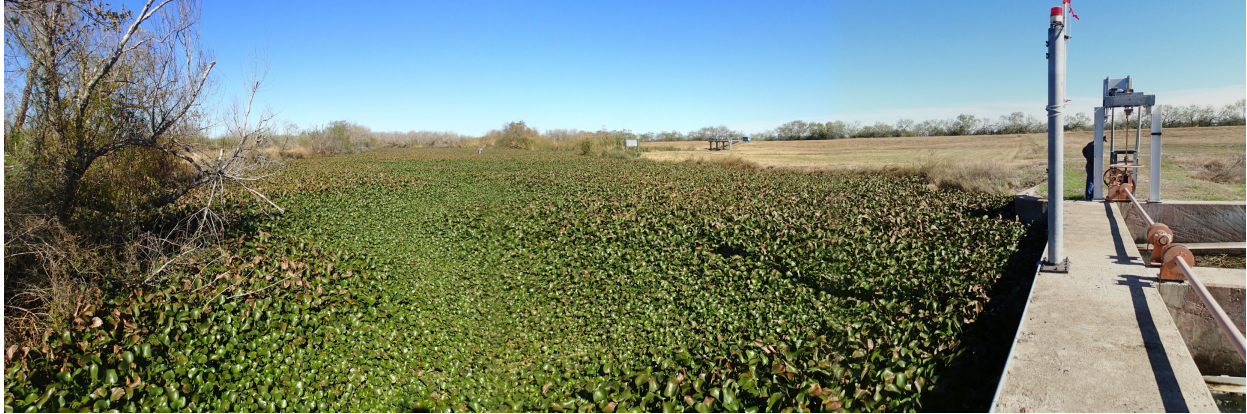
Figure 28. Goff Bayou upstream of gates separating upper and lower portion (wp14). Bayou is completely choked by floating plants (appears to be water hyacinth). Note the gates for the freshwater diversion to industrial canals on the east bank of the Victoria Barge Canal is just visible at center right in the distance. Composite panorama photo using DoubleTake software distorts linear relationships. Photograph by Ben R. Hodges, ©2013. File wp014 bNWtoNE GoffBayouGates p100to102

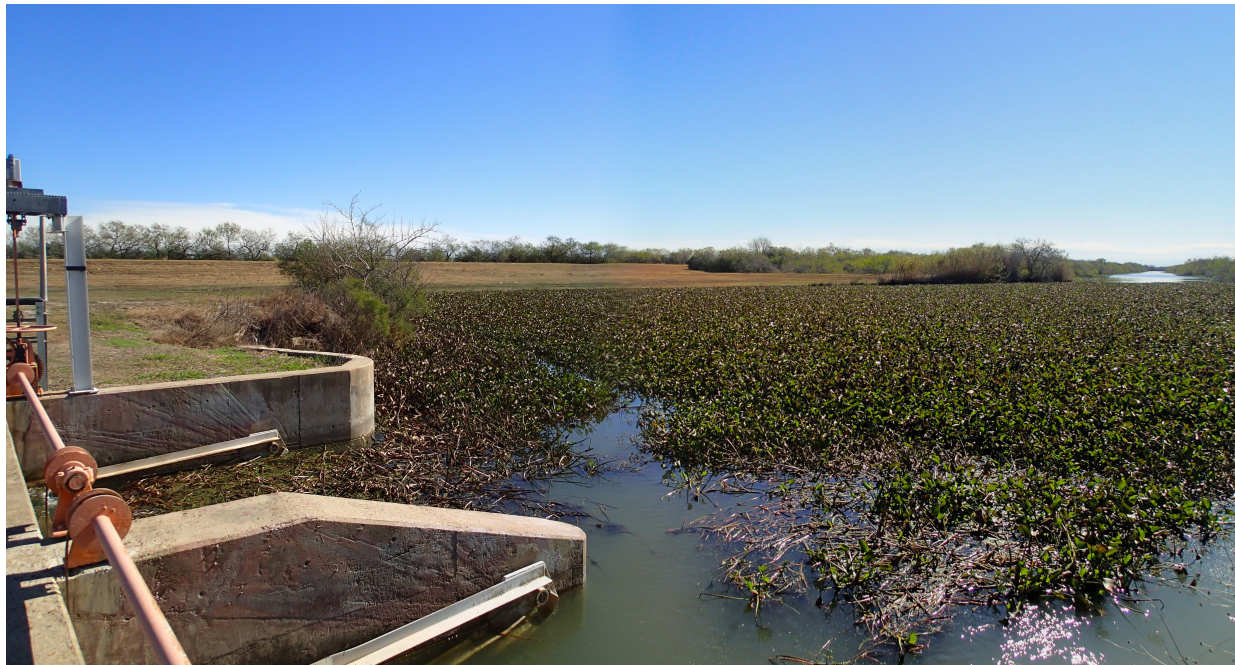
Figure 29. Looking downstream from gates separating upper from lower sections of Goff Bayou (wp14). Note rapid decline of floating plants downstream, likely indicating brackish water with salt in excess of plant tolerance. Composite panorama photo using DoubleTake software distorts linear relationships. Photograph by Ben R. Hodges, ©2013. File wp014 bSSEtoS GoffBayouGates p098to099.
