**Testing of Emergency Wood Shoring Towers for use in Urban Search
and Rescue Operations**

Thesis

The University of Texas at Austin

May 2012

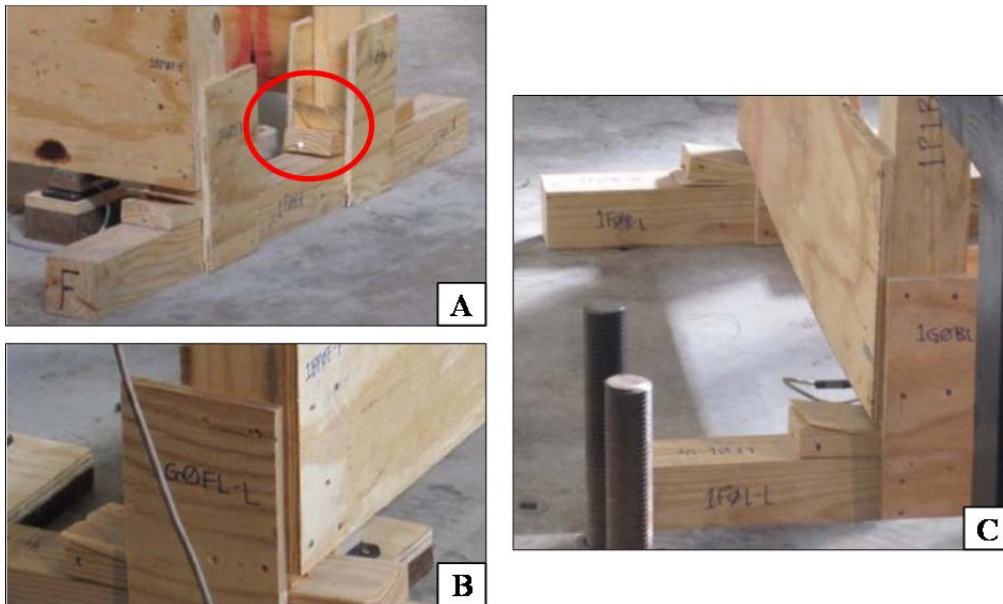
During loading, audible sounds of the wood creaking and cracking were heard from periods of low loads (20-30kips) up to failure. These noises intensified at loads of around 70kips and above. Also visibly noted during testing was the cupping action of some of the wedges. In particular, the two sets of wedges on the right side of the shore cupped to a greater degree than the two sets on the left. This cupping action progressed from approximately 50kips to failure. Figure 5.2 shows the performance of the wedges.

Figure 5.2 Test 1 Wedge Performance A) Right Side Cupping B) No cupping at Front Left C) Minor Cupping of Back Right

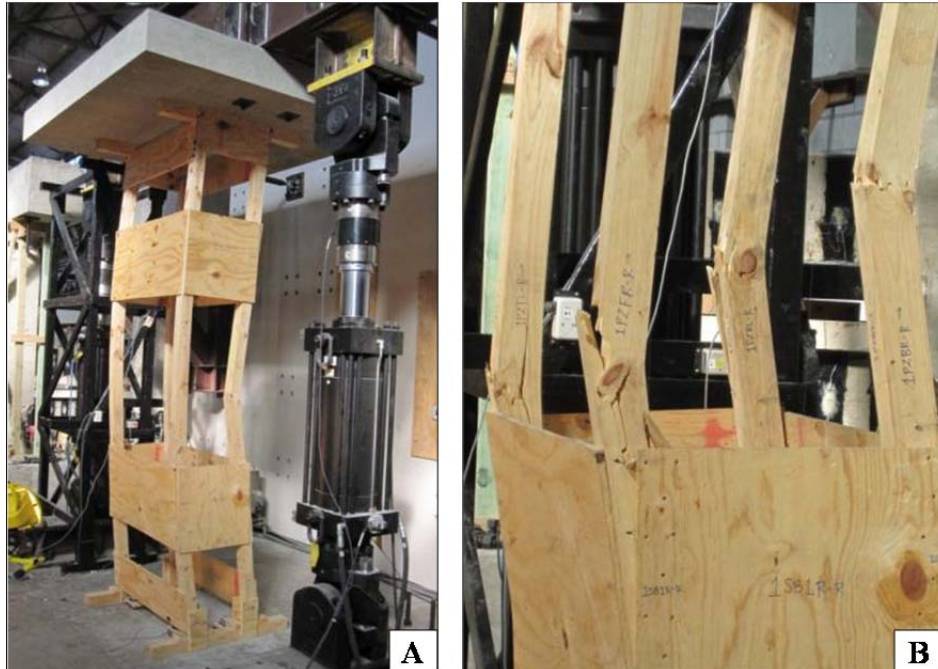
Prior to failure, all four posts began to bow outward towards the front. The first failure occurred at a knot in the back right post at approximately the midpoint between the intermediate braces at a total vertical load of 65kips. The front right post also cracked around a spike knot just above the lower intermediate brace at 65kips and progressively split as loading continued. At approximately 32kips, the two left posts simultaneously failed at knots. This load progression is presented using the load-displacement curve in Figure 5.3. Photographs of the failures are also provided.

Figure 5.4 Test 1 A) First Failure and Bowing of Posts B) All Post Failures

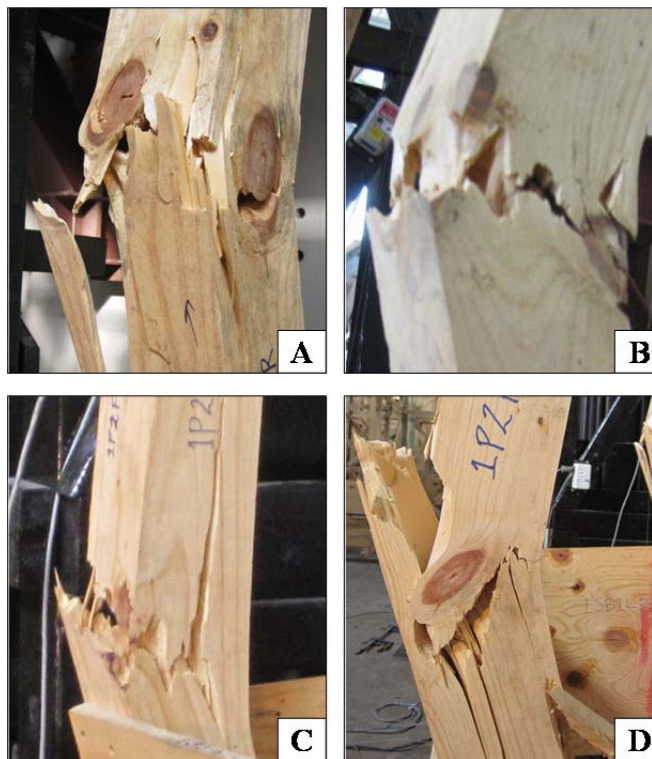
Figure 5.6 Post Failures A) Back-Left B) Back-Right
C) Front-Left D) Front-Right

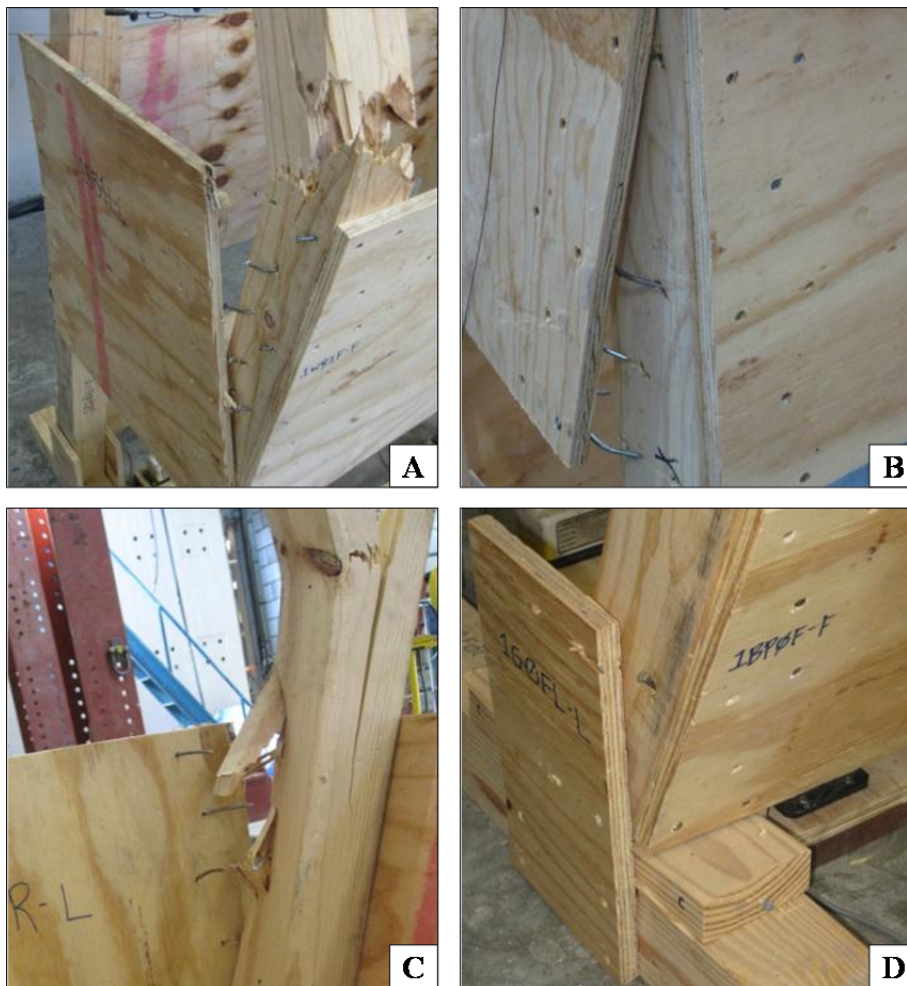
All brace failures were at the connections, not within the plywood section. Failure of the braces consisted of nail withdrawal in the direction of the post bowing. In some cases the nails withdrawal from the posts and in others the nails pulled through the plywood cross-section. Connections of the half-gusset plates also pulled through as the posts rotated about the wedges. Figure 5.7 shows the different types of connection failures in shore 1.

Figure 5.7 Connection Failures A) Pull Through B) Pullout C) Post Splintering D) Half-Gusset Rotation and Pull Through

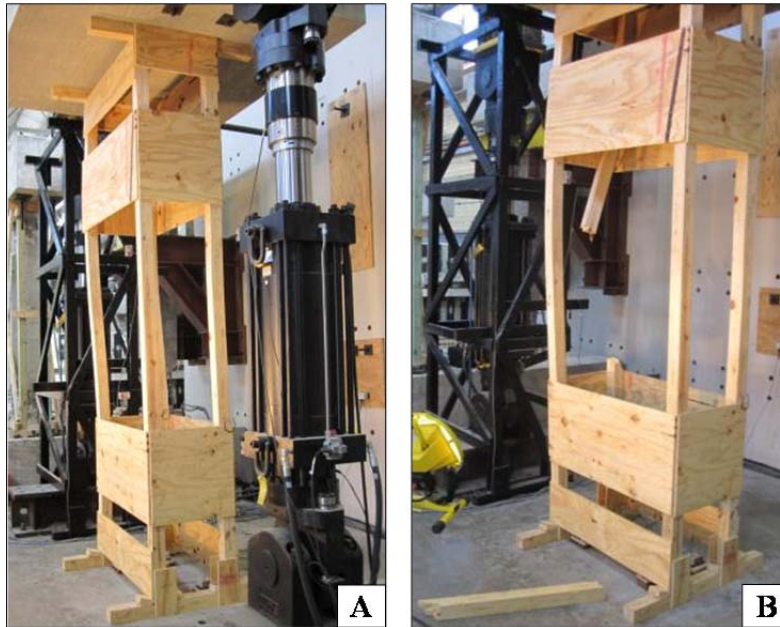
Photographs of each post failure are included in the following figures. It is interesting to note that all three failures were unique and did not follow the same one-directional buckling failure as was seen in test 1. Failures 1 and 2 included multiple points of fracture and the failure planes were 90 degrees from one another.

Figure 5.10 Specimen 2 A) Left Post Buckling B) First Failure

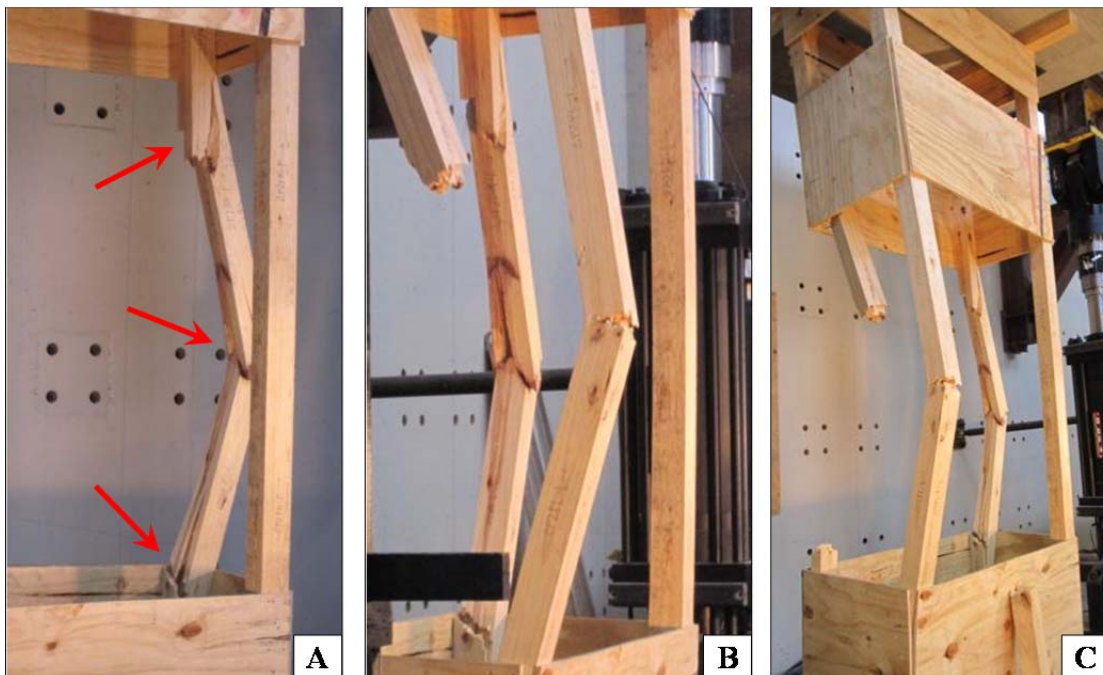
Figure 5.11 Specimen 2 A) Second Failure B) Third Failure C) End of Test Condition

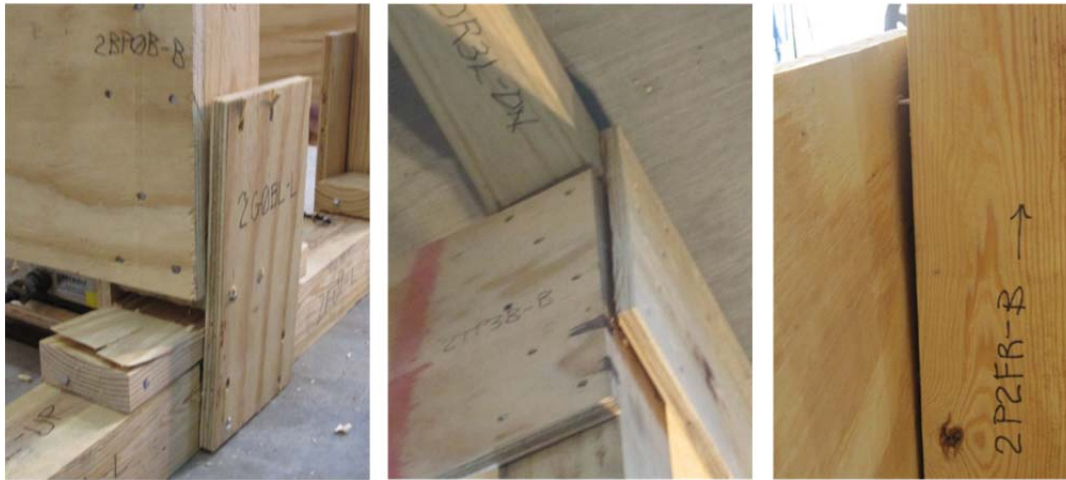
Figure 5.13 Samples of Minor Pullout from Specimen 2

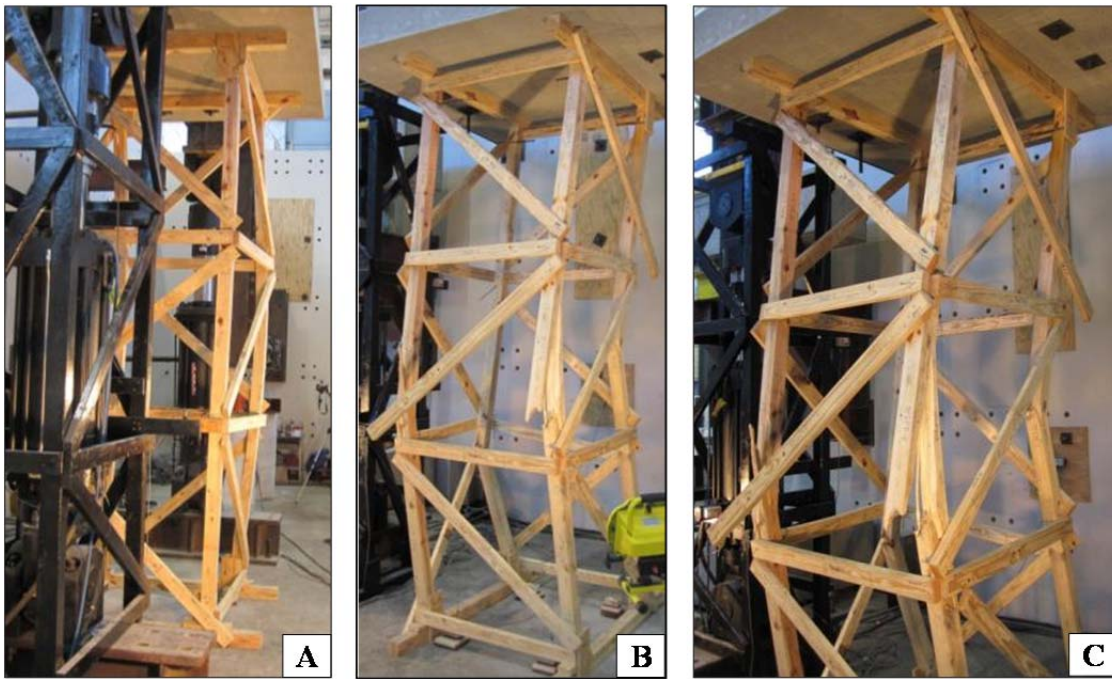
Bowing of the right posts prior to failure and the failures of all four posts are displayed in Figure 5.15. The buckling plane of the third failure (back left) was to the left whereas the buckling planes of the other three posts were towards the front, as seen in Figure 5.15-B.

Figure 5.15 Specimen 3 A) Bowing of Right Posts before Failure B) End of Test Condition C) Close-up of All Four Post Failures

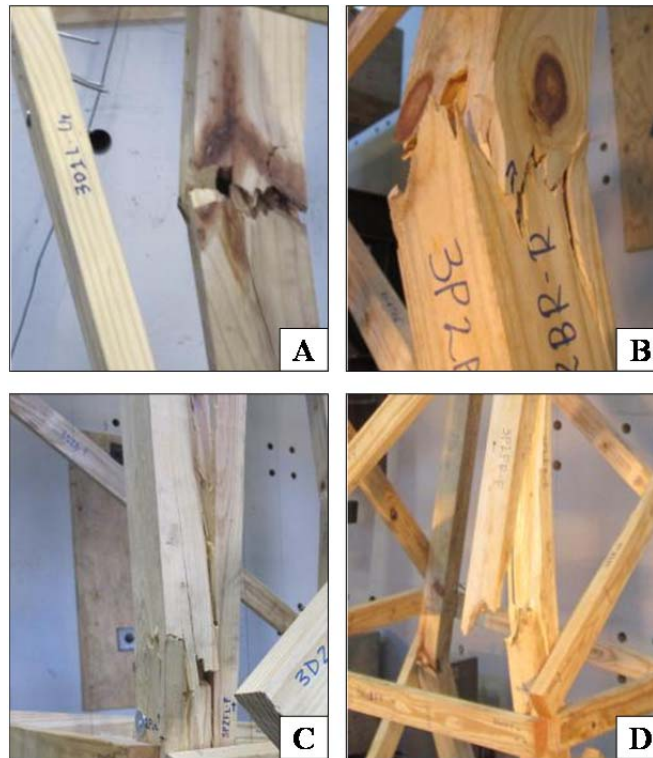
The load-displacement plot is shown in Figure 5.16. Figure 5.17 shows a close-up view of each of the four post failures. Each failure occurred at a knot in the post.

Figure 5.17 Post Failures A) Back Left B) Back Right C) Front Left D) Front Right

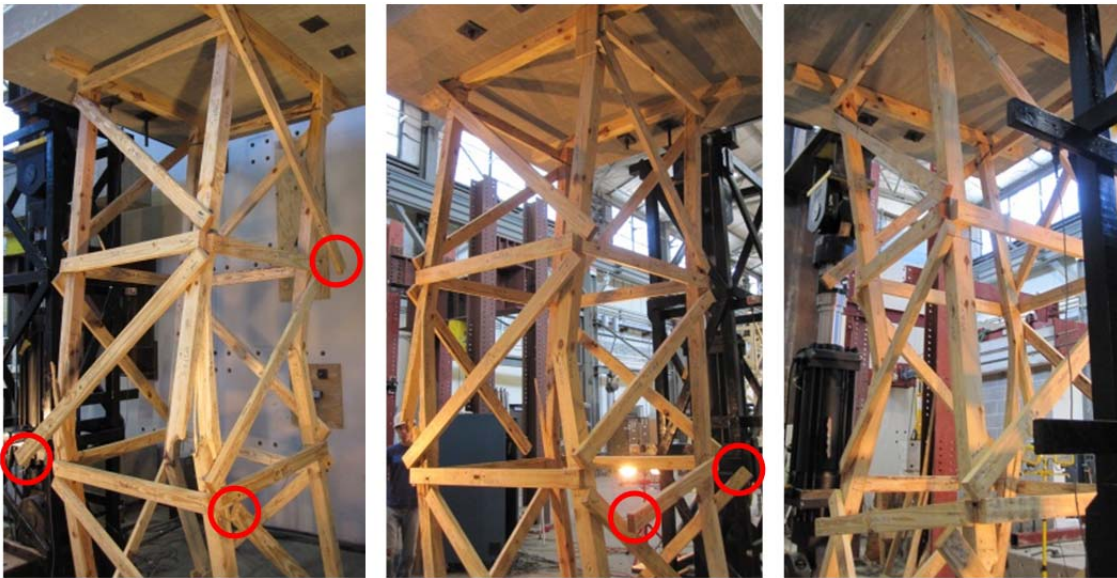
Multiple 2x4 brace connections failed during the extent of the test. Connection failures generally consisted of nail pullout due to splitting of the brace, or nail withdrawal from the post. The five connections that failed were: first level diagonal on left side (3D1L), first level diagonal on right side (3D1R), first level horizontal on back (3Hz1B), second level diagonal on front (3D2F), third level diagonal on right (3D3R). A partial nail withdrawal from the post was also observed on the third level diagonal on the left side (3D3L). The following photographs illustrate the locations of the failed braces and close-up images depicting a typical pullout scenario.

Figure 5.18 Photographs of the Five Brace Connection Failures at End of Test

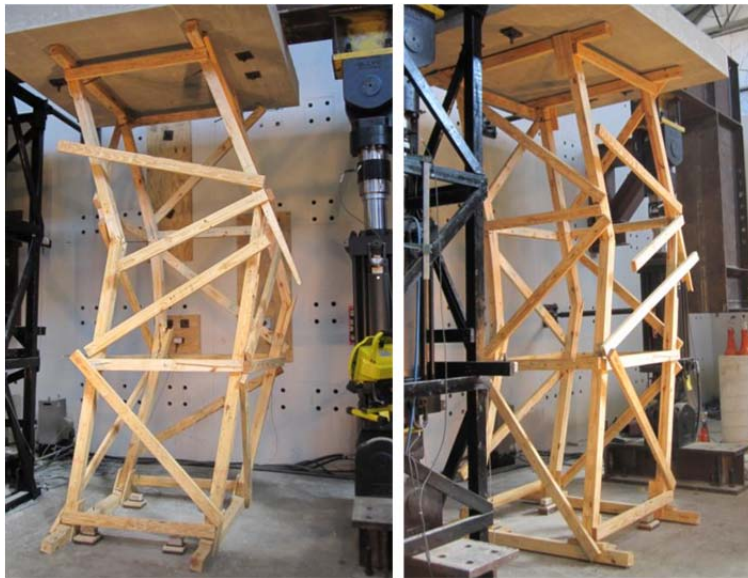
As the peak load was reached, the two back posts buckled to the right, followed closely by the buckling of the front two posts. The failure of all four posts occurred in approximately one second, in contrast to the progressive failures of the displacement-controlled tests. The load-displacement plot and post-failure photographs of test 4 are included in the following figures.

Figure 5.22 Specimen 4 Failure Photographs at Conclusion of Test

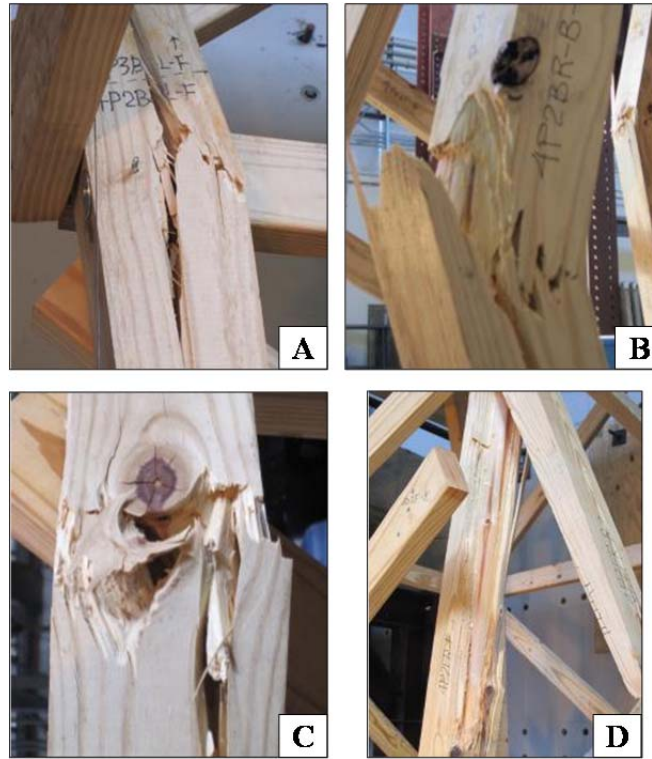
Figure 5.23 Post Failures A) Back-Left B) Back-Right C) Front-Left D) Front-Right

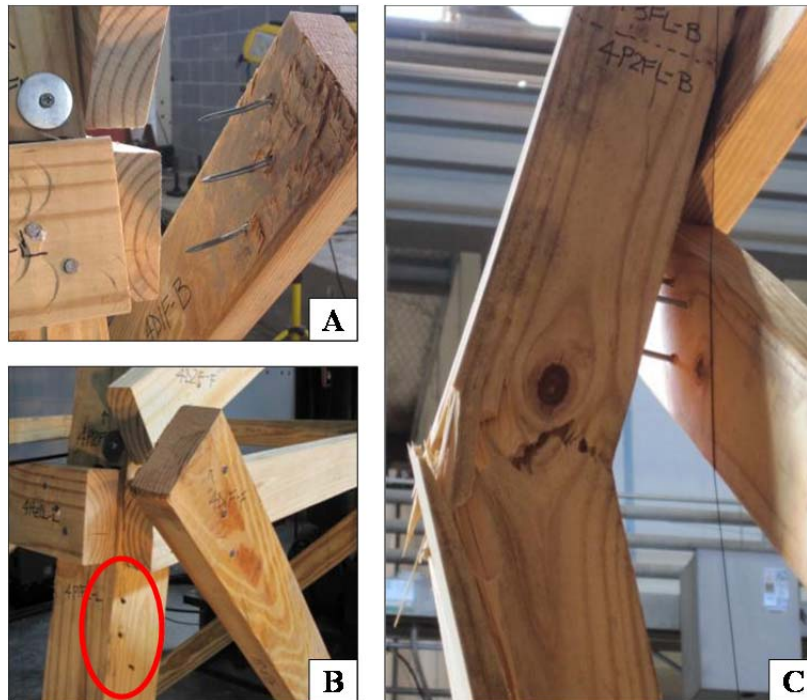
Figure 5.25 Specimen 4 Connection Failures A) Nail Pullout B) Nail Pullout Holes C) Partial Pullout on Left Side

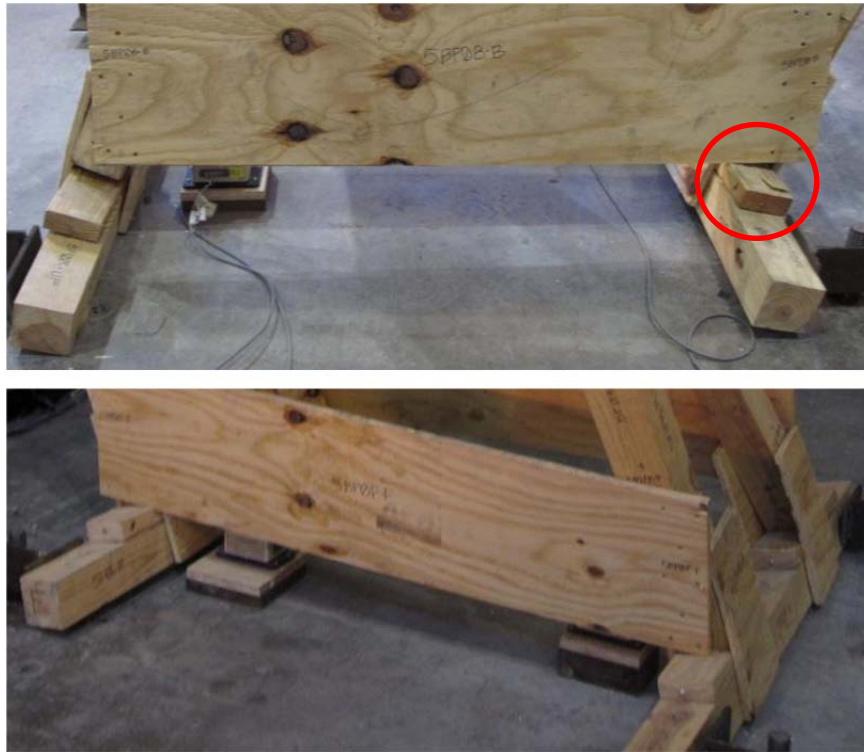
Wedge cupping was relatively absent throughout the entire loading sequence. Longitudinal wedge splitting was observed, but vertical cupping was not witnessed. Figure 5.26 shows the condition of the wedges at the conclusion of the test.

Figure 5.26 Photographs of Wedges at the End of Test

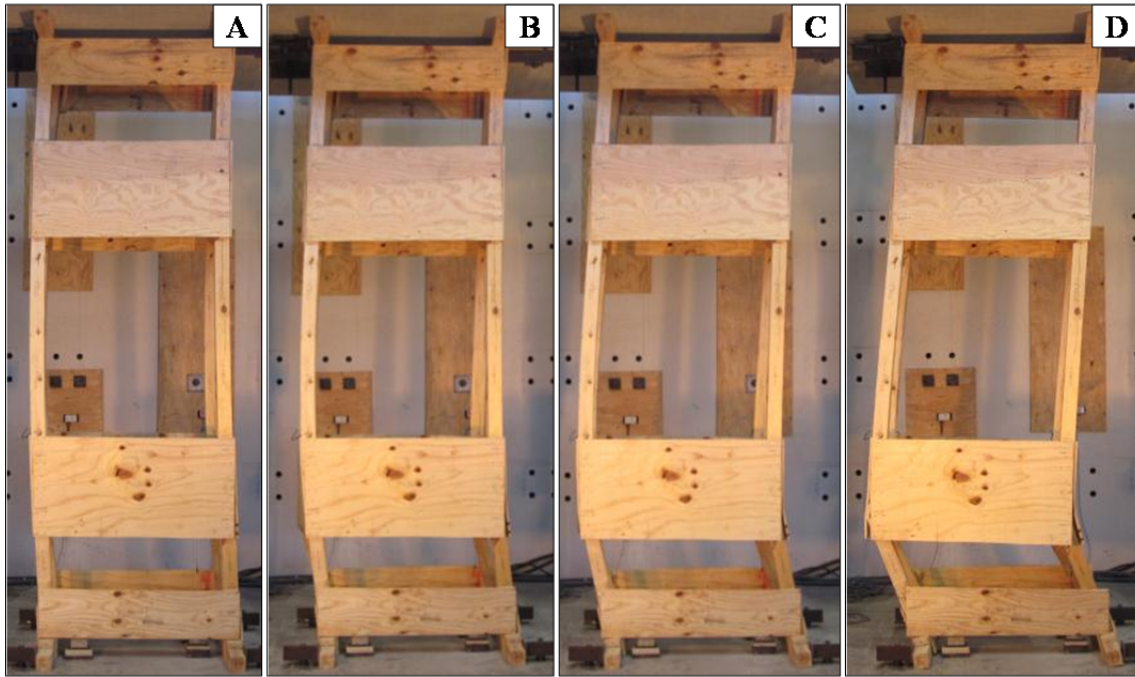
Rather than bending in double curvature as was seen during the lateral displacement phase of the test, the posts buckled in single curvature under the increasing vertical load. At approximately 62kips, both back posts failed at relatively the same time in the region of the lower intermediate plywood brace. The front two posts failed around 26kips in the same direction as the back two posts. Figure 5.32 shows the progressive failure and Figure 5.31 shows the vertical load-displacement plot for the entire duration of the test. Vertical loading conducted after the completion of the cyclic phase is shown to the right of the dashed red line.

Figure 5.32 Specimen 5 Failure Progression A) Bowing of Posts B) Back Posts Fail
C) Front Posts Fail D) Final Condition at End of Test

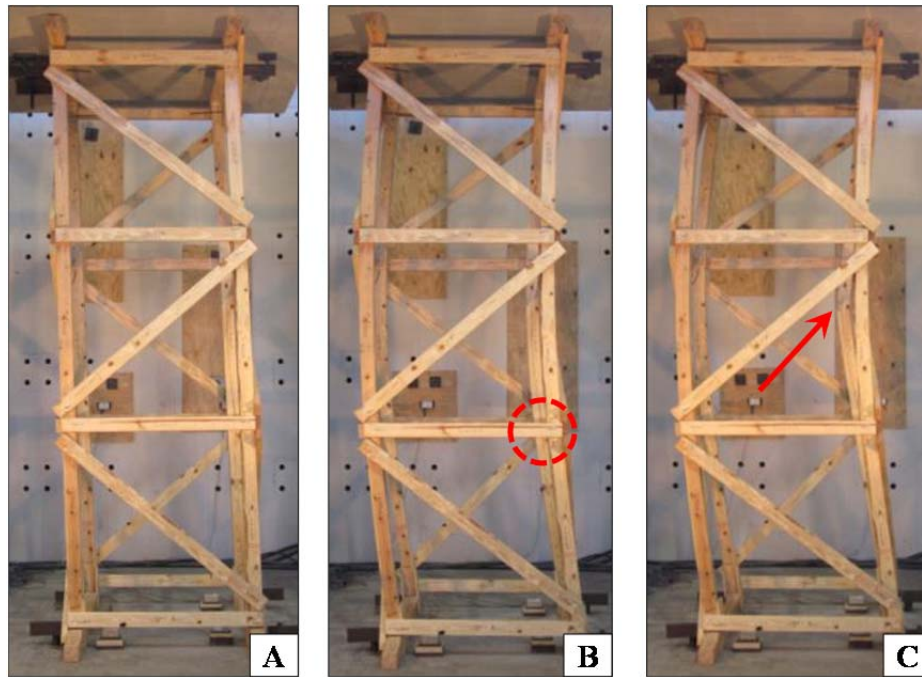
The first failure was a connection failure of the 1st level diagonal on the back side at the back right post. As the maximum load was attained, the top end of the diagonal withdrew from the back right post allowing substantial bending deformation of the post to occur. This connection failure and buckling behavior is depicted in Figure 5.37 as the instantaneous loss of capacity followed by a short re-stiffening of the shore between 55 and 65kips. The first buckling failure of a post occurred in the back-right post at approximately 41kips. Both front posts failed simultaneously at approximately 30kips. A pictorial representation of the different phases of testing and initial failures is presented in Figure 5.36 below.

Figure 5.36 Loading Specimen 6 A) Initial 6in Displacement Prior to Loading B) 1st Connection Failure C) Back Right Post Failure

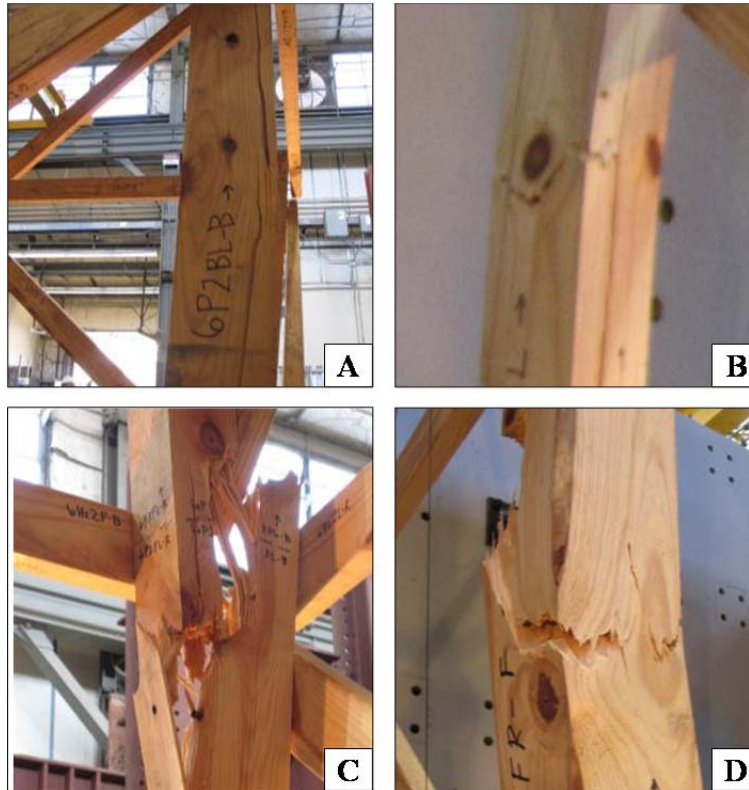
The back left post split longitudinally up the post, but was not recognized until the post-loading autopsy. This split can be seen in Figure 5.39-A.

Figure 5.39 Detailed Photographs of each Post Failure A) Back Left B) Back Right C) Front Left D) Front Right

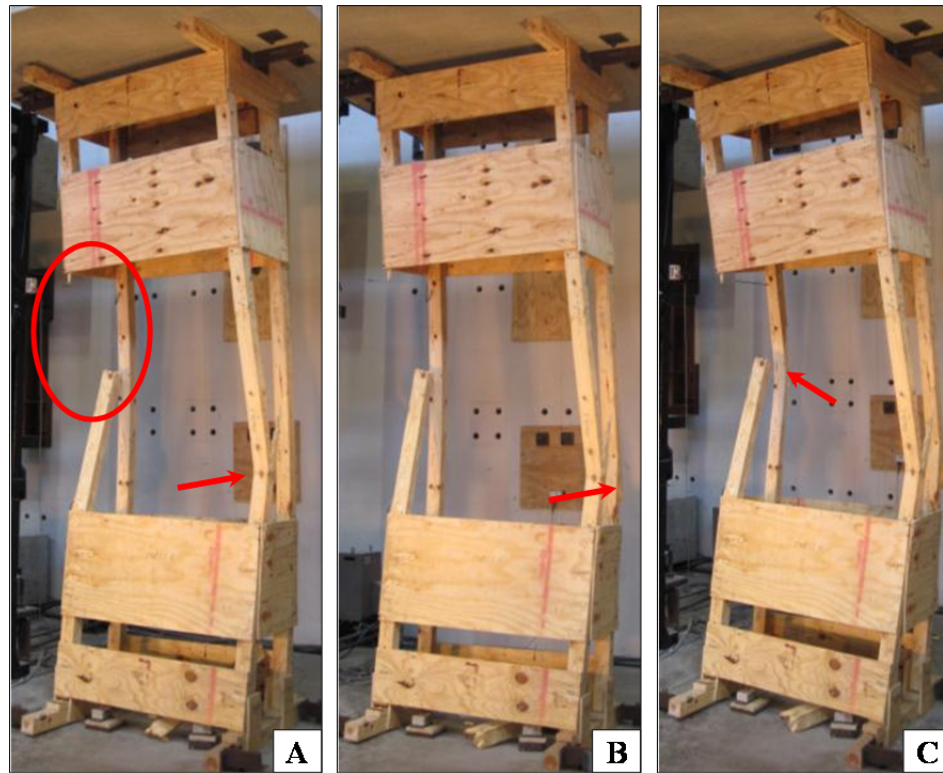
Figure 5.43 Failure Modes A) Initial Failures B) 3rd Failure C) 4th Failure

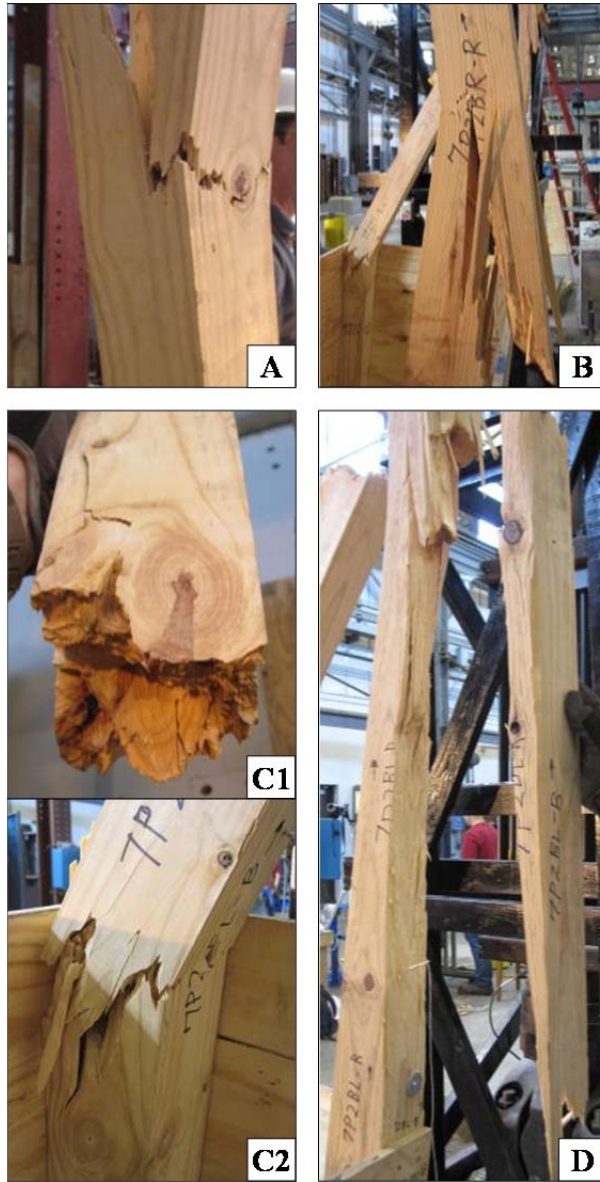
Figure 5.44 Failure Photographs A) Front-Right Post B) Back-Right Post C1) Top Failure of Front-Left Post C2) Bottom Failure of Front-Left Post D) Back-Left Post

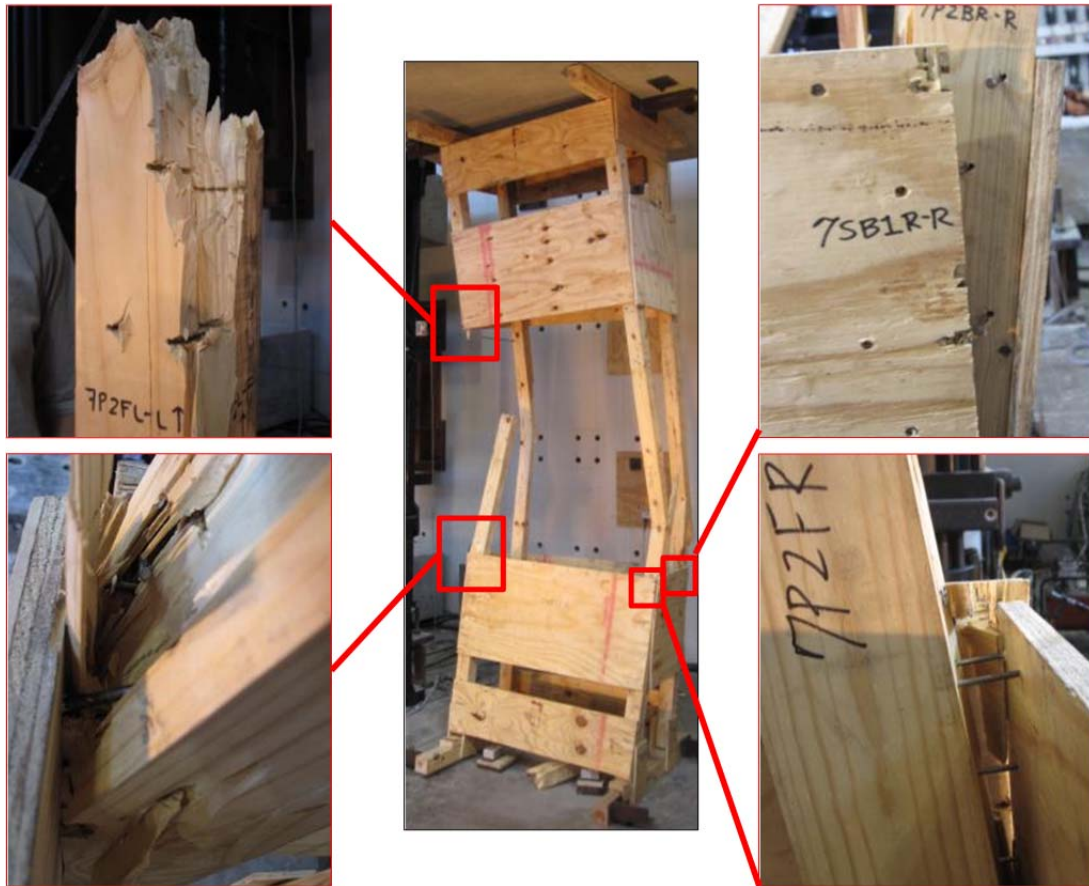
Figure 5.45 Regions of Significant Brace Connection Failures

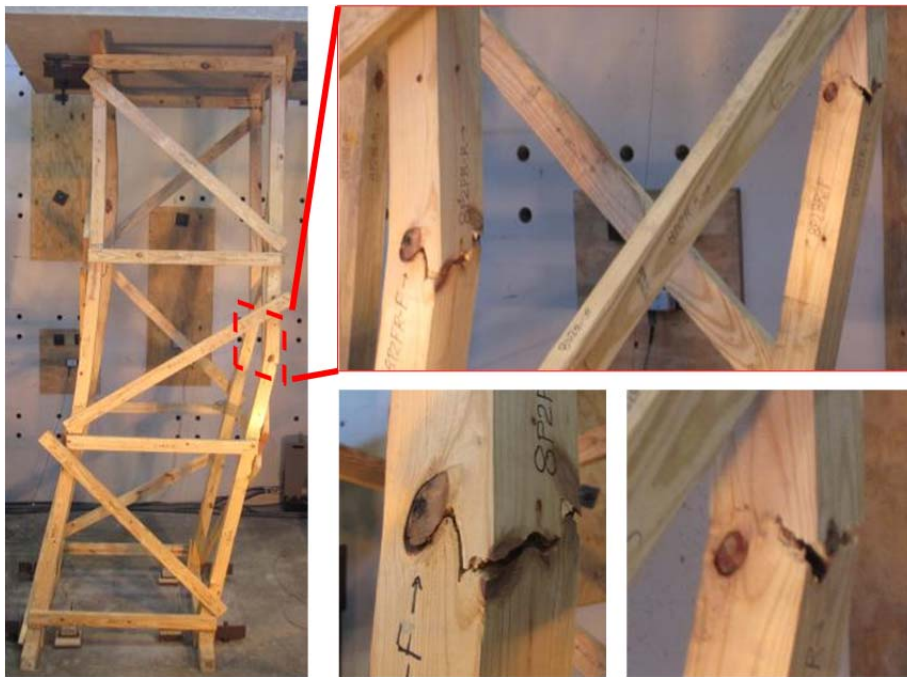
Figure 5.50 Photographs of Right Side Post Failures

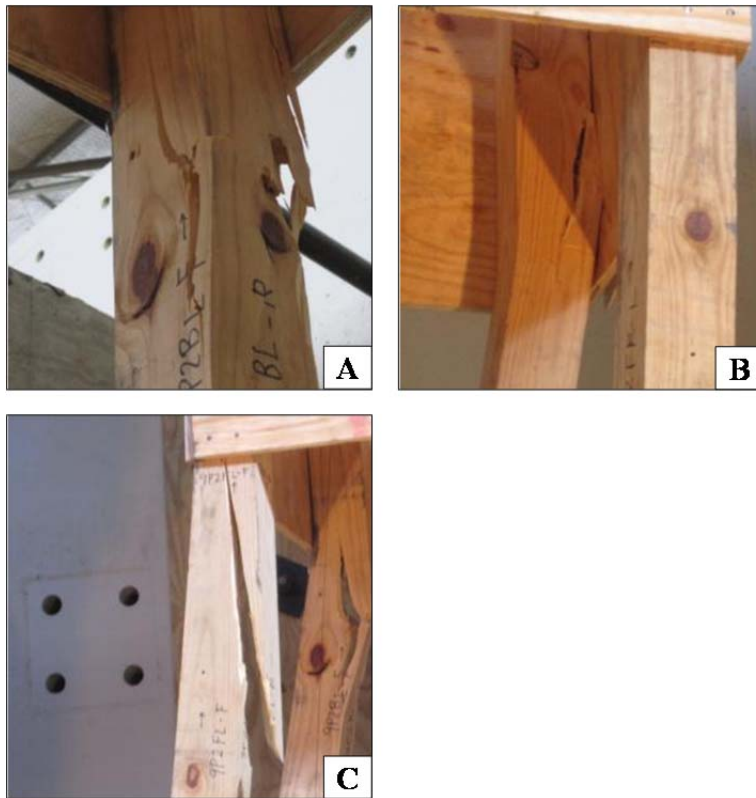
Figure 5.58 Individual Post Failures A) Back Left Post
B) Back Right Post C) Front Left Post

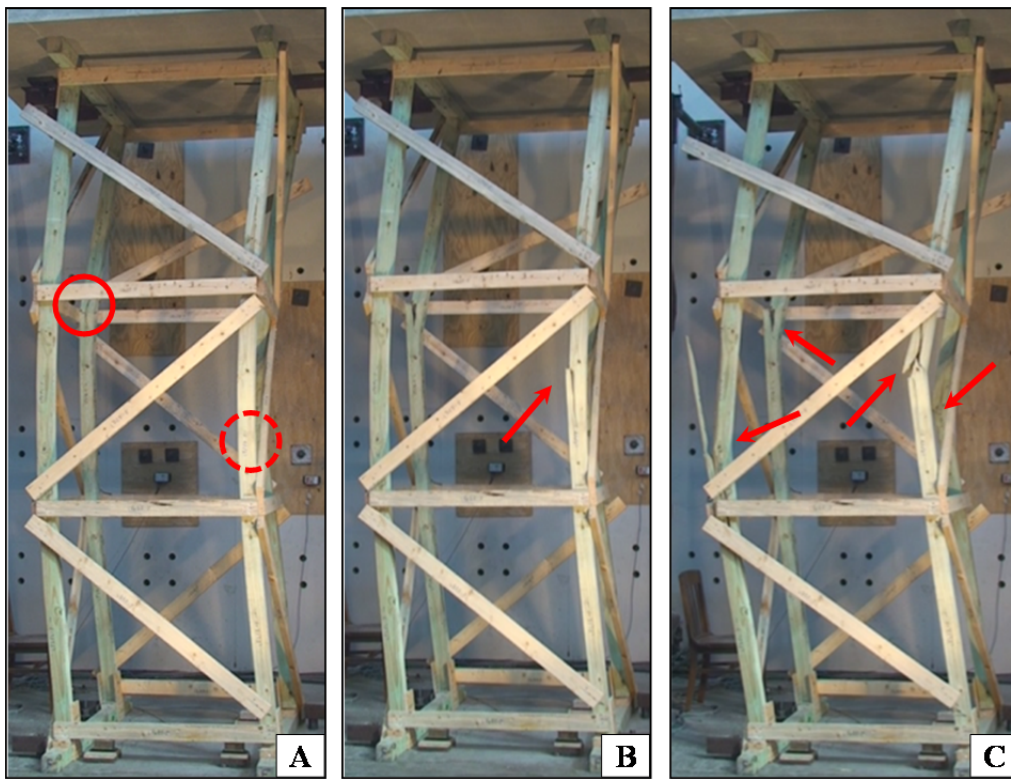
Figure 5.64 Post Failures A) Initial Failures B) Secondary Failure C) Final State

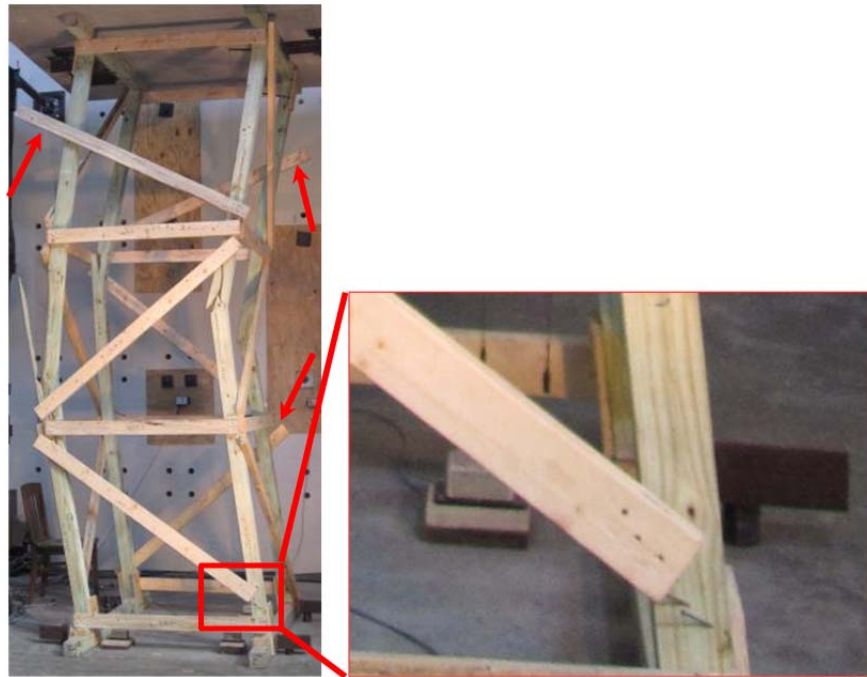
Figure 5.66 Diagonal Brace Connection Failures

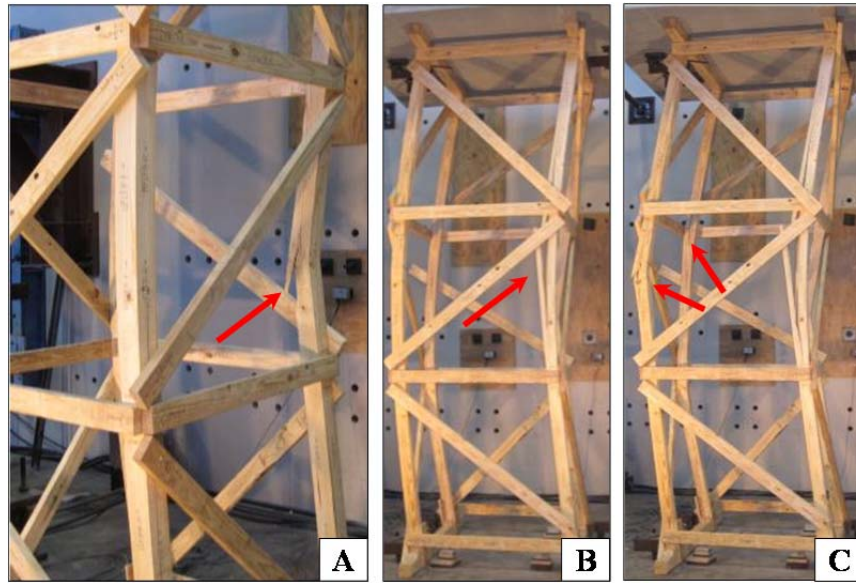
Figure 5.71 Failure Sequence A) 1st Failure B) 2nd Failure C) Final Failures

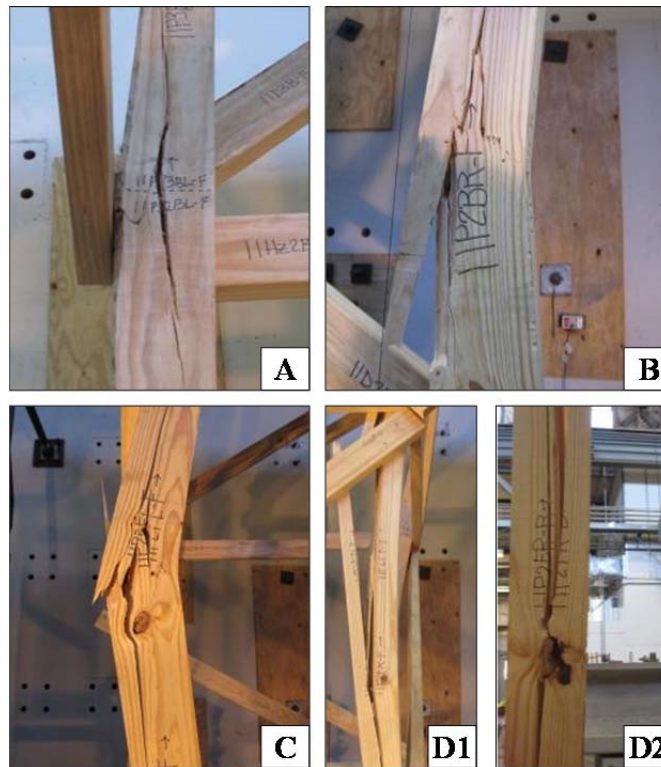
Figure 5.72 Failures A) Back Left Post B) Back Right Post C) Front Left Post D1) Front Right (Front) D2) Front Right (Back)

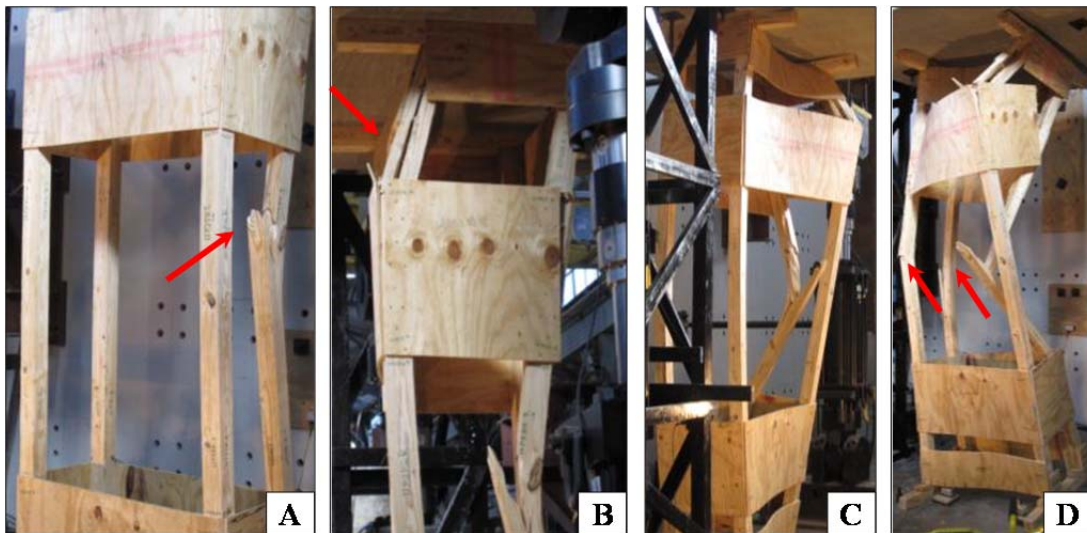
Figure 5.76 Failures A) 1st Failure B) 2nd Failure C) Excessive Torsional Buckling of Braces, Excessive Deflection D) Final Failure of Left Posts

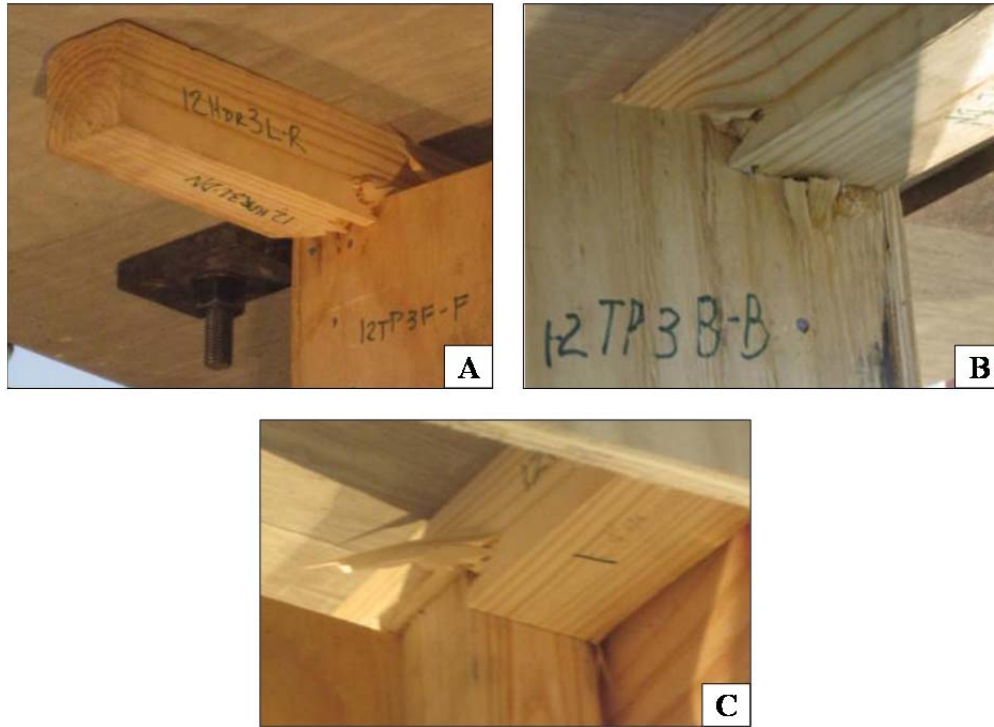
Figure 5.79 Bearing Into Left Header A) Front Left B) Back Left C) Front Left
(Interior)

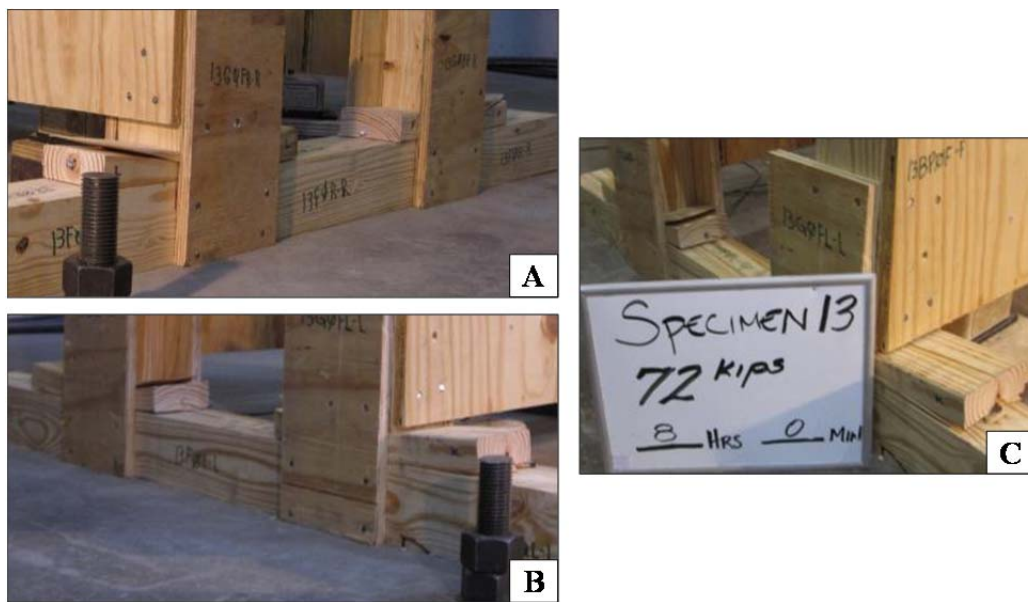
Figure 5.80 Wedge Performance with 72kip Load A) Right Side at 0.0hrs
B) Left Side at 0.0hrs C) Left Side at 8.0hrs

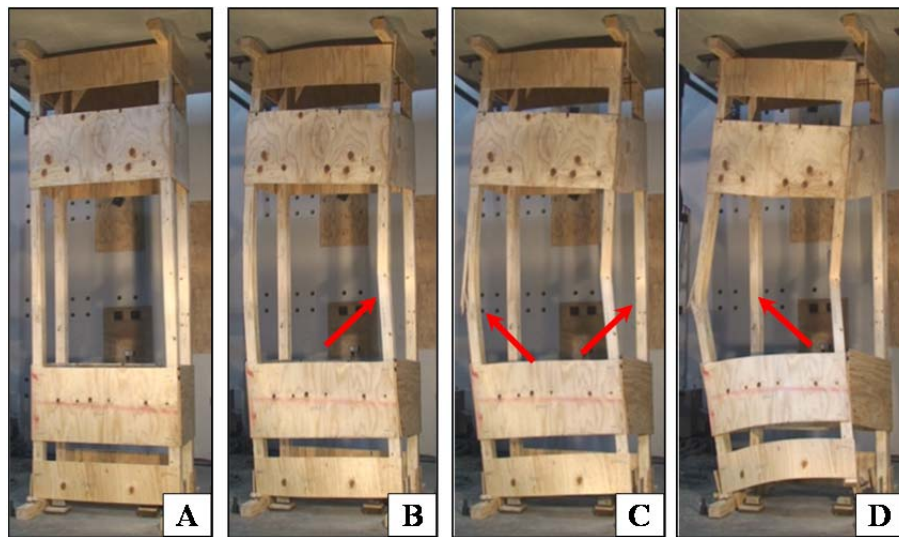
Figure 5.82 Progressive Failures A) 72kips B) 1st Failure C) Front Left and Back Right Posts Fail D) Back Left Post Fails (End of Test)

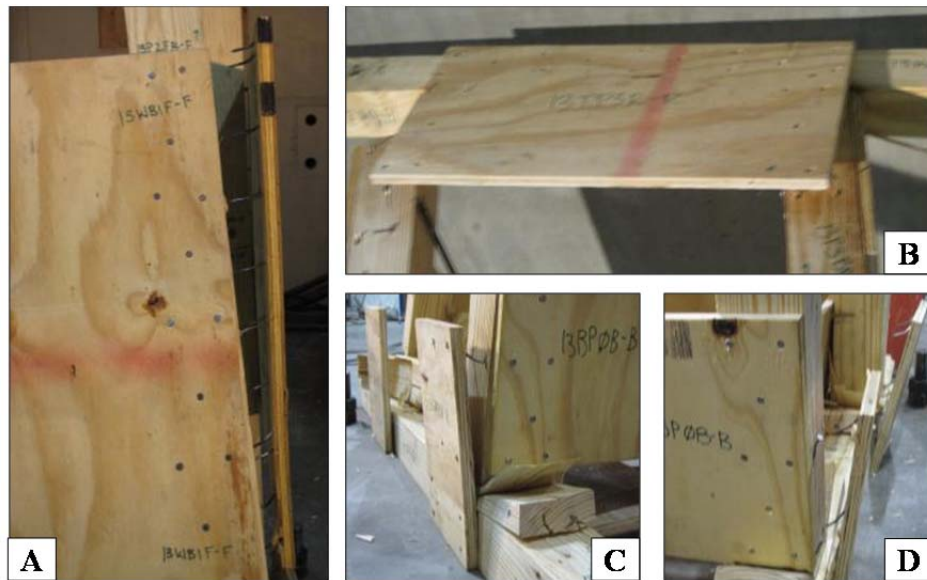
Figure 5.84 Brace Failures A) 1st Level Brace on Right Side B) Top Plate on Right Side C) Gusset Plates on Right Side D) Gusset Plates on Left Side

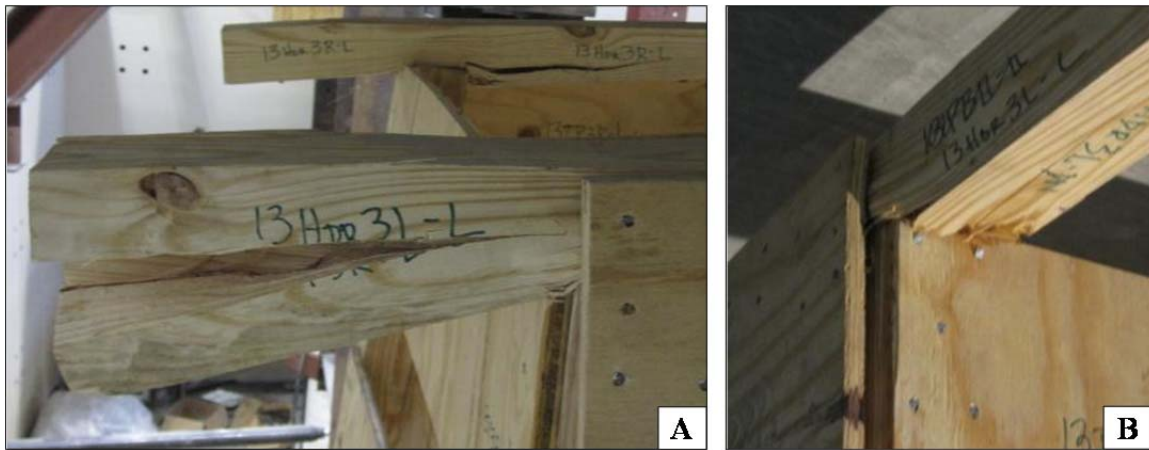
Figure 5.85 Condition of the Headers A) Split Left Header (foreground) and Split Right Header (background) B) Bearing of Left Front Post into Left Header
