**Analysis, Testing, and Load Rating of  
Historic Steel Truss Bridge Decks**

**Charles Merrill Bowen, B.S., M.S., M. Eng.**

**Dissertation**

**The University of Texas at Austin**

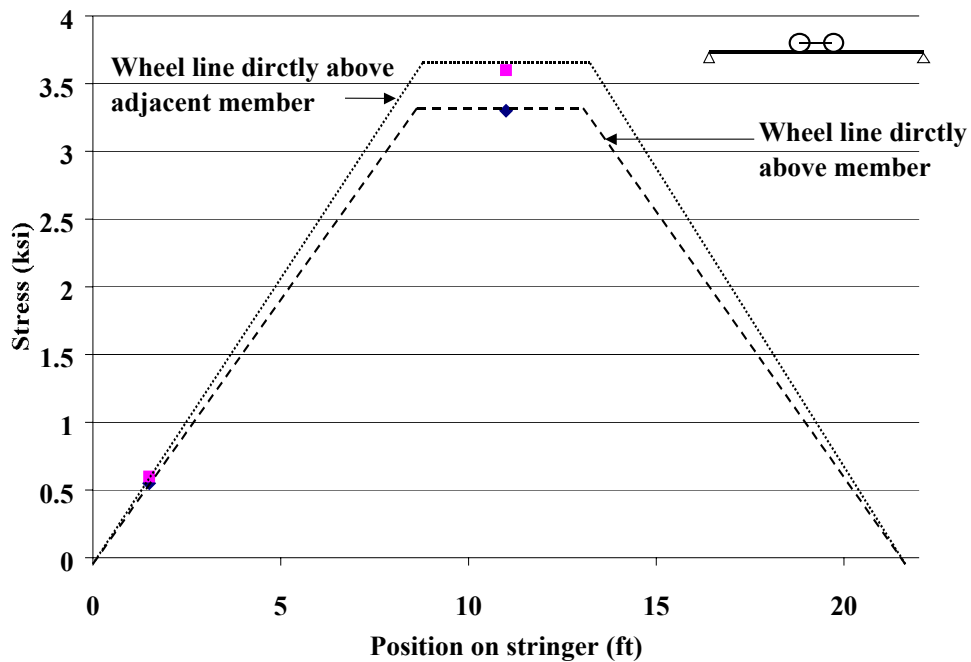
*Figure 4.27 Stress along length of stringer S7*

Results from the first Llano test also suggest there was little restraint at the ends of the longitudinal stringers. Stringer S7 was gaged approximately 18" in from the connection and also at midspan. Figure 4.27 shows a plot of the stresses for a load test with the wheel line directly above the member and for a wheel line directly above the adjacent member. Modeling the tandem acting as two point loads centered around the midpoint of the beam, the expected moment diagram along the length of the beam would be as shown in the dashed lines in Figure 4.27. Again, the extrapolated stresses at the ends of the member suggest little if any fixity at the connections.

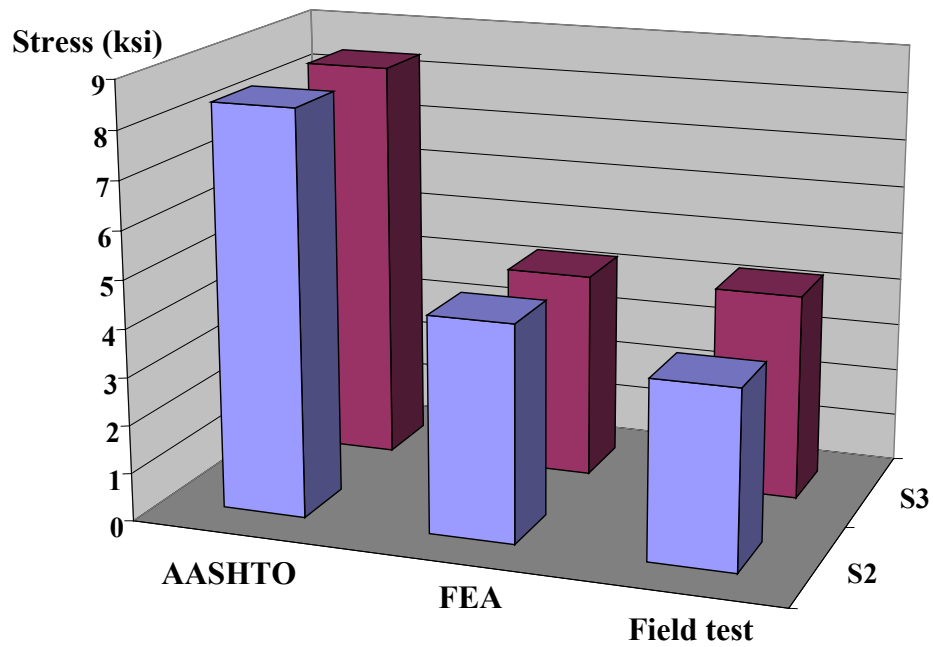
**Figure 4.31 Stress comparisons for longitudinal stringers S2 and S3**

<b>Member</b>	<b>AASHTO</b>	<b>FEA</b>	<b>Field test</b>	<b>FEA/AASHTO</b>	<b>Field/AASHTO</b>
<b>S2, S5</b>	8.4 ksi	4.5 ksi	3.6 ksi	53.6%	42.9%
<b>S3, S4</b>	8.4 ksi	4.3 ksi	4.1 ksi	51.2%	48.8%
<b>B2</b>	8.4 ksi	6.8 ksi	5.1 ksi	80.9%	60.7%

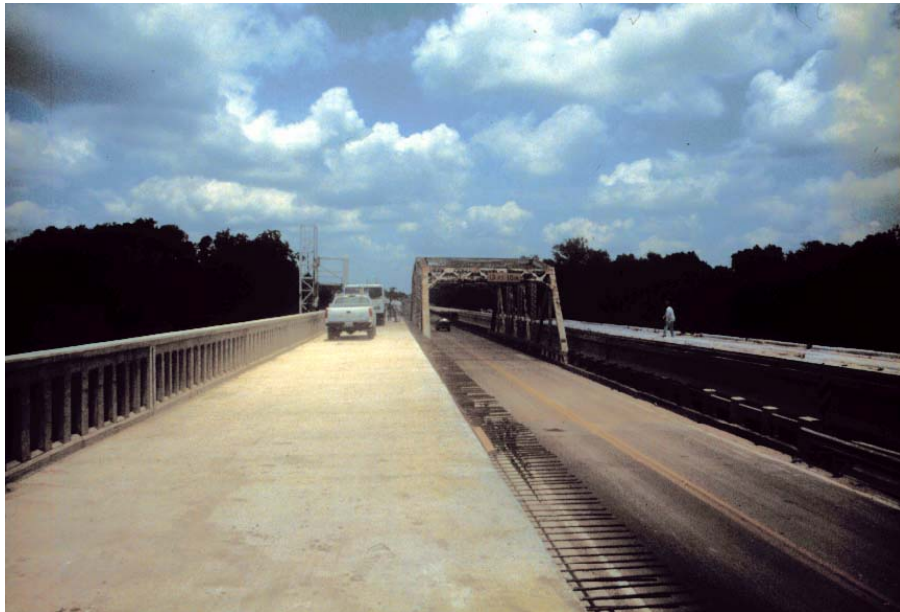
Figures 5.2 and 5.3 show the new bridge during construction, and after completion. Reinforcement steel can be seen protruding from the side lanes, ready to tie the future center lanes together. Figures 5.4 and 5.5 show the replacement bridge after completion.

*Figure 5.2 Lanes built around the original bridge*

*Figure 5.3 Detail showing connecting rebar*

The Goliad truss bridge is located on US Highway 183 and crosses the San Antonio River. The truss bridge was replaced and demolished in August of 1999. In the sequence of replacement and demolition, new single lane prestressed concrete bridges were first constructed on both sides of the truss bridge, while the truss bridge remained in service. Traffic was then diverted to the new single lane bridges, and the old truss bridge was demolished. Subsequently, an additional prestressed concrete bridge was constructed in between the new outer lanes to complete the new bridge. Field load tests were conducted after traffic was diverted off the old truss bridge, just prior to demolition.

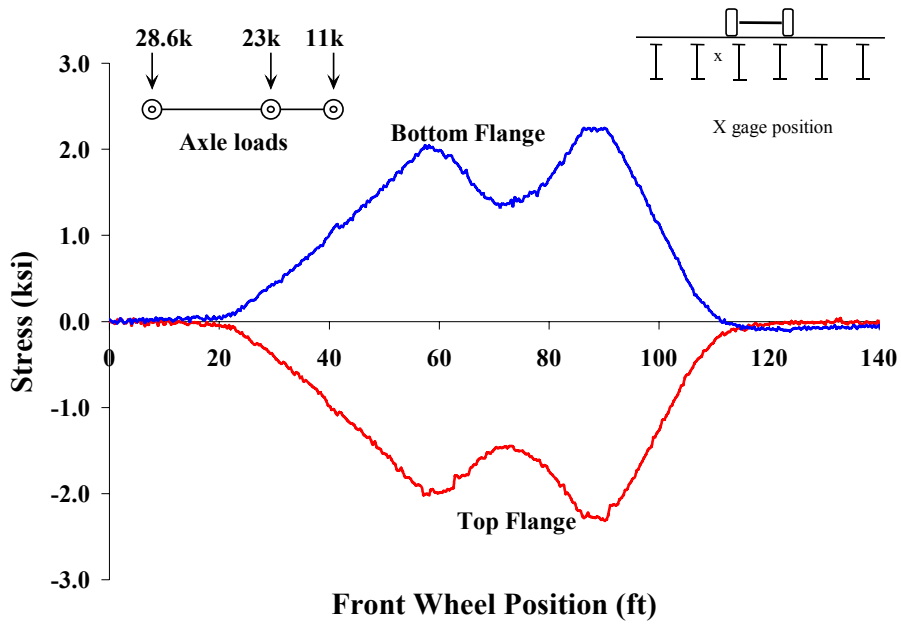
Representative plots of field test data for transverse beams are shown in Figures 5.25 through 5.28. Compared to the Llano field tests, the Goliad tests showed virtually no unintended composite action in the beams. Although not consistent, the Llano Bridge did show some partial composite action in the transverse beams, (Figure 4.24). Goliad test results showed little if any difference in top and bottom flange stresses in the transverse beams, indicating non-composite behavior. Although it is difficult to compare exactly the Llano and Goliad tests because of different member sizes, spans, loads and load spacing, approximate comparisons show reasonable similarity in the overall behavior of the two bridge deck systems. For example, Figure 5.28 shows the Goliad test results for a transverse beam with a maximum axle loading of approximately 37.9 kips. The maximum induced stress at midspan is approximately 3.9 ksi. Figure 5.29 shows a similar result for the Llano test, with a maximum induced stress of a transverse member at midspan to be approximately 3.3 ksi. Both members are the same length, and the higher stress associated with the Goliad test may be attributed to a smaller section modulus ( $385 \text{ in}^3$  vs.  $414 \text{ in}^3$ ) and a higher axle weight (approximately 38 kips vs. 34 kips).

Figure 5.25 Goliad test results for midspan of transverse beam B4

Figure 5.26 Goliad test results for midspan of transverse beam B5

*Figure 5.27 Goliad test result for quarter point transverse beam B4*

Similar to the Llano field test, strain data was taken in the Goliad field test and converted to stress. The stresses were then plotted against the truck longitudinal position. Unfortunately, apparently due to the long time gap between gaging and testing, there were a larger number of defective gages in the Goliad test. Because of the inaccessibility of the members in Goliad, gages could not be

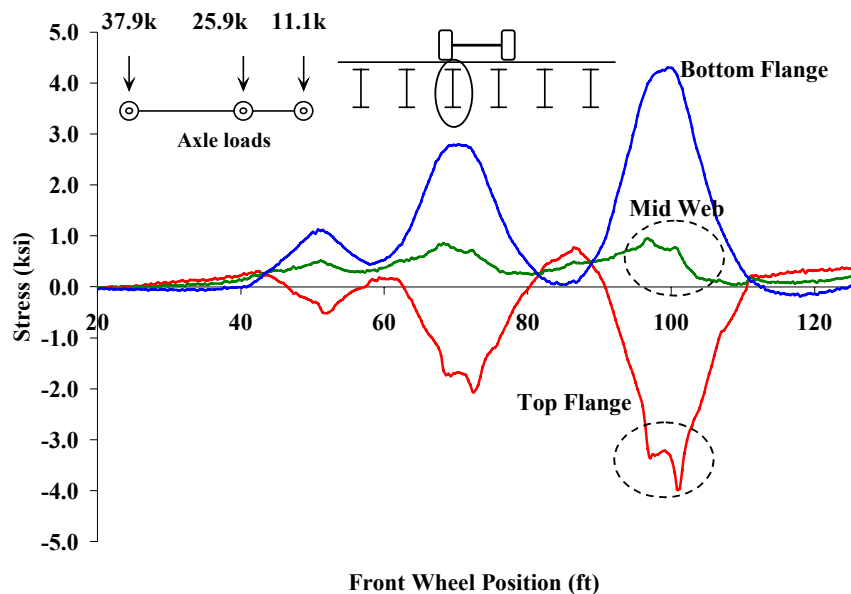
*Figure 5.35 Midspan stress in stringer S3: truck loaded with two barriers*

As illustrated by the data in Figure 5.35, results of the Goliad field test suggest that this unintended composite action may not be a reliable source of additional strength. The points marked by the ovals indicate a sudden shift in stress. This occurrence was repeated in both of the instrumented stringers for different loads and load positions, as seen in Figures 5.36 and 5.37. All plots indicate the same sudden jump in stress at the maximum loadings.

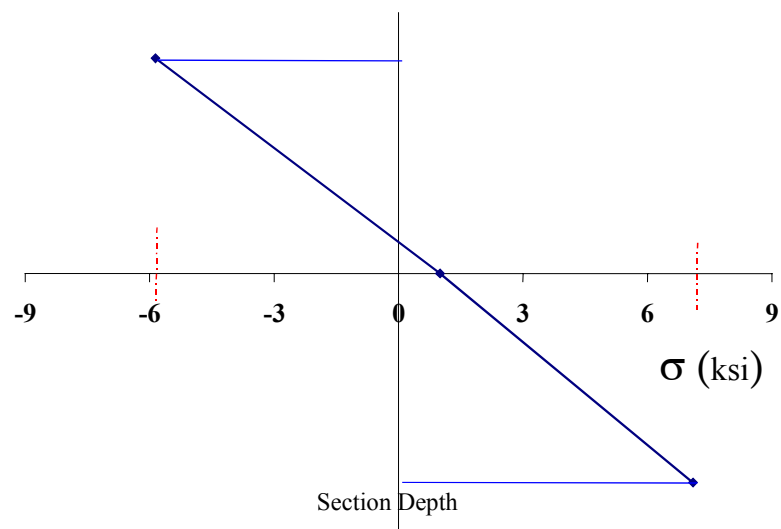
***Figure 5.38 Pre-slip stress profile over depth of stringer***

In data taken from the graph depicted in Figure 5.36, a stress distribution over section depth is plotted in Figure 5.38 for the condition prior to slip.

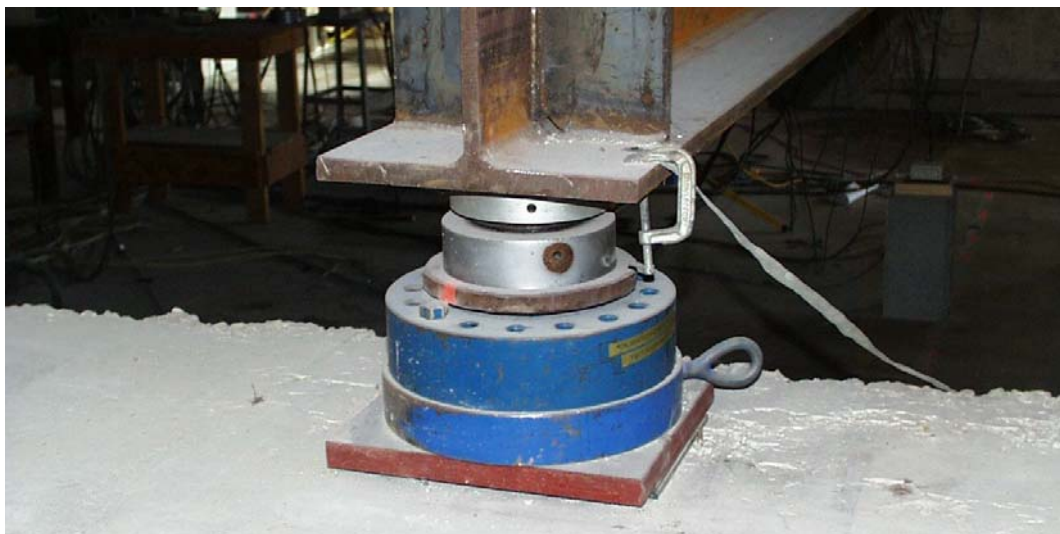
***Figure 6.4 Transverse beam placed on (top to bottom) a swivel plate, a load cell, and leveling plates***

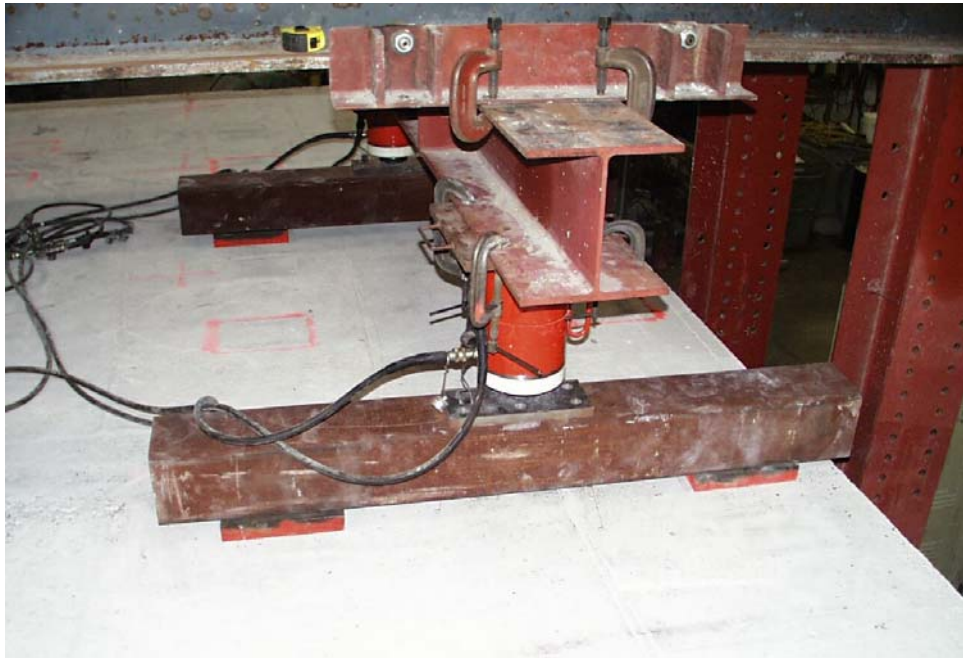
*Figure 6.18 Approximation of tandem axle with structural tubing and rubber pads*

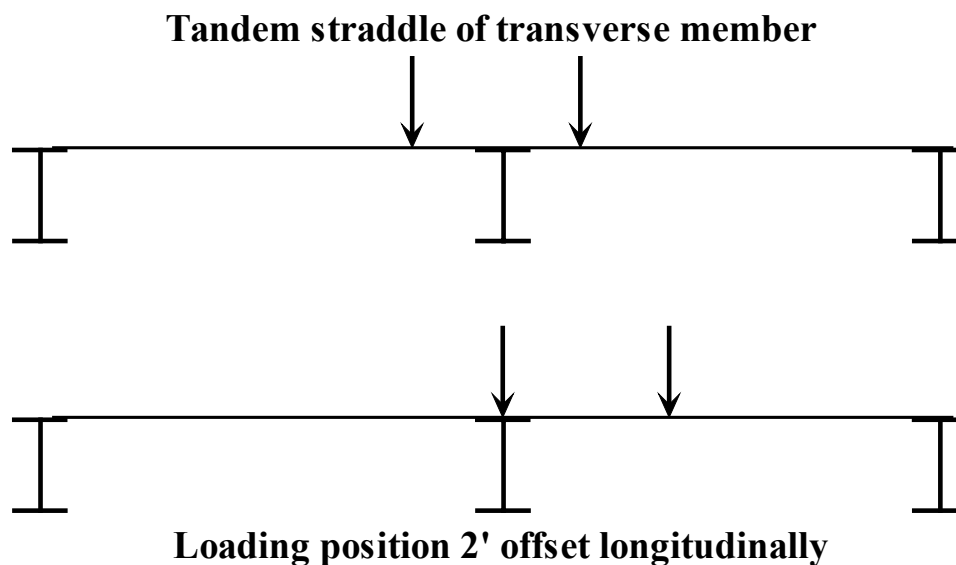
*Figure 6.62 Loading position for maximum response (top) and loading position used for comparison with laboratory loading (bottom)*

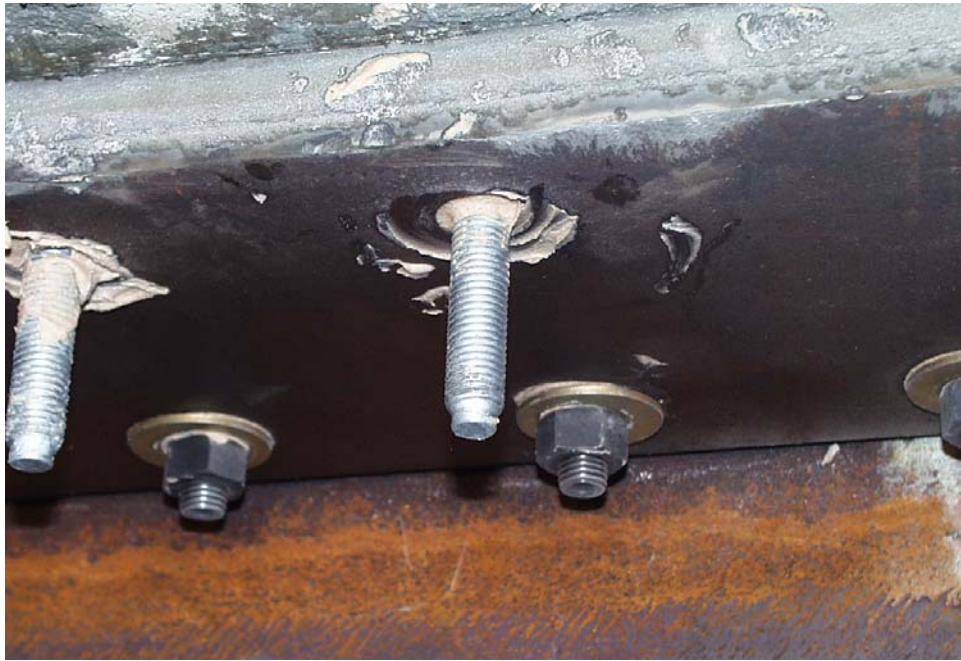
*Figure 6.67 Threaded rod installed in slab with epoxy*

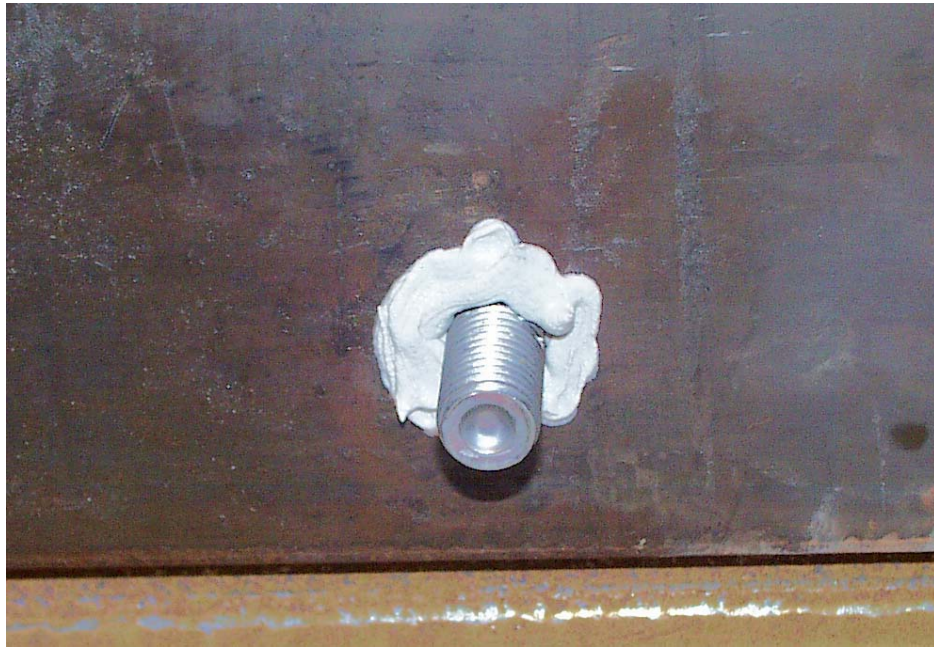
*Figure 6.76 Gap filled with HSE 2421 epoxy*

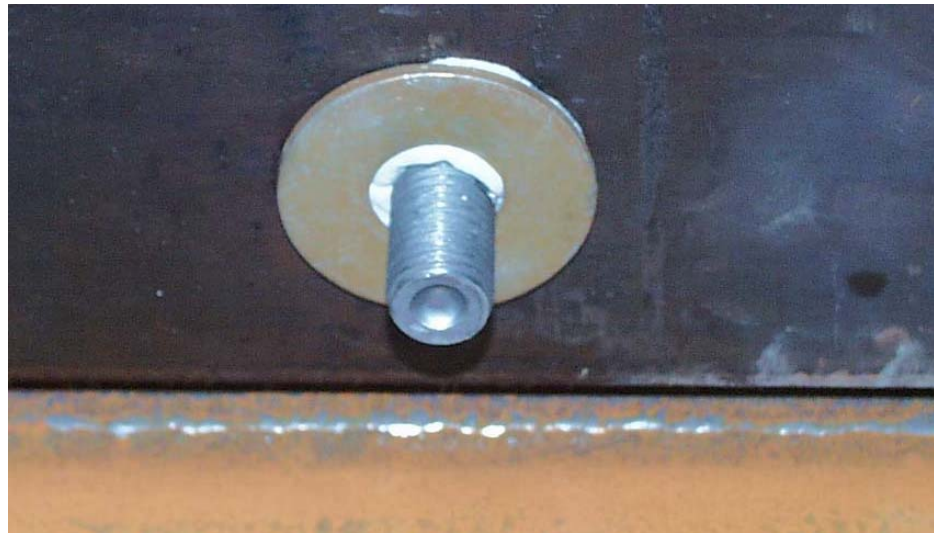
*Figure 6.77 Washer covering epoxy filling*
