**Experimental Performance of High Mast Illumination
Poles with Pre-Existing Cracks**

Thesis

The University of Texas at Austin

The work reported in this thesis is part of TxDOT Research Project 0-6829: “Fatigue Resistance and Reliability of High Mast Illumination Poles (HMIPs) with Pre-Existing Cracks.” TxDOT Project 0-6829 is aimed at generating data and information to support a probabilistic based assessment of the remaining life of pre-cracked HMIPs. The scope of Project 0-6829 includes laboratory fatigue tests on galvanized HMIPs with pre-existing cracks, field studies and measurements to characterize the wind response of

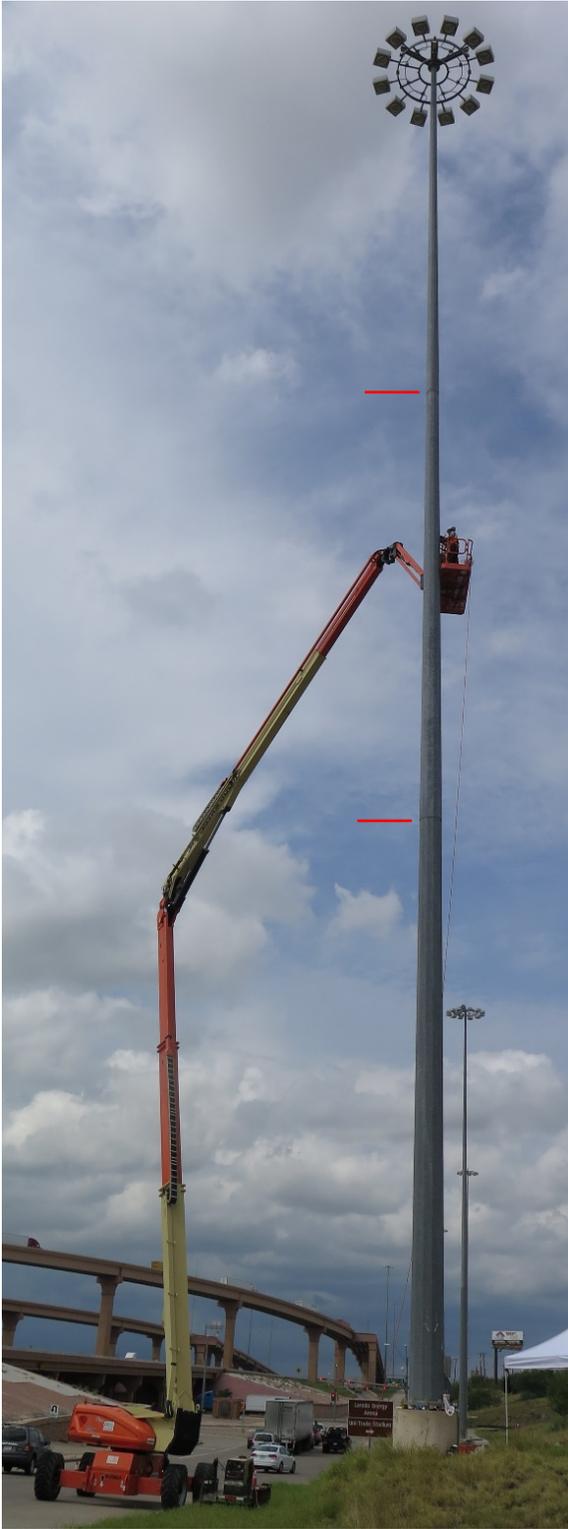
Figure 1.1: A Typical High Mast Illumination Pole

This study addresses the fatigue performance of High Mast Illumination Poles (HMIPs) in Texas, with pre-existing cracks at their base. HMIPs are tall multi-sided galvanized steel structures commonly used to provide lighting along highways and at highway interchanges. While poles vary in height from one site to the next, typical Texas HMIPs have heights of 100, 125, 150, or 175 feet. A 150 foot tall specimen can be seen in Figure 1.1.

At the top of the final section is the lighting fixture used to provide illumination. The lighting fixture is composed of eight or more lights fixed to a sliding circular mount (Stam, 2009). This mount can be lowered for maintenance or replacement using a winch system located within the pole. This system is accessible via a small hatch near the base of the pole.

At the base of the pole, the pole's shaft is welded to a thick baseplate. This baseplate is connected to a concrete foundation through the use of anchor rods. The number of anchor rods ranges from 6 rods to 16 rods, with increases occurring at changes in pole height and designed wind speed. The foundation, light fixtures, and splices can be seen in Figure 1.1. Splices are marked to assist in the identification of their locations.

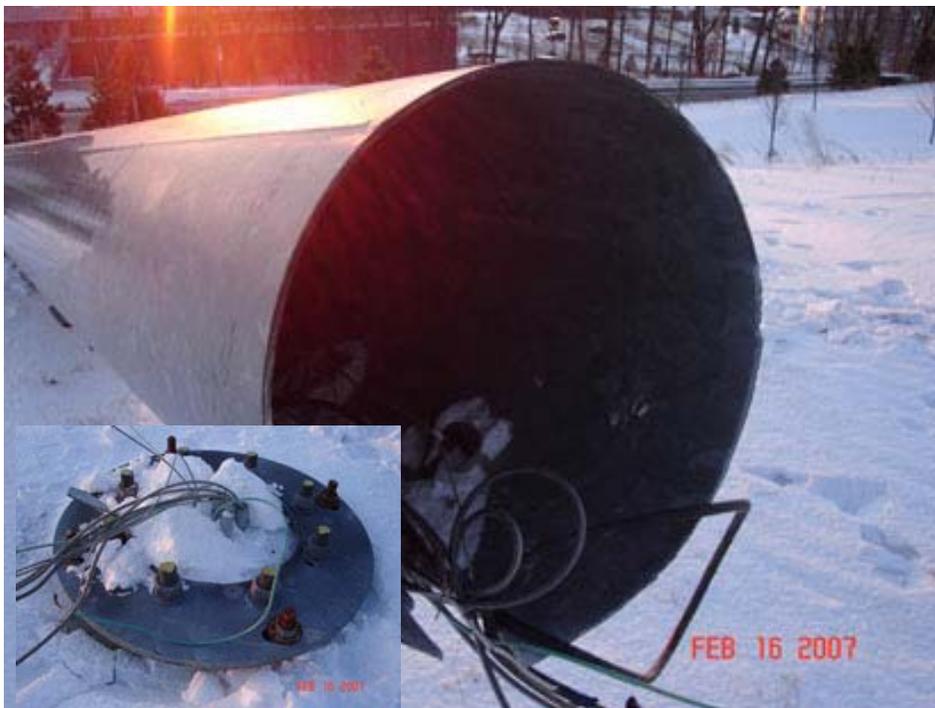
Figure 1.2: Failure of an HMIP in Colorado (Rios, 2007)

A number of collapses of HMIPs have been reported in recent years, including the collapse of a 140 ft. HMIP along Interstate 29 in Sioux City, Iowa in 2003 and the collapse of a 150 ft. HMIP in Rapid City, South Dakota in 2005. These collapses have occurred by fracture at the shaft-to-baseplate joint. An example of a failed HMIP is shown in Figure 1.2. Collapses have also been reported for HMIPs used at schools and at outdoor stadiums, including an incident of a HMIP falling through the roof of a school gymnasium (Magenes 2011). These collapses have been attributed to fatigue failures at the shaft-to-base plate connection (Rios 2007).

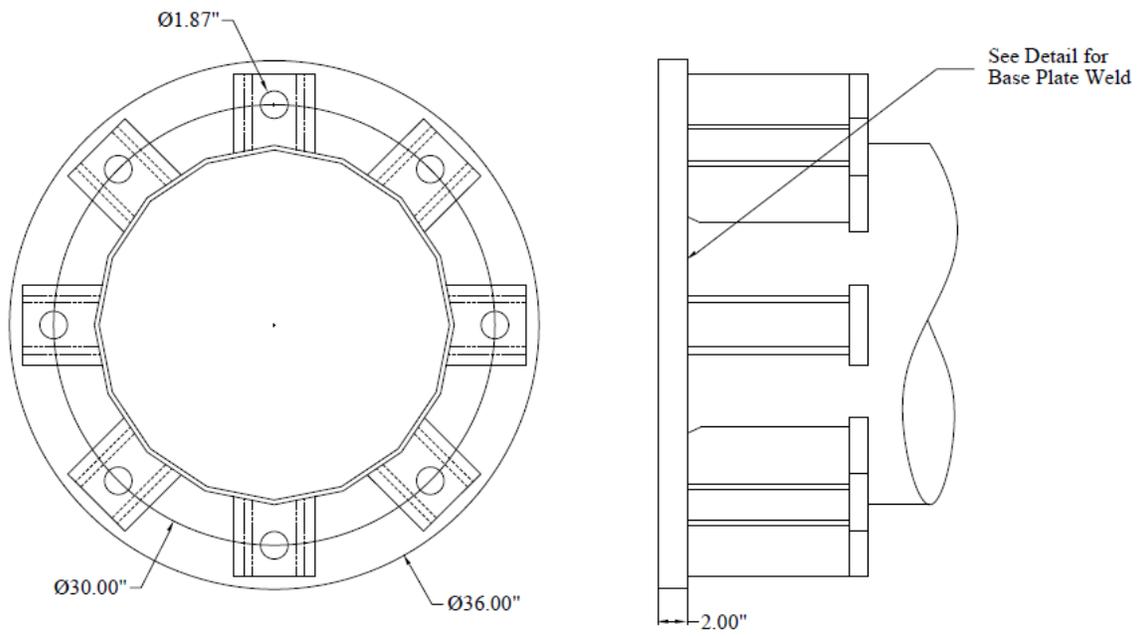
Figure 2.7: Stool Base Connection Detail (Rios, 2007)

The final connection used during the first phase of research was dubbed the stool base connection. This connection used vertical plates to stiffen the shaft-to-baseplate connection. These stiffeners were installed with a cap plate to create a bearing surface for the nuts attaching the pole to its foundation. Figures 2.7 and 2.8 below show the details for the stool base connection.

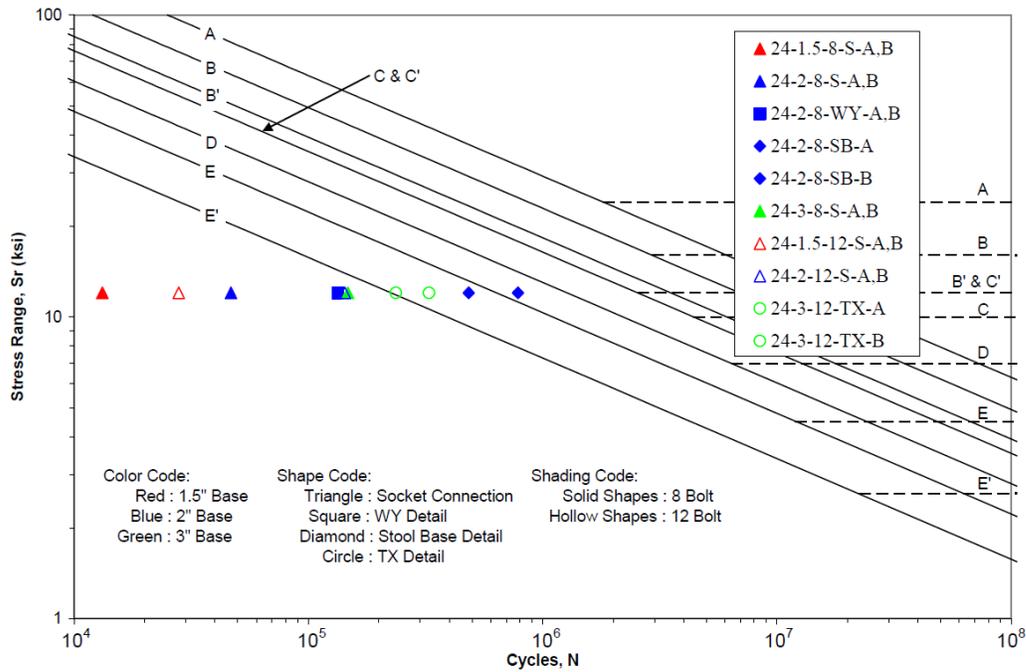
Figure 2.9: S-N Plot of Phase 1 Fatigue Test Results (Rios, 2007)

The results from the research in Phase 1 are presented in a combined plot below. This figure presents this data in an S-N plot. This graph takes the stress range that specimens were tests at and plots them again the number of cycles taken to fail the specimens. This failure criteria was defined as a 10-percent reduction in specimen stiffness. Also plotted on the S-N plot are the fatigue category limits from A through E'. These limits are simply linear relationships with a lower bound value called a Constant Amplitude Fatigue Limit (CAFL). These categories are taken from the AASHTO specifications. Note that in the S-N plot below, specimens are reported using a specific naming convention. The naming convention used in Phase 1 is presented in Figure 2.10.

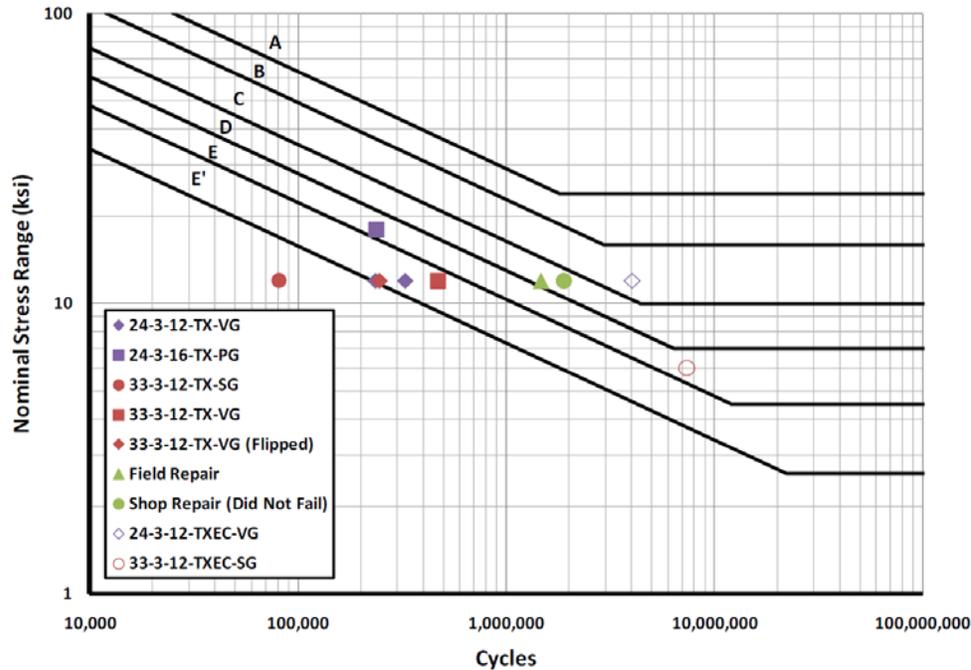
Figure 2.20: S-N Plot of Phase 3 Test Results (Pool, 2010)

The results of the fatigue tests of Phase 3 can be seen in Figure 2.20. All of this data represents galvanized specimens. The naming scheme for this phase is the same as that used in Phase 2. One thing worth noting on this plot is the inclusion of two repaired

specimens. After two specimens were tested to failure, they were repaired using two weld repair procedures. To learn more about these procedures, consult Pool (2010).

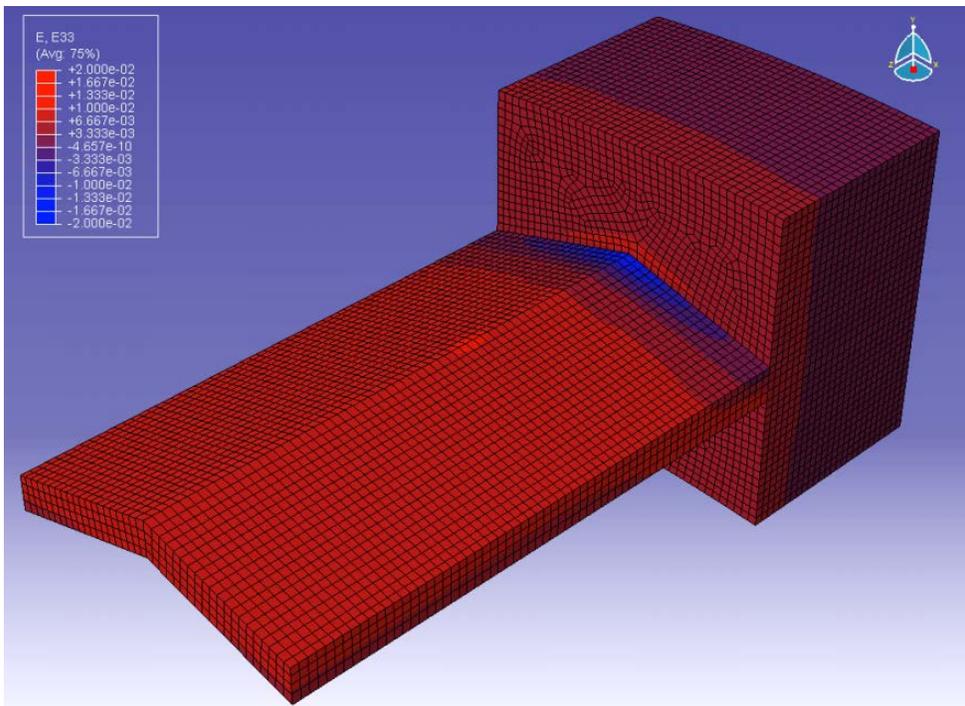
Figure 2.21: A Typical Submodel Showing the Concentration of Forces at the Shaft-to-Baseplate Connection (Kleineck, 2011)

thermal effects. A parametric study was run to study the effect of various pole geometries when subjected to the measured thermal strains. One significant result of this study was the confirmation that the thermal stresses varied throughout the specimens. The highest stresses were seen at the shaft-to-baseplate connection, specifically at the bends of the specimen. This can be seen in Figure 2.21. This result was expected, as the 3 inch thick baseplates took longer to heat than the 5/16 inch thick pole shaft. Improved behavior was noticed when the model's pole shaft thickness was increased from 5/16 inch to 7/16 inch or 1/2 inch thicknesses. After concluding the parametric study, researchers concluded that the ratio of the pole diameter to pole thickness played a substantial role in determining whether or not a specimen will crack during galvanization. The lower this ratio is, the less likely a specimen is develop cracks from galvanization.

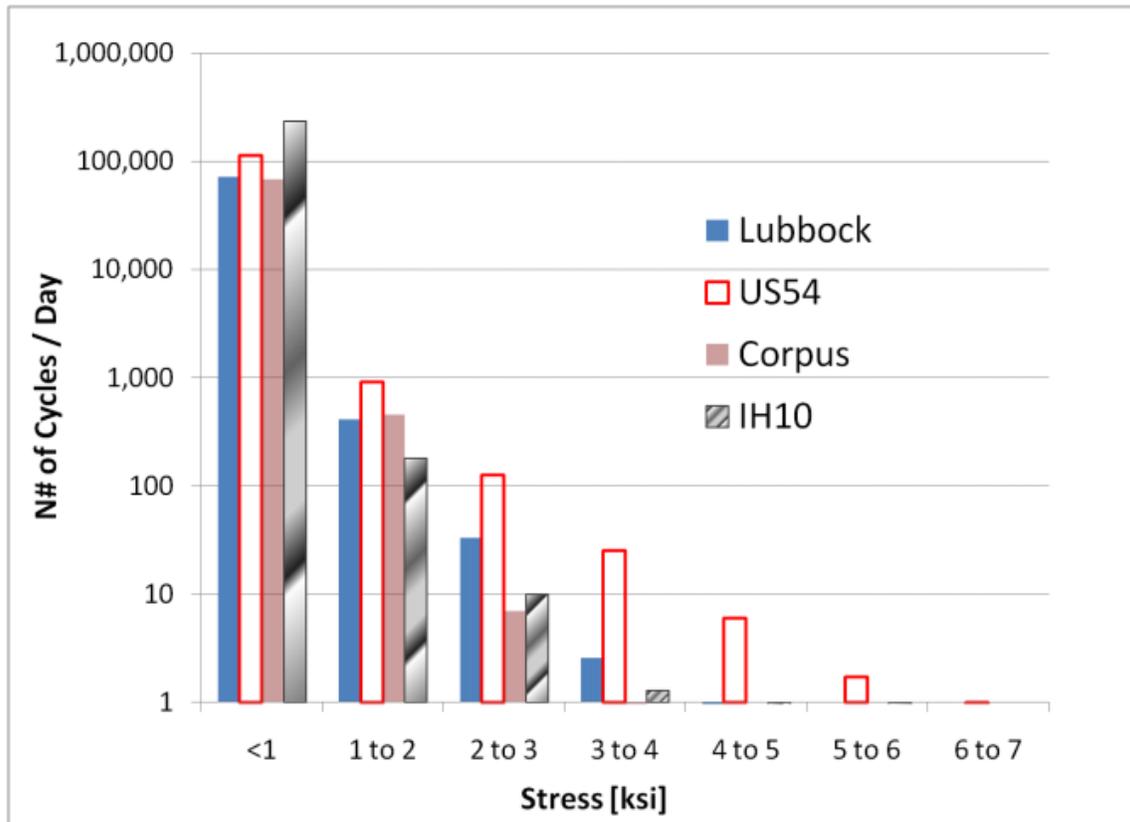
Figure 2.22: HMIP Daily Stresses and Cycles (Magenes, 2011)

Analysis of the field data showed that vortex shedding induced stresses that were much lower than those at which specimens had been tested in the first three phases. Magenes concluded that this induced stress was typically around 1 ksi, not the 12 ksi stress that most specimens had been tested at. Figure 2.22 shows the typical daily stress values that were measured during the field monitoring phase. Note that the wind induced stresses typically dropped off after around 5 to 6 ksi. This would cause researchers to reconsider testing stresses in future experimental phases.

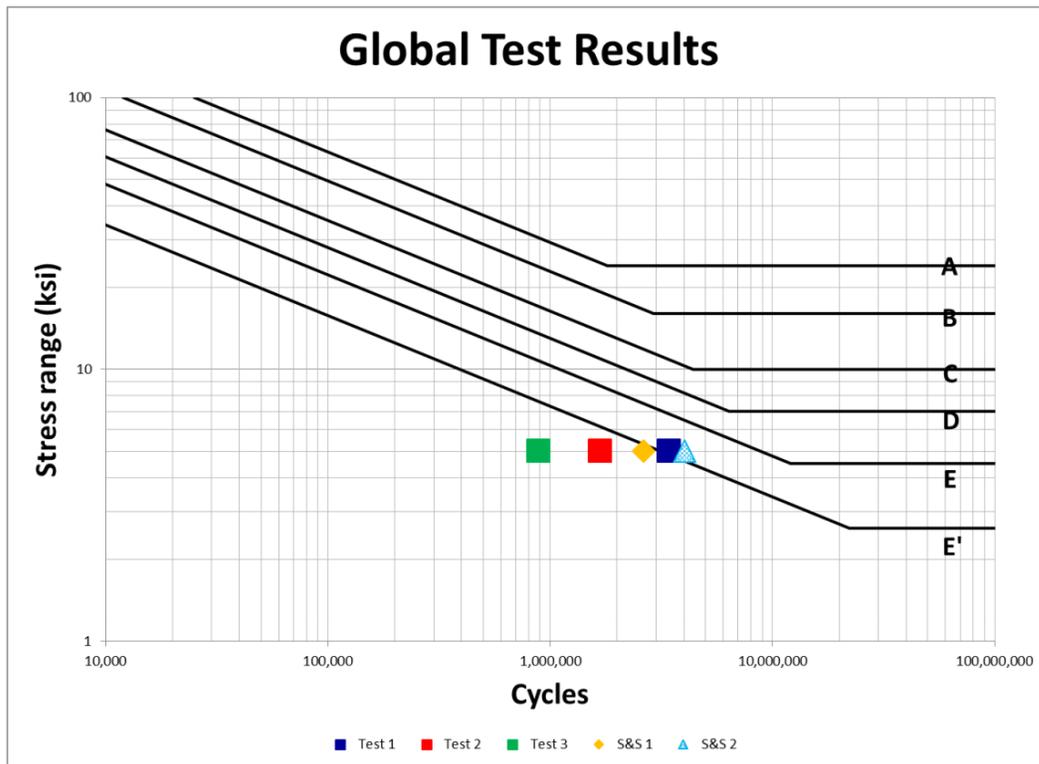
Figure 2.23: S-N Plot of Phase 6 Testing Results (Belivanis, 2014)

The Phase 6 full scale testing concluded with three fatigue tests on the specimen that was removed from service and two on its partner specimen. The results of these tests are displayed in the S-N plot shown in Figure 2.23. In this plot, tests 1, 2, and 3 correspond with the specimen that was removed from the field. S&S1 and S&S2 correspond with the partner specimen. During testing, this partner specimen failed before the field specimen and required weld repairs. After weld repairs, the specimen showed no signs of failure. Its second point on the plot corresponds to the number of cycles that the specimen had been tested to at the time of the projects conclusion. The three tests represented for the field specimen correspond to three orientations at which the specimen was tested. All tests were conducted at a stress range of 5 ksi.

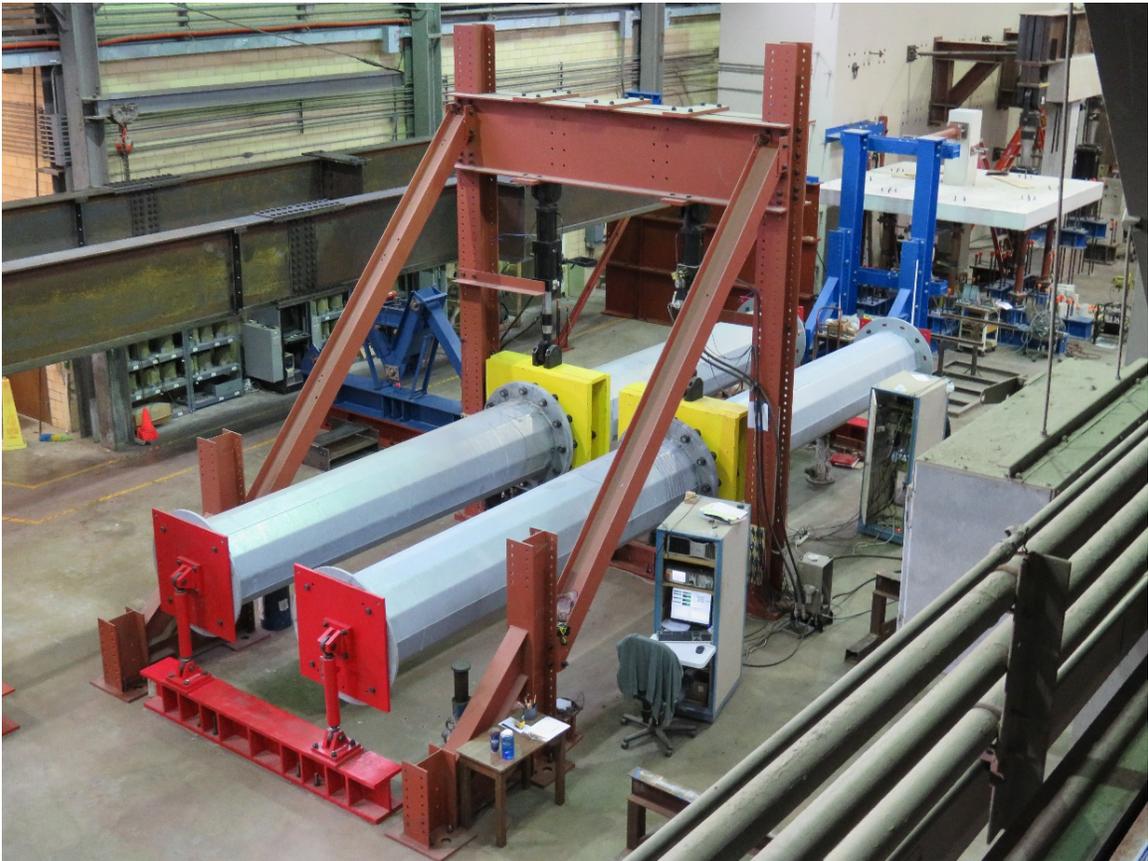
Figure 3.3: Portal Loading Frame with Four Specimens Attached

Vertical loads are imparted by a 55-kip MTS actuator. These loads are resisted by a portal frame that was designed accommodate two test setups simultaneously, allowing four HMIP specimens (two HMIP specimens per setup) to be tested simultaneously. The frame consists of two wide-flange column sections, one coped wide flange section connecting the columns, and two diagonal bracing elements, all of which are ultimately tied down to the laboratory strong floor. The portal frame, specimens, and loading boxes can all be seen in Figure 3.3.

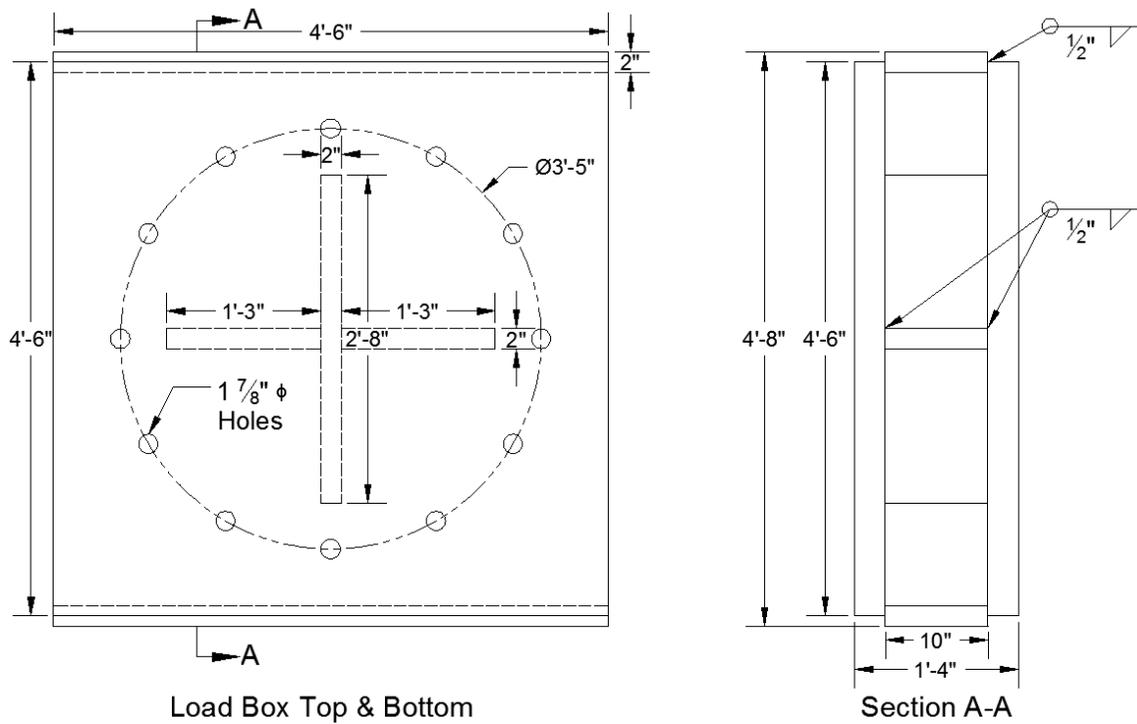
Figure 3.4: Schematic Design of Load Box

The load box was fabricated out of two vertical 3” thick plates welded to two horizontal 2” thick plates. Two internal 2” internal plates were welded within the box in a cruciform shape to provide additional stiffness. The 3” thick plates were drilled with twelve 1-7/8” holes sized to accommodate the 1-3/4” diameter threaded rods used to connect the box to the high mast baseplate. The design schematics for the load box can be seen in Figure 3.4.

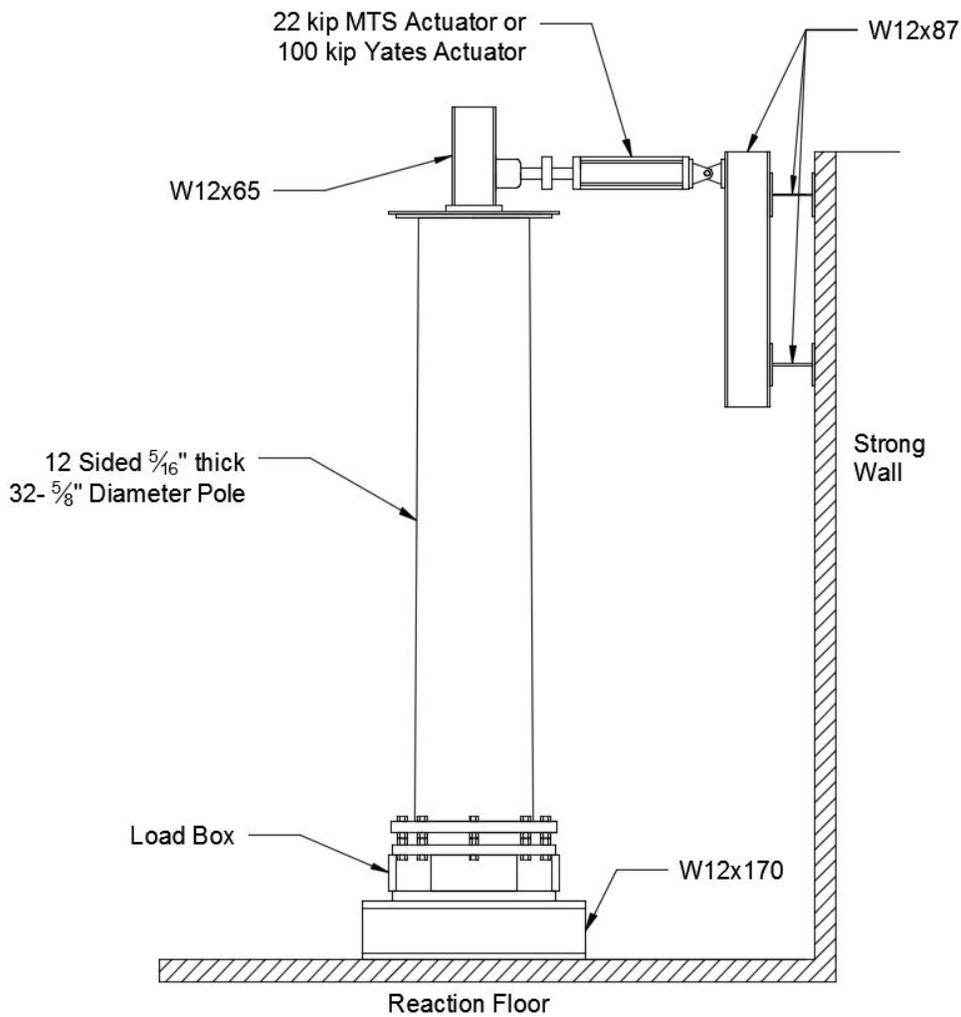
Figure 3.7 Vertical Test Setup

While tests were being run on the horizontal test setup, researchers undertook the task of designing a setup that would be capable of testing the HMIP specimens in a vertical orientation. Two main advantages led researchers to construct this setup. The first is that this setup could be used to test specimens in a full stress reversal. The second advantage is that this setup can be used for ultimate strength tests in addition to fatigue tests. Specimens that have been tested to failure in the fatigue tests can be placed in this setup and pushed in one direction to determine the remaining static strength. These tests provide an estimate of the remaining static ultimate strength of an HMIP with significant fatigue damage.

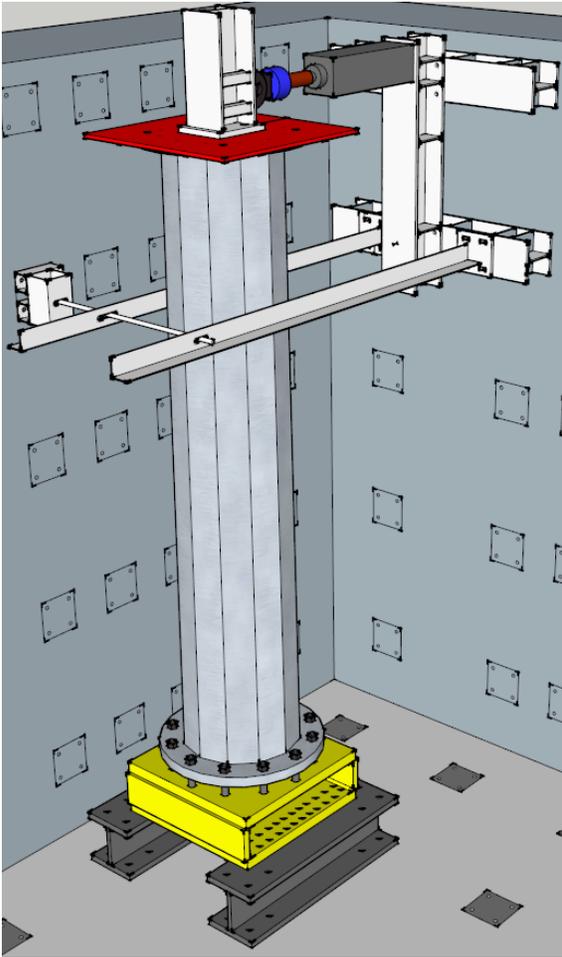
Figure 3.9: Vertical Test Setup Isometric View

side of the actuator. This section was then bolted to two horizontally running wide flange sections that were connected directly to the strong wall. Where permissible, these connections were slotted to allow for any errors that arose in fabrication. An isometric drawing of this setup is available in Figure 3.9.

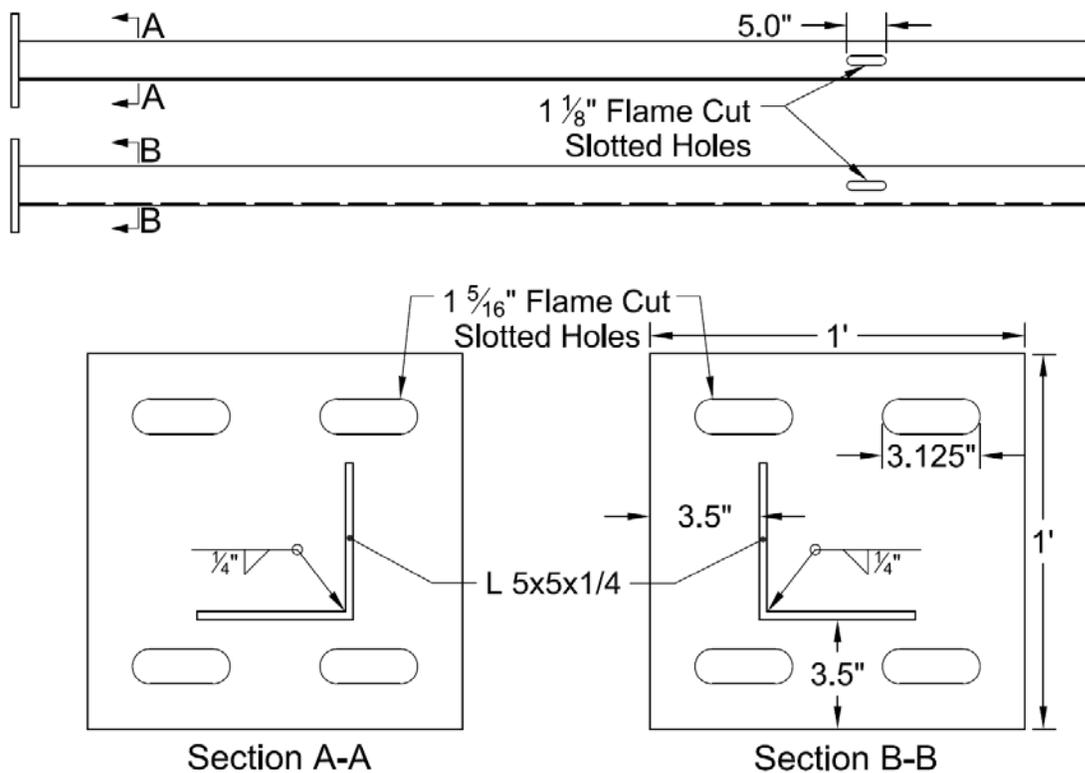
Figure 3.10: Lateral System Restraint Details

loading system by bolting to the lower wide flange section on the strong wall. At the free end of these angles, there is a slotted hole. Through these holes, a threaded rod is fit. This threaded rod is in turn tied back to a tube section that is connected to the strong wall. This system is adjustable to account for imperfect specimens and the displacements corresponding with different loading ranges. This system is pictured above in Figure 3.9. Detailed drawings can be seen in Figure 3.10.

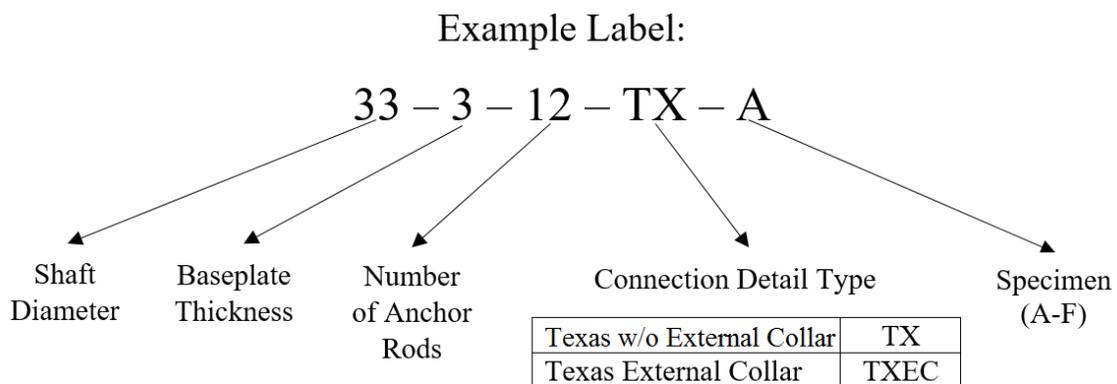
Figure 4.1: Specimen Naming Scheme

The naming scheme used in this phase of research is similar to those used in previous research phases at Ferguson Lab. This naming scheme provides a concise means of summarizing the critical geometric details for each specimen. The naming scheme used in this phase of research can be found in Figure 4.1.

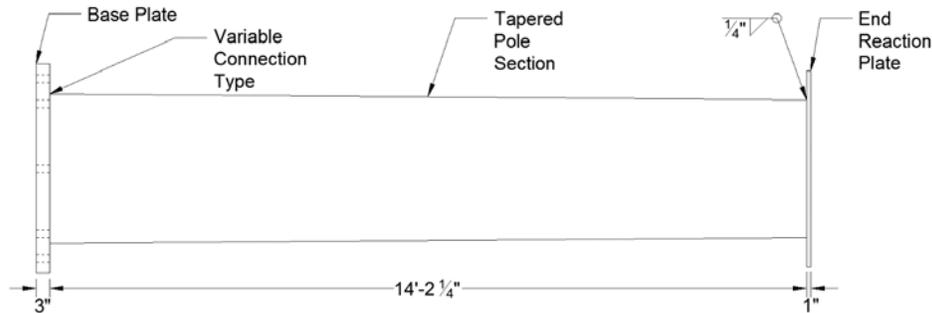
Figure 4.2: Test Specimen Components

High mast specimens tested at the University of Texas Ferguson Structural Engineering Laboratory were composed of four major components: a baseplate, a pole shaft, an end reaction plate, and a shaft-to-baseplate connection. These components can be seen in Figure 4.2. At the time of this report, all but one of these components, the connection, had been kept constant between all specimens. The outlier in these components was varied on two of the eight specimens when the connection was changed from having no external collar to including an external collar. For the majority of specimens, researchers opted to vary the tested stress range in lieu of geometric components.

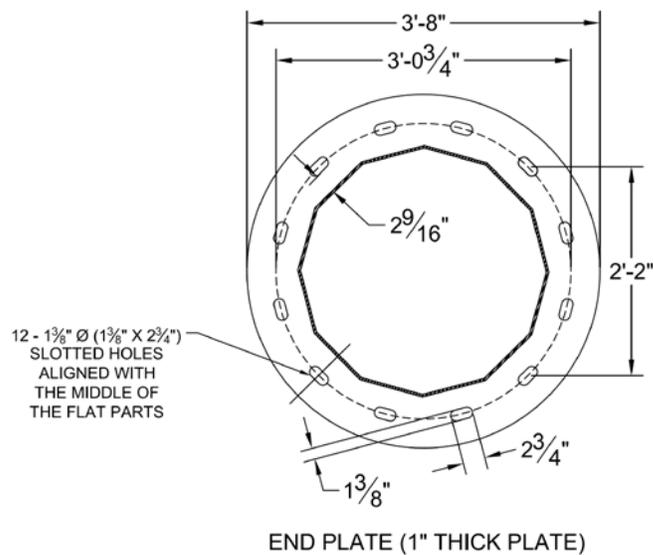
Figure 4.3: Specimen End Plate Connection Details

frames. All end plates were made using one inch thick steel plates which were welded to the shaft using a fillet welds. The end plates were drilled with slotted holes to permit connection to the end supports of the test setup. See Figure 4.3 for the shop drawing of these end plates.

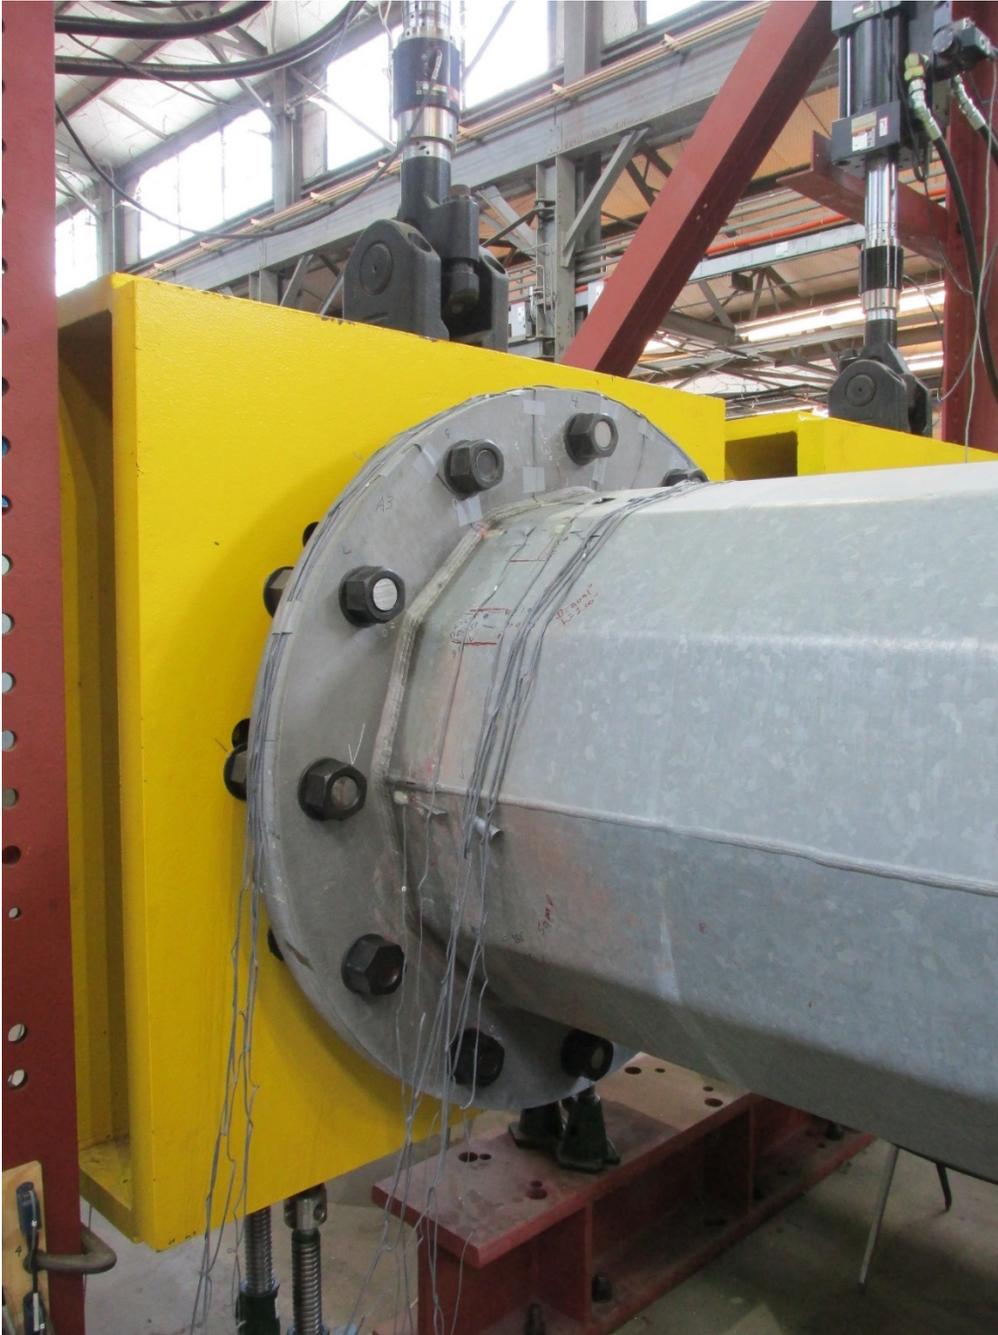
Figure 4.4: Specimen Base

three inch thick circular plates with a 47 inch diameter and a 22 inch diameter hole cut out of the middle.

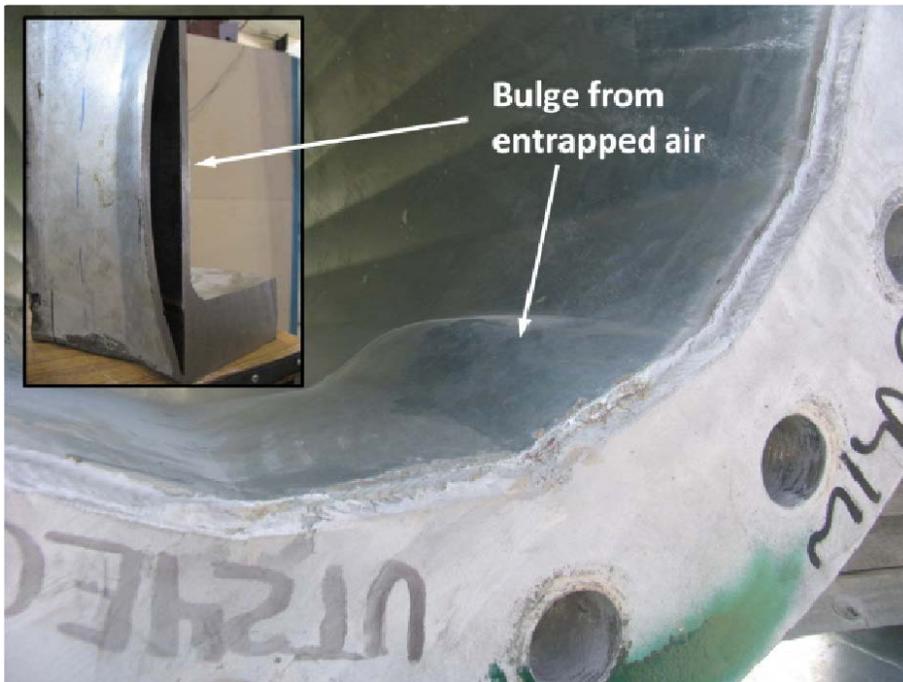
Figure 4.13: Bulging Caused by Entrapped Air (Stam, 2009)

One significant factor worth noting in the design of specimens with external collars is the addition of vent holes. These holes permit the escape of the air from the seam between the external collar and the pole shaft. They must be drilled through the external collar to the shaft such that they can permit the escape of gas. This process must be done before galvanizing, but after pickling, as the pickling process can result in severe corrosion (Pool 2010). The drilling of these vent holes adds an additional step during the galvanizing process, which in turn slows the galvanization process and increases the cost of production. Figure 4.13 shows a specimen with an external from Phase II that experienced bulging due to a lack of vent holes.

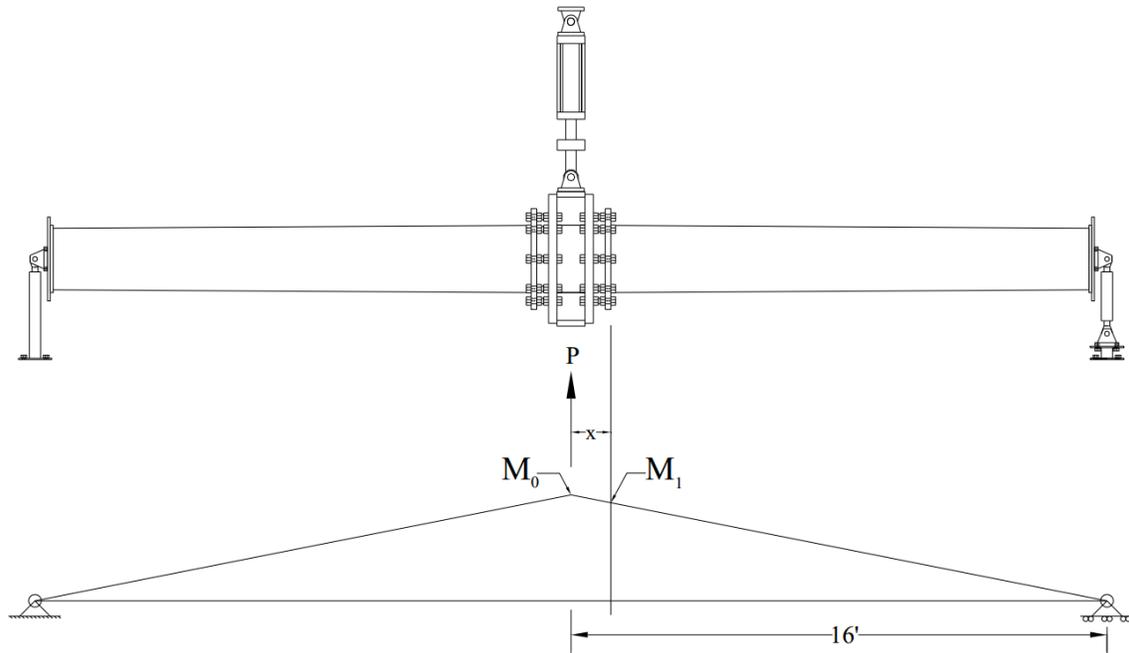
Figure 4.14: Moment Diagram for Calculating Testing Loads (Rios, 2007)

section to the exterior side of the top most bend. The bending moment, M_1 , is the bending moment at the location of the weld. This moment was determined using simple beam analysis, which can be seen in Figure 4.14.

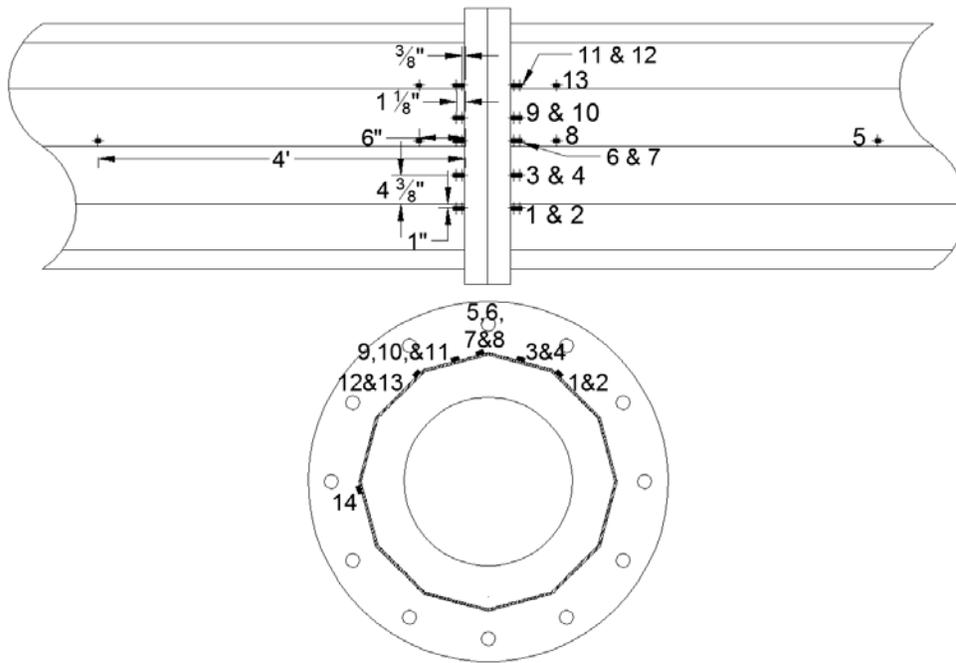
Figure 4.15: Schematic Layout of Strain Gages

Following this calculation, these load values were compared to the static loads required to meet their corresponding stresses. These stresses were checked using strain gages installed near the weld. A layout schematic of these strain gages can be seen in Figure 4.15. Note that the strain gauges closest to the weld were placed back-to-back to better capture the stresses near the weld. The strain gages placed 6 inches away from the weld were used to monitor the stress at the weld. These strain gages were sufficiently far away from the weld to avoid the stress concentration, but close enough to estimate the stress at the shaft-to-baseplate connection.

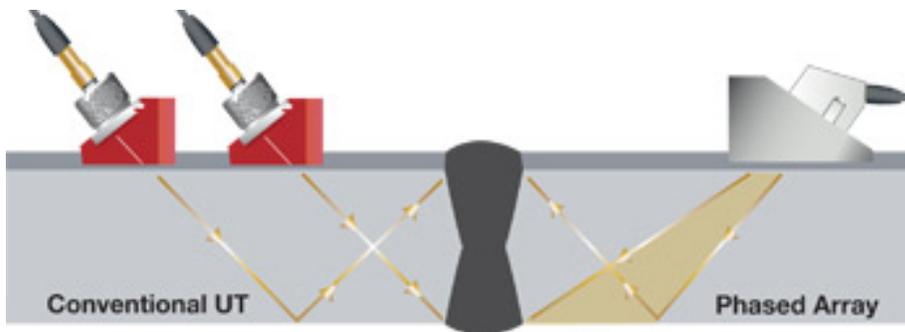
Figure 4.16 Conventional vs. Phased Array Ultrasonic Tests (“Phased Array Tutorial”)

Before, during, and after fatigue tests were completed, ultrasonic testing was performed on the specimens. This testing was done to provide measurements for length and depth and to monitor crack growth. Unlike previous research phases, this phase of research used Phased Array Ultrasonic Tests (PAUTs) in lieu of conventional ultrasonic tests. Like conventional ultrasonic tests, these tests emit sound waves through a transducer. When a discontinuity, a crack or material property change, lies in the path of the sound waves, they are reflected back and received by the transducer. This received signal is turned into an electrical signal and displayed on the PAUT receiver which is then used to read crack lengths and depths.

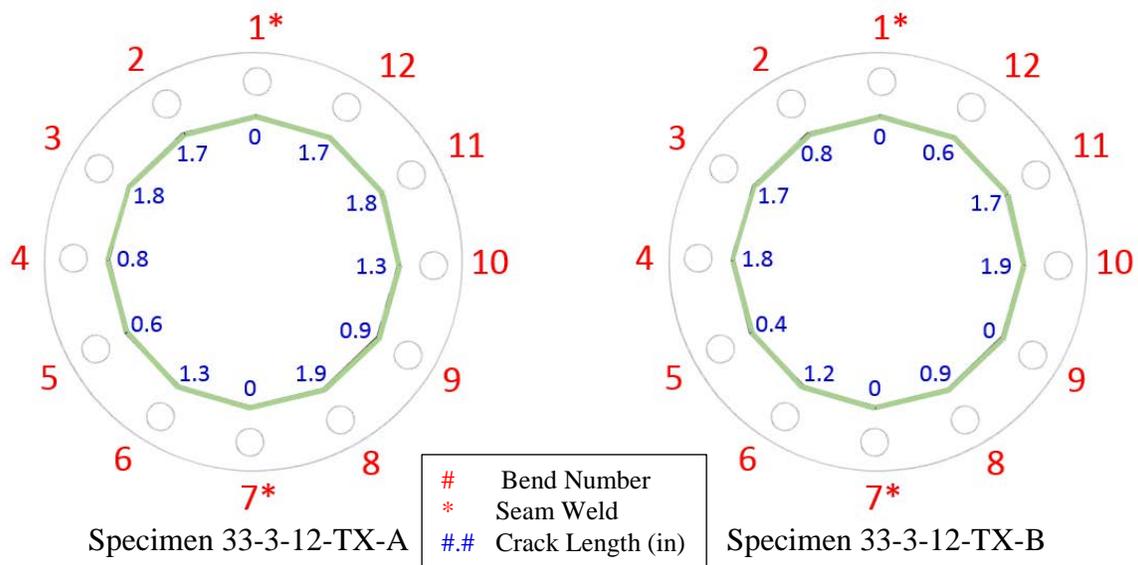
Figure 5.1: Initial Cracks in Specimens 33-3-12-TX-A and 33-3-12-TX-B

The initial crack measurements for specimens 33-3-12-TX-A and 33-3-12-TX-B can be seen in Figure 5.1. While the depths of these cracks were not measured, their lengths were measured and recorded for future comparisons. Note that each of these specimens had approximately 10-percent of their 105” perimeters cracked before testing began.

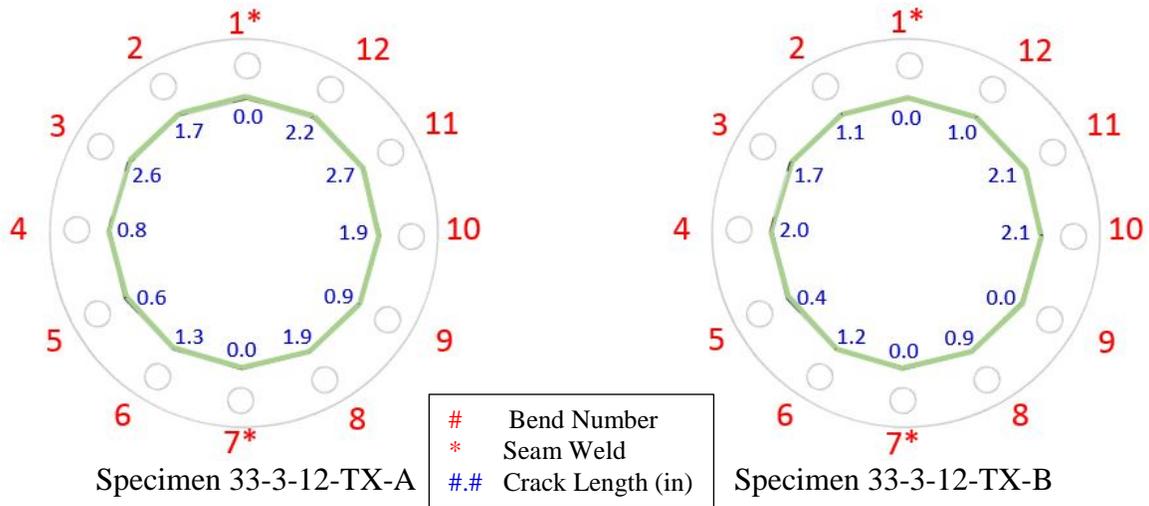
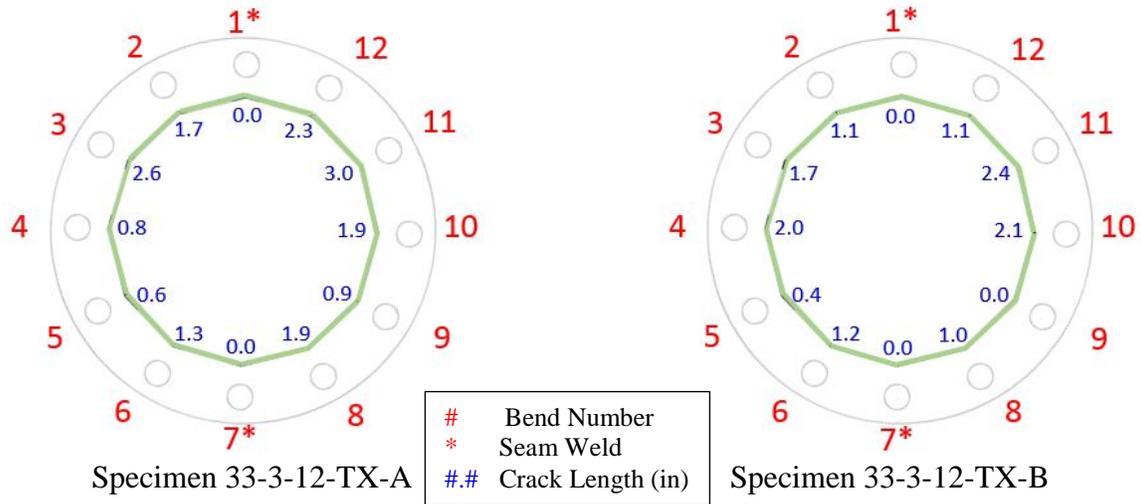
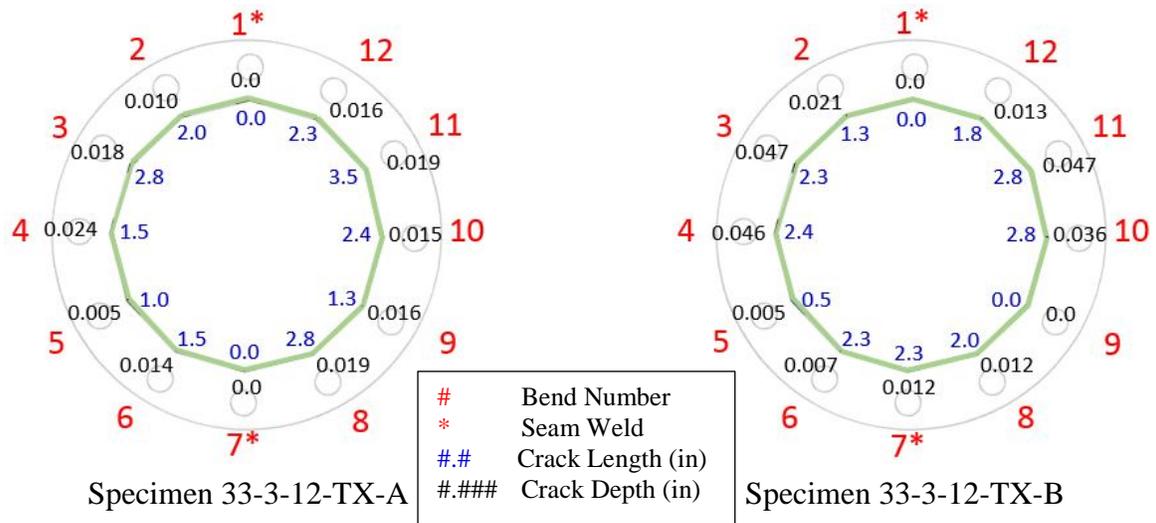
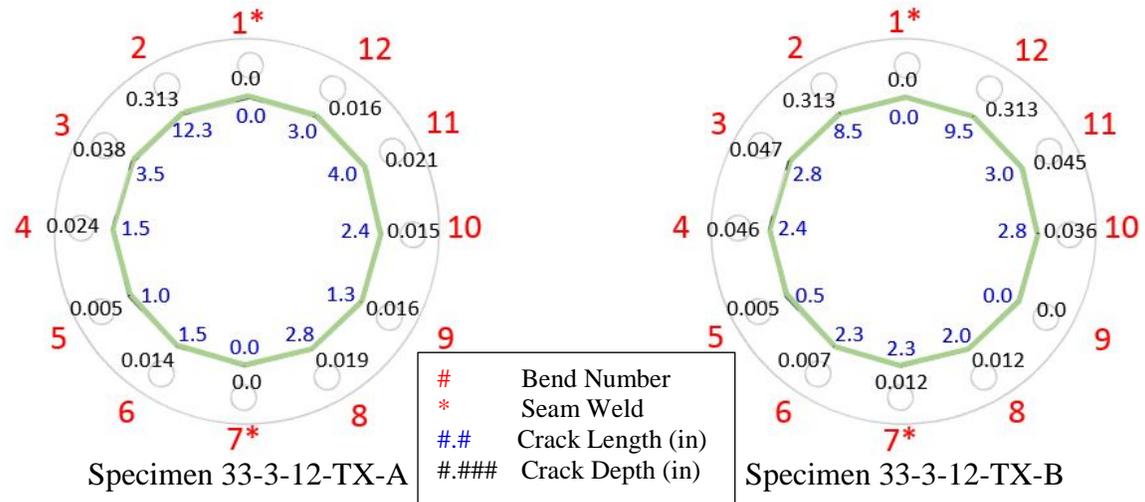
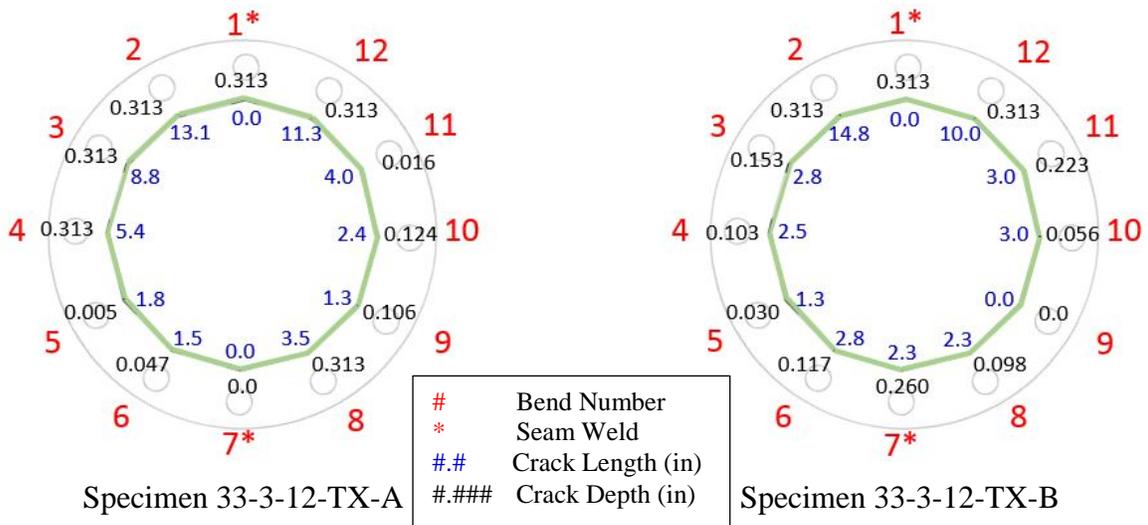
crack length as the number of loading cycles progressed. This successive ultrasonic test data for the first two specimens can be seen below in Figures 5.2 through 5.6.
