**Experimental Performance of High Mast Illumination
Poles with Pre-Existing Cracks**

Thesis

The University of Texas at Austin

The work reported in this thesis is part of TxDOT Research Project 0-6829: “Fatigue Resistance and Reliability of High Mast Illumination Poles (HMIPs) with Pre-Existing Cracks.” TxDOT Project 0-6829 is aimed at generating data and information to support a probabilistic based assessment of the remaining life of pre-cracked HMIPs. The scope of Project 0-6829 includes laboratory fatigue tests on galvanized HMIPs with pre-existing cracks, field studies and measurements to characterize the wind response of

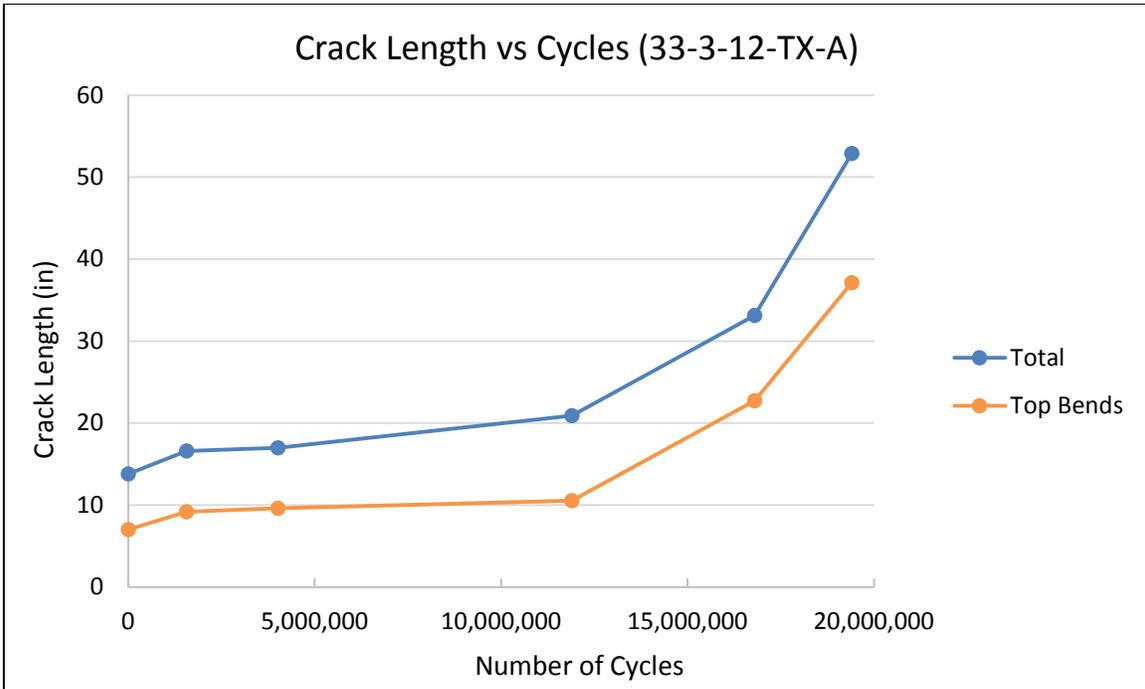
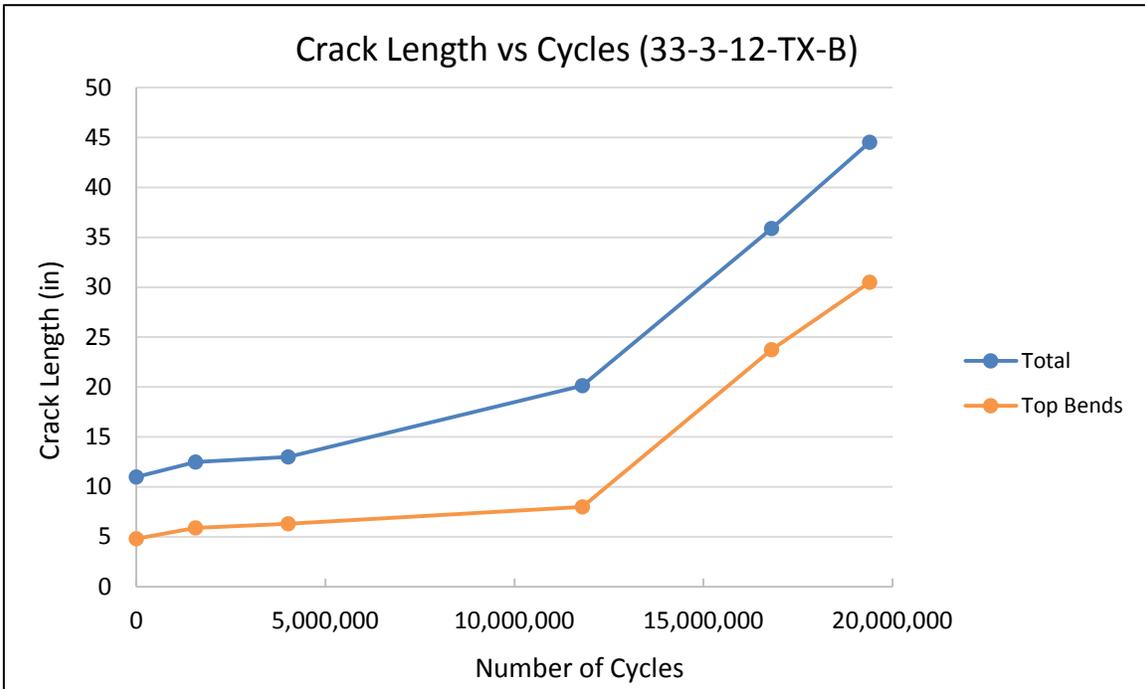
The vertical axis in each plot is the total crack length for all bends of the specimen.

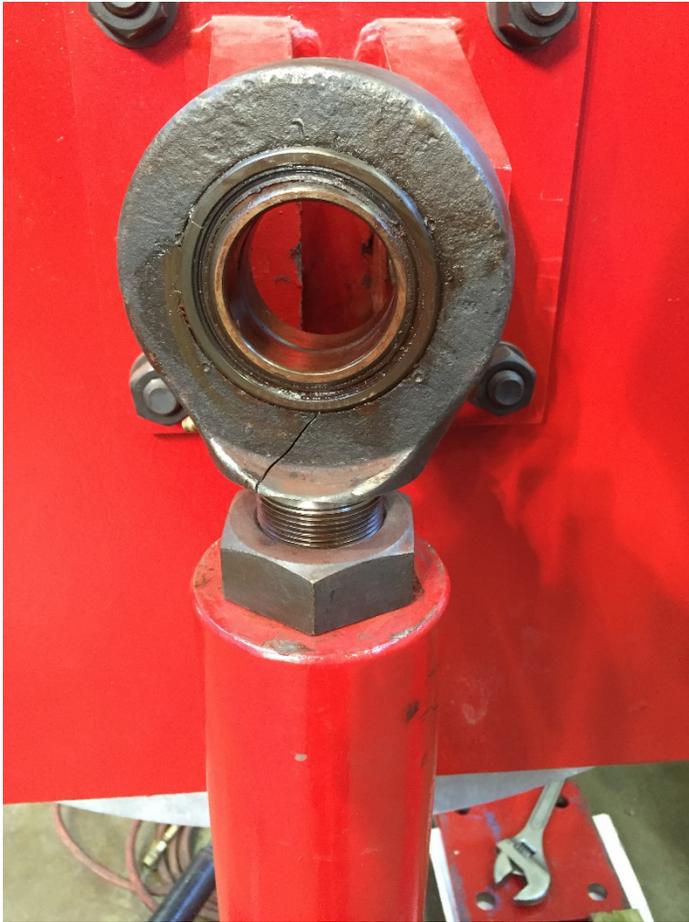
Figure 5.9: A Spherical Rod Eye that Fractured During Fatigue Tests

spreader beams was a one-time delay that was done to strengthen the testing setup. The failure of the spherical rod eye was also a one-time delay, but unlike the spreader beams, it was unplanned. It was the result of an imperfect alignment between the rod eye and the reaction plate. The rod eye was slightly twisted in one direction. This created a torque on

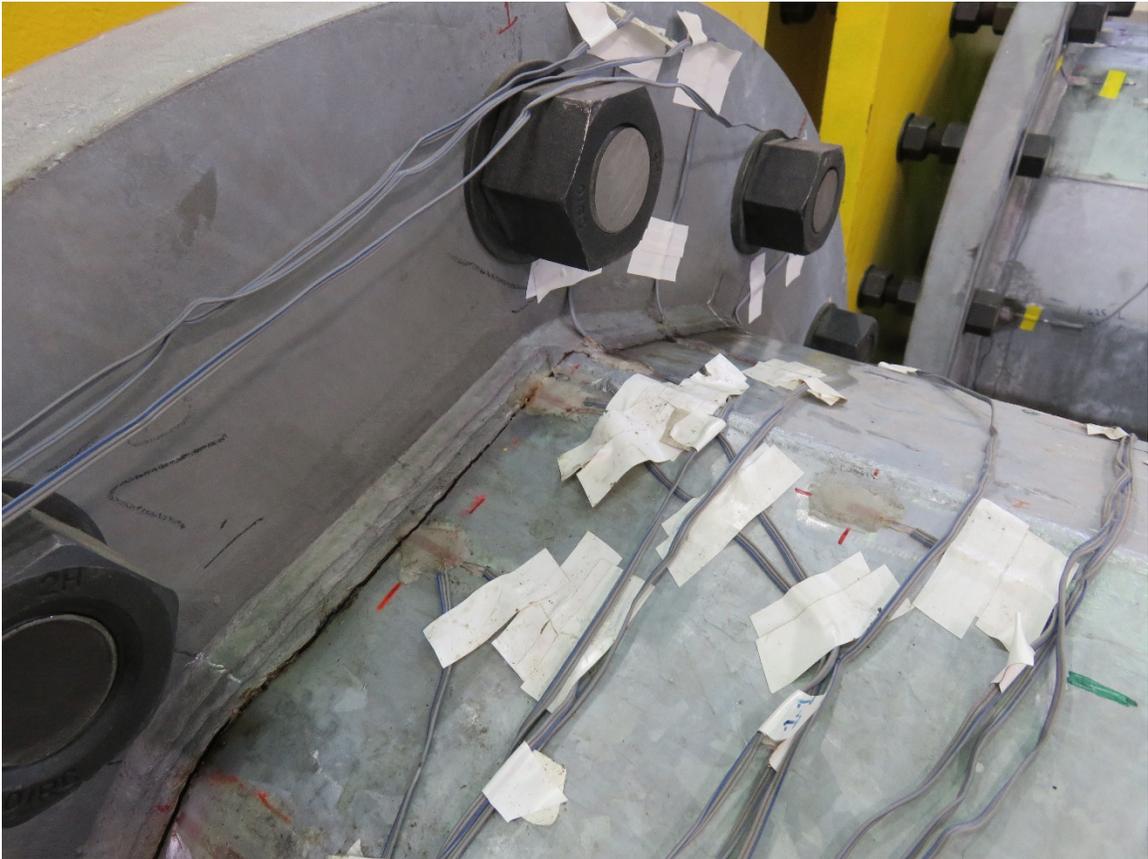
Figure 5.11: Cracking in Specimen 33-3-12-TX-A's Top (Seam Welded) Bend after 19.4 Million Cycles of Loading

Like Specimen B, Specimen A underwent severe cracking during the fatigue tests. Similar, but more severe, cracking was noticed at bend 2 and bend 12. Cracks at these bends coalesced to create a large crack spanning across the top bend, between bends 2 and 12. This crack joined those starting from other bends to create one large crack that extended beyond the specimen's neutral axis. This crack can be seen in Figure 5.11 and Figure 5.12.

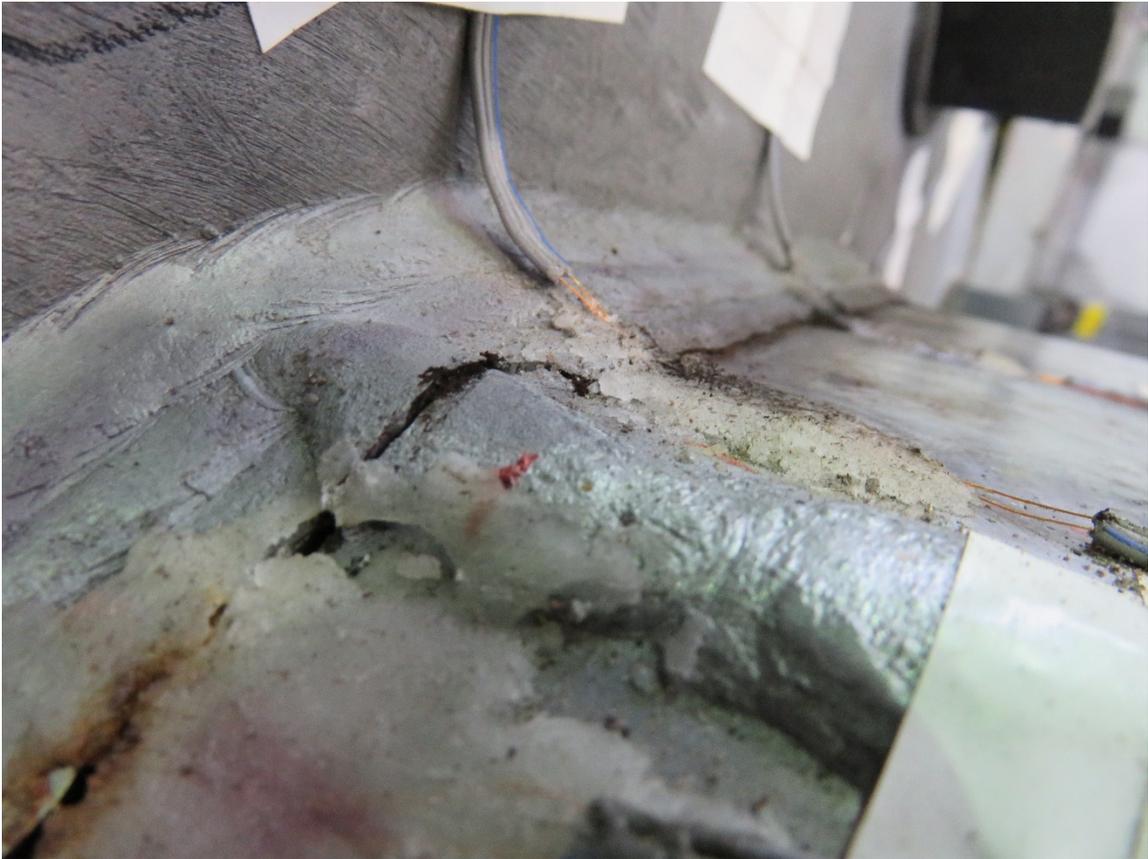
Figure 5.12: Close up of Specimen 33-3-12-TX-A's Top (Seam Welded) Bend after 19.4 Million Cycles of Loading

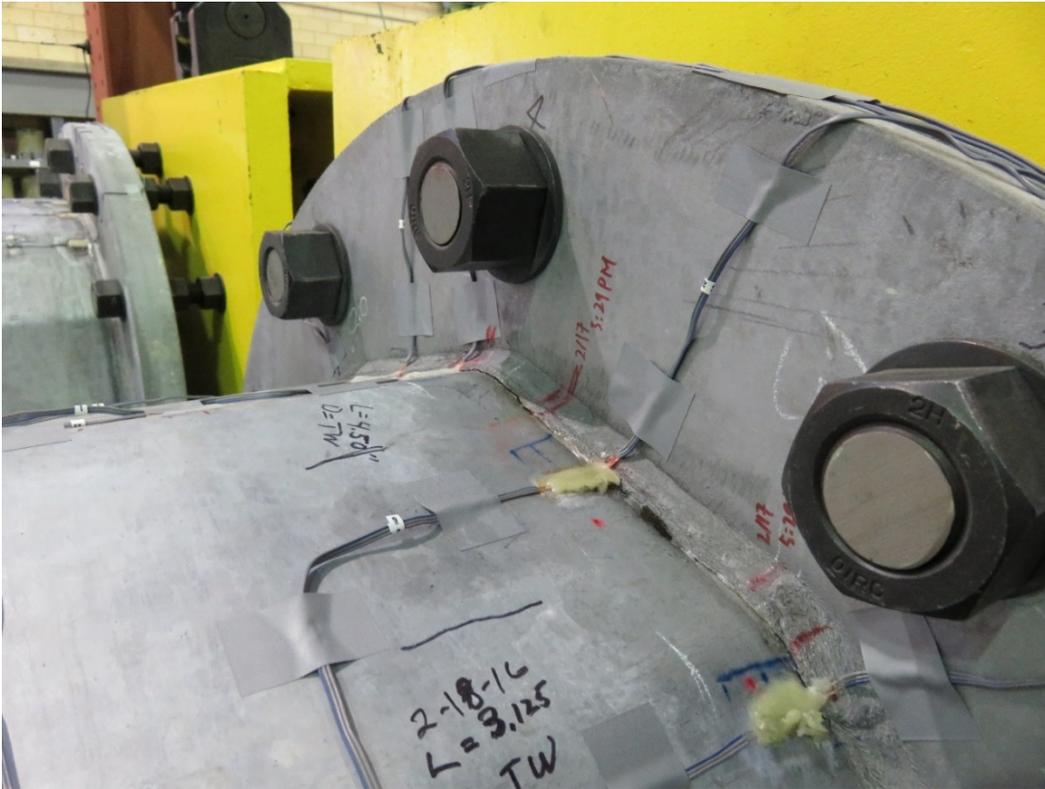
Figure 5.26: Specimen 33-3-12-TX-D after the Conclusion of Test D-1 (Photo Taken after 3.8 Million Cycles)

Test D-1 was completed after approximately one month of fatigue tests. Specimen D was deemed to have failed after it had developed sufficient cracking to reduce its stiffness by 10 percent. This reduction in stiffness occurred at 2.6 million cycles. The test was allowed to run to 3.8 million cycles before researchers stopped the test. At this point, the monitoring strain gauge measured 0 ksi. A picture of Specimen D after failure can be seen in Figure 5.26.

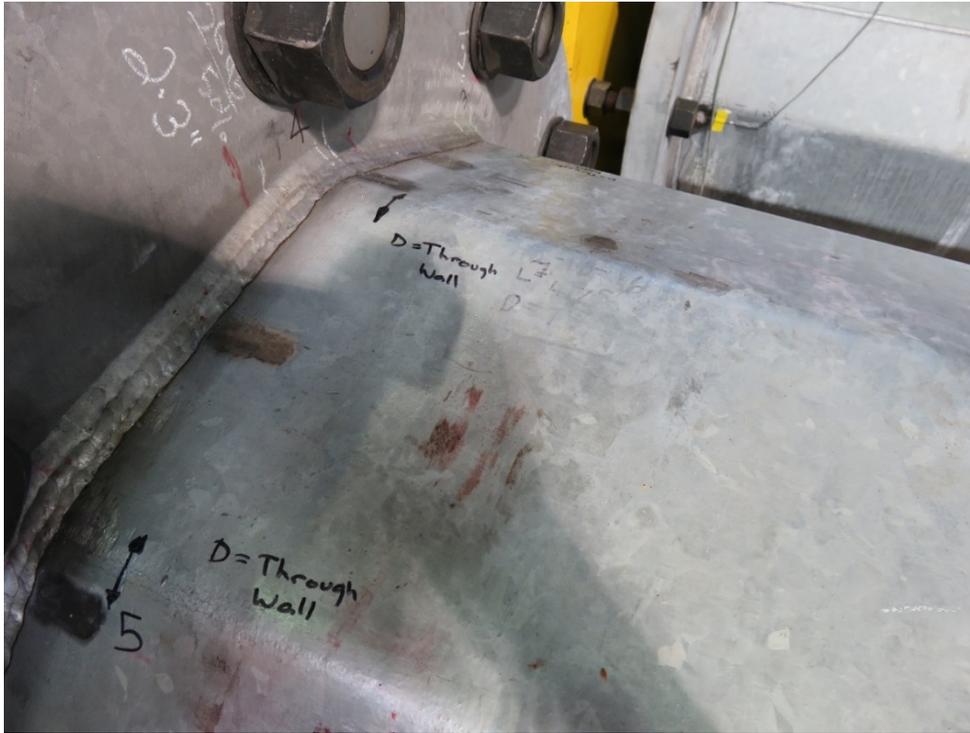
Figure 5.31: Specimen 33-3-12-TX-C after the Conclusion of Test C-1 (Photo Taken after 5.5 Million Cycles)

Test C-1 was completed shortly after. Specimen C was deemed to have failed after it had developed sufficient cracking to reduce its stiffness by 10 percent. This reduction in stiffness occurred at 4.1 million cycles. The test was allowed to run to 5.5 million cycles before researchers declared it to be complete. At this point, the monitoring strain gauge measured 0 ksi. A picture of Specimen C after failure can be seen in Figure 5.31.

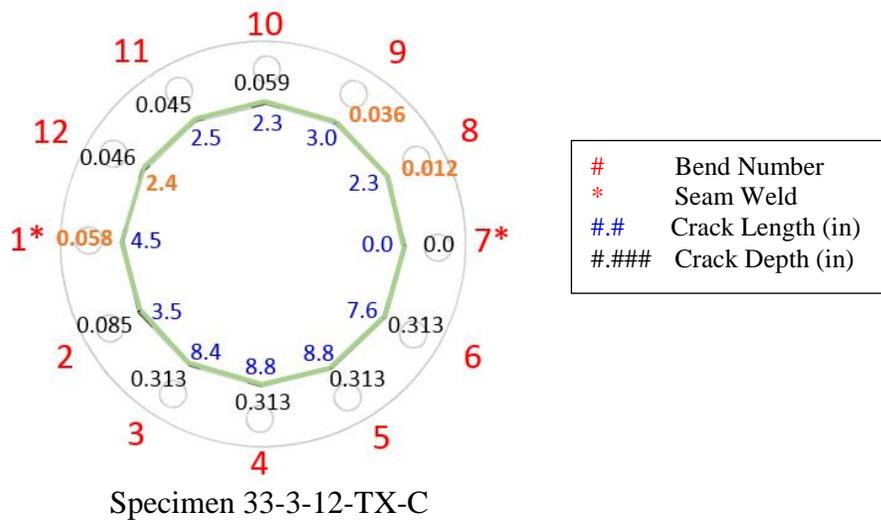
Figure 5.37: Cracks in specimen 33-3-12-TX-C after 4.8 Million Cycles in Test C-2, the Conclusion of Test C-2

No intermediate crack measurements were made during test C-2. As such, the second and final PAUT results for this test can be seen in Figure 5.37.

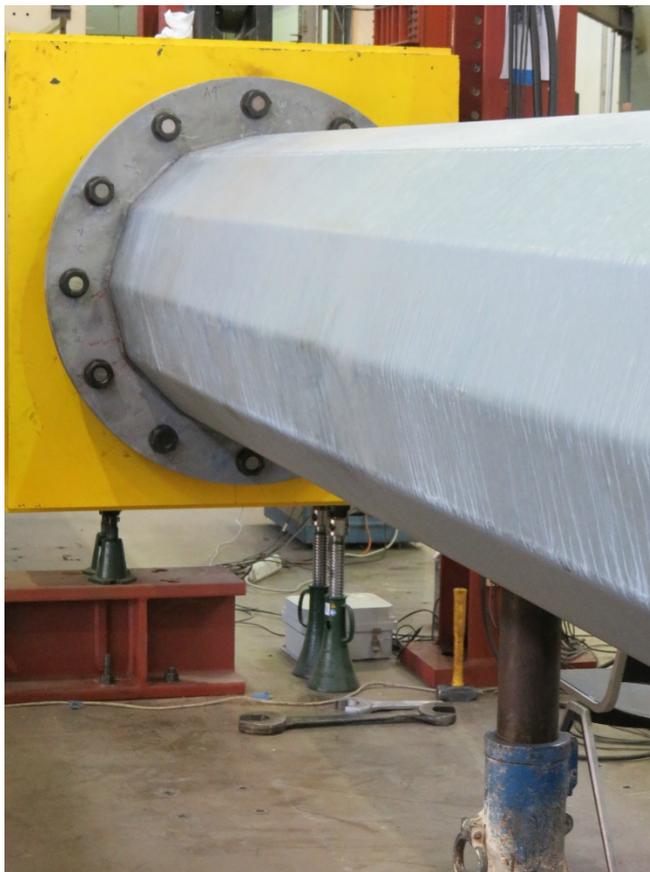
Figure A1: A Load Box and Specimen Rest on Jacks during Installation

Lower the load box onto the jacks, which can be seen in Figure A1. These jacks were adjusted such that the ends of the specimen would be level when the entire setup was complete i.e., the specimens would not sag.

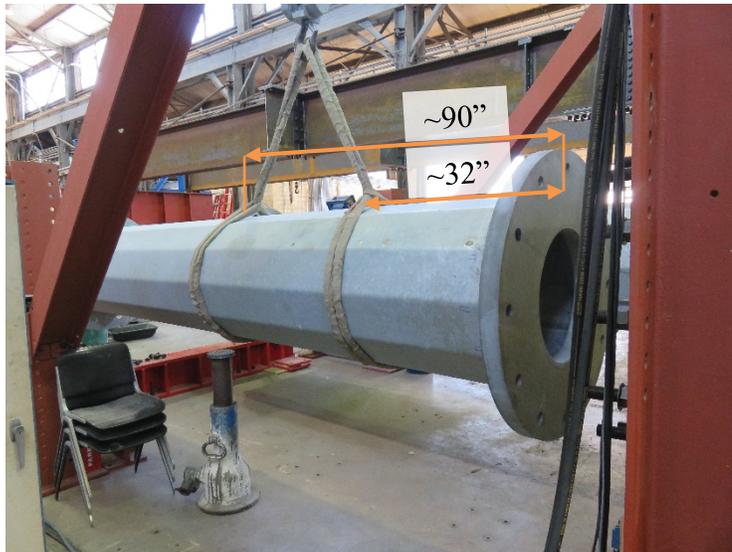
Figure A2: Strap Locations for Lifting Specimens

3. Install leveling nuts and washers to a stand-off distance (distance from load box to the baseplate) of 4.5 inches.
4. Position lifting straps around the incoming high mast specimen at the lengths specified in Figure A2.

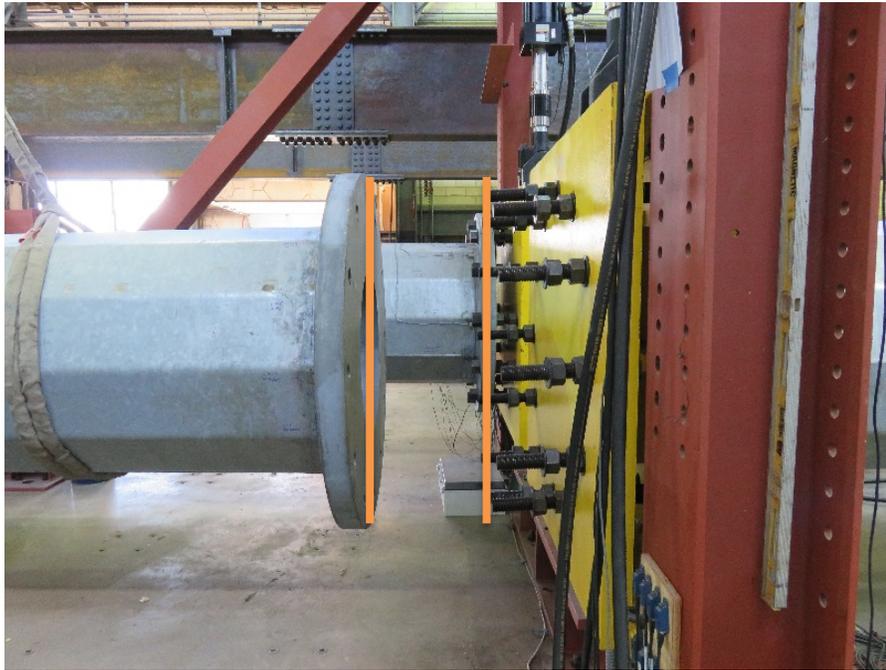
Figure A3: A “Leveled” Specimen is Moved into Place

5. Using a gantry crane, lift the specimen until it is just off of the ground. Place a level on the back side of the baseplate and verify that it is level. After this, use a plumb bob to align the top and bottom most bolt holes. This will simplify mating of the specimen to the load box. Adjust the lifting strap positions as necessary. See Figure A3 to see a “leveled” specimen.
6. Beginning on either side of the test setup, mate the first specimen with the anchor rods. It may be necessary to raise and lower the gantry crane or rock the specimen to “walk” it onto the anchor rods. During this process it may be necessary to insert

the remaining rods into the base plate if they do not align perfectly. As the specimen is “walked” onto the anchor rods, begin attaching nuts on the outside of the baseplate to prevent the specimen from sliding off the anchor rods.

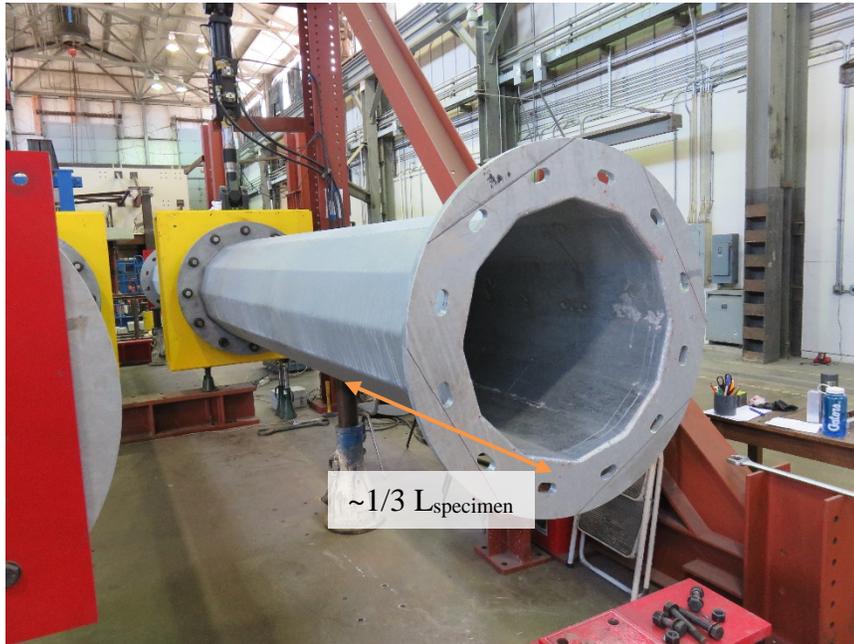
Figure A4: An Installed Specimen is Supported by a Jack

7. Secure the specimen to the load box by tightening all nuts on the load box and specimen until all are hand tight.
8. While the specimen is still supported by the crane, place a heavy duty jack under the specimen at approximately $1/3^{\text{rd}}$ of the specimen’s length from its free end. Adjust this jack until it supports the specimen. After this is completed, the gantry crane can be lowered and the straps can be removed. See Figure A4.
9. Repeat steps 4 through 8 for the remaining specimen.

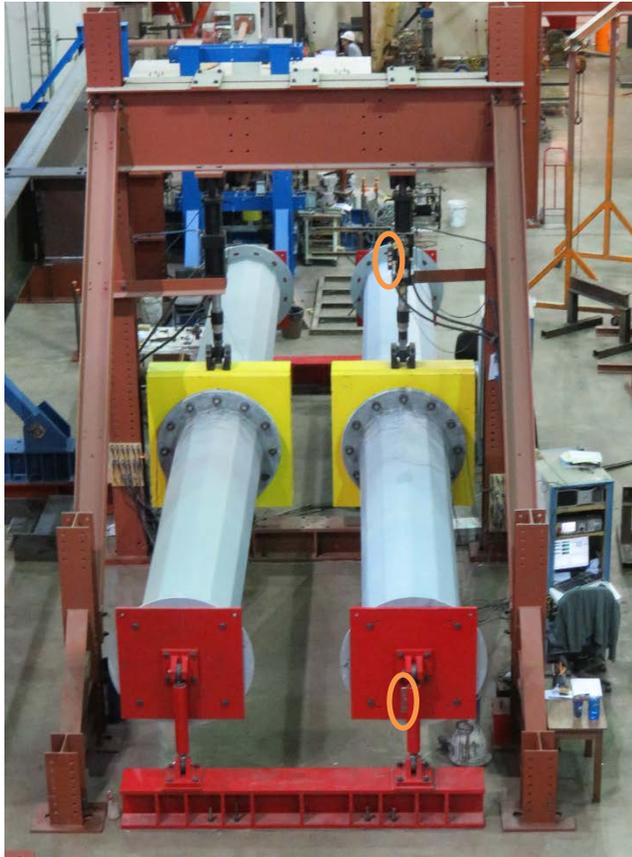
Figure A5: Level Locations

10. After both specimens have been installed to the baseplate, use the gantry crane to lift the pinned-end support in place, mating it with the specimen. Tighten bolts between the specimen and pinned-end support plate. Leave the connection between the support's baseplate and spreader beams undone.
11. Repeat step 10 for the roller-end support.
12. Using the hydraulic actuator, lift the loading box, specimens, and end supports until the load box and specimens are no longer supported by the jacks.
13. Acquire three levels and place one on the pinned-end support, one on the roller-end support, and one on the actuator. All of these should be placed on a vertical portion of each support and the actuator such that they show rotation about the long axis of the specimens. See figure A5 for these locations.

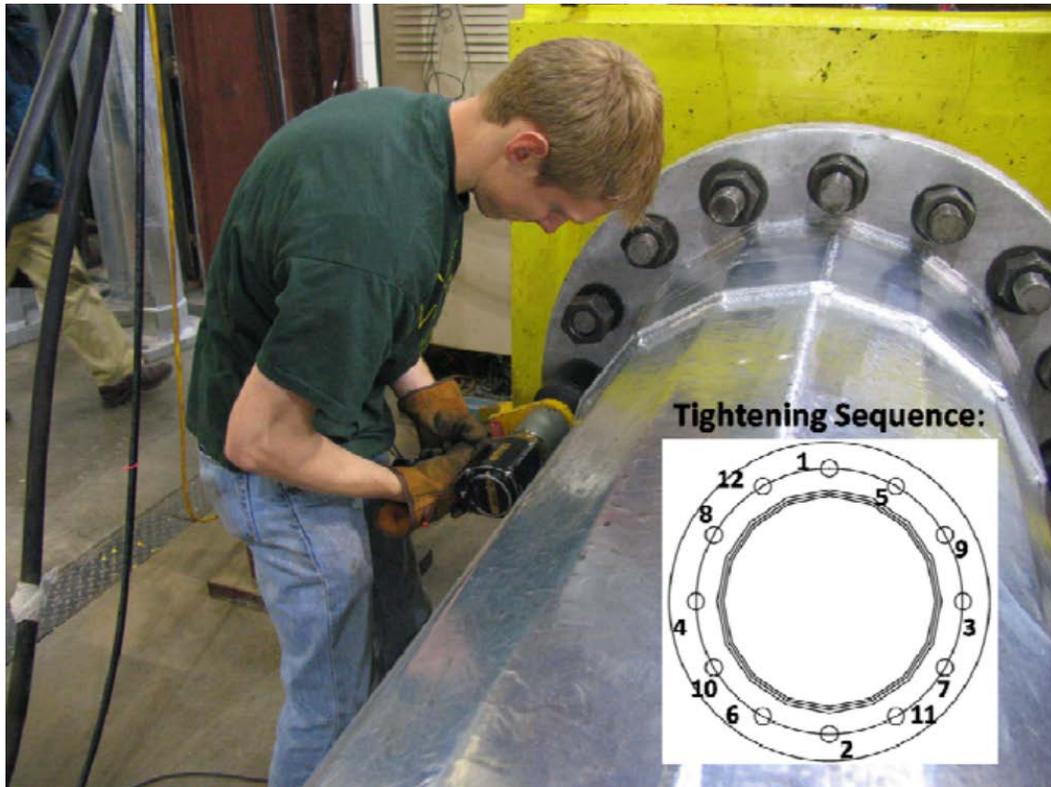
Figure A6: Tightening Baseplate Nuts (Stam, 2009)

- b. Drawing leveling nuts out to a distance of 4.5 inches.
 - c. Working in a star pattern, tighten all baseplate nuts using a pneumatic torque wrench at approximately 850 ft-lbs torque. See figure A6 for this pattern.
