No. 2307: February 15, 1923

The Austin, Texas, Tornadoes of May 4, 1922

FREDERIC W. SIMONDS

Professor of Geology

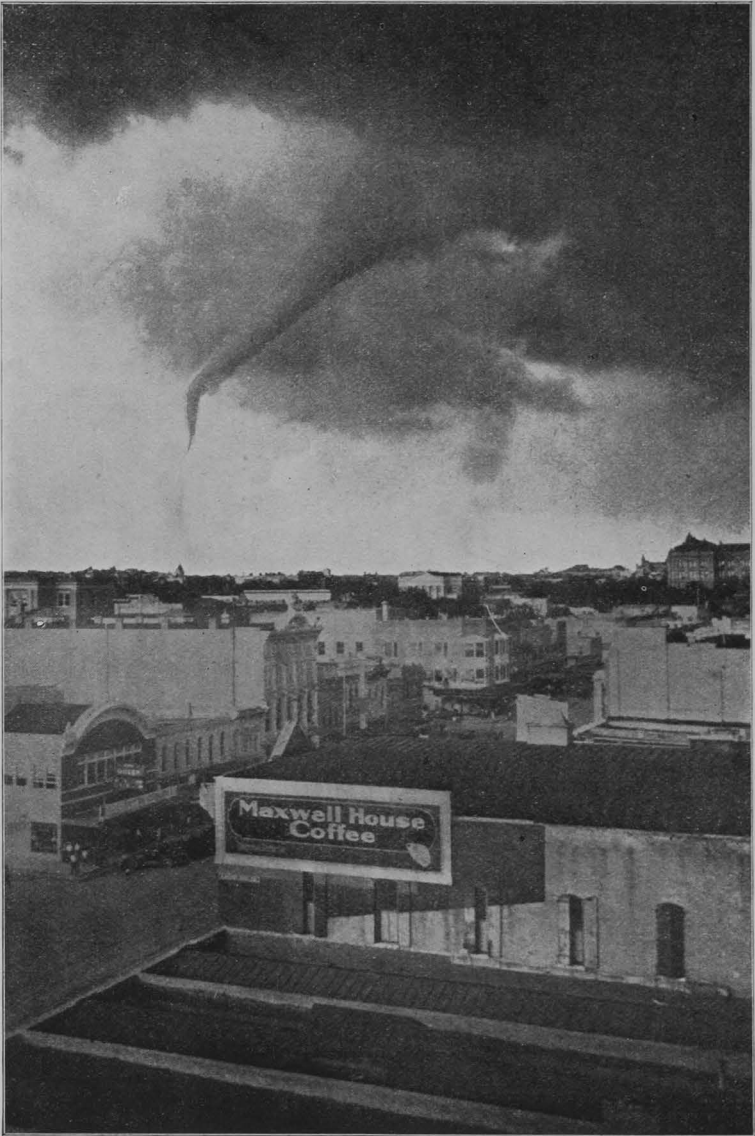
Plate I. The First Austin Tornado of May 4, 1922, as seen from the Littlefield Building looking northwest.

Even while we looked the attenuated end of the funnel broke into two or three pieces which were quickly welded together. An excellent photograph, taken from the Littlefield Building in the heart of the city, shows the inclined funnel with its extremity bent downward. (Pls. I-II.)

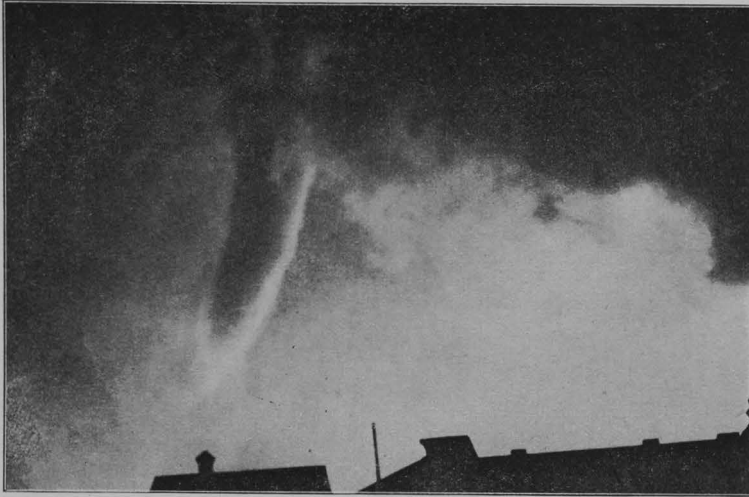
Plate II. Another view of the First Austin Tornado, as seen from building, 615 Congress Avenue, looking northwest.

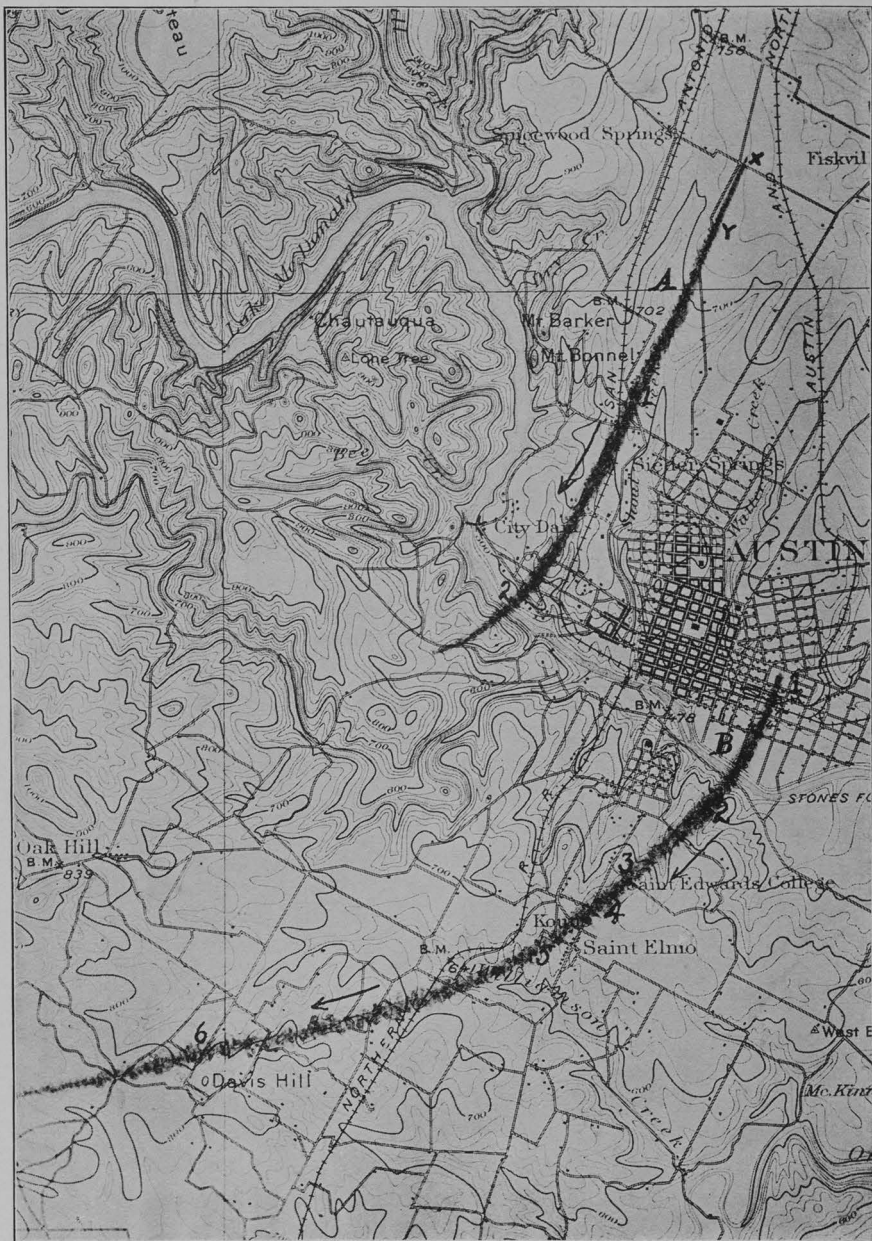
Plate III. Map showing the paths of the Austin, Texas, Tornadoes of May 4, 1922. "A" Tornado first seen in the northwest. "B" Tornado originating in the eastern part of the city. Base: Topographic map of the Austin Folio, U. S. G. S. Scale: |———|———|=2 miles.

Springs road six miles north of Austin; by leveling of a small house a mile to the southwest; by the extensive property damage at the State Institute for Deaf, Dumb and Blind Colored Youths, near the northwest limits of the city; and by the minor wind effects at and near Deep Eddy, a summer camp on the Colorado River. These localities are indicated on the accompanying map (Pl. III) as Ax, Ay, A1, and A2, respectively.

It first struck the ground in the State Cemetery where a tree was uprooted (B1 on map); next, the store of Fogle and Fogle, 1401 East Sixth Street, corner of Navasota, the building being unroofed and otherwise injured;* crossing Navasota Street in a southwest direction, it blew a small house from its foundation and destroyed its front gallery; and beyond the railroad tracks it unroofed a small building belonging to the Producers Oil Company. Farther on it damaged the Tenth Ward Fire Station and several small houses and outbuildings in the Colorado River bottom, crossed the river throwing spray, observers say, high in the air, and invaded Travis Heights, a recently built suburb (B2 on map). Here also houses were unroofed and otherwise badly damaged and large trees uprooted (Pl. X). The storm now swept over rising ground; the larger trees were prostrated and the cedar growth torn and twisted, but for the most part retaining its hold upon the rocky soil. Speeding on it completely annihilated several dwellings, and in some instances stripped the larger trees of their foliage. It then encountered St. Edwards College which occupies a

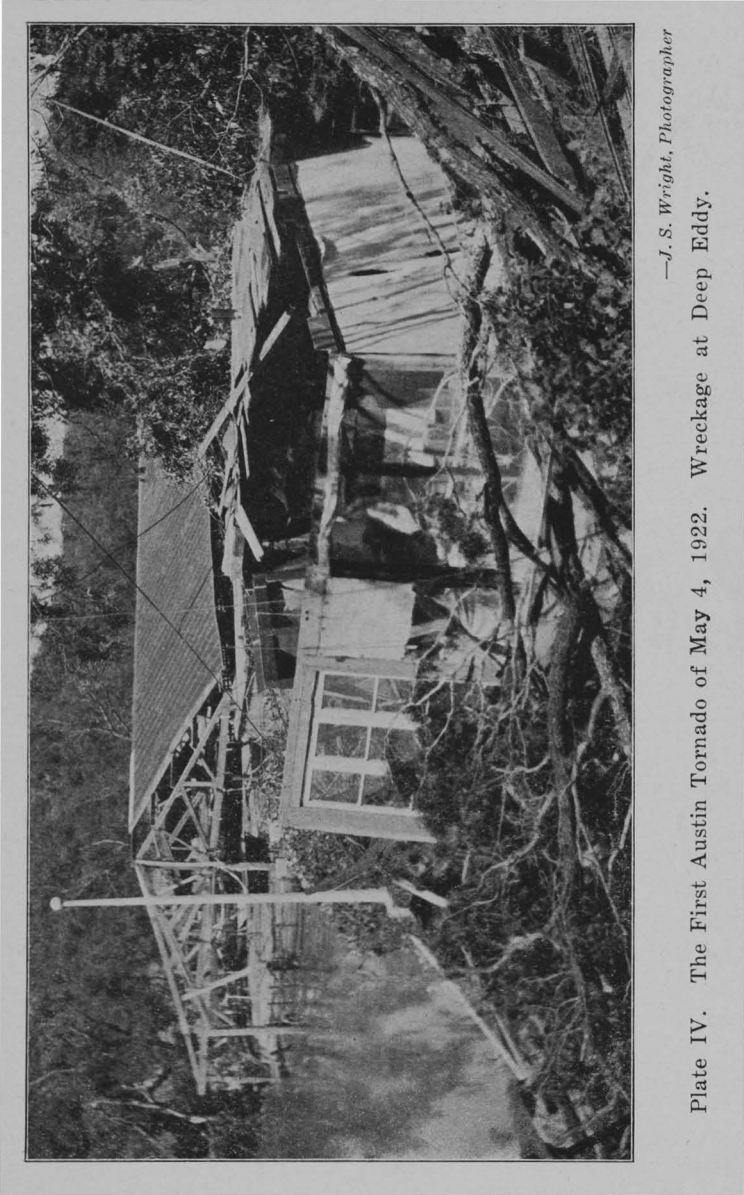
Plate IV. The First Austin Tornado of May 4, 1922. Wreckage at Deep Eddy.

At Deep Eddy trees were uprooted or stripped clean of their foliage, cabins unroofed or blown down and observers

at a distance report tree trunks and branches carried high in the air. (Pl. IV.)

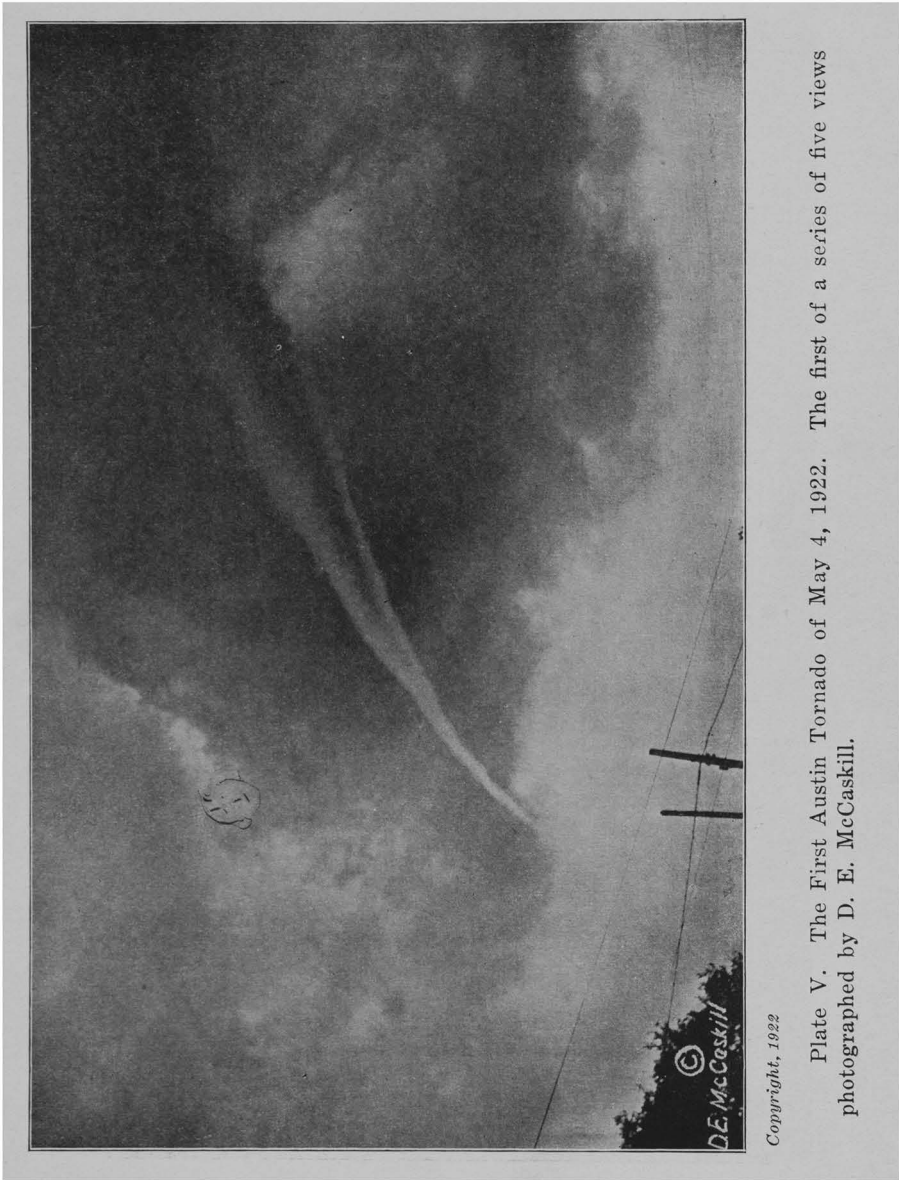
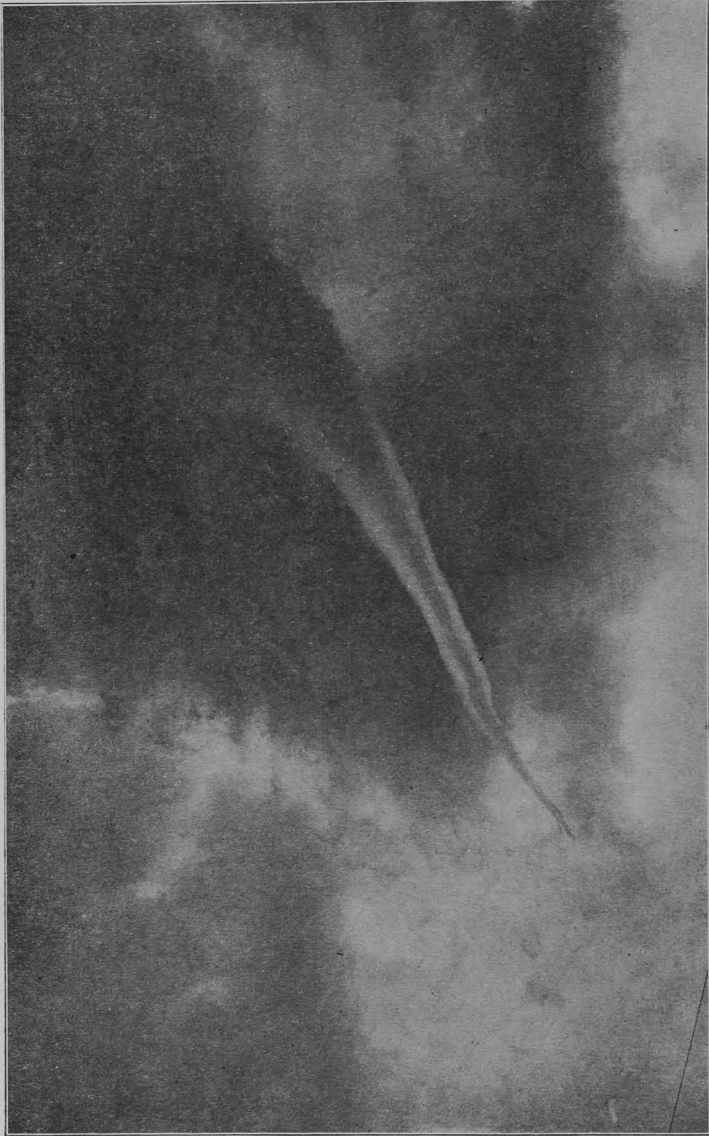
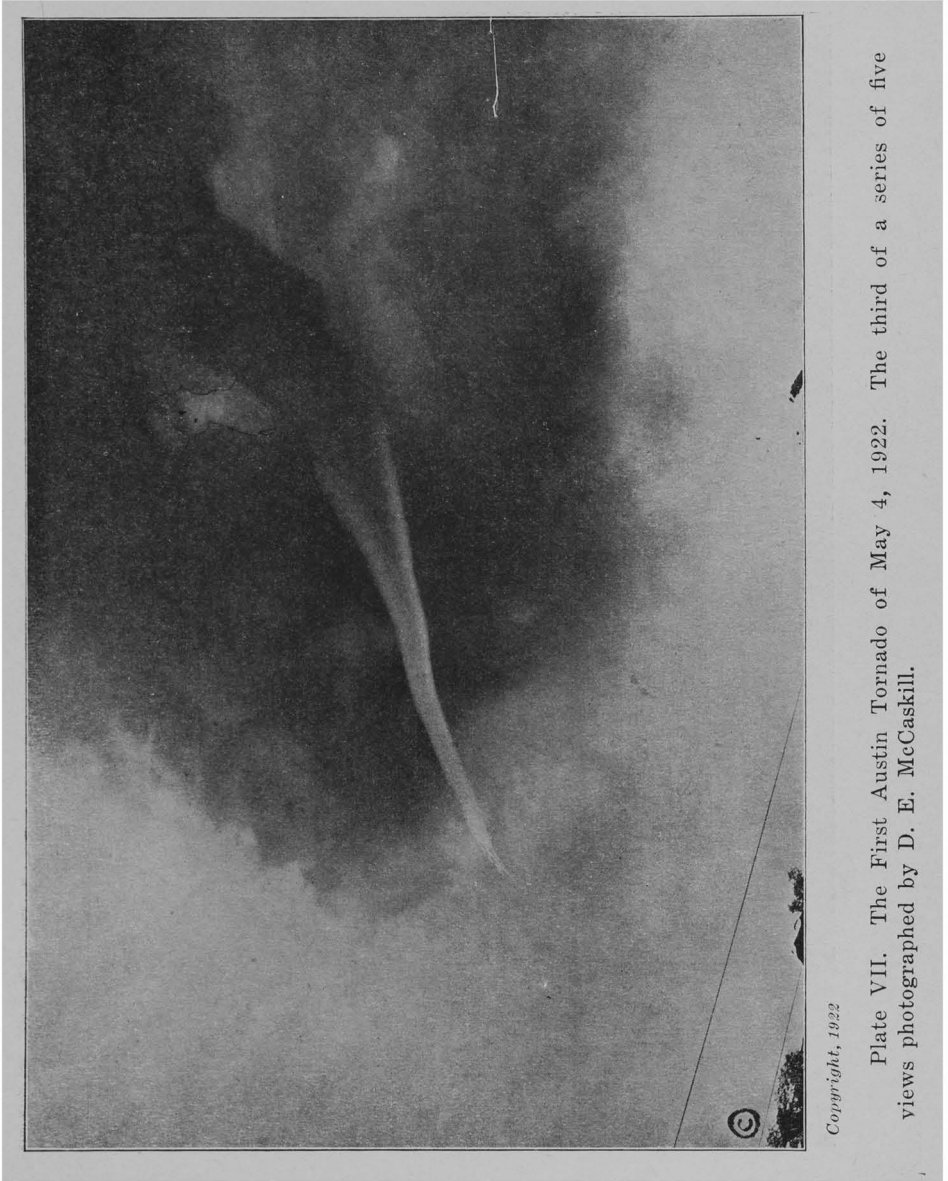
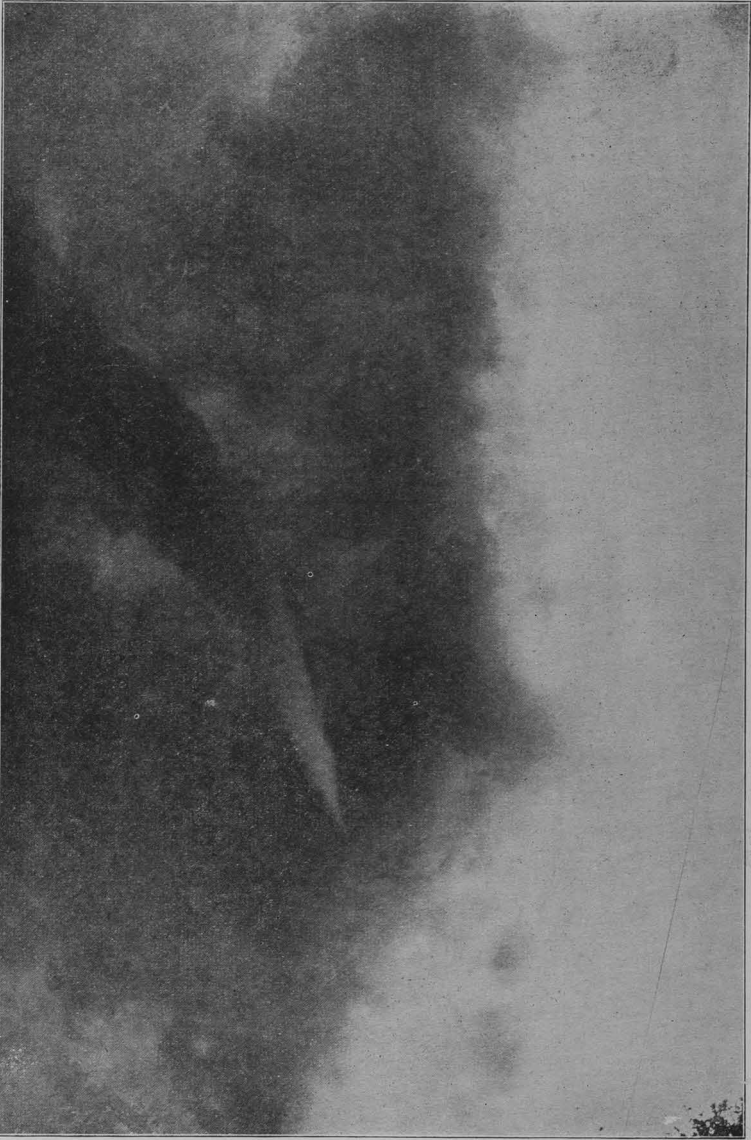
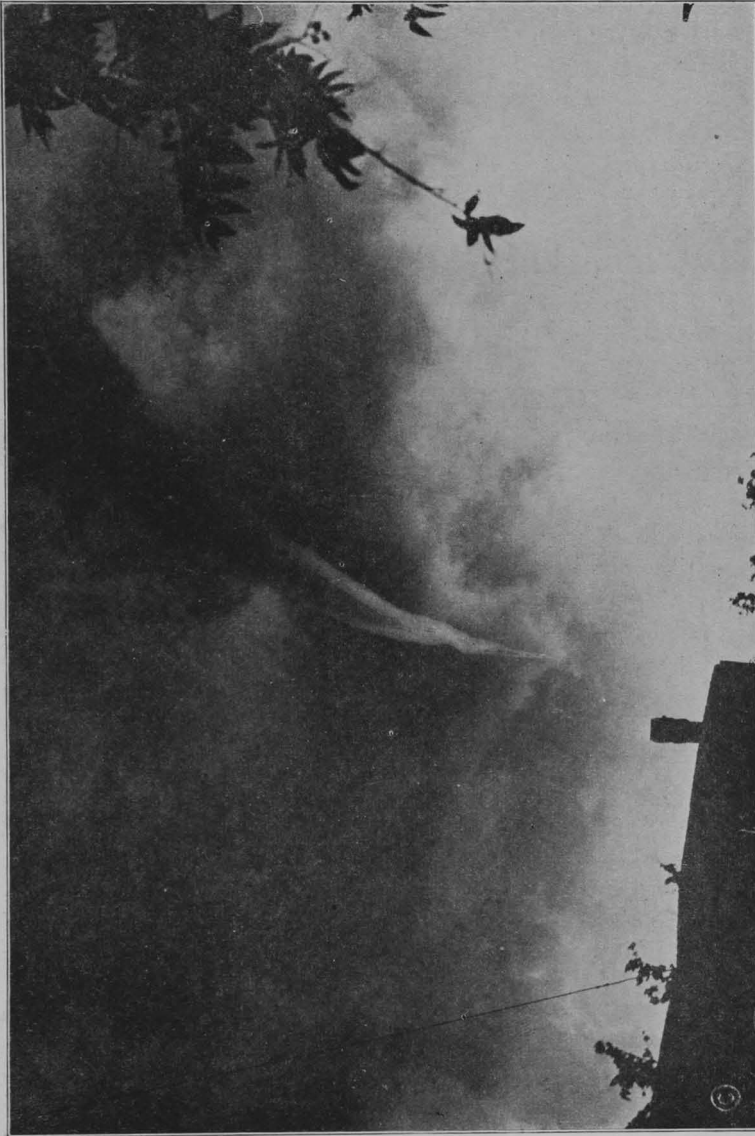
Plate V. The First Austin Tornado of May 4, 1922. The first of a series of five views photographed by D. E. McCaskill.

Plate VI. The First Austin Tornado of May 4, 1922. The second of a series of five views photographed by D. E. McCaskill.

Plate VII. The First Austin Tornado of May 4, 1922. The third of a series of five views photographed by D. E. McCaskill.

Plate VIII. The First Austin Tornado of May 4, 1922. The fourth of a series of five views photographed by D. E. McCaskill.

Plate IX. The First Austin Tornado of May 4, 1922. The last of a series of five views photographed by D. E. McCaskill.

In a series of five excellent photographs, Mr. D. E. McCaskill of the University of Texas Photographic Laboratory (Pls. V-IX), has recorded the wonderful changes in the tornado's funnel during a portion of its course. The pictures were taken at short time intervals from a locality on the west side of the University campus, the camera being directed to the northwest.

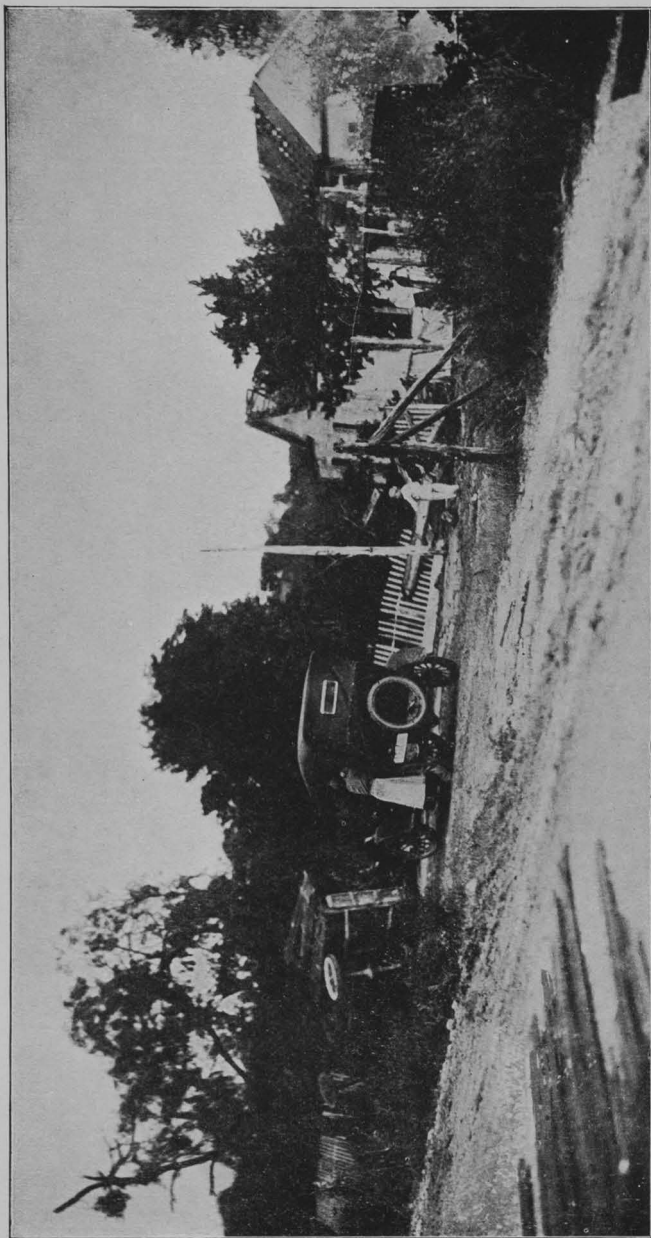
Plate X. The Second Austin Tornado of May 4, 1922. The path of the storm between Travis Heights and St. Edward's College.

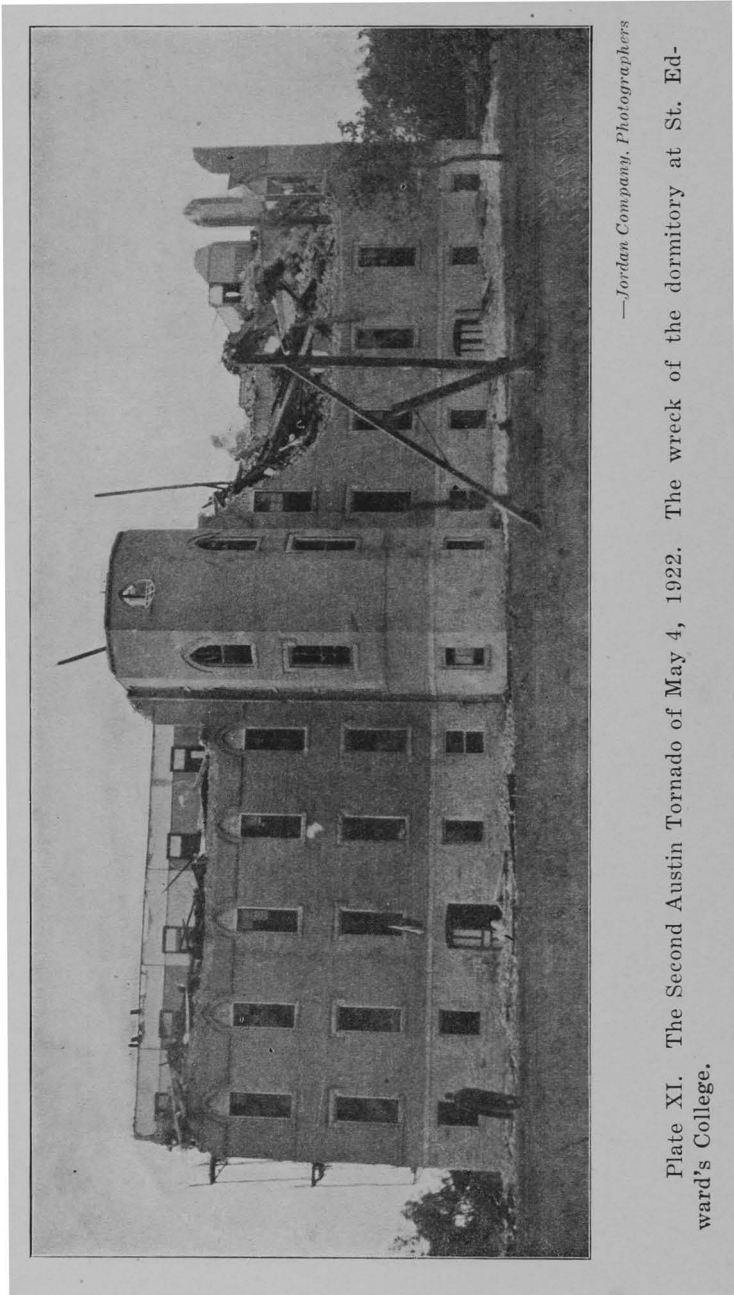
Plate XI. The Second Austin Tornado of May 4, 1922. The wreck of the dormitory at St. Edward's College.

commanding site overlooking the Colorado Valley and the City of Austin (3 on map). Here the dormitory building, a three-story structure of brick, was not only unroofed but the upper story also was destroyed (Pl. XI) and the power plant and the gymnasium wrecked. The students had a thrilling experience and one lost his life. With increasing magnitude and violence the tornado swept over the near-by "Penn Field" (B4 on map), the former seat of the "Radio School" of the University of Texas, now occupied by the Woodward Manufacturing Company. Here occurred the greatest property loss, two people were killed, and a score or more painfully injured. Five large buildings, four of brick and one of frame construction, were reduced to a confused mass of wreckage and the great steel water tank felled to the ground. (Pls. XII-XIII.)

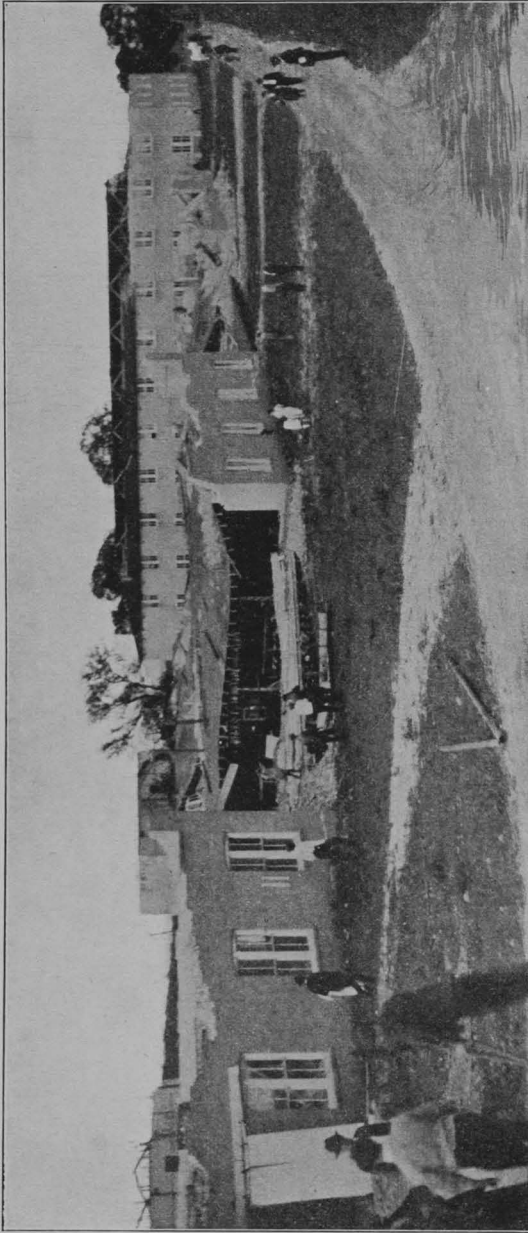
Plate XII. The Second Austin Tornado of May 4, 1922. Damaged buildings of the Woodward Manufacturing Company, Penn Field.

The largest financial loss was sustained by the Woodward Manufacturing Company in the destruction of its Penn Field plant. The greatest loss of life in any one locality occurred near Oak Hill, six persons having been killed in the wreck

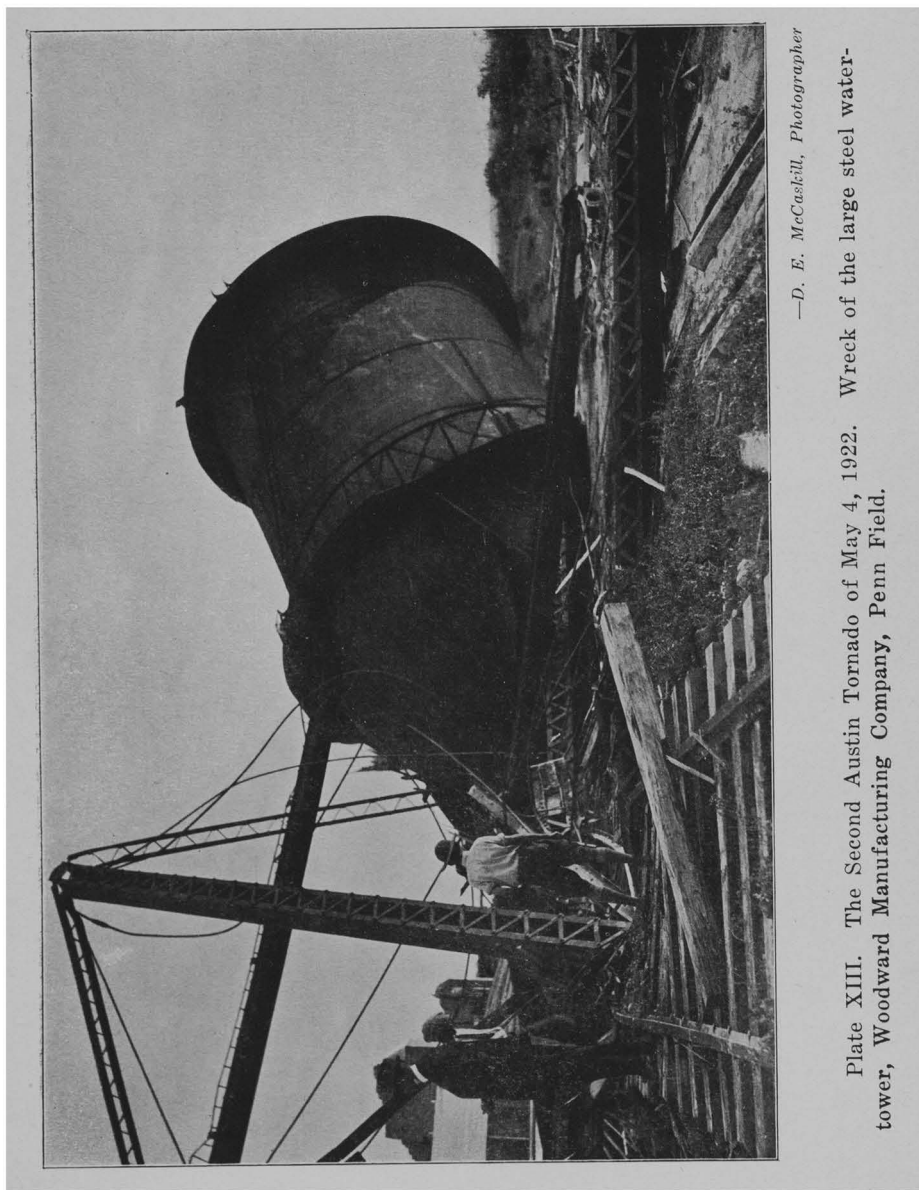
Plate XIII. The Second Austin Tornado of May 4, 1922. Wreck of the large steel water-tower, Woodward Manufacturing Company, Penn Field.

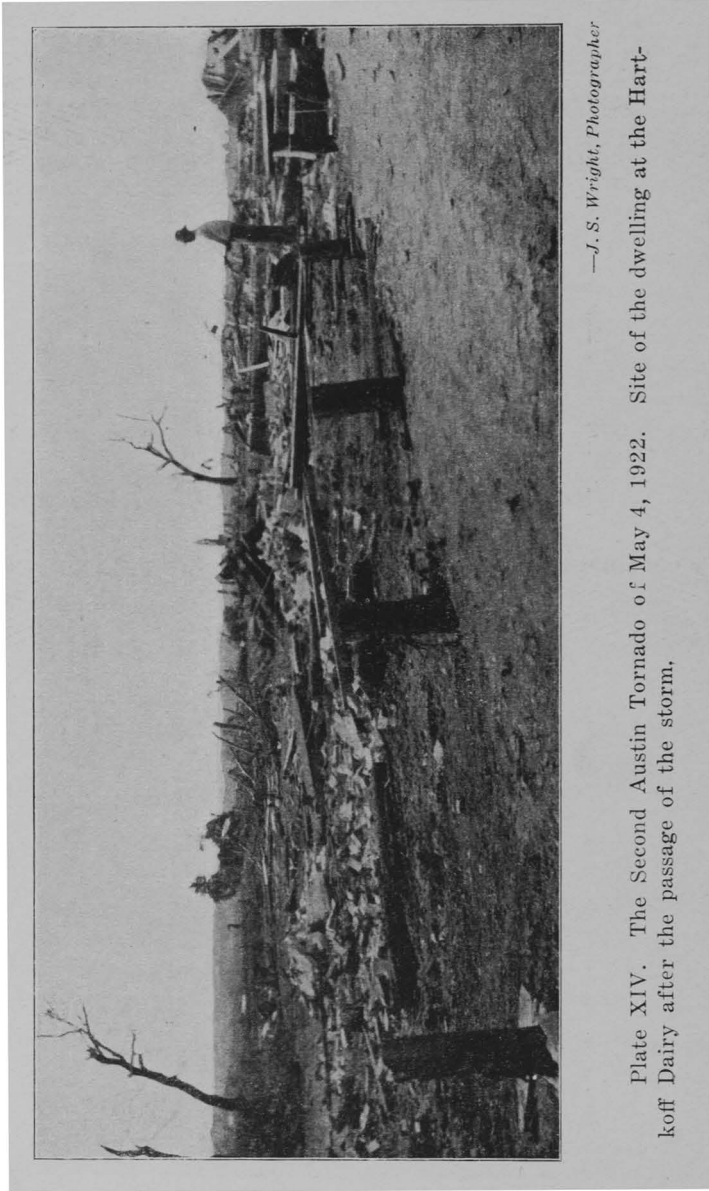
Plate XIV. The Second Austin Tornado of May 4, 1922. Site of the dwelling at the Hartkoff Dairy after the passage of the storm.

St. Elmo schoolhouse next lay in the path of the storm. This building of frame construction, about sixty feet long by thirty feet wide, was pushed at least twenty feet from its foundation but not overturned. Here it was noted that splinters of wood, probably from Penn Field, had penetrated the roof in several places. From this point onward the tornado seems to have veered more strongly to the westward. It soon struck the Hartkoff Dairy and the dwelling and other buildings were swept completely away. (Pl. XIV.)

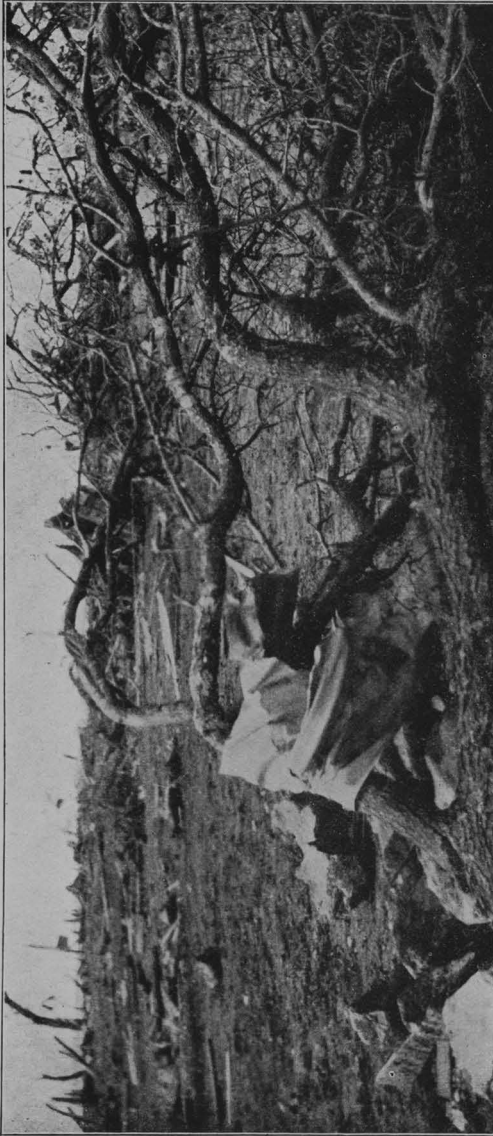
Plate XV. Path of the Second Austin Tornado of May 4, 1922. Destruction of timber near the Hartkoff Dairy.

Thus far fallen trees (Pl. XV) had indicated the general direction taken by the storm but a short distance southeast of the dairy, at the home of a Mr. Tully, which had been partially wrecked, large trees had been uprooted and had fallen in an opposite direction, i.e., towards the northeast. This was of special interest, for here was the evidence of the whirling motion.

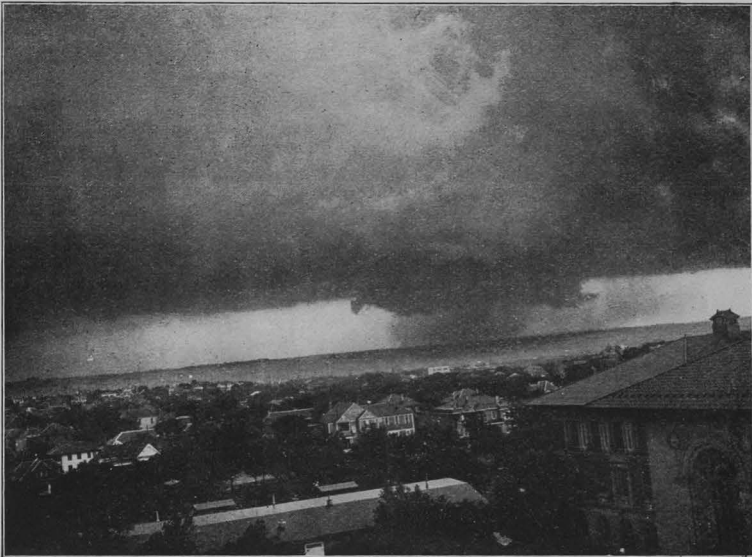
Plate XVI. The Second Austin Tornado of May 4, 1922. The first of two views photographed by R. L. Cannon from the third floor of the Main Building, University of Texas, looking southwest.

Shortly after the tornado had passed Penn Field, on its course to Oak Hill, Mr. R. L. Cannon, from a window on the third floor of the Main Building of the University, secured two photographs. The storm is estimated to have been six or seven miles distant. In the first (Pl. XVI) the curtain of dark storm clouds, in appearance not unlike that of the usual "norther," had nearly reached the horizon. From it a heavy pendant mass, distinctly outlined against a lighter background, reached the surface of the earth. This included not only the funnel of the tornado but probably a great quantity of dust and other debris drawn into the column during its excursion across Penn Field and the dairy plant.

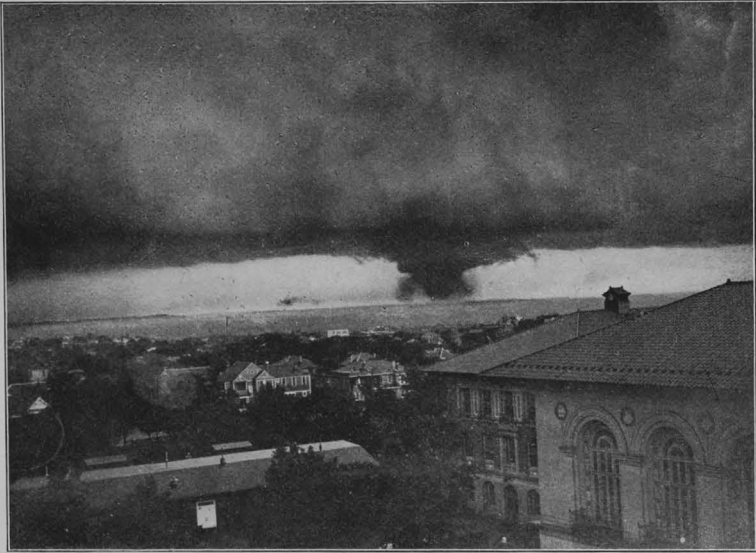
Plate XVII. The Second Austin Tornado of May 4, 1922. The second of two views taken by R. L. Cannon from the third floor of the Main Building of the University of Texas, looking southwest.

In the second photograph (Pl. XVII), taken five minutes or less later, the storm had passed farther to the west and through what we conclude to be dust can be seen the short, thick-set funnel extending to the ground.
