**THE WALLER CREEK TUNNEL PROJECT:
ARCHEOLOGICAL INVESTIGATIONS ALONG WALLER
CREEK
IN THE CITY OF AUSTIN
TRAVIS COUNTY, TEXAS**

SUBMITTED TO:
The City of Austin
and
The Texas Historical Commission

ANTIQUITIES PERMIT 4935

August 2008

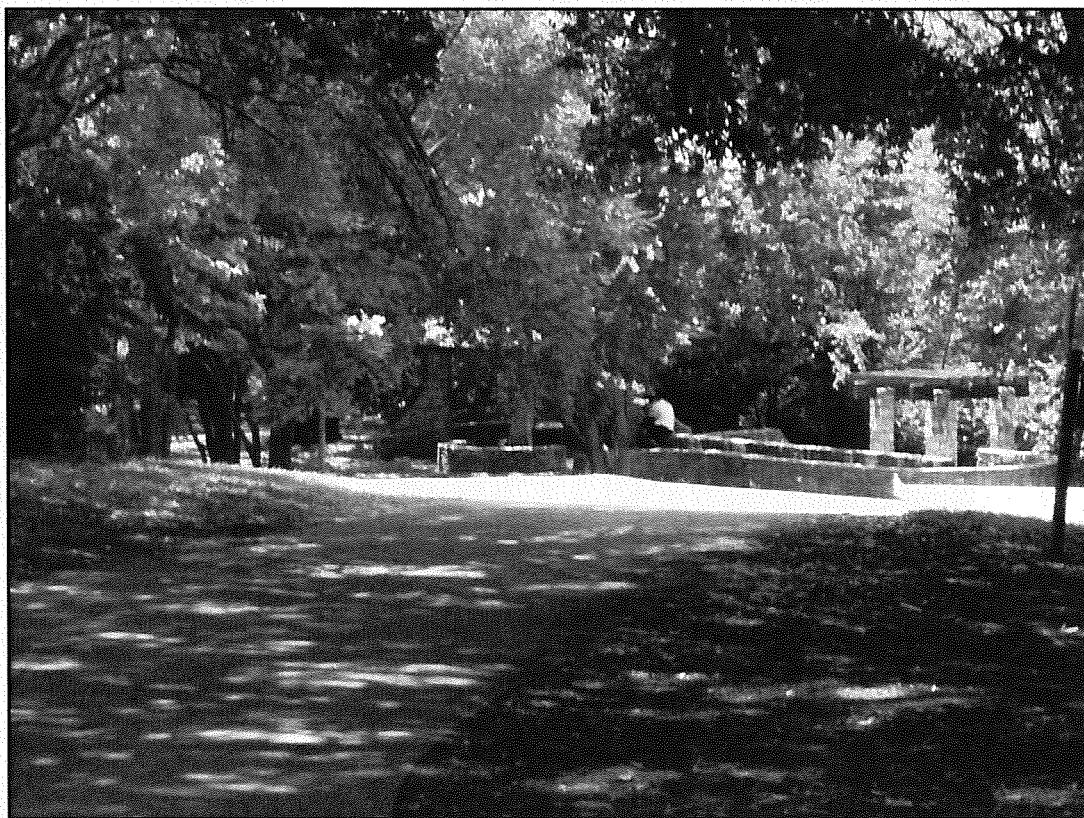
Figure 11. Types of structures and improvements at Waller Beach.

Currently this area is used for recreation. The project area at Waller Beach assumed its current appearance no earlier than 1960, when Town Lake was created, largely through the federal funding secured by Lyndon B. Johnson during his time as a U.S. Senator. Lady Bird Johnson, his wife, was instrumental in securing the funds for a beautification effort along the newly created Town Lake that resulted in the current park-like setting of the Waller Beach area. Today, the Austin Rowing Club's boathouse and dock dominates the Waller Beach area (Figure 11).

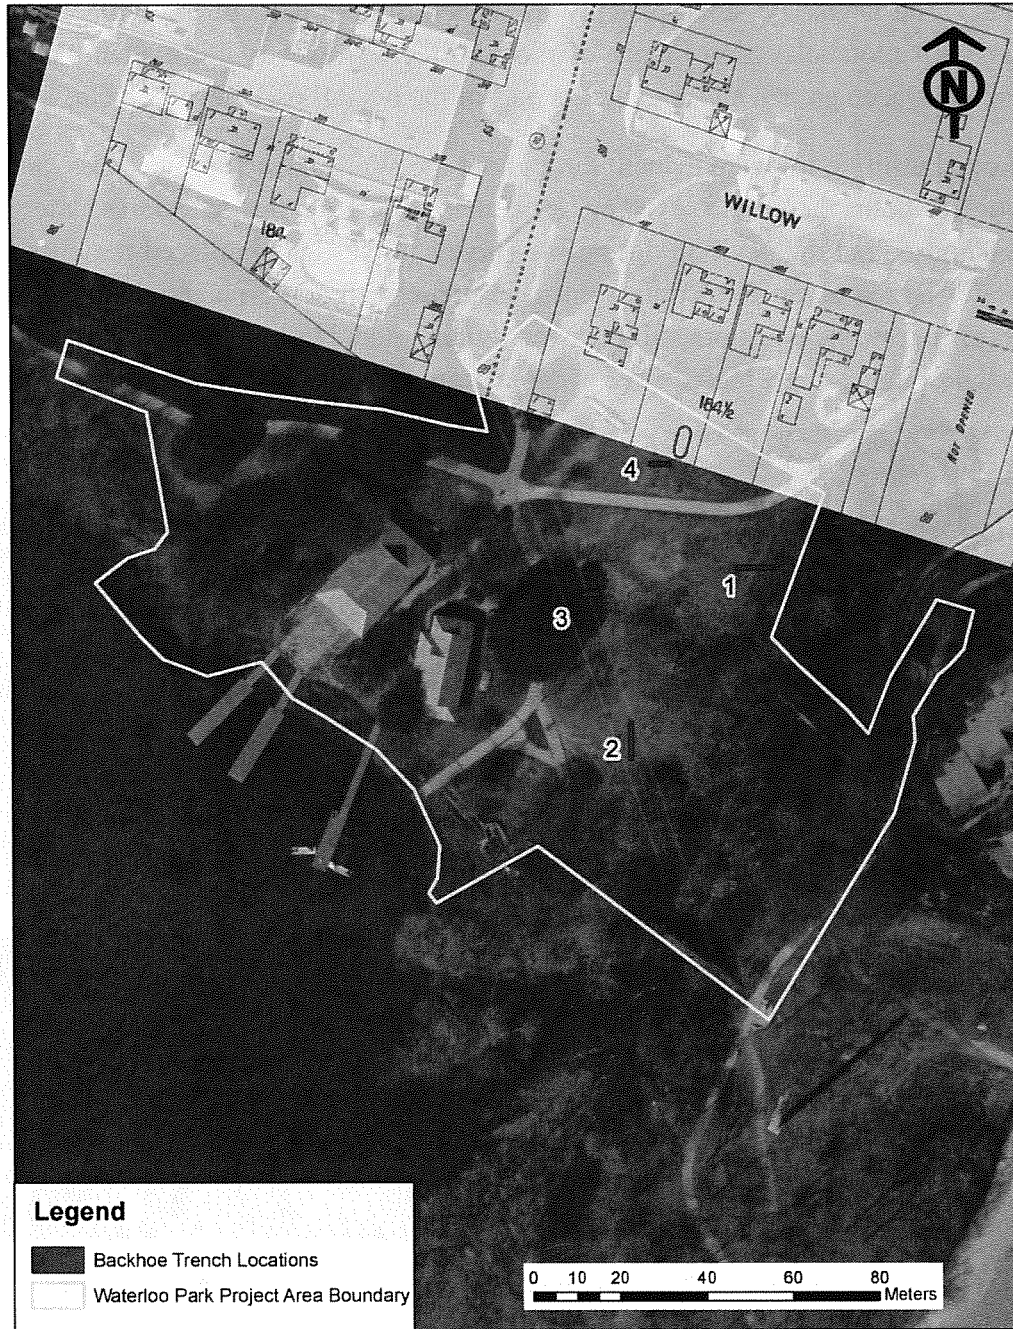
Figure 12. Trench locations at Waller Beach.

Four backhoe trenches (BHTs 1-4) were excavated, documented, photographed, and carefully profiled (Figure 12.). Backhoe excavations at Waller Beach revealed no intact features below the current ground surface; though two trenches (BHTs 2 and 3) did contain zones of early to mid-twentieth century cultural material—primarily architectural and fragmented household debris—which investigators believe was probably pushed over what was once the edge of the bluff overlooking the Colorado River.

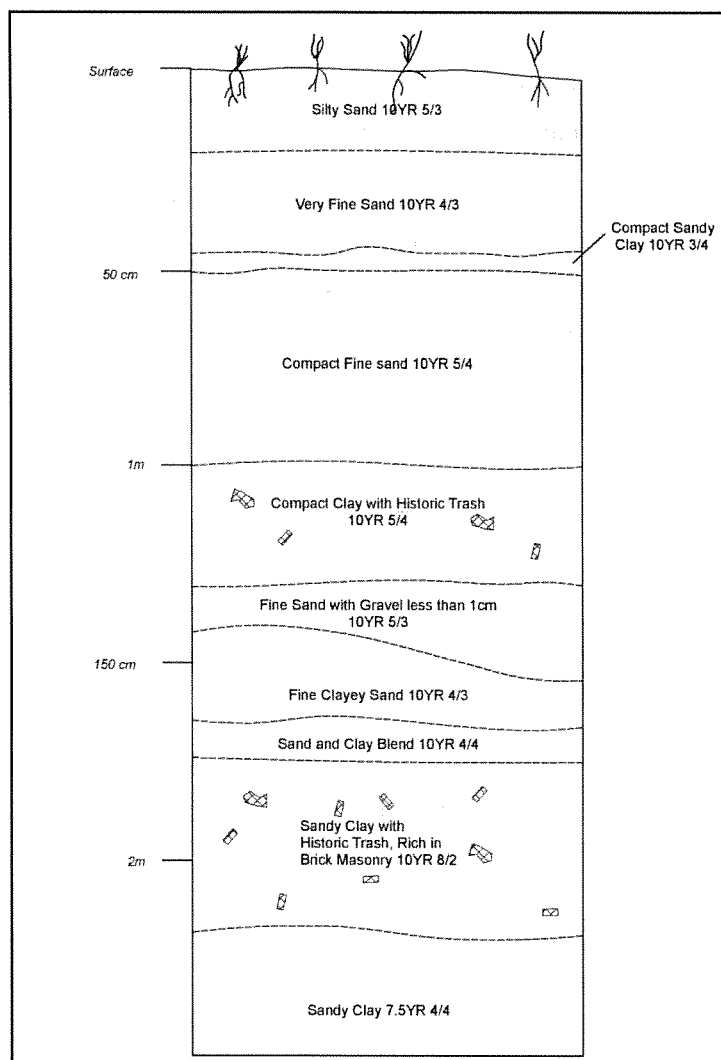
Figure 13. Profile of BHT 2

Older cultural materials were found in two distinct horizons below this. The first cultural horizon was 100 to 130 cmbs; it contained historic trash and masonry from the early to mid-twentieth century. Artifacts collected from this zone include 45 bottle glass fragments of varying colors, two pieces of whiteware, a ceramic insulator, two horseshoes, crimped copper, a rubber hose fragment, wire nails, a broken metal spoon, four pieces of cut bone, tile and brick fragments, wire, and a coal chunk. Though most items are non-diagnostic, the overall character of the assemblage suggests that the artifacts are from the early twentieth century. The second cultural horizon was 175 to 220 cmbs and was mostly made up of brick, mortar, slate, stone and other architectural debris from a razed structure. It is likely that the

levels represent two episodes or phases of demolition that were pushed off what in the past was a steep bluff leading down to the Colorado. The trench was terminated at a depth of 230 cmbs below the second cultural zone. The Principal Investigator judged that this area, at the

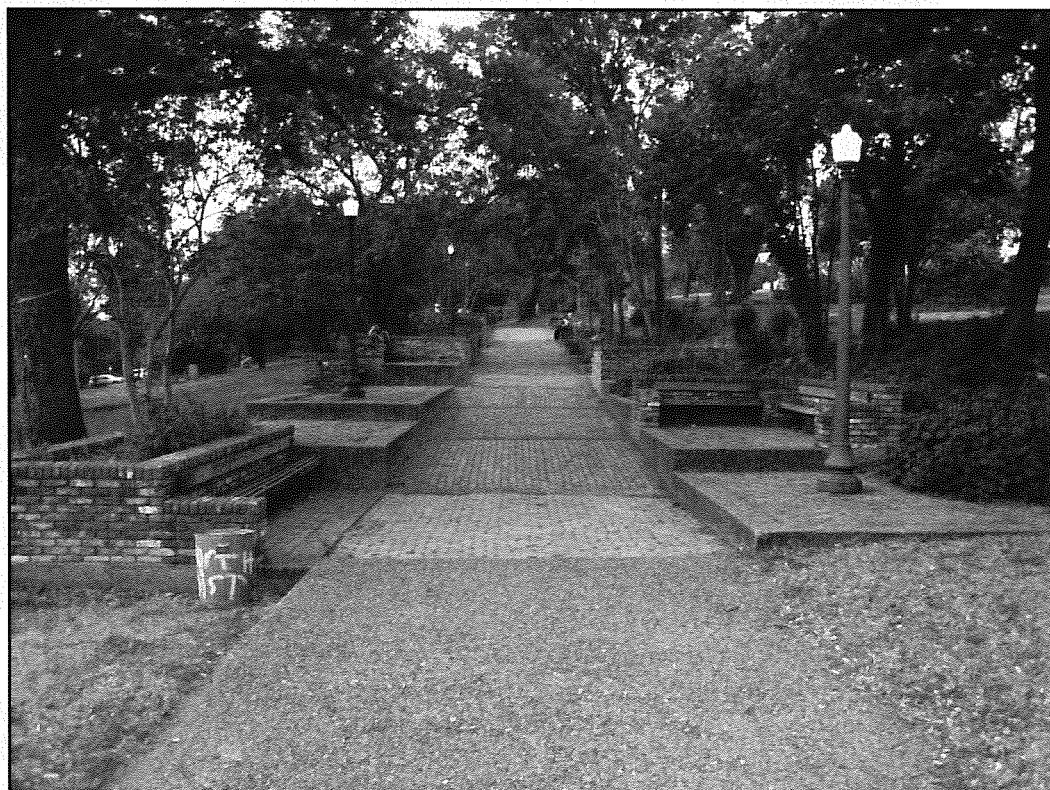
Figure 14. Walkway running along the western edge of Block 145.

Currently there are a number of structures and landscape modifications within Waterloo Park that made investigations impossible over much of the project area. A parking lot is located along 12th Street on what was formerly Block 145. The west half of that same block is entirely built up with walkways, pavilions, viewing decks, gazebos, and statues. There are walkways, bridges and stone walls along both sides of Waller Creek (Figures 14-16). A steep slope runs down to the creek on the east side of it in the project area, and marked water, gas, and electric lines crisscross the entire park. In addition to these obvious above and below ground installations, it was apparent that the west half of Block 163 had been completely dug up and graded in recent years. The ground in that area was bare and early twentieth century artifacts were exposed on the surface in no apparent context. Given all these disturbances, investigators were left with only small areas to survey.

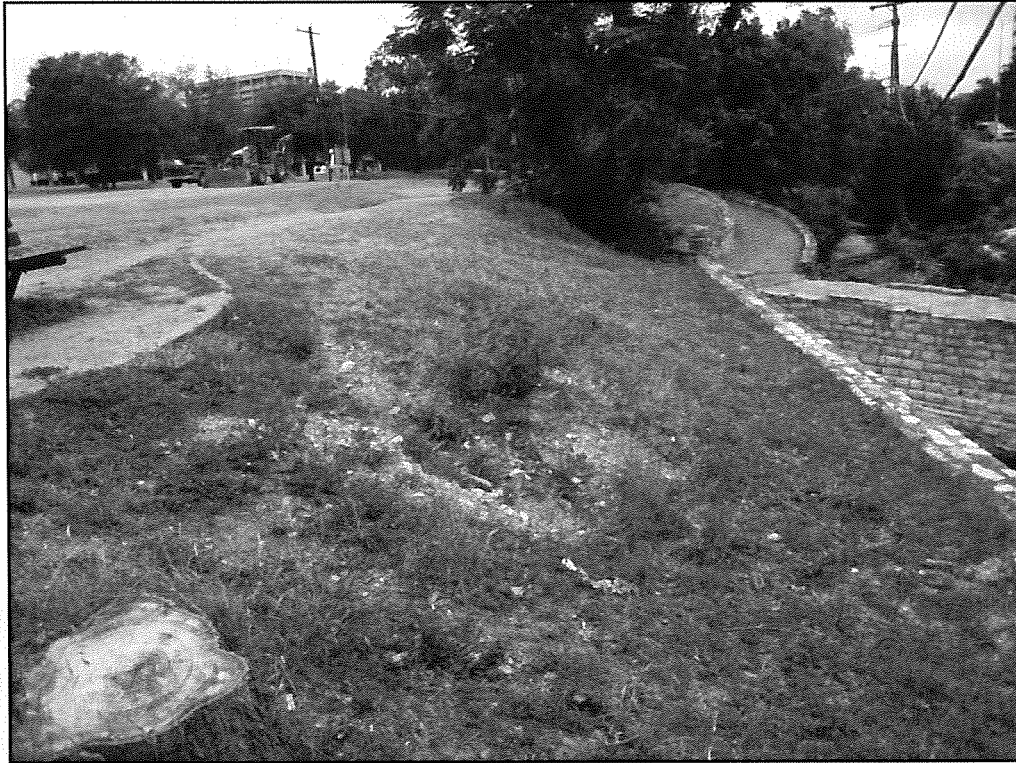
Figure 15. Walkways and stone retaining walls along Waller Creek.

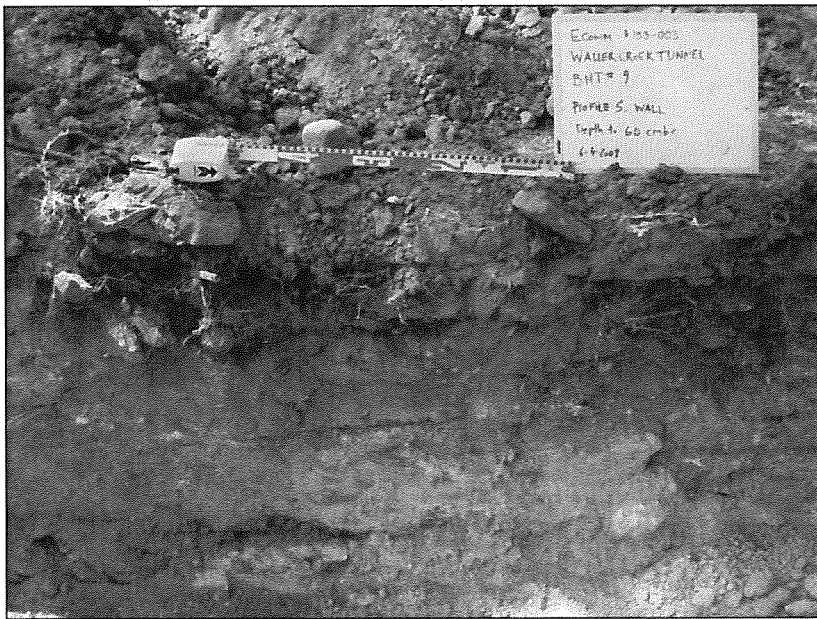
Figure 18. View of Backhoe Trench 9 showing no intact cultural layers.

Backhoe Trench 9 was excavated in Block 145, Lot 5 at the address that used to 1206 Neches Street. The property was once owned by Jacob Lutz who lived there from around 1900 to sometime after 1915, and continued to own the lot until after 1925. The trench was placed

10 meters (32.8 feet) east of an exposed limestone cistern, which has been incorporated into the Waterloo Park design and is now surrounded by a gazebo. Located at the back of this property, the cistern likely collected water from the Lutz house. BHT 9 contained few artifacts and no intact surfaces with archeological material. The trench profile revealed approximately 50 centimeters (1.65 ft) of sandy clay and gravelly
