**FINITE ELEMENT MODELING OF TWIN STEEL BOX-GIRDER  
BRIDGES FOR REDUNDANCY EVALUATION**

**Dissertation**

**The University of Texas at Austin**

**May 2010**

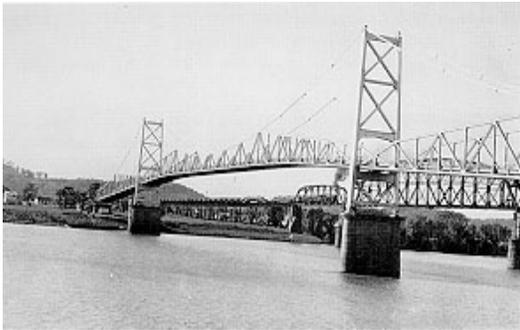
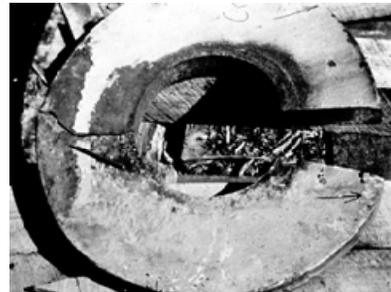
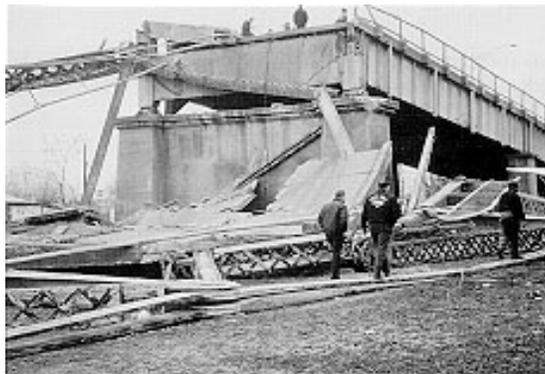
Figure 1.1 Silver bridge before and after fracture (Wikipedia, 2009)

On December 15, 1967, the Silver Bridge (Figure 1.1) over the Ohio River collapsed during rush hour, leading to 46 casualties. The investigation of the failure determined that the fracture of a single eye-bar connecting the bridge's suspension chain released the primary load path, which resulted in the total collapse of the structure (Scheffey, 1971). This tragic accident initiated new legislation mandating regular inspections and maintenance of bridges.

(a) In service

(b) Fractured eye-bar

(b) After fracture

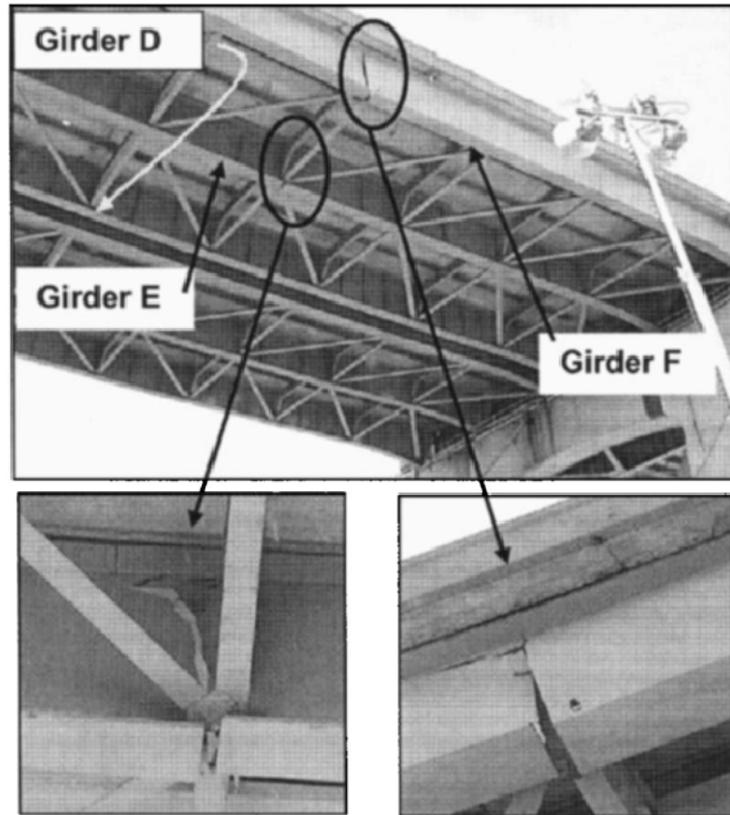
Figure 2.1 Hoan Bridge Fracture (Connor et al., 2007)

through-thickness deformation of the web and consequently resulted in a high tri-axial stress condition. Under such high tri-axial stresses, the web steel fractured suddenly prior to material yielding, which is called a constraint-induced fracture (CIF).

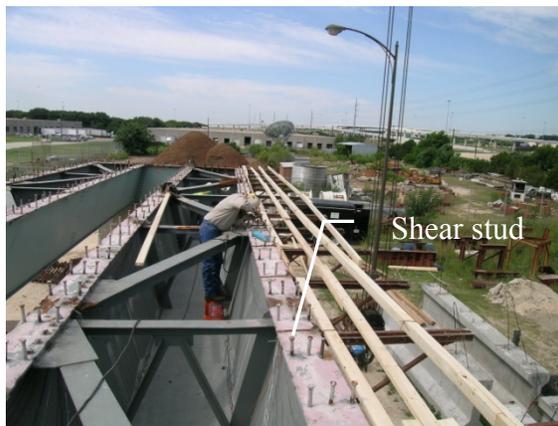
In the construction of a steel box-girder bridge, shear studs are used to develop composite action between the concrete deck and the box girders. These shear studs, as shown in Figure 3.2(a), are installed on the top flanges of the box girders prior to casting of the concrete deck. Haunches above the girder top flanges, as indicated in Figure 3.2(b),

(a) Shear studs installed on top flange

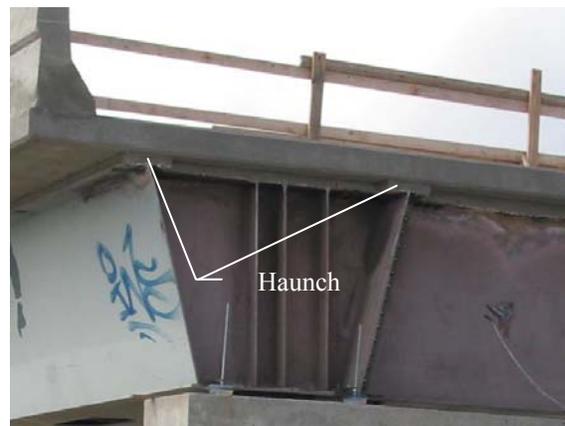
Figure 3.2 Shear studs and haunches of twin box-girder bridge

allow for a uniform deck thickness along the bridge span. In the simulation model, such haunches were not modeled explicitly; instead, their effects on the tensile strength of shear stud connections were incorporated into the vertical response of connector elements (CONN3D2). The shear resistance of shear studs between the deck and the steel box girders were simulated by the horizontal response of the connector elements. Equations used to define the load-deformation response of stud connections were obtained from available literatures that will be described in Section 3.3.3. Bridge rails and railing interactions were modeled by 8-node solid elements and nonlinear spring elements (SPRING2) to account for railing contact. These nonlinear springs were assumed to be effective only in compression after a deflection of 3/4 in. was reached, which was the initial gap distance between rails in the finite element model based on field measurements of the bridge tested at FSEL and the prescribed geometry called for in the TxDOT T501 traffic railing (TxDOT, 2003).

(b) Deck haunch

A haunch as shown in Figure 3.2(b) is typically used in bridge construction to help maintain a uniform thickness of the concrete deck. One potential drawback with the use of a haunch, particularly as it relates to the current study, is that it can reduce the penetration length of a shear stud into the deck. Such reduced penetration of the stud could limit the available shear and tensile capacity of the connection between the concrete deck and the steel girders. For this reason, the AASHTO LRFD Specification (2007) requires that shear connectors penetrate at least 2 in. into the deck, and the TxDOT Bridge Detailing Manual (2001) limits the maximum haunch height to 3 in. when there is no reinforcement in the haunch region.

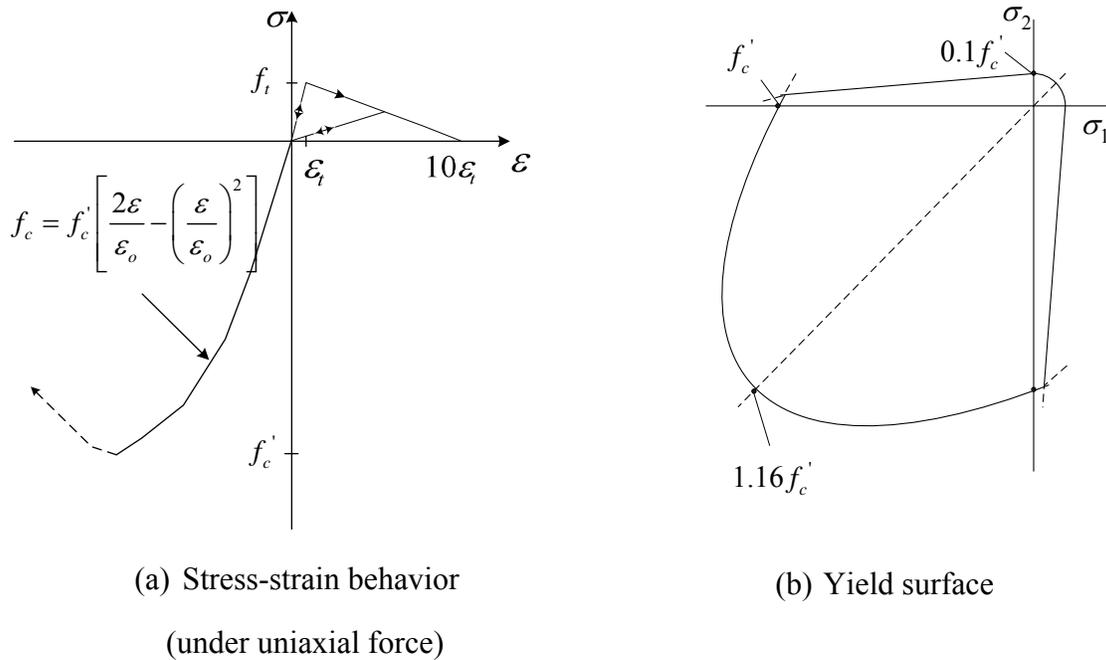
Figure 3.5 Material behavior in concrete smeared cracking model

The concrete deck and rails were modeled using 8-node solid elements. To account for the inelastic behavior of concrete, such as tensile cracking and compressive crushing, ABAQUS/Standard (v6.7) provides a concrete smeared cracking model and a concrete damaged plasticity model. The latter model is appropriate for cases in which high confining pressures exist, while the former model is appropriate for problems with low confining pressures (Dassault Systemes, 2007a). For the concrete deck of a twin steel box-girder bridge, high confining pressures are not expected due to the fact that the thickness of the deck is much smaller than the width and the length and because the axial restraint in the plane of the deck is limited. For this reason, the concrete smeared cracking model was initially adopted to simulate the response of the full-scale bridge tested during this research.

Figure 3.9 shows the uniaxial behavior and the yield surface of the cast iron plasticity model, which was used to model concrete material behavior in this study. Basically, the model has a von Mises-type yield surface, but it is truncated by a Rankine fracture criterion to incorporate a reduced yield strength in tension. Under a plane stress state, the von Mises yield surface has an elliptical shape, and the Rankine yield surface is a square (Ugural, 1995). Figure 3.9(b) depicts the resultant yield surface under a biaxial stress state. This yield surface has a shape similar to that of the concrete smeared cracking model under the biaxial stress state, as shown in Figure 3.5(b).

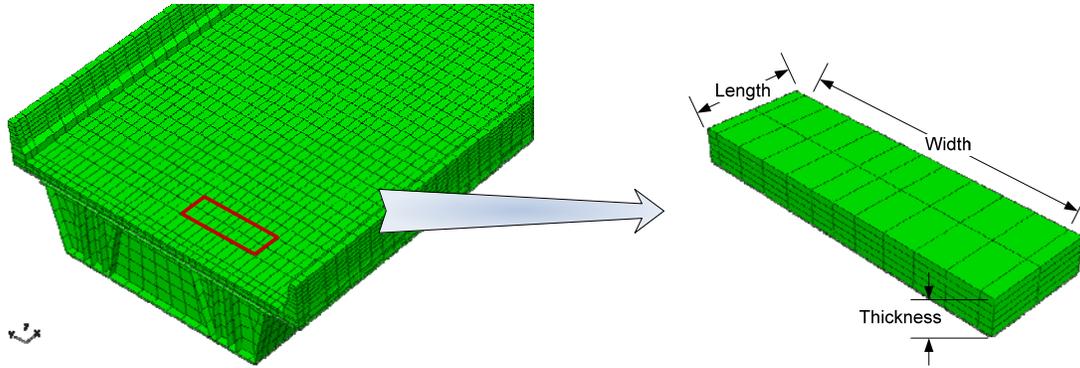
The small deck model, as shown in Figure 3.6(a), was developed based on the expected deck deflection behavior in a damaged bridge. With one girder fractured, as assumed for the redundancy evaluation, the bridge deck would initially bend transversely in double curvature to transfer loads from the fractured girder to the intact girder, as shown in Figure 3.6(b). When the deck deflects in double curvature, an inflection point results approximately at the mid-section of the deck between the two girders, and tension forces act on the shear studs of the fractured girder due to the bending of the deck. Figure 3.7 shows a small deck test specimen and a finite element simulation model used to represent the assumed bending response of the deck following the fracture of one girder. The small deck tests, also referred to as stud pull-out tests herein, were conducted by Sutton (2007) and Mouras (2008) as part of the research program. From their tests, the load-displacement response of small deck specimens and the tensile strengths of shear stud connections were obtained, and the measured data were used to calibrate the small deck finite element models.

(a) Small deck portion in full-scale bridge for small deck model

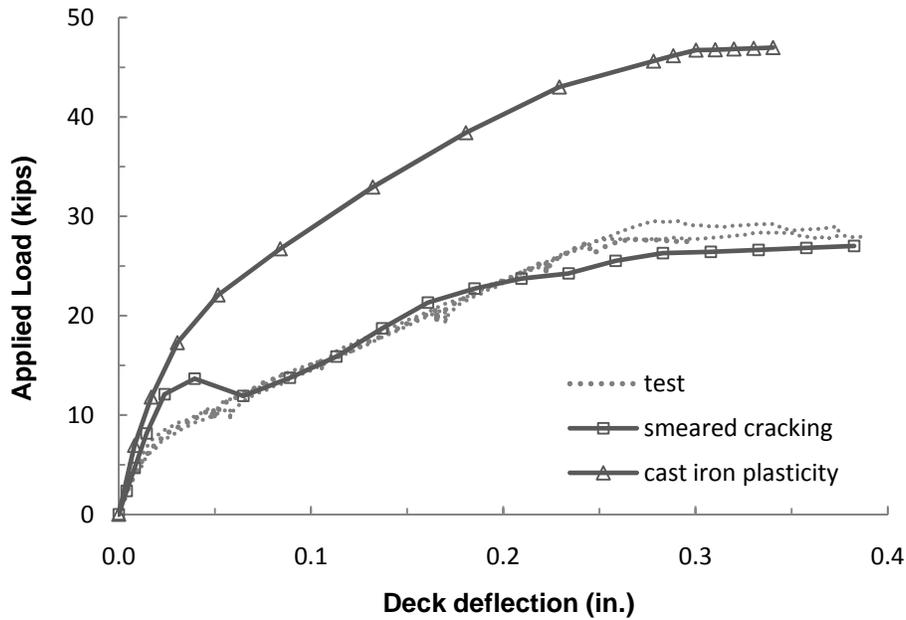
Figure 3.10 Deflection behavior of small deck (cast iron plasticity)

compressive strength for both concrete material models. As expected, because of the post-yielding stress-strain behavior, the deck model utilizing the cast iron plasticity model was stiffer than that of the concrete smeared cracking model.

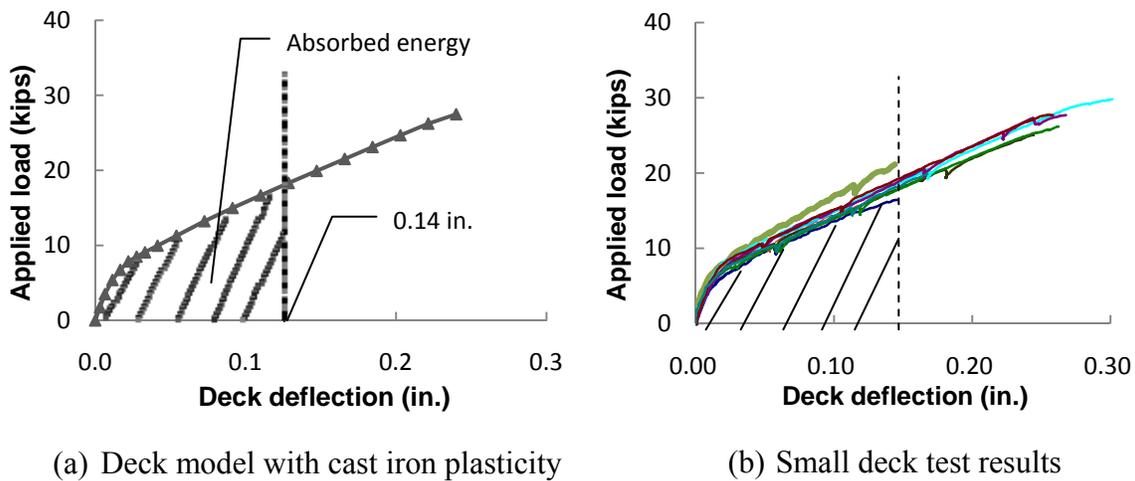
Figure 3.12 Deck top deflection vs. tension force

strength further caused numerical instability during the analysis. Therefore, it was decided to decrease the number of elements through the thickness of the small deck model from five to three because the bending stiffness of the deck model tended to decrease as the number of elements through the thickness diminished, as discussed in the small deck simulations with the concrete smeared cracking model.

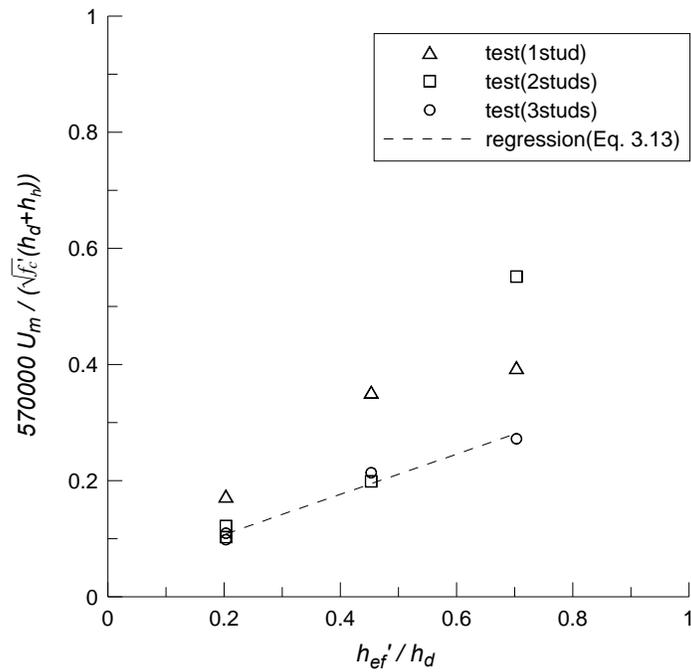
Figure 3.17 Displacement at tensile strength

measured test data and to ensure a smooth change of the deflection curve so as to avoid a numerical convergence failure in the finite element analyses.

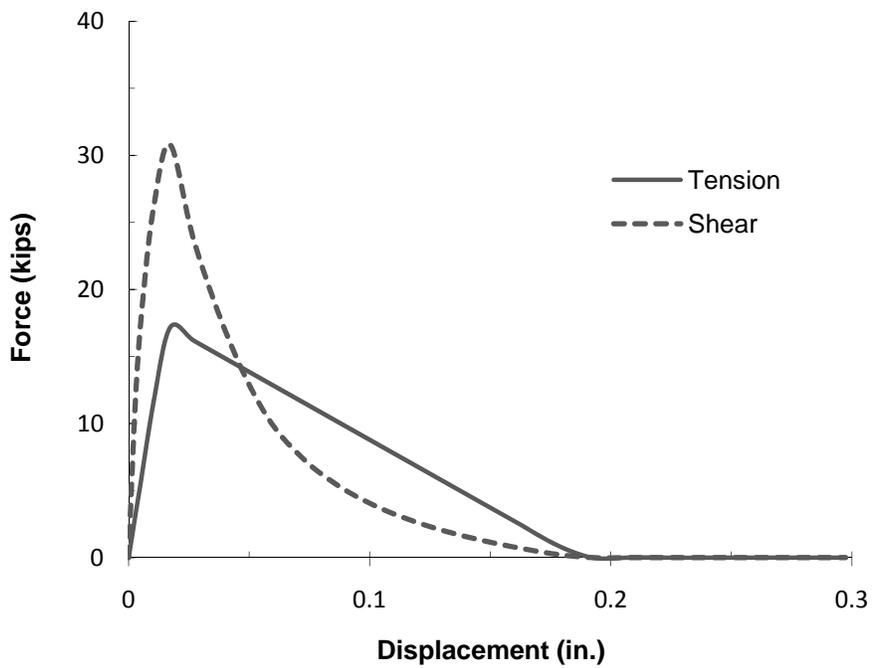
Figure 3.19 Single connector element behavior under tension and shear forces

To investigate the behavior of a single connector element with the assumed linear damage model under combined shear and tensile loading, the same displacement magnitudes were applied transversely (for shear) and vertically (for tension), both acting on one end node of a connector element. Although a linear damage evolution was assumed for the shear resistance, Figure 3.19 shows a nonlinear load-deflection response in the shear load-slip behavior. This response is due to the nonlinear plasticity hardening rule of the shear studs, which was presented in the previous section.

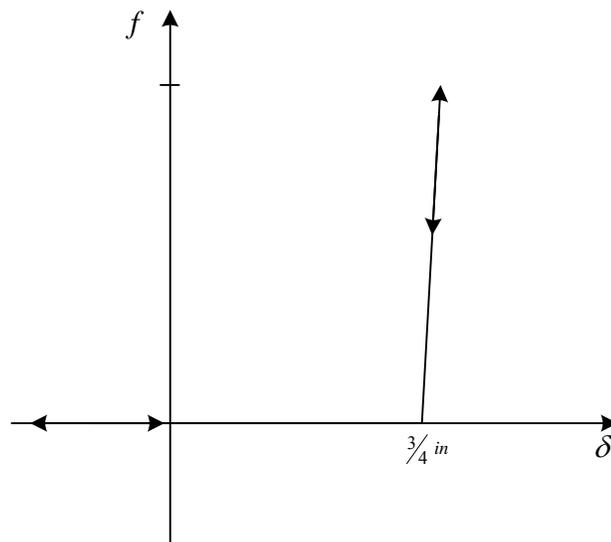
Figure 3.20 Spring element behavior between rails

deflection behavior shown in Figure 3.20. This figure shows that the spring elements resist only compression forces once the deflection exceeds 3/4 in., which was the initial gap distance of the rails in the test bridge and the value specified by TxDOT. Beyond the 3/4-in. deflection, a stiffness corresponding to the initial concrete stiffness was assumed for the spring element to simulate railing contact. The specific stiffness value is not very important, but it must be large enough to cause a large increase in force; however, it must not be so large as to lead to numerical inaccuracies in the conditioning of the structural stiffness matrix. The value selected provided reasonable results, and the computed response was not very sensitive to variations in the selected stiffness value.

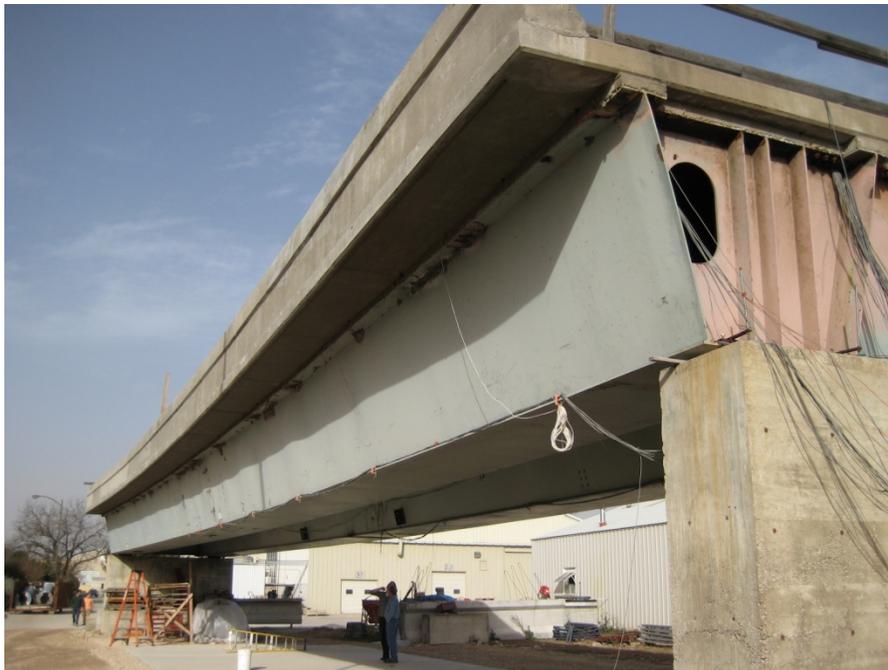
Figure 4.1 Full-scale test bridge

approximately 10 in. below the top flange. The temporary truss support was designed to rapidly release the load it was carrying by severing a tension tie using an explosive in a similar fashion as the first test. The third test was performed to investigate the reserve load-carrying capacity of the damaged bridge and the contributions made by individual bridge components to the overall capacity of the system. To apply loads incrementally in the experiment, road base was placed on the deck along with concrete blocks. Loading continued until the bridge collapsed.

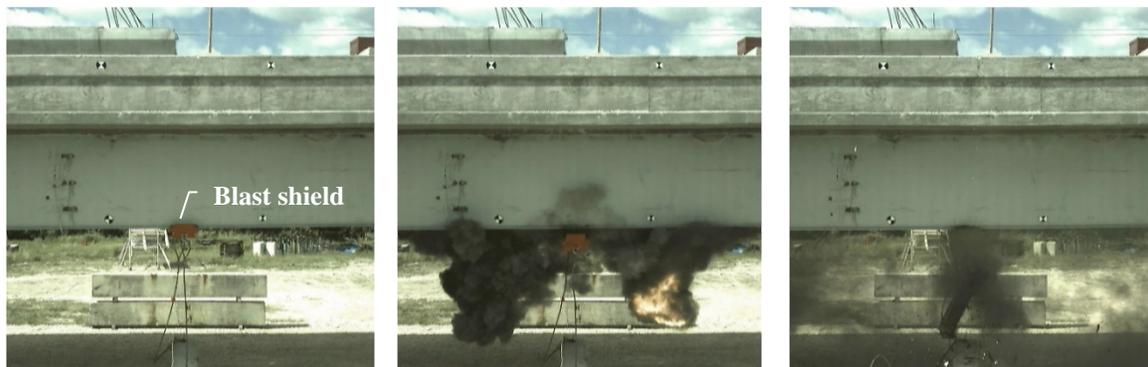
Figure 4.2 First bridge fracture test (bottom flange removal by explosion)

The first bridge test was performed to investigate how the bridge responds when the bottom flange of one girder suddenly fails as might be expected if a fracture were to occur. The bottom flange is currently classified as a fracture-critical member in the two-girder bridge system. An explosive was used to cut the bottom flange extremely rapidly to imitate the sudden loss of the whole bottom flange of one girder (east side girder) at the midspan as shown in Figure 4.2. For safety purposes, the explosive was encased in a blast shield, which was attached underneath the bottom flange of the east girder and tethered to a concrete block placed under the bridge. Other concrete blocks (in the form of prestressed concrete girders) intended to simulate the AASHTO standard HS-20 design truck load were placed on the deck so as to cause the maximum positive bending moment at the damaged location. Detailed descriptions of the bridge test setup and the results that were collected have been reported by Neuman (2009).

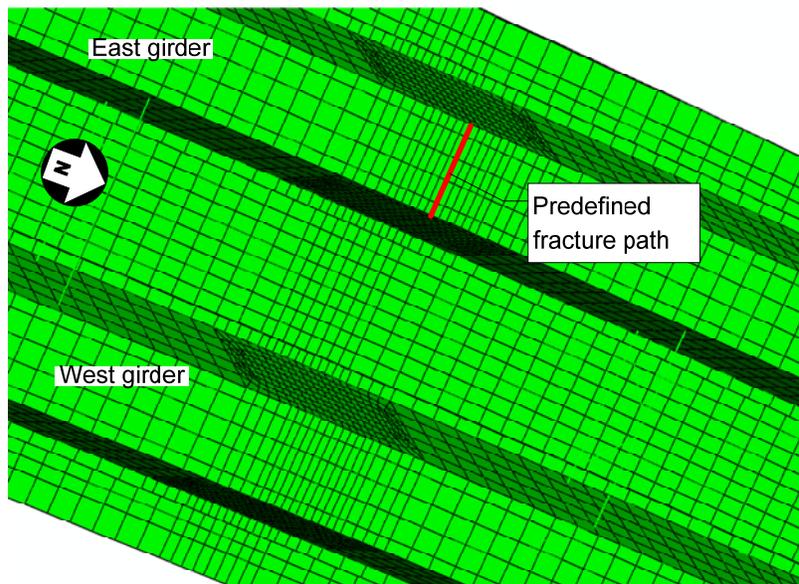
Figure 4.3 Predefined bottom flange fracture path

joined by connector elements (CONN3D2) with weld properties to mimic the intact condition of the bottom flange. The cutting of the bottom flange was simulated, therefore, by removing the connector elements using the element deactivation technique. The removal of the connector elements was sudden, as was the explosive damage inflicted during the first bridge fracture test. Computationally, this step was carried out using a transient dynamic analysis with a “step-amplitude” loading in ABAQUS/Standard v6.7.

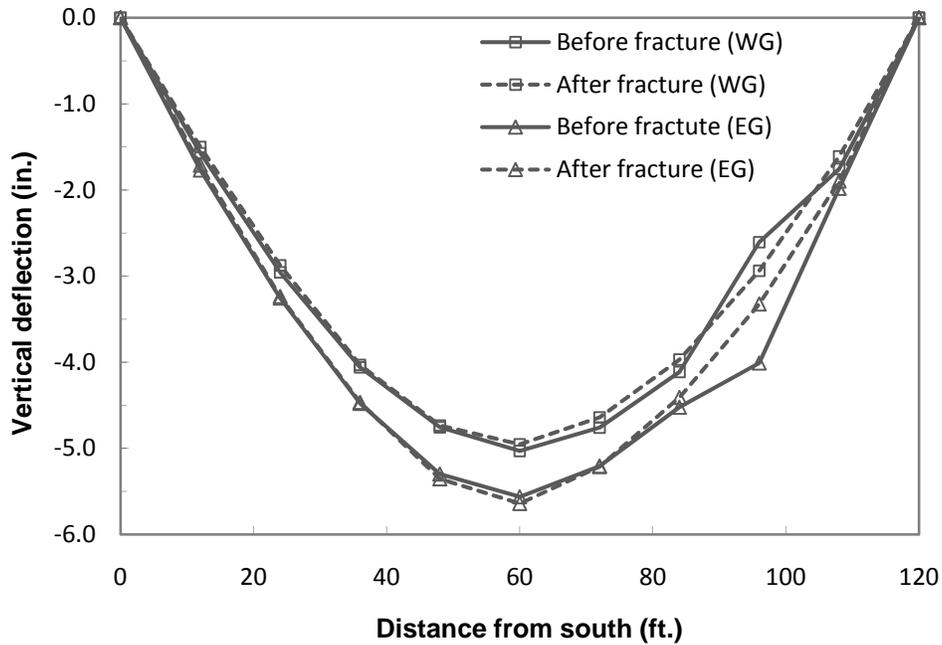
Figure 4.5 Girder deflection of intact and fractured girder

(used to simulate an HS-20 truck) were biased transversely toward the east girder to create the worst-case loading scenario on the fractured girder (Neuman, 2009).

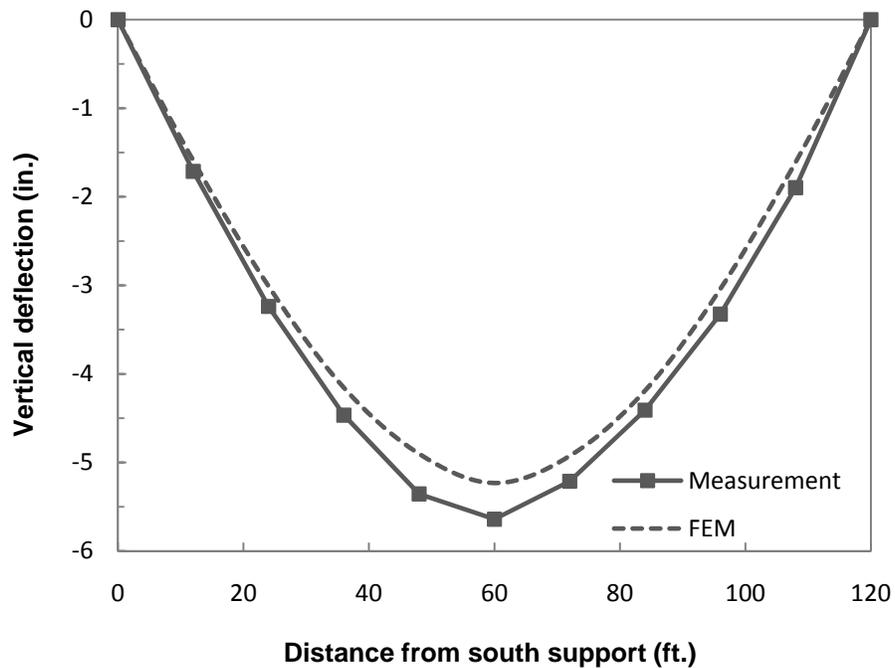
Figure 4.6 Fractured girder deflection after bottom flange removal

deflection might not be caused solely by the bottom flange fracture of the east girder. Nonetheless, the measured deflections and post-test observations of the bridge indicate that the fracture of the bottom flange of the exterior girder caused limited damage to the overall load-carrying capacity of the bridge.

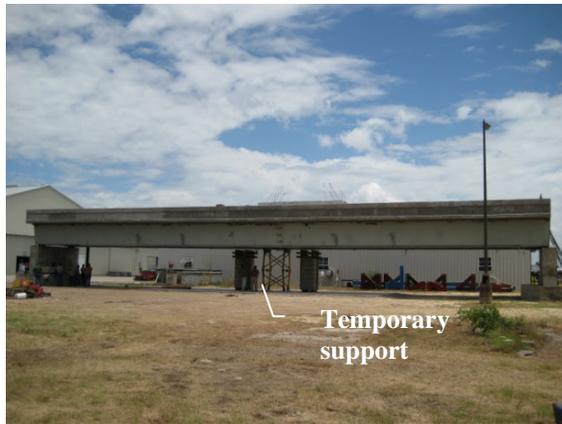
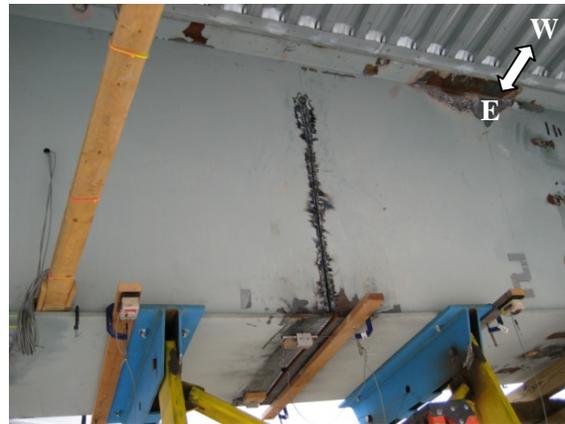
Figure 4.7 Temporary support and web cutting

The purpose of the second bridge test was to investigate whether or not the FSEL bridge could sustain a simulated dynamic loading following a nearly full-depth fracture of the exterior girder (the east side girder). The applied damage and loading conditions were similar to those described in Chapter 2 for the redundancy evaluation of a twin steel box-girder bridge. The only difference was the level of damage that existed prior to the test. In the experiment, 83% of the east girder's web was cut, rather than the total web, because of safety issues. For the bridge test, in order to apply the additional web damage without the loss of the gravitational potential energy of the bridge, a temporary truss support was installed under the fractured girder. Then, the bottom flange fracture made in the first bridge fracture test was manually extended to the inside and outside webs of the east girder using an acetylene torch. Figure 4.7 shows the condition of the bridge after the webs had been cut.

(a) Second bridge test setup

(b) Manually extended cut to webs

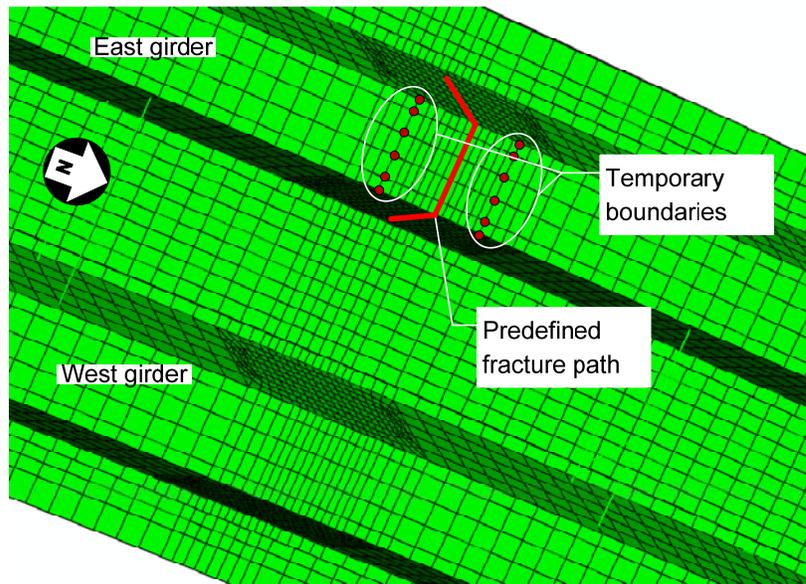
Figure 4.11 predefined fracture path in east girder

boundaries constrained the vertical translation of the east girder while the bottom flange damage, the web damage, and the simulated truck live load were applied to the simulation model. To incorporate damage on the east girder, connector elements initially binding separated nodes along a predefined fracture path were deactivated. The predefined fracture path and temporary boundaries under the bottom flange are shown in Figure 4.11. The truck live load represented by the concrete blocks in the bridge test was simulated with concentrated forces acting on the bridge deck.

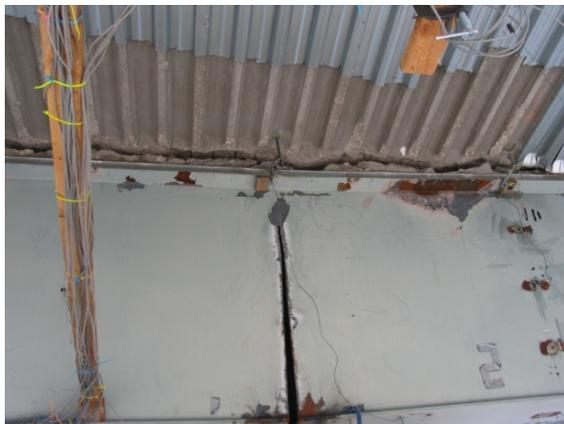
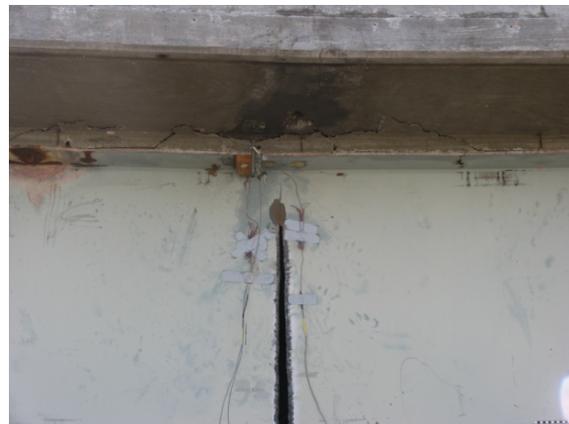
Figure 4.12 Haunch separation of fractured girder

After the second bridge fracture test, visual inspections were conducted to investigate the overall condition of the bridge. During the initial inspections, the only damage observed included tensile cracks on the deck and crushed cover concrete on the top of the east railing at the midspan. Analytical models of the deck response (Samaras, 2009) and finite element simulations, however, predicted that extensive stud tensile failures would occur along the inside of the fractured girder. For this reason, the corrugated metal deck spanning between the girders and used as formwork during the construction of the deck was removed to inspect the stud connections closely, and it revealed that a large amount of haunch separation along the inside of the fractured girder had in fact occurred (Figure 4.12 (a)). Along the outside of the fractured girder, both longitudinal and diagonal cracks were observed where the studs connected with the concrete deck, as shown in Figure 4.12 (b). These cracks developed near the midspan. As indicated by the figure, haunch separation on the inside of the girder was more severe than on the outside.

(a) Fractured girder: inside

(b) Fractured girder: outside

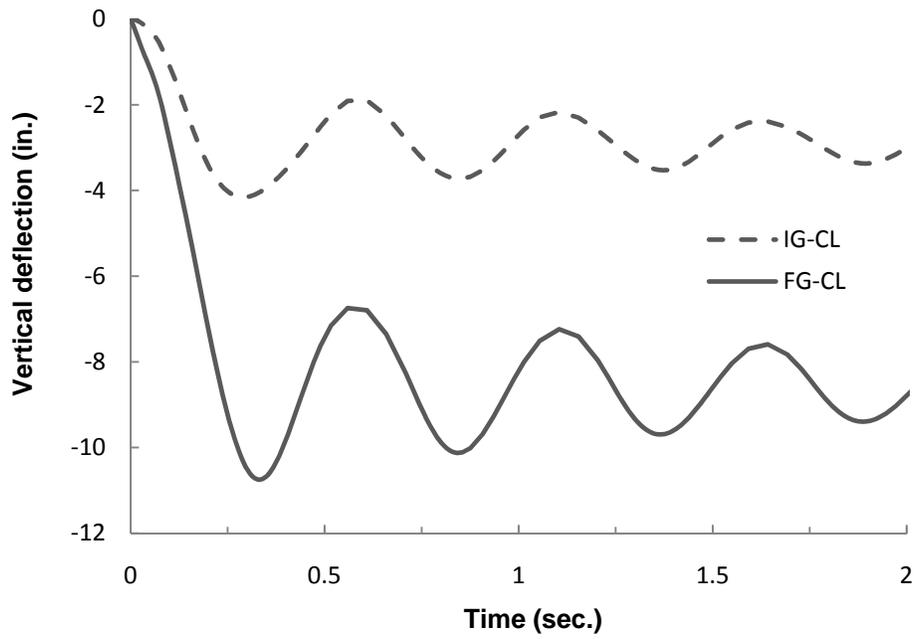
Figure 4.16 Dynamic girder deflection

Figure 4.16 shows the girder midspan deflections as a function of time obtained from the finite element simulation. The dashed line indicates the vertical deflection of the intact girder (IG-CL), and the solid line represents the vertical deflection of the fractured girder (FG-CL); both quantities were obtained from the centerline position of the bottom flange. To obtain the centerline deflections at the midspan of the bridge, edge deflections of the bottom flange of each girder were averaged. Because of the simulated girder fracture and the transversely biased loading position of the live load, the vertical displacement of the fractured girder was significantly larger than that of the intact girder (Figure 4.16). It is important to note that haunch separations are included in the vertical displacements that are plotted because the girder displacements were computed from the response of the bottom flanges.

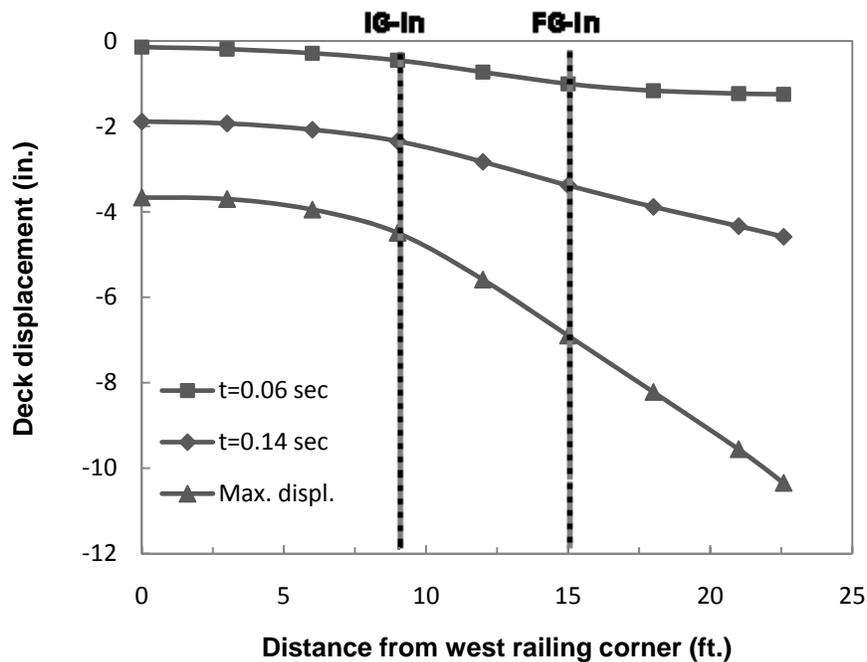
Figure 4.18 Deck displacement at midspan

Early in time ( $t = 0.06$  sec.), the graph shows that the deck bends in double curvature; as time progresses, however, the shape transitions to single curvature.

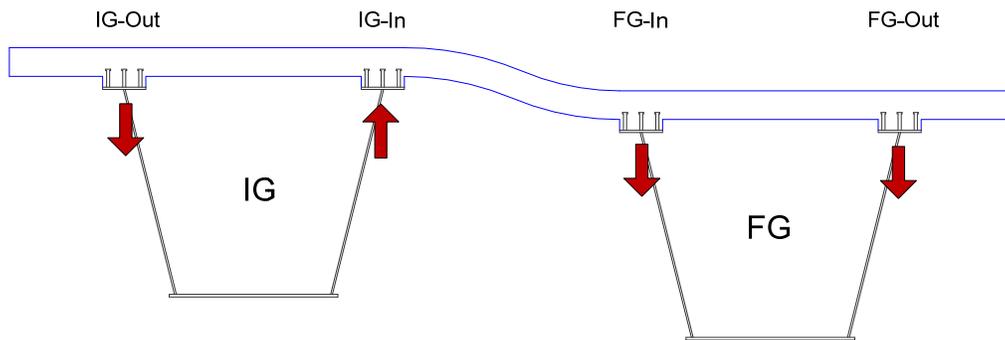
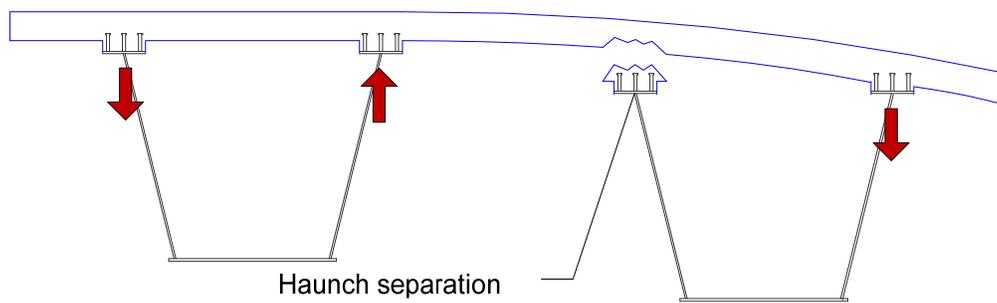
Figure 4.19 deck deflection shape change caused by haunch separation

moment arm for transverse bending of the deck. Therefore, with a wider separation of the haunch on the inside of the fractured girder, a larger deflection could be expected in the fractured girder than what was observed in the test.

(a) Deck deflection before haunch separation

(b) Deck deflection after haunch separation

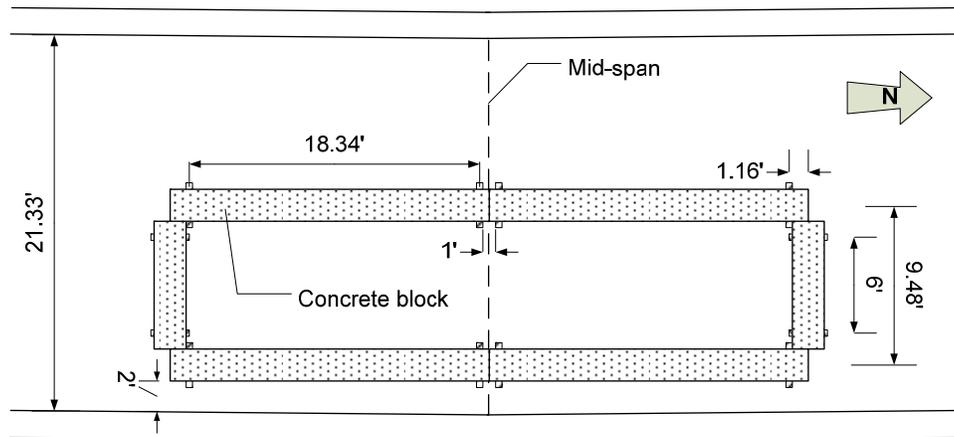
Figure 4.21 Concrete block configuration on bridge deck

The third bridge test was performed to determine the ultimate load-carrying capacity of the FSEL bridge in its damaged state. It should be noted that no attempts were made to repair the bridge following either of the first two tests. The concrete blocks used to simulate the truck live load in the second bridge fracture test were rearranged for the third test, and one additional concrete block was utilized to create a bin that could accommodate the road base that was used to incrementally load the bridge (Figure 4.21). Accordingly, the total weight of the concrete blocks in the third bridge fracture test was 82.1 kips. Figure 4.21 shows a schematic of the concrete block configuration on the bridge deck. The concrete blocks were symmetrically arranged about the bridge midspan, and they were transversely biased toward the fractured girder. Wooden planks used to support the concrete blocks were located 2 ft. away from the east railing.

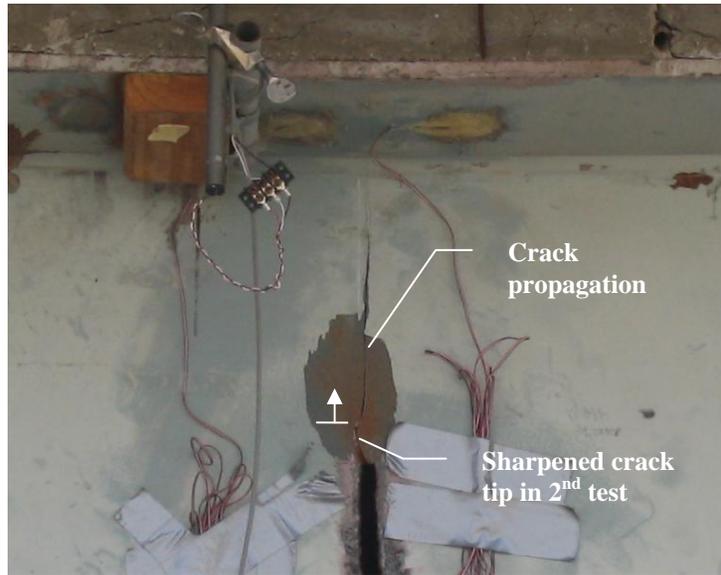
Figure 4.22 Crack propagation in fractured girder outside web

While positioning the concrete blocks on the deck, the crack in the outside web of the fractured girder propagated toward the top flange, as shown in Figure 4.22. Prior to this crack propagation, the crack was sharpened by the 1-in. crack extension upward from the point where the torch cut terminated during the second bridge fracture test. The total loaded weight of the concrete blocks was 40.9 kips when the crack propagation occurred. This sudden crack propagation caused the bridge to vibrate, but the small oscillations quickly subsided. The crack on the inside web did not propagate when the concrete blocks were placed on the bridge. Though the weight and positioning of the blocks represented a less severe load case than the bridge withstood during the second test, it is believed that the cold weather present while the blocks were being placed during the third bridge test contributed to the crack extension (Neuman, 2009).

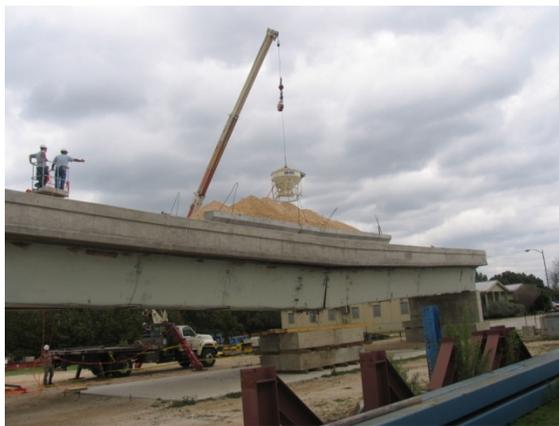
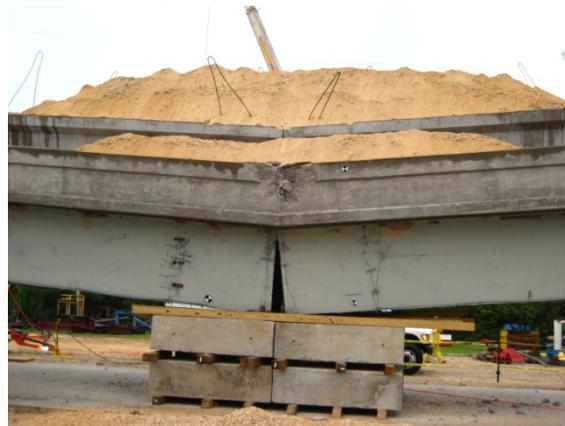
Figure 4.23 Loading process and bridge collapse in third bridge fracture test

(a) Incremental loading

(b) Collapsed bridge

Figure 4.23(a) shows the loading process used during the third test on the FSEL bridge. Road base, consisting primarily of gravel and dirt, was placed in an air-operated lift bucket using a small backhoe. The lift bucket was attached to the lifting hook of a crane. Once the bucket was filled, the weight of the road base was measured using a load cell attached to the end of the crane hook. After the crane lifted the bucket and the weight was recorded, the lift bucket was positioned above the bridge, and the road base was placed inside the concrete bin located on the bridge deck (Figure 4.21). When 258.3 kips of road base was loaded onto the bridge, there was no more space available inside the bin. Therefore, it was decided to apply additional road base between the concrete blocks and the east railing. The bridge finally collapsed when the total applied load of the concrete blocks and road base reached 363 kips—more than five times the legal truck load—as shown in Figure 4.23(b).

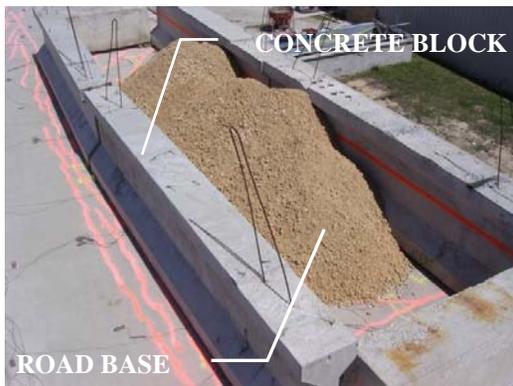
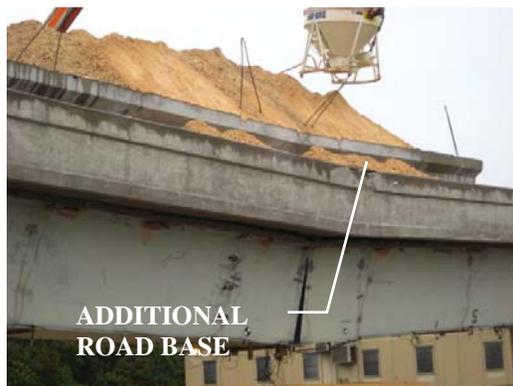
Figure 4.24 Applying concrete block and road base load

After removing the web connections, the weight of the concrete blocks and the road base were applied to the bridge using pressure forces placed consistently with the bridge test as shown in Figure 4.24. When 258.3 kips of road base was placed inside the concrete bin during the third bridge test, there was no more space available to accommodate any additional material inside the bin. Consequently, additional road base was placed outside the bin between the east railing and the concrete block forming the eastern edge of the bin as shown in Figure 4.24(c). To match the loading location of this

additional road base, the pressure load for the additional road base was applied between the east railing and the concrete block as shown in Figure 4.24(d).

(a) Concrete block and load base

(c) Additional road base

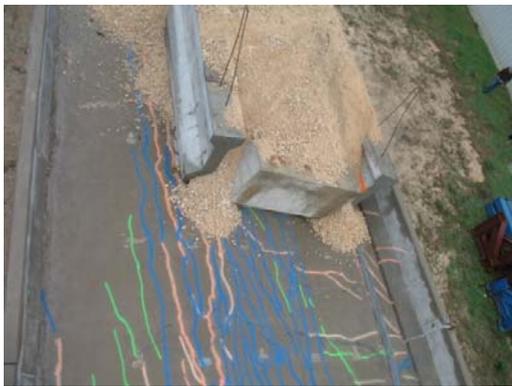
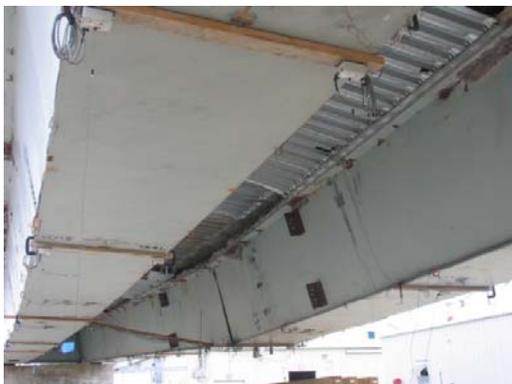
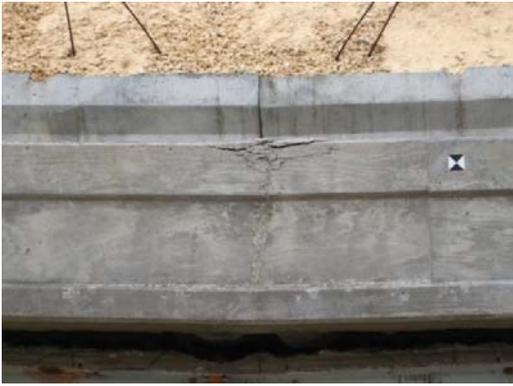
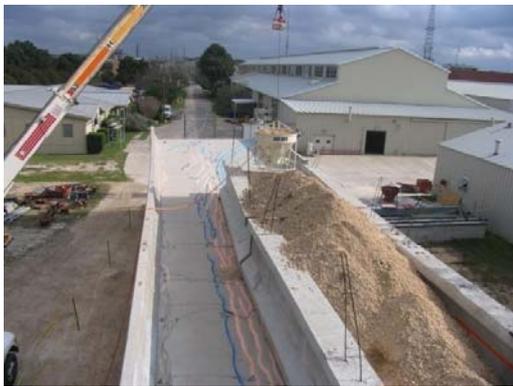
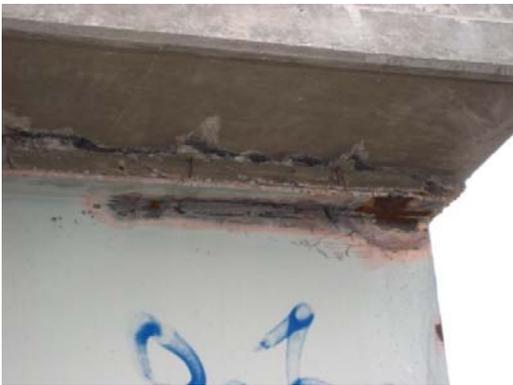
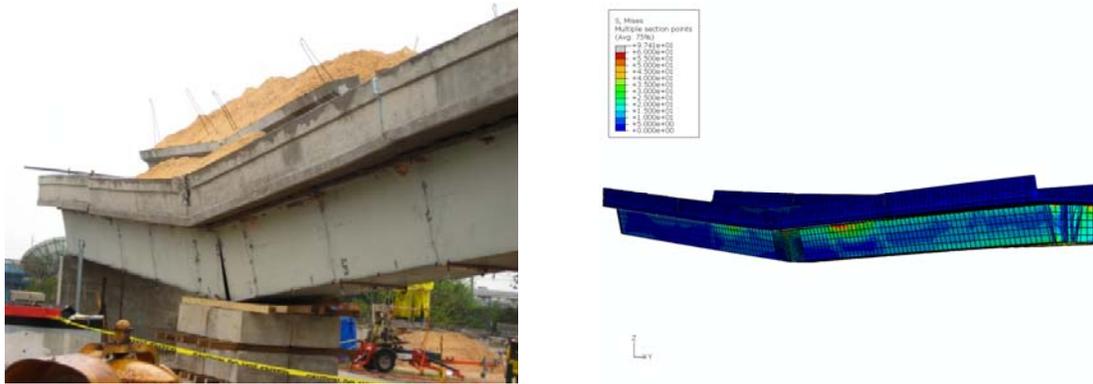
Figure 4.25 Bridge component failure sequence

With the exception of the haunch separation along the outside of the intact girder near midspan, the simulation model predicted failure modes consistent with those observed in the bridge test. In Figure 4.25, the failure sequences predicted by the simulation and those observed during the bridge test are compared at each prominent component failure event. The failure sequence leading to the collapse of the bridge initiated with the concrete deck cracking due to transverse bending. As the loading

continued, extensive tensile cracking started to form on the top of the concrete deck above the inside top flange of the intact girder and propagated along the bridge span. While the bridge continued to deform under the applied loads and transverse bending increased across the width of the deck, the demand on the shear studs along the inside of the fractured girder exceeded the tensile strength, leading to extensive tensile failures of stud connections on both top flanges of the fractured girder. As the tensile failures propagated along the bridge span, the inside haunch of the fractured girder began to separate from the bottom of the deck near the midspan of the bridge. While the separated haunch length along the inside of the fractured girder kept extending over the bridge span, the bridge deck experienced large deformations near the midspan, and the expansion joint at the top of the east railing closed over most of its height. Because of the contact forces acting over the depth of the expansion joint of the east rail at the midspan location, crushing of cover concrete became pronounced. As the east railing began to pick up loading and started to crush, the haunch separation along the inside of the fractured girder continued to extend as did the haunch separation along the outside of the fractured girder near the midspan. Separation of the haunch along the outside of the fractured girder was arrested when the separation had propagated to the next expansion joints (the expansion joint 30 ft. south and the expansion joint 30 ft. north away from the midspan expansion joint) along the length of the bridge. As the damage in the haunches of the fractured girder and the east railing progressed, the bottom of the reinforced concrete deck next to the interior top flange of the intact girder began to crush as a result of the transverse bending of the deck. Crushing at this location started at the midspan and propagated in both the north and south directions along the bridge span. This crushing of the deck was not readily detectable during the test because the permanent metal deck forms between the girders did not allow the concrete to be observed directly, but the

extensive cracking on the top of the deck along a line corresponding to the position of the interior top flange of the intact girder and deck rotation about this line provided evidence that the bottom of the deck was crushed. As the applied load approached the maximum load, shear stresses along the haunch on the outside of the fractured girder increased, and bridge collapse eventually occurred when a shear failure took place over the entire length of the outside haunch of the fractured girder.

(a) Tensile cracking on top of the deck above IG-In top flange

(b) Haunch separation along FG-In haunch

(c) Railing crushing from top

(d) Deck hinge formation along IG-In top flange

(e) Shear and tension failure of shear studs along FG-Out haunch

(f) Bridge collapse

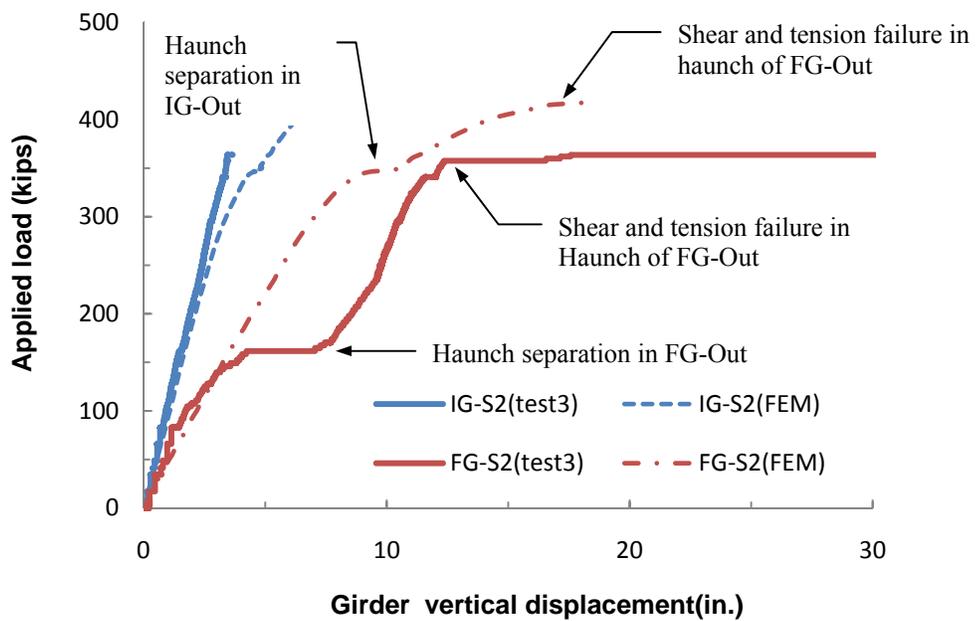
Figure 4.26 Girder deflection response (18 ft. away from midspan)

simulation. Although the gradual haunch separation in the simulation was not consistent with the sudden jump observed during the test, the simulation predicted 36 ft. of haunch separation along the outside of the fractured girder, which is similar to the actual haunch separation length of approximately 40 ft. observed during the test.

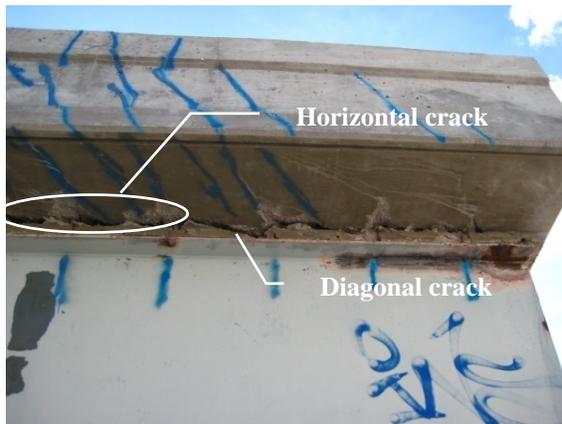
Figure 4.28 Slip between the deck and girder top flange along FG-Out

Another prominent feature in the girder deflection response of the test bridge occurred at the maximum load. When the applied load reached 363 kips, the fractured girder deflected significantly, and the bridge collapsed. This large deflection was initiated by the slip between the outside top flange of the fractured girder and the concrete deck, as

shown in Figure 4.28. Along the outside haunch of the fractured girder, horizontal cracks and diagonal cracks were observed, which suggests that failure of the stud connection was due to the interaction of tension and shear forces. In the simulation model, shear forces in the connector elements became large along the outside of the fractured girder when the applied load approached its maximum value of 413 kips. Although the simulation showed a failure mode that was similar to that of the test bridge, the maximum load of the simulation model was 14% higher than that of the test bridge.
