**FINITE ELEMENT MODELING OF TWIN STEEL BOX-GIRDER  
BRIDGES FOR REDUNDANCY EVALUATION**

**Dissertation**

**The University of Texas at Austin**

**May 2010**

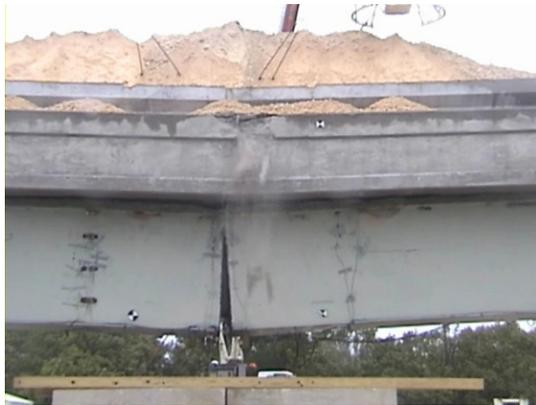
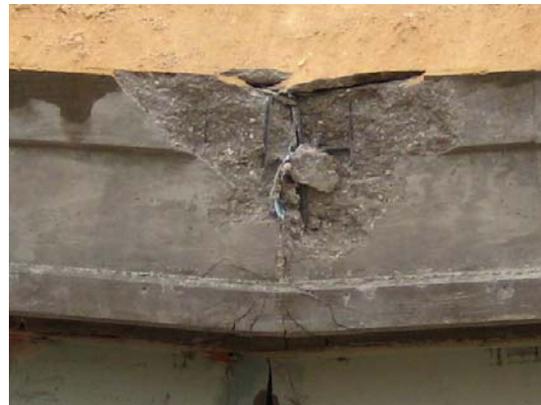
Figure 4.30 East railing crush at midspan

In the test bridge, the concrete cover on top of the east railing at the midspan location spalled off during the second bridge test, and the railing remained closed (i.e., in contact) at the top following the test. As the applied load was increased during the third bridge test, the concrete at the top of the railing began to crush, and the crushing propagated downward along the height of the rail. When the applied load reached approximately 360 kips, a large amount of concrete spalled off, as shown in Figure 4.30. The depth of spall was approximately  $2/3$  the height of the railing.

(a) Railing crush during test

(b) Railing crush after collapse

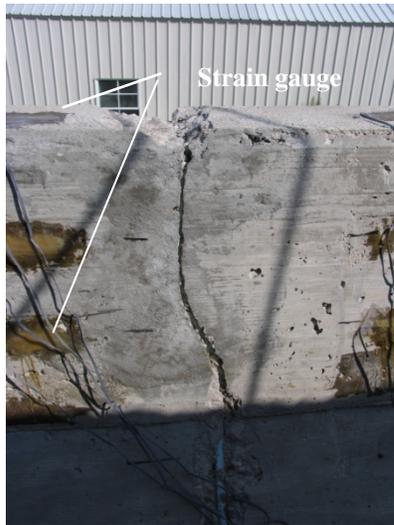
Figure 4.31 Longitudinal strain response along railing height

To account for the engagement of the rails at the midspan expansion joint, nonlinear spring elements were used rather than conducting a direct contact analysis. As discussed in the previous chapter, this choice was made based on computational efficiency. Figure 4.31(a) shows strain gauges installed on the inside of the east rail, and Figure 4.31(b) compares the longitudinal strains obtained from the bridge test with those computed from the finite element simulation. Railing contact occurred progressively from the top to the bottom of the east rail, which was confirmed by the strain gauge readings. Figure 4.31 (b) indicates that the simulation successfully captures the progressive contact of the rails along the railing height; however, the computed strains start to deviate from the test results after railing contact initiated. It is uncertain why such discrepancies exist, but they could be attributed to such factors as spalling of concrete cover, crushing and cracking of the rail concrete, and the presence of non-uniform contact forces through the width of the railing. The simplified modeling approach used in this study is not capable of representing these localized effects. After the bridge test, a large amount of spalled concrete cover was observed on the inside of the east rail at midspan. This observation suggests that the concrete strain gage readings may not accurately represent the strain variation in the rails during the test. In addition, it is likely that the contact forces that existed through the width of the railing were not uniform because the large deck deflection above the fractured girder caused the rails to rotate about a longitudinal axis parallel to the bridge span. The simulation model could not account for these effects because of limitations in the material model that was used to represent concrete and due to a limited mesh density through the width of the rails.

(a) Strain gauge setup

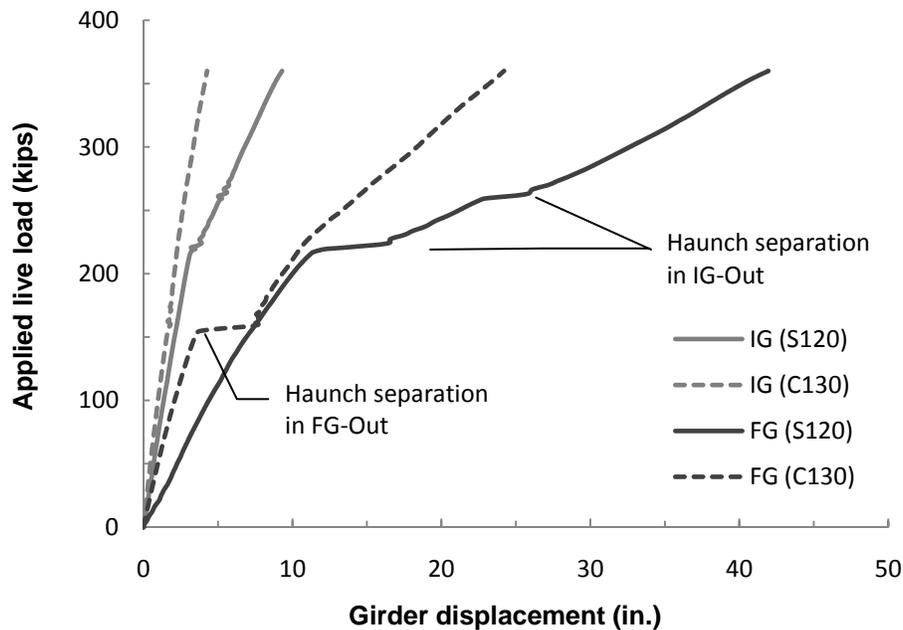
Figure 5.14 Girder deflection at midspan (continuous span with T501 rail)

the unstable deflection in the fractured girder under the loading range considered (i.e., 5 times an HS-20 truck load).
