Materials Selection for Concrete Overlays

Thesis

The University of Texas at Austin

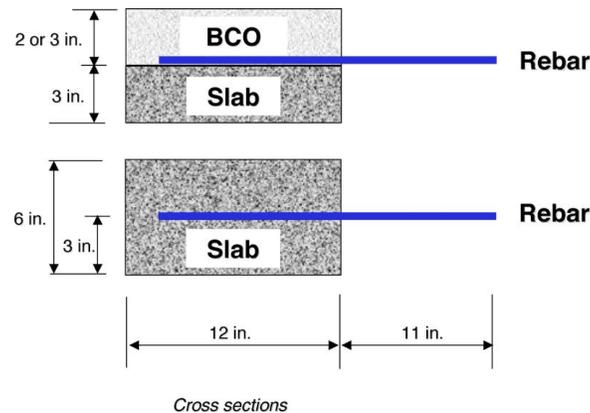
Figure 2.1: Experiment on reinforcement location

second set of slabs, 12 more specimens were cast, this time placing the steel at mid-depth. All slabs were cured under normal laboratory conditions. Schematics of both types of specimens are shown in Figure 2.1.

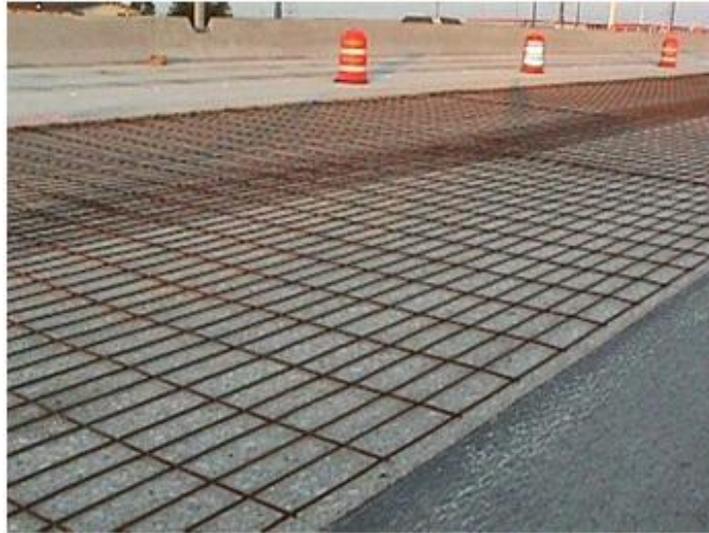
Figure 2.2: Steel placed directly on top of existing pavement

The test consisted of pulling the steel bars from the slabs. All bars failed in tension before they could be pulled out from the slab, showing that its bond strength is higher than the steel tensile strength, regardless of the position of the bars. From the test, it is inferred that the bars will not fail in anchorage, even when placed directly on the surface of an existing pavement. Therefore, the reinforcement steel can be placed directly on the surface, as is shown in Figure 2.2, saving construction time, labor, and money. Furthermore, the reinforcement placed directly on top of the substrate helps to restrain the movement of the new concrete slab due to environmental changes, which in turn, improves the bond between both pavement layers. The steel will restrain concrete volume changes at the interface most effectively, which will prevent or retard debonding. It is most desired that least movement at near the interface.

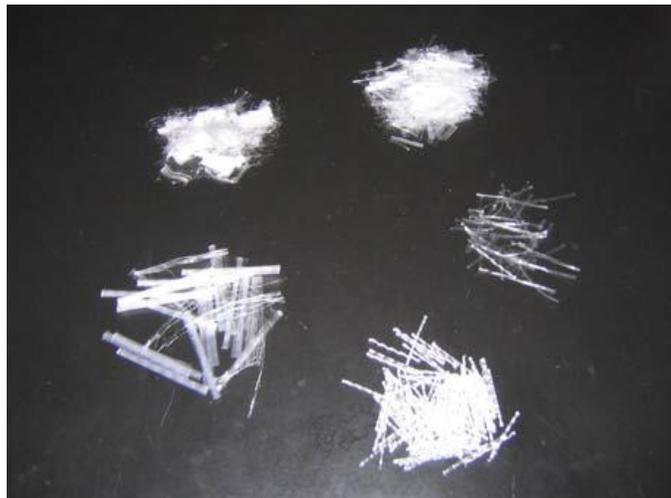
Figure 2.3: Different forms of polypropylene fibers

Polypropylene microfibers are produced either as cylindrical monofilaments or fine fibrils with a rectangular cross section. Polypropylene microfibers can be in monofilament, multifilament, or fibrillated form (Figure 2.3).

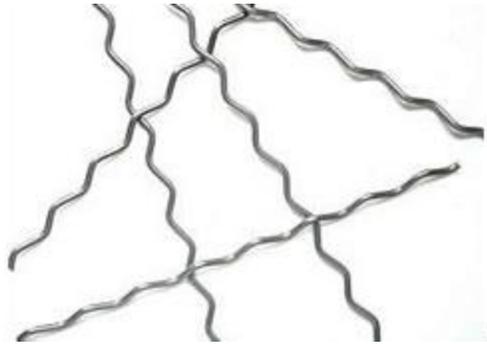
Figure 2.4: Deformed steel fiber

The aspect ratio is an important parameter influencing the bond between the concrete and the fiber, with longer fibers providing greater bond strength and toughness, often at the expense of workability. Steel fibers may also have certain geometric features to enhance pullout or anchorage within the concrete mixture. These features may include crimped or hooked ends or surface deformations and irregularities (Figure 2.4).

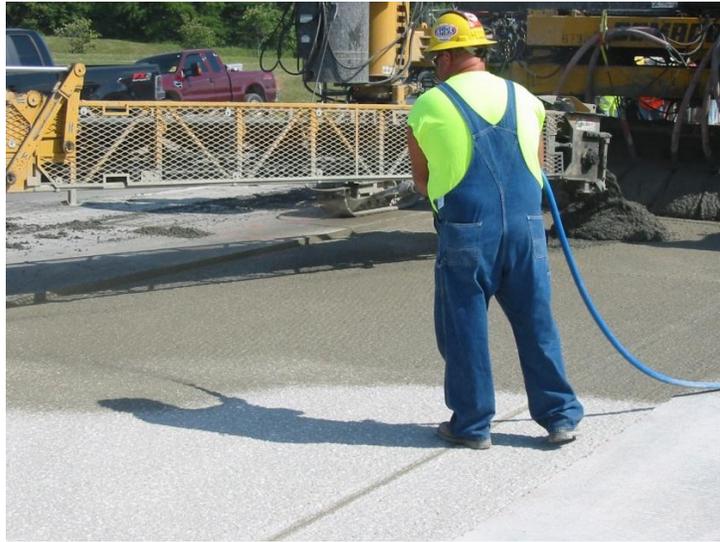
Figure 2.5: Spraying grout immediately ahead of paver

Figure 2.5 shows that immediately before paving, a grout can be uniformly broomed over the full width of the prepared surface. The prepared surface must be in SSD condition. Typically water-to-cement ratio of the grout is around 0.62 to 0.70 by weight, or approximately seven gallons of water per sack of cement [27].

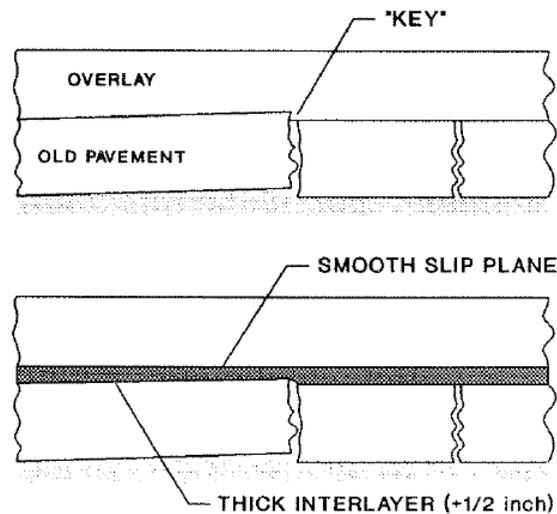
Figure 2.6: Purpose of interlayer

Thin separation layers (such as sheathings) must be avoided because they are more likely to permit reflective cracking from the existing pavement. Thicker separation layers can prevent reflective cracks from occurring [44]. Figure 2.6 shows how a smooth slip plane can prevent reflective cracks from occurring.

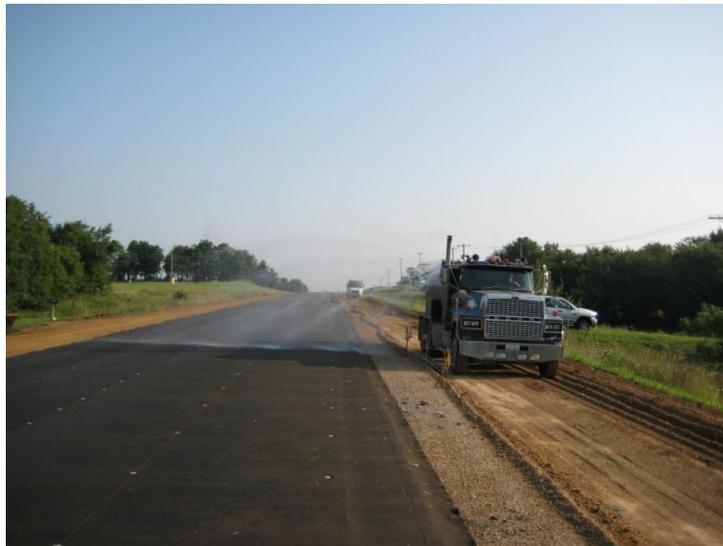
Figure 2.7: Cooling down the prepared surface before placement

surface, reducing shrinkage cracking in the concrete and potential paving problems due to a soft surface [8, 24]. Water fogging is another method that can reduce the asphalt temperature. Figure 2.7 shows a way to cool down the prepared surface by spraying with water. It is good practice to water fog if the asphalt surface heat makes it uncomfortable to touch with an open palm [37]. It was found that mix water in the fresh concrete overlay was absorbed into the dry substrate, reducing the amount of water available to fully hydrate the cement paste at the bonding interface [38].

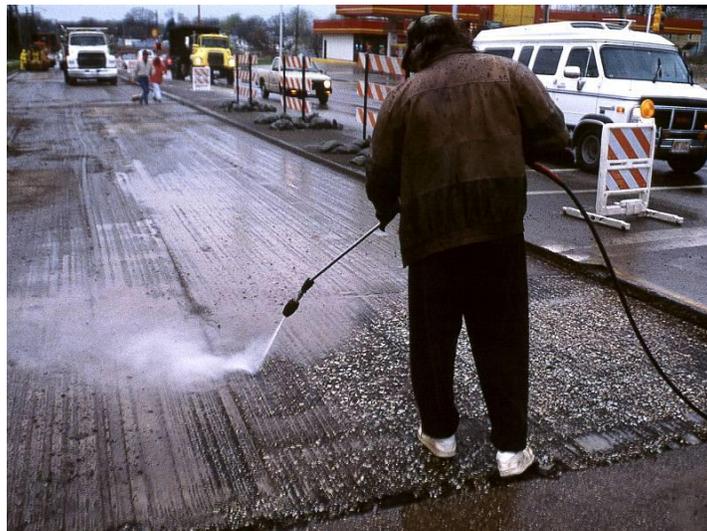
Figure 2.8: Cleaning the surface with hydro cleaning equipment

After the surface preparation operations are finalized and the reinforcing steel is in place, the last cleaning of the surface is done by air blasting just before concrete placement. It should be noted that air blasting and water blasting should be used only as supplementary cleaning procedures for loose material and debris elimination from the surface after milling, shotblasting, or sandblasting, because these methods are not capable of removing paint stripes, tire marks, or grout matrix. Air blasting is to be used just before overlaying to thoroughly remove debris from milling or shotblasting operations. It is important not to leave a large time lag between the final surface cleaning and paving in order to prevent the contaminants from resettling. Figure 2.8 shows hydro cleaning as a way to clean the prepared surface.

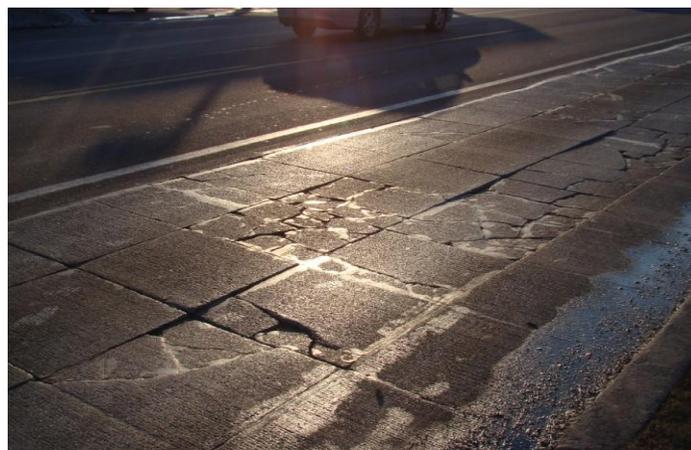
Figure 2.10: Failed joints in wheel path

- The timing of joint sawing is critical. Sawing too early can cause excess raveling, and sawing too late can result in shrinkage stress causing uncontrolled random cracking.
- ACPA recommends that joint spacing be about 12 to 15 times the slab thickness.
- Joint spacing has a significant effect on the rate of corner cracking. Short joint spacing, common on thin concrete overlays, reduces load-related stresses, because the slabs are not long enough to develop as much bending moment [8]. The joint location is also important to avoid concentrated loads. For example, 4-ft. by 4-ft. panels on a 12-ft.-wide lane would put truck tires on the edge of the panels, and significant distress would occur if the thin concrete overlays became de-bonded from the existing pavement [9]. Figure 2.10 is a good example of failed joints in wheel paths.

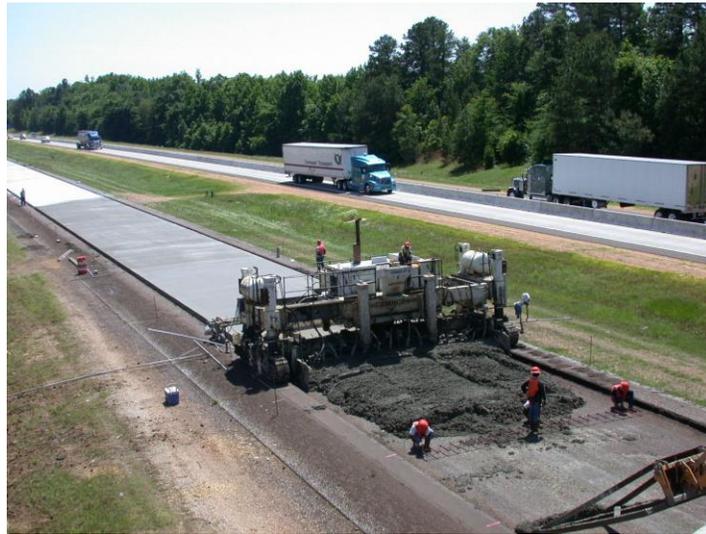
Figure 2.11: Prompt curing following the paver

The importance of proper curing can never be understated. Proper curing procedures are essential in preventing excessive moisture loss at early ages that can result in plastic shrinkage and loss in tensile strength capacity at the surface. Curing should begin as soon after placement and finishing as possible to minimize loss of bleed water. Figure 2.11 shows the curing crew following the paving machine closely. For concrete overlays, It is recommended that a double application of the curing compound be used [5, 32].

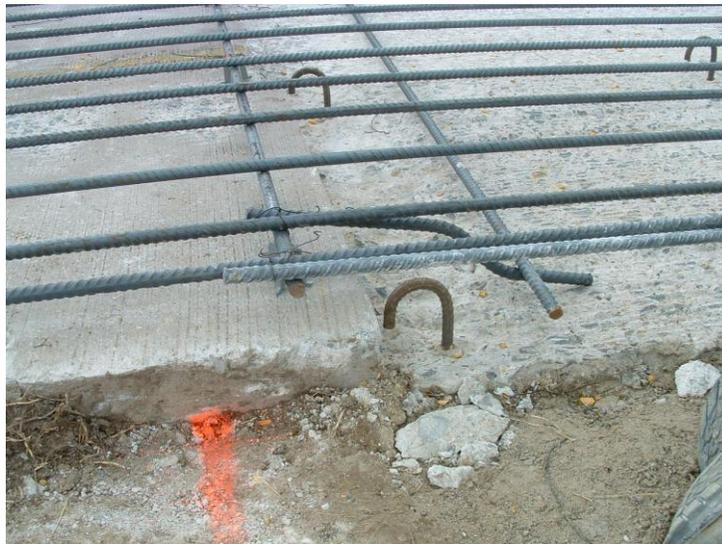
Figure 3.7 Transition reinforcement detail

propagate through the concrete overlay due to repeated dynamic wheel loads. As the figures show, there is a row of bent reinforcement extruding from the prepared surface. In cases of poor or uncertain bond or in areas with specific demands (e.g., high shear or tensile stresses are serious contributors in failures), it might be necessary to strengthen the shear and tension capacity by installing anti-shear reinforcement crossing through the interface.

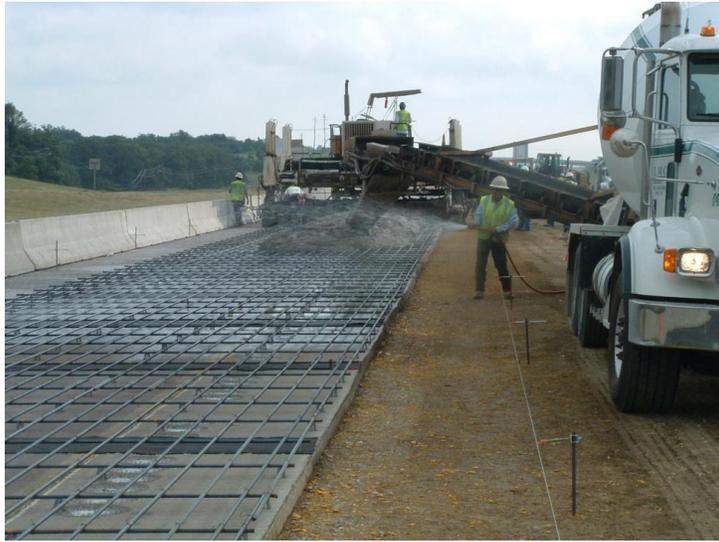
Figure 3.9: A worker spraying water on the surface ahead of the paver

There were instances when concrete was placed too far ahead of the paving machine, creating risks of the concrete setting even before the paving machine reached those areas. Also, the substrate surface around the prematurely dumped pile of fresh concrete dried while waiting for the paving machine. Figure 3.10 shows the deposited concrete waiting for the paving machine to catch up, and Figure 3.11 shows the dried surface around the concrete. The contractor was asked to slow the depositing of concrete ahead of the paving machine.

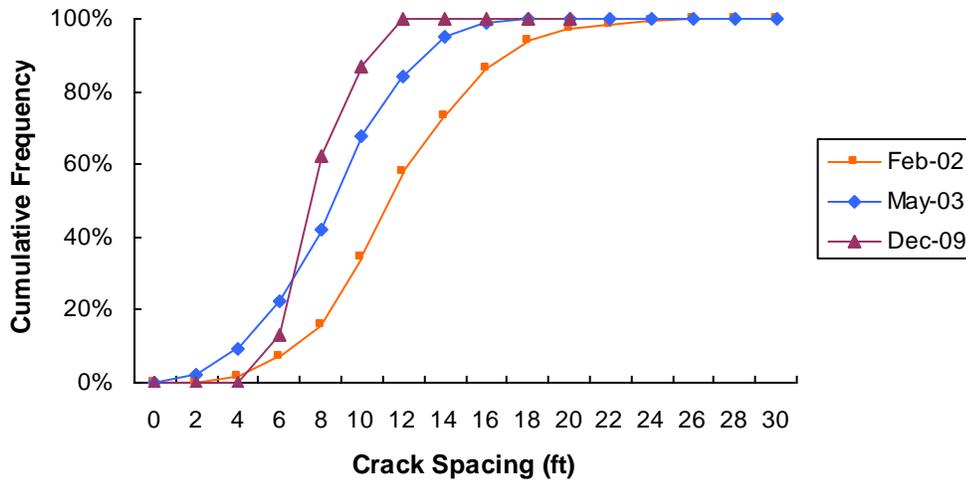
Figure 3.16: Crack spacing distribution

coefficient of variation was 14.6%. Figure 3.16 illustrates the cumulative frequency distributions obtained in the three surveys. No distress was found during the previous two surveys.

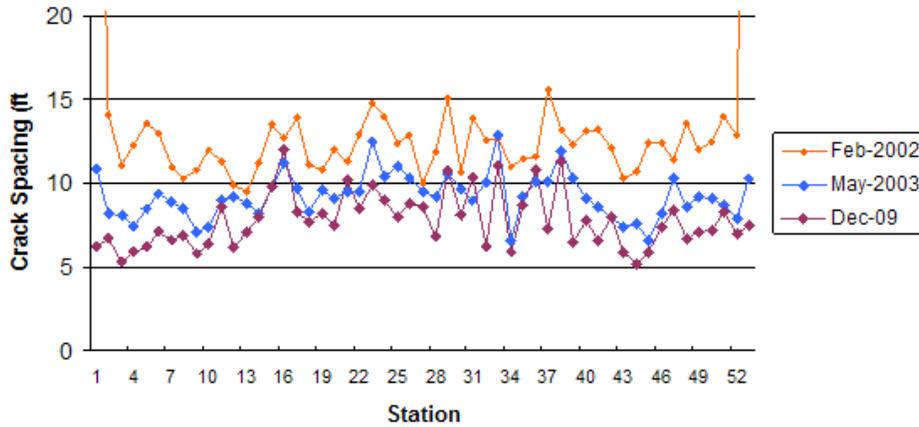
Figure 3.17: Average crack spacing with time by station

A comparison of the changes of crack spacing with time can be seen in Figure 3.17, in which the average crack spacings by station are plotted for the three surveys.

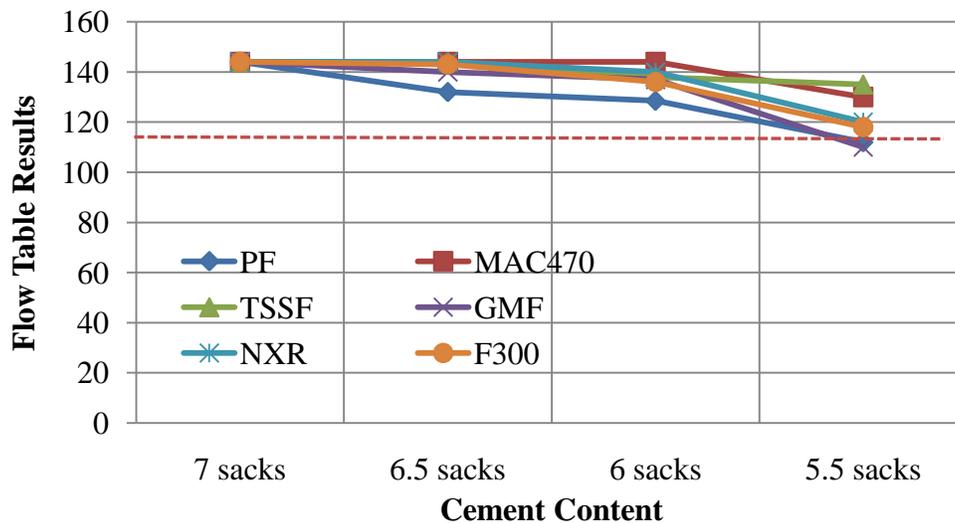
Figure 4.2: Workability comparison at FA/(FA+CA) = 0.35

The basic approach was to determine the lowest cement content that can be allowed before losing workability. As seen in Figures 4.2 through 4.4, when the FA content was increased or the cement content (paste content for a fixed w/c) was decreased, the workability was reduced. At the highest aggregate ratio and at the lowest cement content, the workability was below the acceptable limit (the red dotted line). The acceptable limit was decided based on the experience that mortars that produced a flow table number of 110 and below gave poor slump values for pavement mixtures.

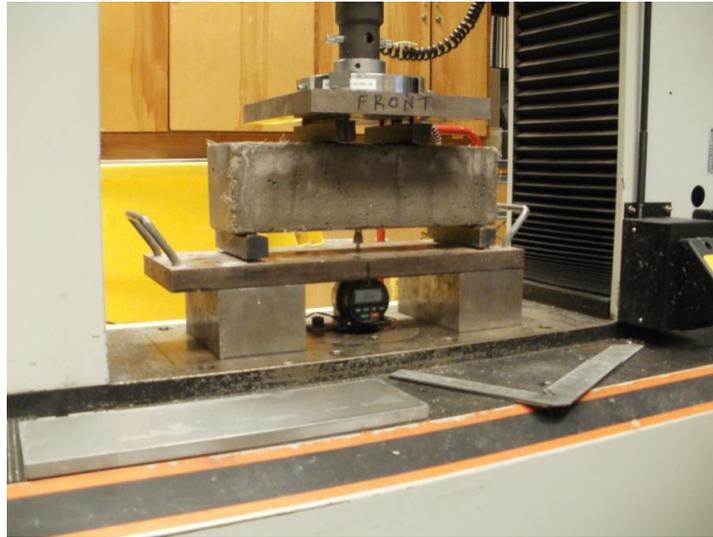
Figure 4.8 TxDOT ARS setup

The average residual strengths (ARS) were determined in accordance with ASTM C1399 – 10 “Standard Test Method for Obtaining Average Residual-Strength of Fiber-Reinforced Concrete” with a modification to the apparatus and procedure using four-point bending. For each type of fibers tested, five 4-in. by 4-in. by 14-in. specimens were made using cast-in-place method. It was made sure that the specimens were in 100% humidity until the specimens were ready for testing at 7 days. The test was performed at TxDOT Materials Lab using their modified test setup, as shown in Figure 4.8.

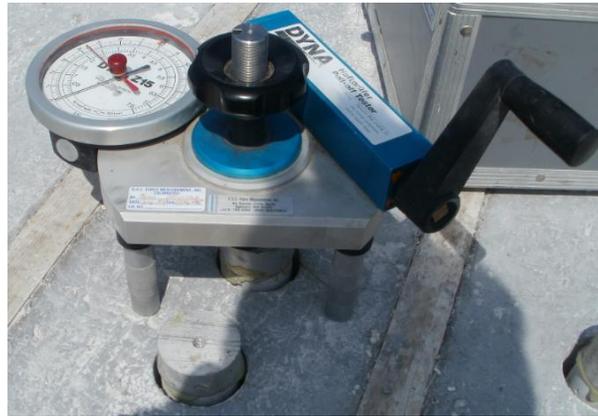
Figure 4.9: Pull-off testing

Bond strength of the 3-in. concrete overlays was measured in accordance with ASTM C1583, and 2-in. diameter cores were tested in tension at 3, 7, and 28 days. A Dyna pull-off tester from Humboldt was used to measure the bond strength. It was made certain that each core was drilled at least 3.5 in. deep, well past the 3-in. depth of the interface for these concrete overlays. After the tops of the cored surfaces were cleaned off and dried, a thin layer of 3000-psi epoxy was applied, and the aluminum caps were then glued to the tops of the cores. After sufficient time had passed for the epoxy to cure, the pull-off test was performed to measure bond strength.

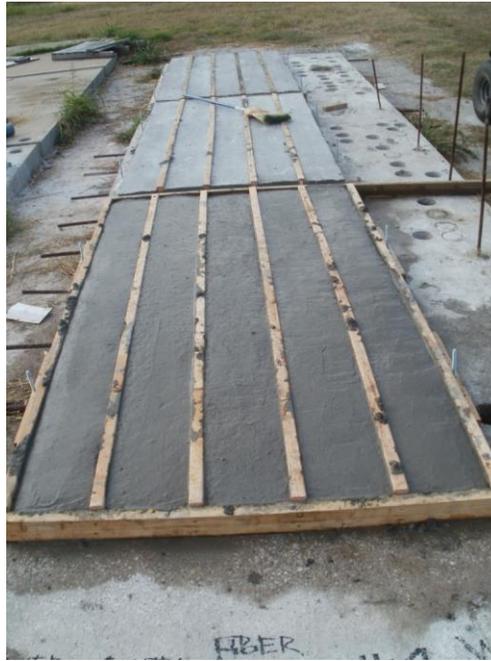
Figure 4.10: Customized Restrained Shrinkage Slabs

Initial plan of the research was to perform restrained shrinkage tests according to ASTM C1581 – 09a “Standard Test Method for Determining Age at Cracking under Restrained Shrinkage” as a part of the laboratory testing phase. However, based on the past experiences with the unreliability of the test procedures, equipment, and the results at CMRG, a customized test to measure restrained shrinkage cracking was developed. To more closely simulate the dimensional constraints on typical roadways, long and thin bonded concrete overlay slabs (9-in. by 3-in. by 8-ft.) were placed on cure concrete substrates outside as seen in Figure 4.10. This geometry induces transverse cracks in the specimens by making the specimens long and thin and restrained to the existing slab.

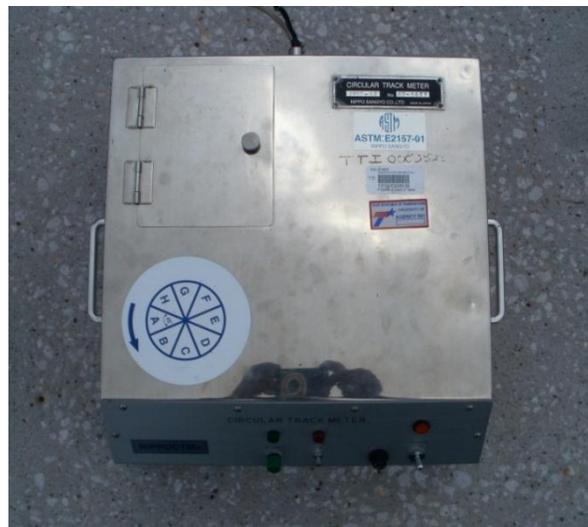
Figure 4.13: Circular Track Meter (CT Meter)

find an average MPD of all the areas tested. The data collected is then put through computer software called “C.T.Meter” that produces a plot and MPD. MPD found by using a CT Meter is highly correlated to find mean texture depth (MTD), which is a measurement of the depth of the prepared surface texture. Figure 4.14 shows a plot of test results that were performed at five different spots (shown by five different colored graphs). The letters on the top represents the eight segments of the circle, and the numbers on the left represents the profile depth. As shown, the graphs are consistent to each other with an exception to a peak at Segment F. This means that the surface texture is mainly consistent except a small area.

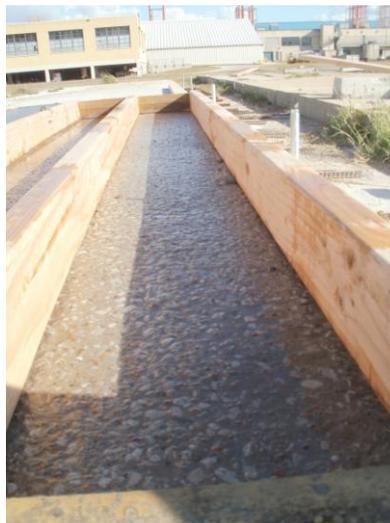
Figure 4.15: Exposed CA shown in the prepared surface in SSD condition

After seeing that the MTD was satisfactory, the surface was cleaned and dampened to reach SSD condition just before the placement of concrete as shown in Figure 4.15.

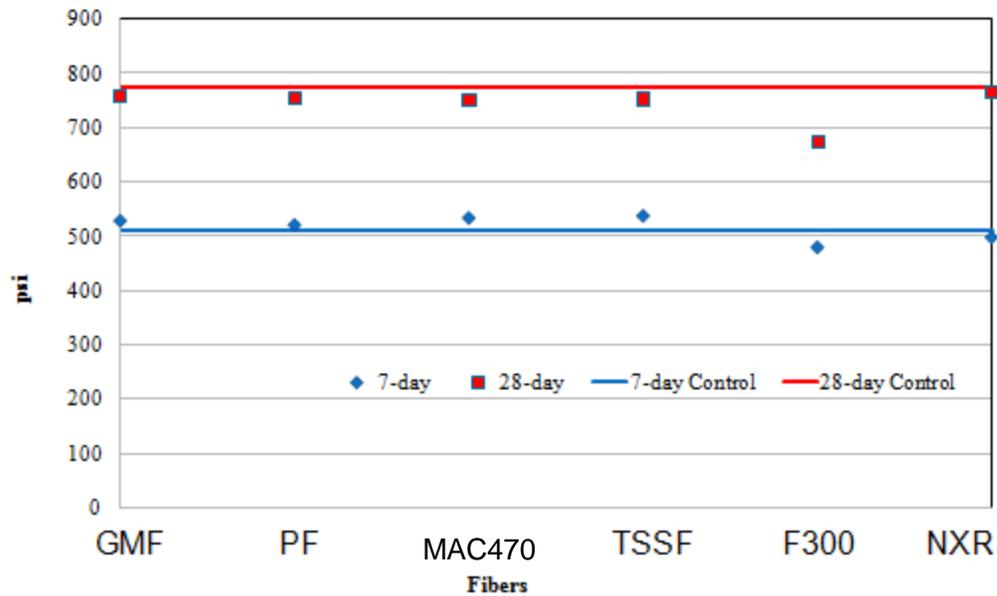
Figure 4.17: Flexural strength with fiber addition

With a constant mixture design, flexural strength change due to fiber addition was also explored. Fiber addition slightly improved 7-day (or early age) strength in some specimens. However, fiber addition slightly decreased 28-day strength in all specimens. The results are provided in Figure 4.17.

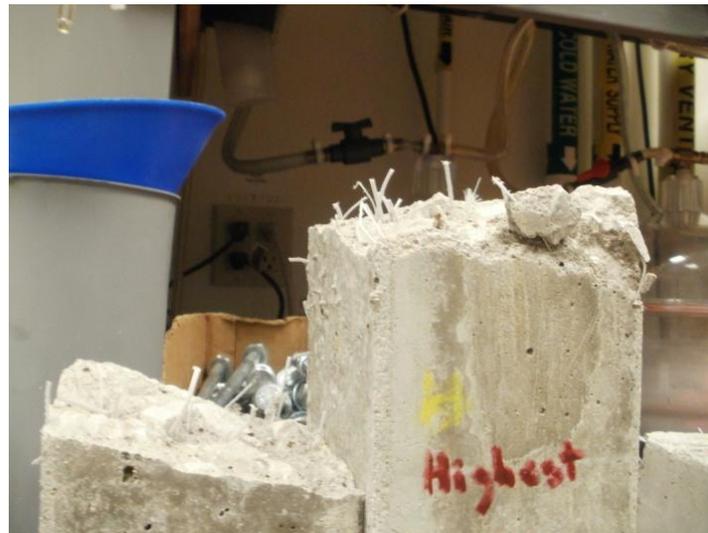
Figure 4.27: Failed interface of the specimen with highest ARS

Specimens that had larger amount of fibers present at the interface gave higher ARS compared to the specimens with lower amount of fibers at the interface. Figure 4.27 shows significantly more fibers present at the interface while Figure 4.28 shows significantly less. Consequently, the specimen in Figure 4.27 had the highest ARS, and the specimen in Figure 4.28 had the lowest ARS.

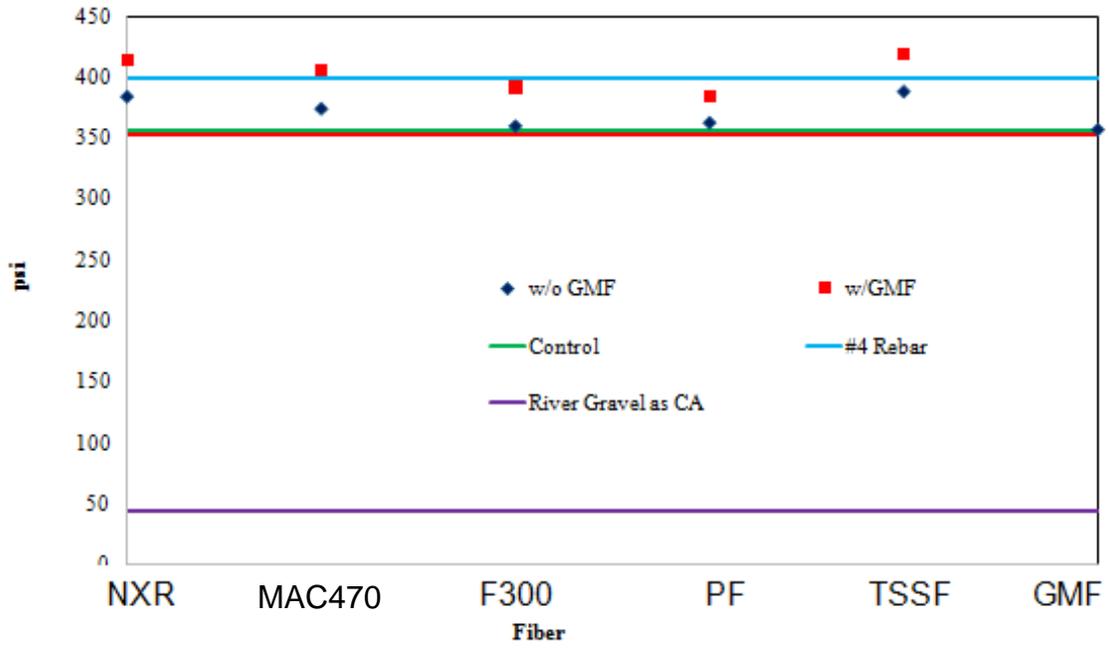
Figure 4.29: Bond strength with fibers

The results are shown in Figure 4.29. Fibers increased bond strength and blending microfiber with either macro or steel fiber increased bonded strength even further. The specimens with river gravel as CA produced very poor bond strength due to its high CTE and induced high stress at the interface. No. 4 reinforcement bars produced very high bond strength because they effectively controlled the stress at the interface. Using reinforcement bars are still less expensive than using fibers.

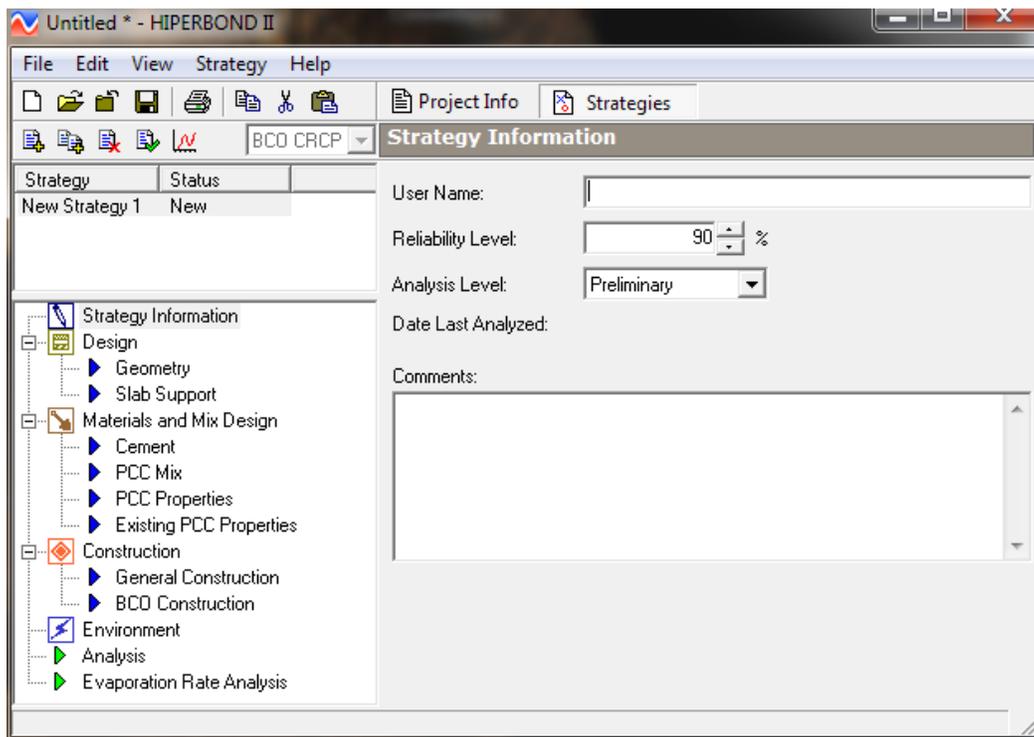
Figure 5.1: HIPERBOND interface

HIPERBOND requires inputs for BCO design, materials and mixture design, construction procedure, and environmental conditions. Figure 5.1 shows an example of the software interface.

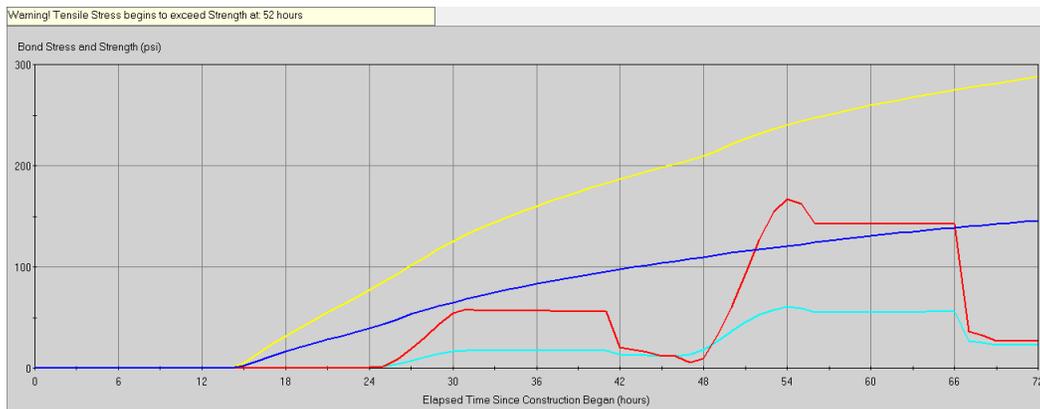
Figure 5.2: An example analysis predicting failure

After all the required information is inputted, the analysis tab is selected. Once the analysis starts, tensile and shear stresses are calculated and compared to strength as a function of time since construction. If at any time either stress exceeds the available strength, the overlay is predicted to fail. Figure 5.2 shows an example analysis where tensile stress exceeded tensile stress, which predicts a failure. Figure 5.3 shows an example analysis where both tensile and shear stress fell below the strength, which predicts a satisfactory BCO design.

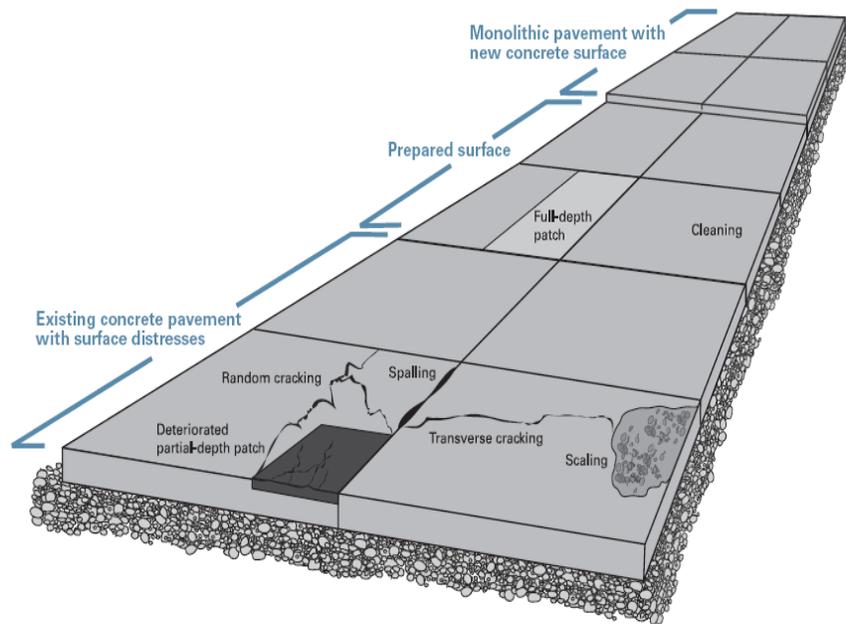
Figure 7.1: Notable distress on existing pavement and possible repairs for BCOs [4]

It is recommended to perform spot-repairs to any severely deteriorated areas. Working cracks must be repaired or sawed out, removed or replaced, since they will reflect through the new concrete overlay. Severe edge failures and any longitudinal cracks must be patched. Localized areas of weakness can be strengthened through patching or can be removed. Figures 7.1 and 7.2 show typical distresses found in existing pavements and possible repairs for candidate bonded type concrete overlays.

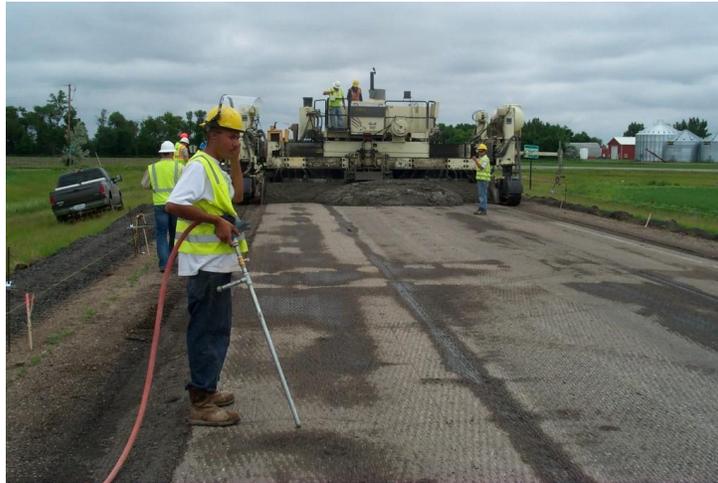
Figure 7.5: Use of an air hose to clean the surface and spread pooled water just ahead of the paver

Immediately prior to placing concrete, the prepared and textured surface shall be thoroughly cleaned of all dust and loose particles by vacuum, air blowing, and/or by hydro blasting. During cleaning the surface shall be dry, and thoroughly cleaned of all vegetation, dirt, mud, and other objectionable materials. Figure 7.5 shows a worker using an air hose to clean the surface and spread any pooled water just ahead of the paver.

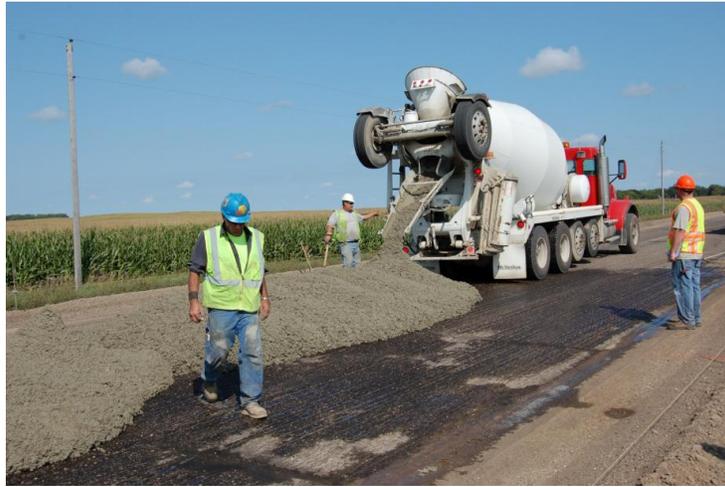
Figure 7.6: Wettered surface and dried surface

The goal is to achieve saturated surface dry (SSD) condition on the cleaned surface in order to lower the surface temperature and prevent moisture loss from the fresh overlay to the existing pavement. The surface should be adequately wetted (but free of puddle water) immediately before the placement. Pooling of water must be avoided since the excessive water may introduce weakened planes at the interface and hinder bond strength. Figure 7.6 shows a surface that has been wetted but beginning to dry.

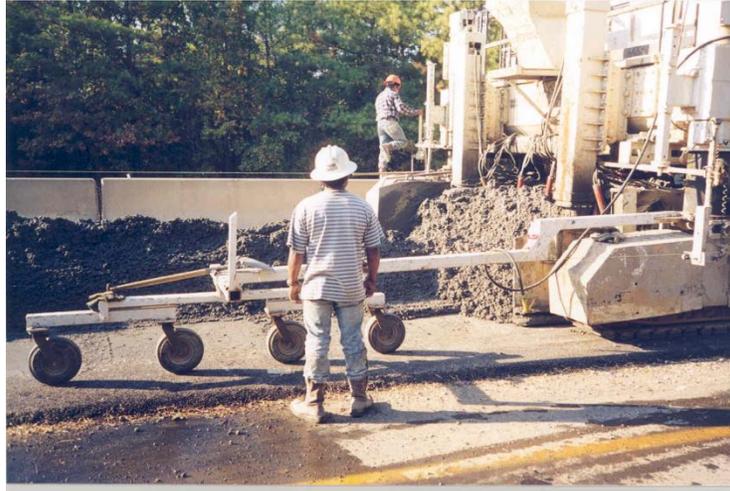
Figure 7.9: Existing pavement, 2-in. thick asphalt separation layer, and concrete overlay placement

Separation layer is essential to isolate the unbonded concrete overlay from the existing concrete pavement, to minimize reflective cracking, and to provide a smooth and level surface. Typically, an asphalt layer is placed about 1-in thick. Some states have used a 2-in. asphalt layer. For whitetoppings that are intended to be unbonded, no separation layer is required. However, the substrate surface should be level and provide a uniform strength platform. Figure 7.9 shows construction of an UBCO.

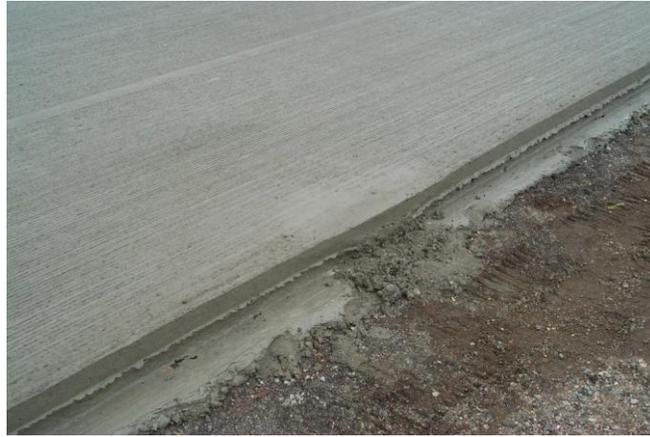
Figure 7.10: Carpet dragged surface texture

entangled in the burlap, leading to other fibers and coarse aggregate being pulled from the surface of the pavement. An unweighted carpet drag is an alternative option to provide an acceptable finish. Figure 7.10 shows a finished surface with carpet dragged surface texture.

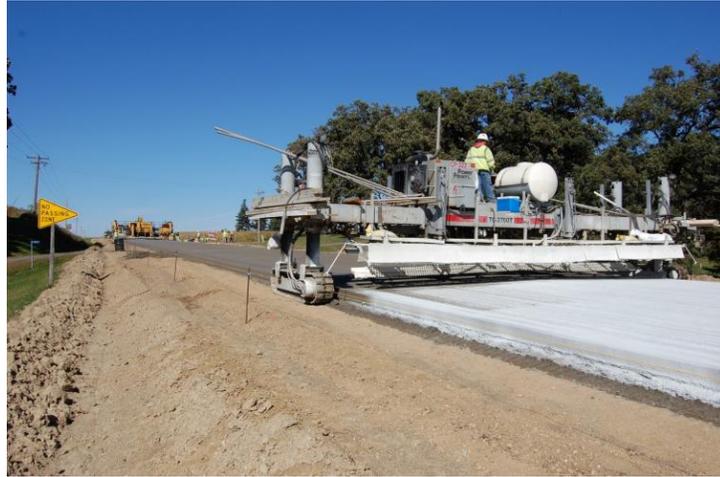
Figure 7.11: Curing compound being promptly applied following paving operation

Curing prevents moisture loss and thereby reduces early age shrinkage, leading to higher tensile strength at the onset of normal drying shrinkage. Simultaneously, other advantages are gained: reduced risk of cracking, higher strength, improved durability, and better wear resistance. Curing compound should be applied promptly following paving operation. Figure 7.11 shows curing compound being promptly applied following paving operation.

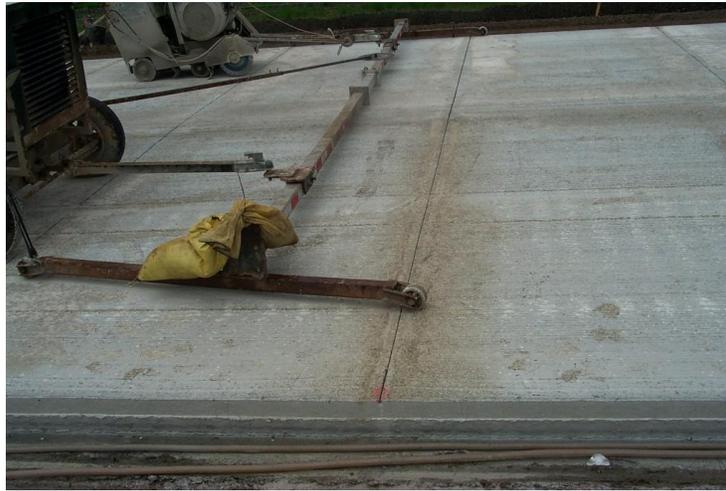
Figure 7.12: Early entry sawing

following the sawing operation. Narrow joints, 1/8-in. wide by 1-in. deep, produced from these saws should minimize incompressible materials entering the joints; therefore no joint sealant is necessary. A maturity curve can be used to predict the right timing for the sawing operation. When the concrete is predicted to have attained adequate strength, according to the maturity curve, the early entry sawing can be allowed to begin. Figure 7.12 shows an early entry sawing at work.

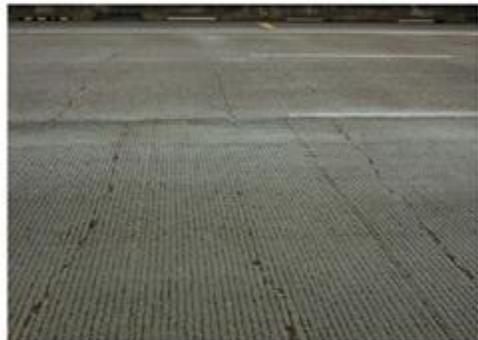
Closely spaced transverse cracks

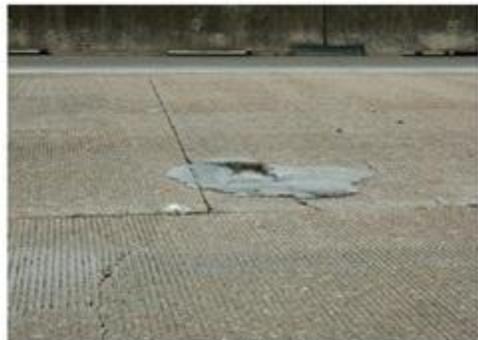
AC patch with failure

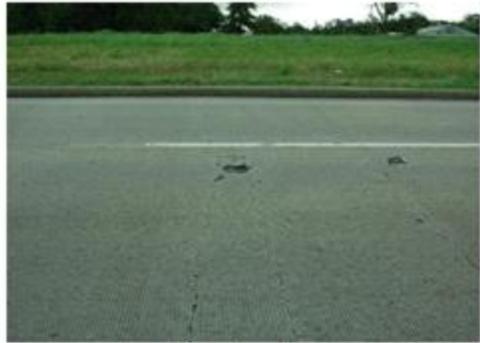
Punchouts

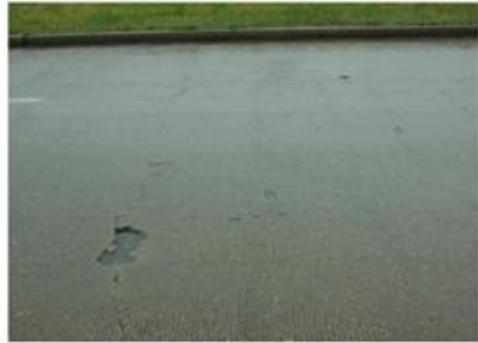
Spalls

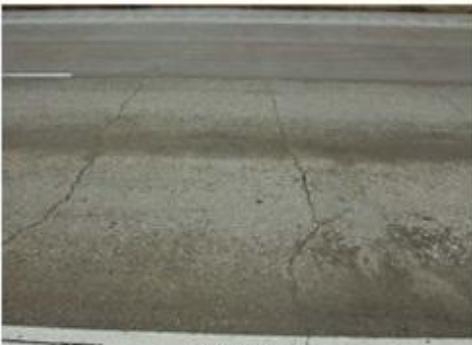
Picture 3
Transverse cracks

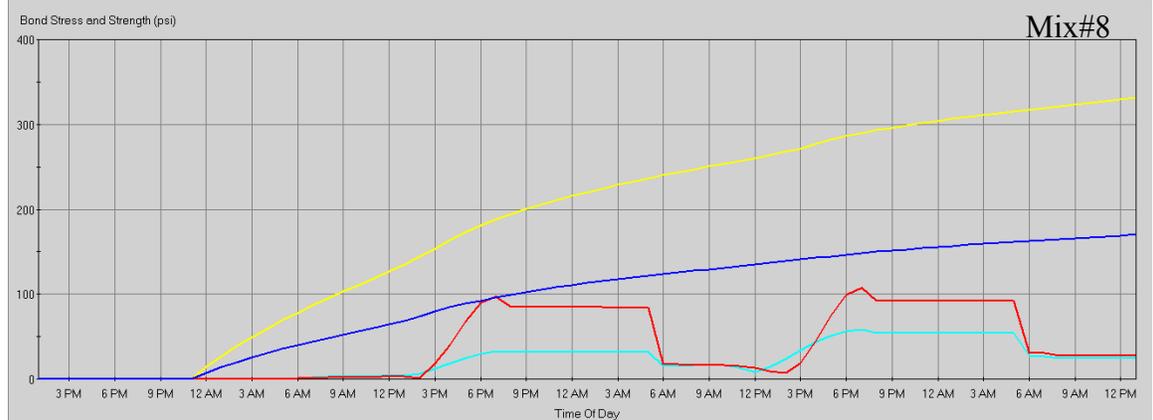
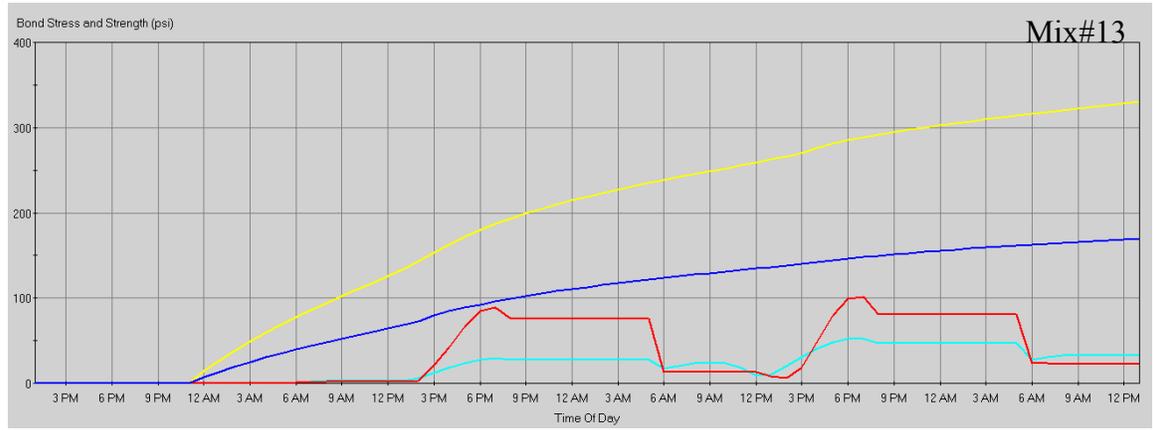
Warning! Tensile Stress begins to exceed Strength at 7 PM
