Effects of Photocatalysis on Concrete Surfaces

Thesis

The University of Texas at Austin

May 2012

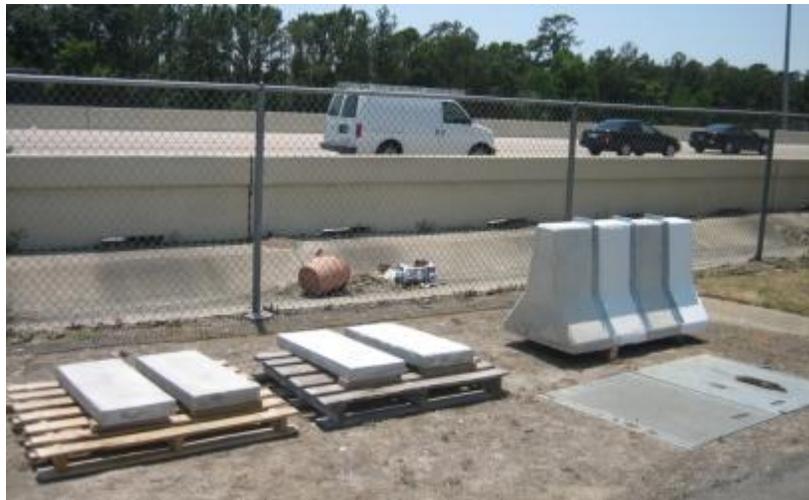
Figure 3.1: Houston Site (a) Aerial Map and (b) Facing I-10

The Houston site was selected as the Texas Department of Transportation district office located at 7600 Washington Avenue, close to I-10 in Houston, Texas. Figure 3.1 shows the location of the concrete specimens and weather station in relation to the highway. This field site is referred to throughout this thesis as the Houston field site.

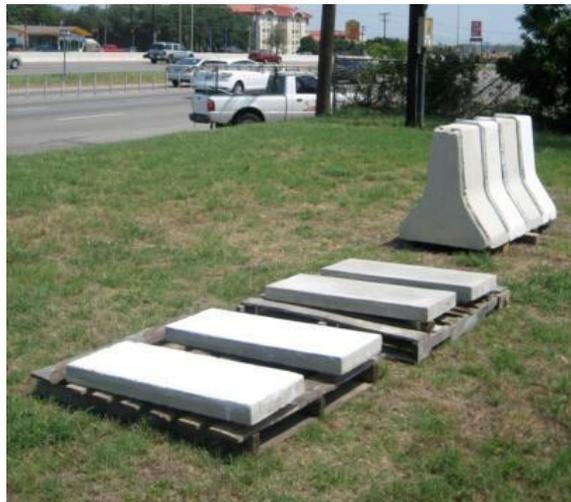
Figure 3.2: Austin Site (a) Aerial Map and (b) Facing I-35

The second field site was selected at the Texas Department of Transportation district office at 7901 North I-35 in Austin, Texas near the intersection of I-35 with Route 183. Figure 3.2 shows its location and proximity to I-35. This field site is referred to throughout this thesis as the Austin field site.

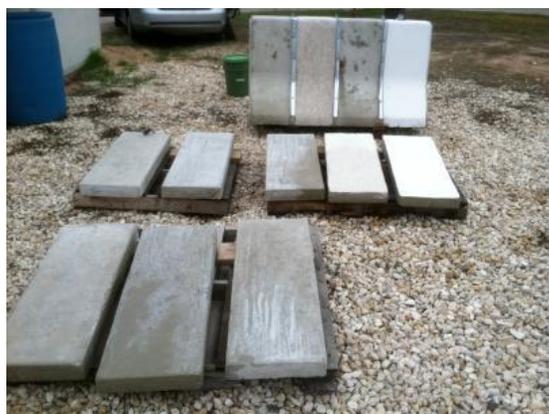
Figure 3.3: Lab Site (a) Aerial Map and (b) Facing North

The third location was at J.J. Pickle Research Campus at 10100 Burnet Road in Austin, Texas. This site was not directly adjacent to any major highway; however, its proximity to the laboratory allowed for more frequent monitoring and evaluation. Figure 3.3 shows its location. This field site is referred to throughout this thesis as the Lab field site.

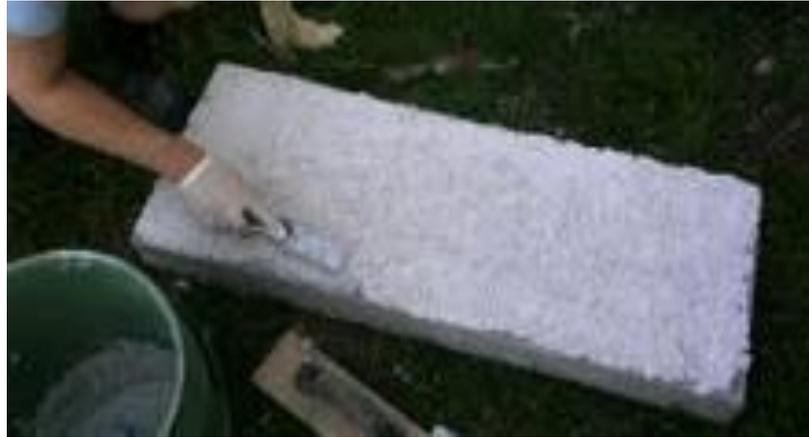
Figure 3.4: TxActive® Stucco Cement Application

eighth in. layer, approximately 500 g of stucco were used per full size slab, or 145 g/ft², or 1.56 kg/m². Figure 3.4 shows an example of the application method.

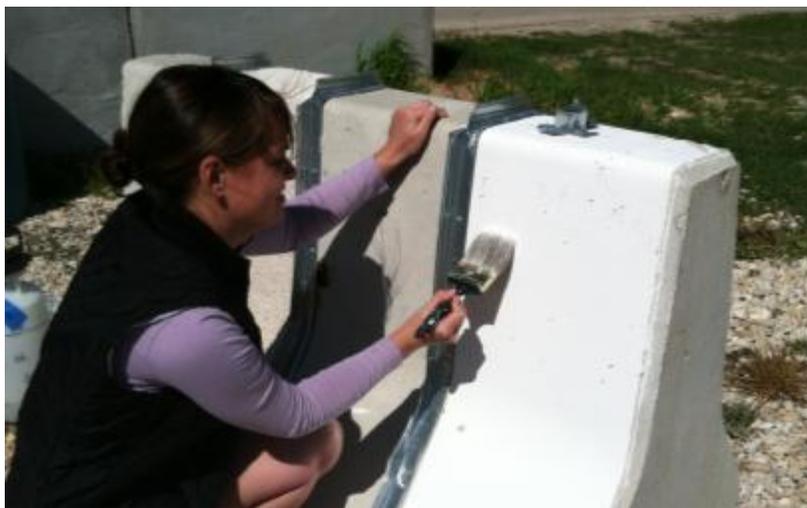
Figure 3.5: Application of Keim Soldalit®-ME Paint

Keim Soldalit®-ME is a silica sol and water glass-based exterior paint that is appropriate for mineral substrates. According to the manufacturer's recommendations, the substrate must be dry, sound, non-chalking, clean and dust-free prior to application of the paint. Soldalit®-ME can be applied by paintbrush, roller, or airless sprayer and a minimum dry time of 12 hours is required between coats. The paint is applied in a two-coat process. The base coat is diluted with up to 5% KEIM Soldalit-Fixativ or up to 10% for strongly absorbent surfaces. The top coat consists of Soldalit-ME in its undiluted form. The two-coat system should be applied in a concentration of about 0.45 kg/m² for a smooth substrate, although exact values can only be determined during the application process. Figure 3.5 shows the paint application process.

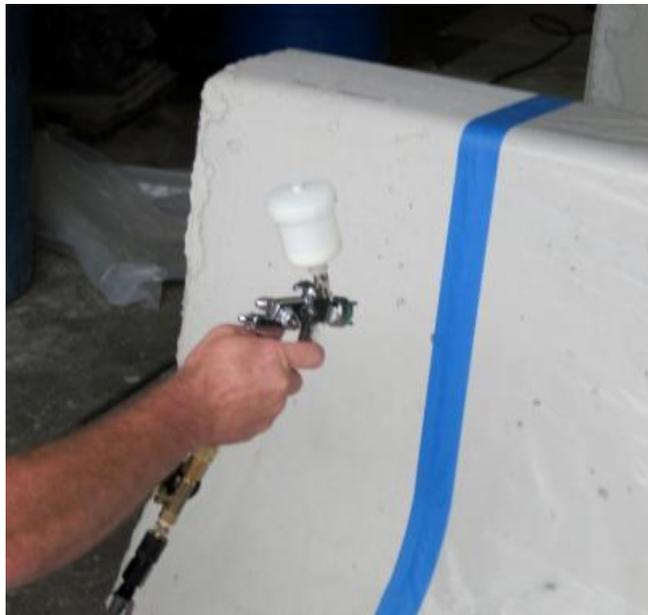
Figure 3.6: Pureti Clean™ Application by Sprayer

Pureti Clean™ is a water-based photocatalytic spray that can be applied to virtually any surface, including both interior and exterior surfaces. Pureti Clean™ contains anatase TiO_2 , titanium hydroxide, and de-ionized water. The product is applied by spraying to a clean surface only. A layer of Pureti's protective basecoat is first applied at a concentration of 0.2 kg/m^2 . A layer of Pureti Clean™ is then applied in a concentration of 0.2 kg/m^2 . The product can be applied using a sprayer or electrostatic spray system, although a sprayer was used for this application. Professionals from Pantheon Tile, a local distributor of Pureti products, applied this product to the concrete specimens at the Construction Materials Research Group (CMRG) building located at the JJ Pickle Research Facility. Figure 3.6 shows the application process at CMRG in April 2011.

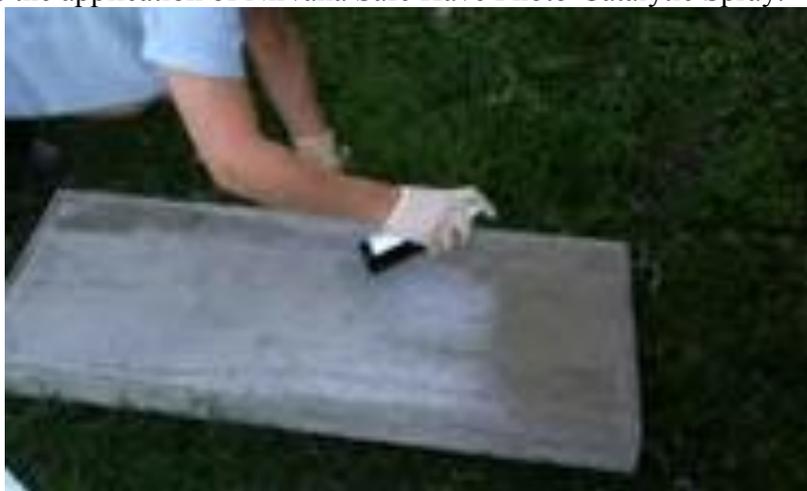
Figure 3.7: Application of Nirvana Safe Haven Photo-Catalytic Spray

Nirvana Safe Haven Photo-Catalytic Spray is a water-based photocatalytic spray. According to the manufacturer, it should be applied 5 in. from a surface using a fine sprayer. It is applied in a concentration of 8 ounces per 250 to 500 square feet of surface. Figure 3.7 shows the application of Nirvana Safe Have Photo-Catalytic Spray.

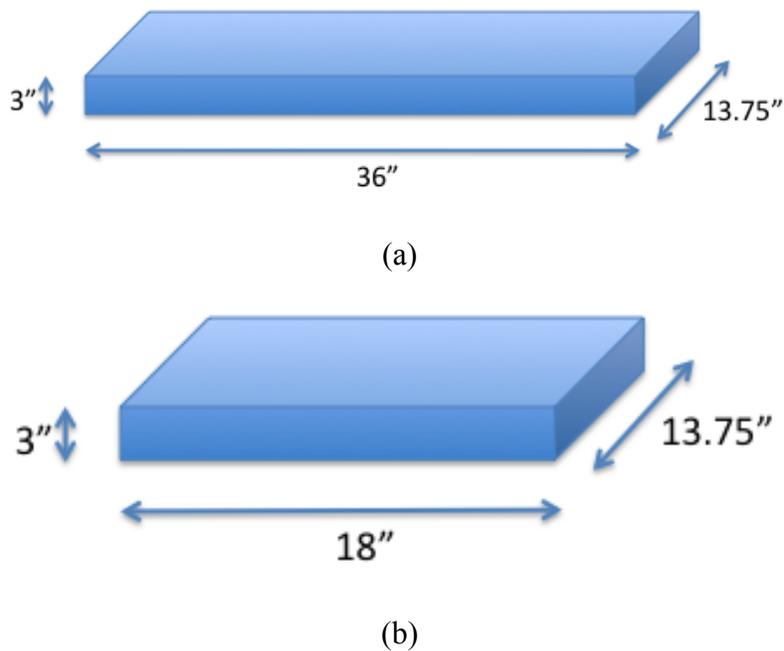
Figure 3.9: Dimensions of (a) Full Size and (b) Half Size Slab Specimens

In addition to the barrier specimens, full size concrete slabs were created for both chamber testing and field testing. The dimensions of the full size slabs were determined based on the size of the chamber. In addition to the full size slabs, half size slabs were also created for chamber testing towards the end of the project. These half size slabs were not placed at any field sites and were only used in chamber testing. Figure 3.9 shows the dimensions of the full and half size slabs.

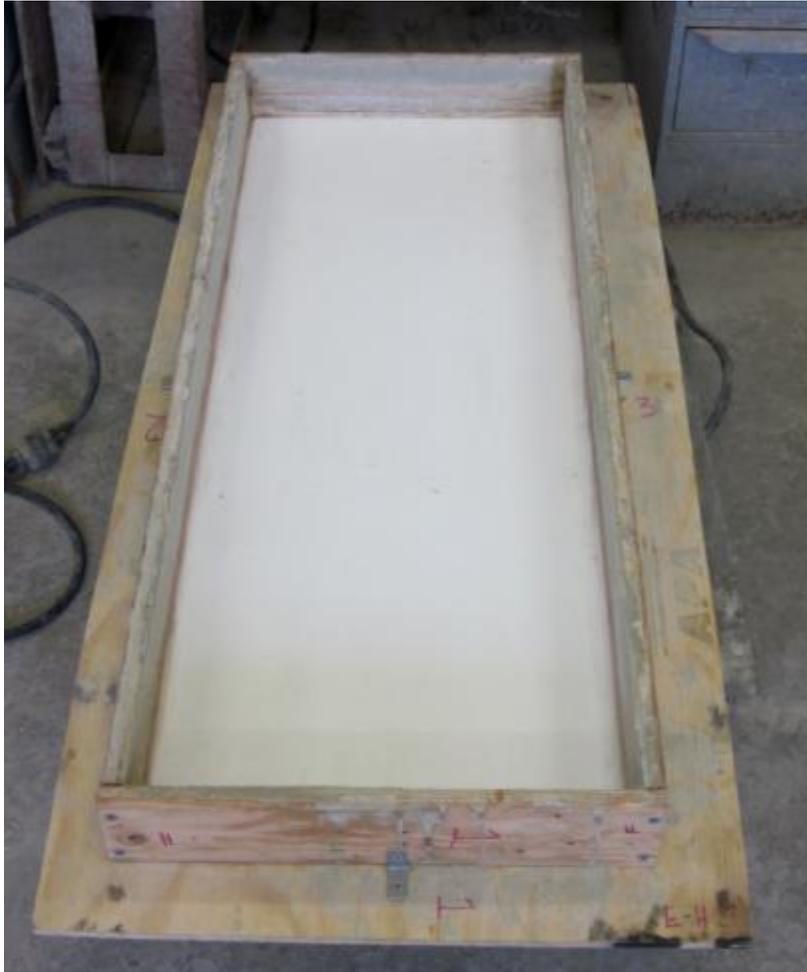
Figure 3.10: Completed Slab Formwork

a smooth surface for coating without applying any greases or oils that could interfere with the air chamber testing. An example of completed formwork is shown in Figure 3.10.

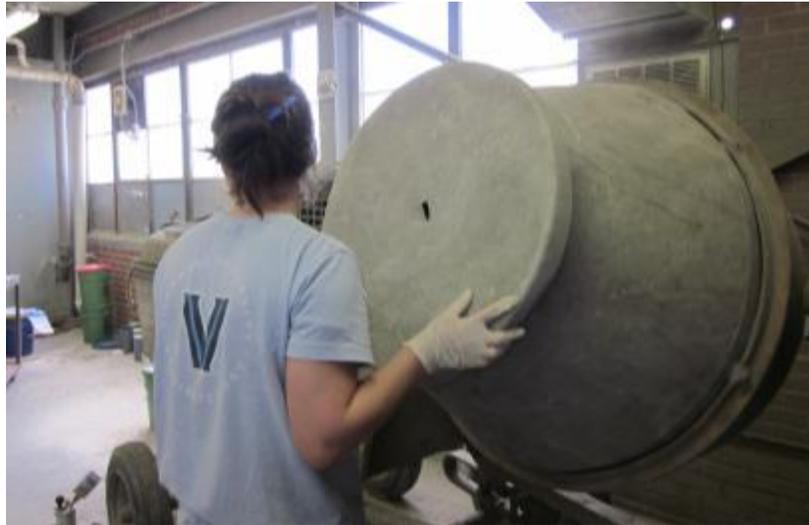
Figure 3.11: Concrete Mixing Procedure

Next, the fine and coarse aggregates were placed in the concrete mixer with approximately one-third of the mixing water. The aggregate and water mixture was mixed for approximately 1 minute. At this point the mixer was stopped and the cement and fly ash were added. After placing a lid on the mixer opening, the mixer was started again and allowed to run for about 30 seconds. Figure 3.11 shows this concrete mixing procedure step.

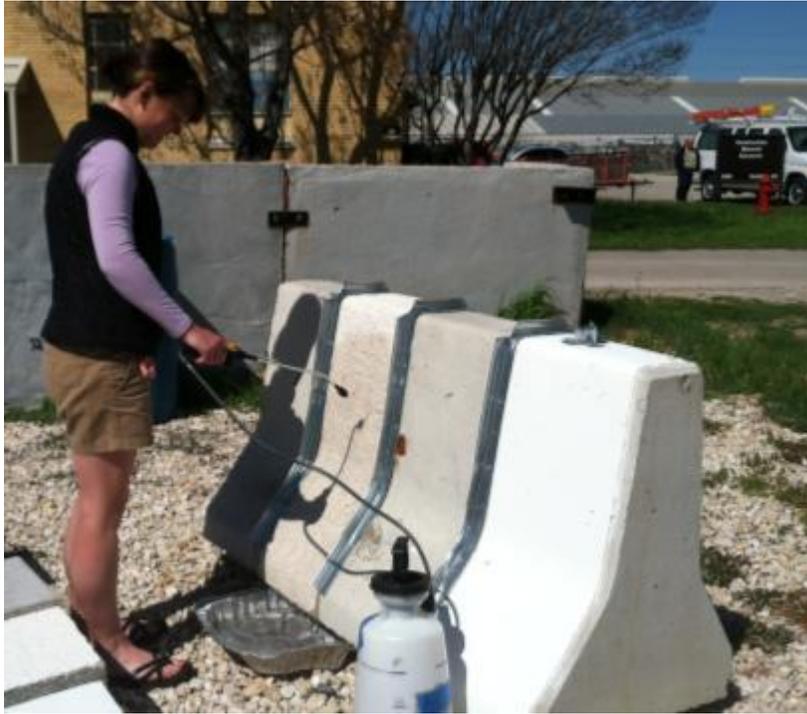
Figure 3.12: Concrete Washing Procedure

stream onto the coated concrete surfaces, as shown in Figure 3.12. This volume was selected because it is approximately equal to a 1 in. rainfall over the surface of the specimen.

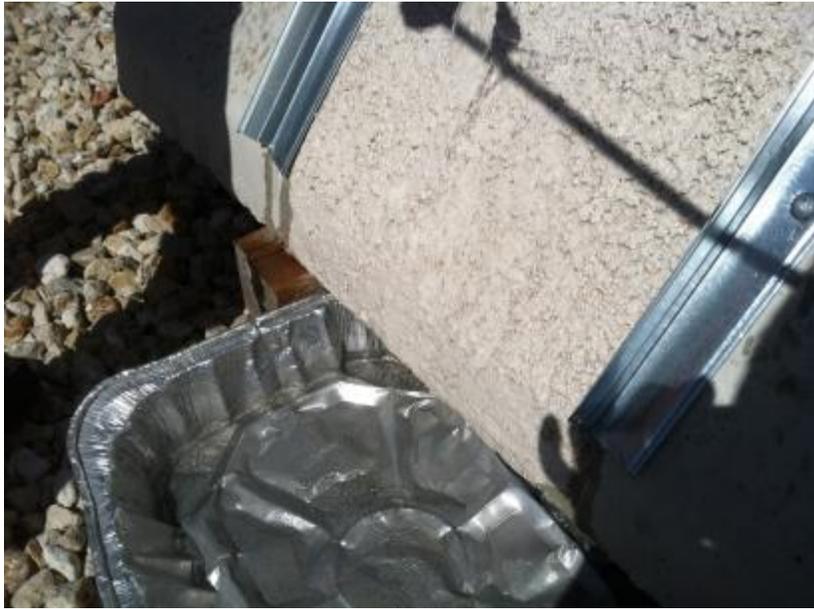
Figure 3.13: Water Collection Procedure for Concrete Specimens

This process was repeated for each of the four sections of the barrier specimens and each of the slab specimens. Each of the water samples was collected in an aluminum dish and transferred to plastic bottles using a funnel. The samples were then capped. Figure 3.13 shows the collection procedure.

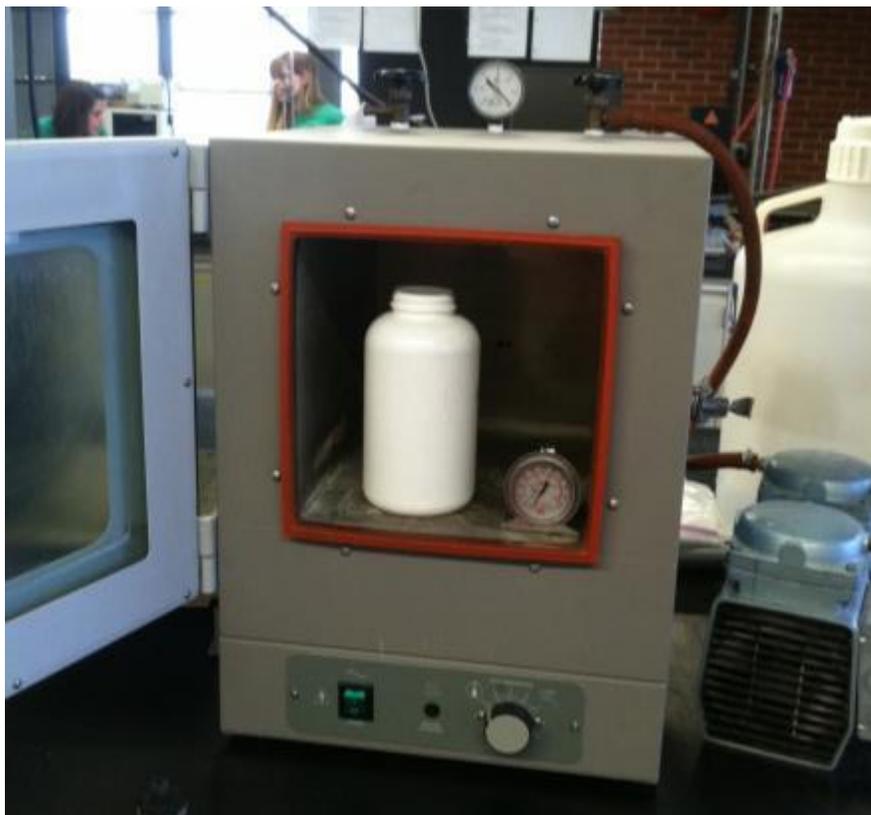
Figure 3.14: Ion Chromatography Sample Evaporation

The samples were transported back to the lab. Each sample was weighed and then divided in half, and the half-samples were weighed again. One of the halves was stored and the other was uncapped and placed in a vacuum oven. Each sample was evaporated until it reached a volume close to or just above the volume necessary for ion chromatography testing, which was approximately 150 milliliters. The purpose of evaporation was to concentrate the samples in order to be better able to detect nitrate and nitrite concentrations near or below the minimum detection limit. Figure 3.14 shows the vacuum oven drying process.

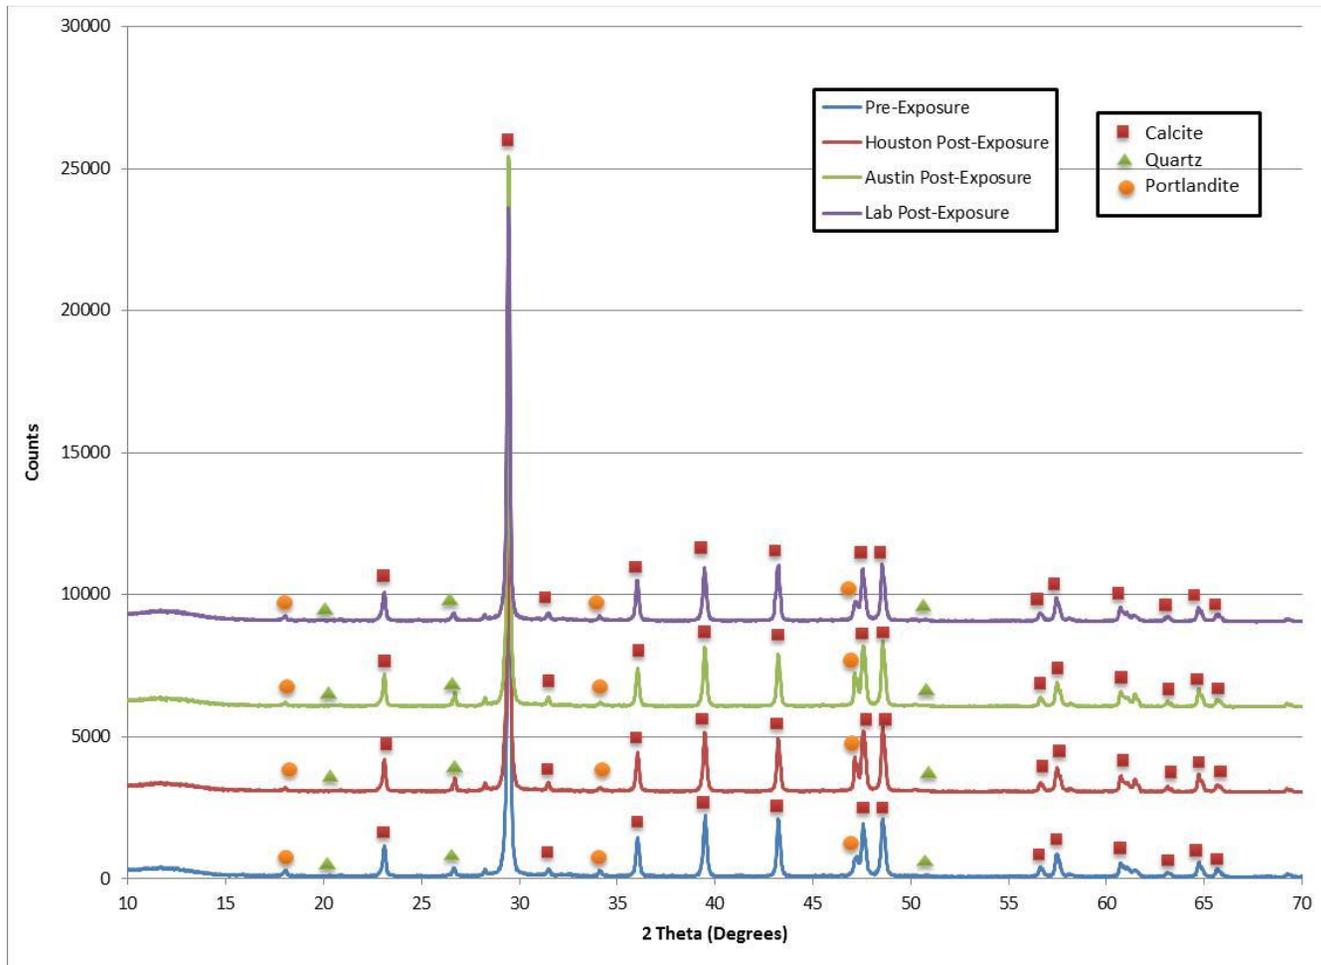
Figure 4.1: XRD Analysis of Uncoated Barrier Core Before Exposure and After Exposure in Houston, Austin, and the Lab Sites

Figure 4.1, which shows the XRD analysis for the uncoated section, indicates no major change in composition after the exposure period for any of the field sites. The major phases that were identified both before and after exposure were calcite, the mineral present in both aggregates used in all concrete specimens, quartz, a major component of sand, and portlandite, which is present in hydrated cement. Since TiO_2 was not applied to this surface, it is not surprising that neither anatase nor rutile were identified.

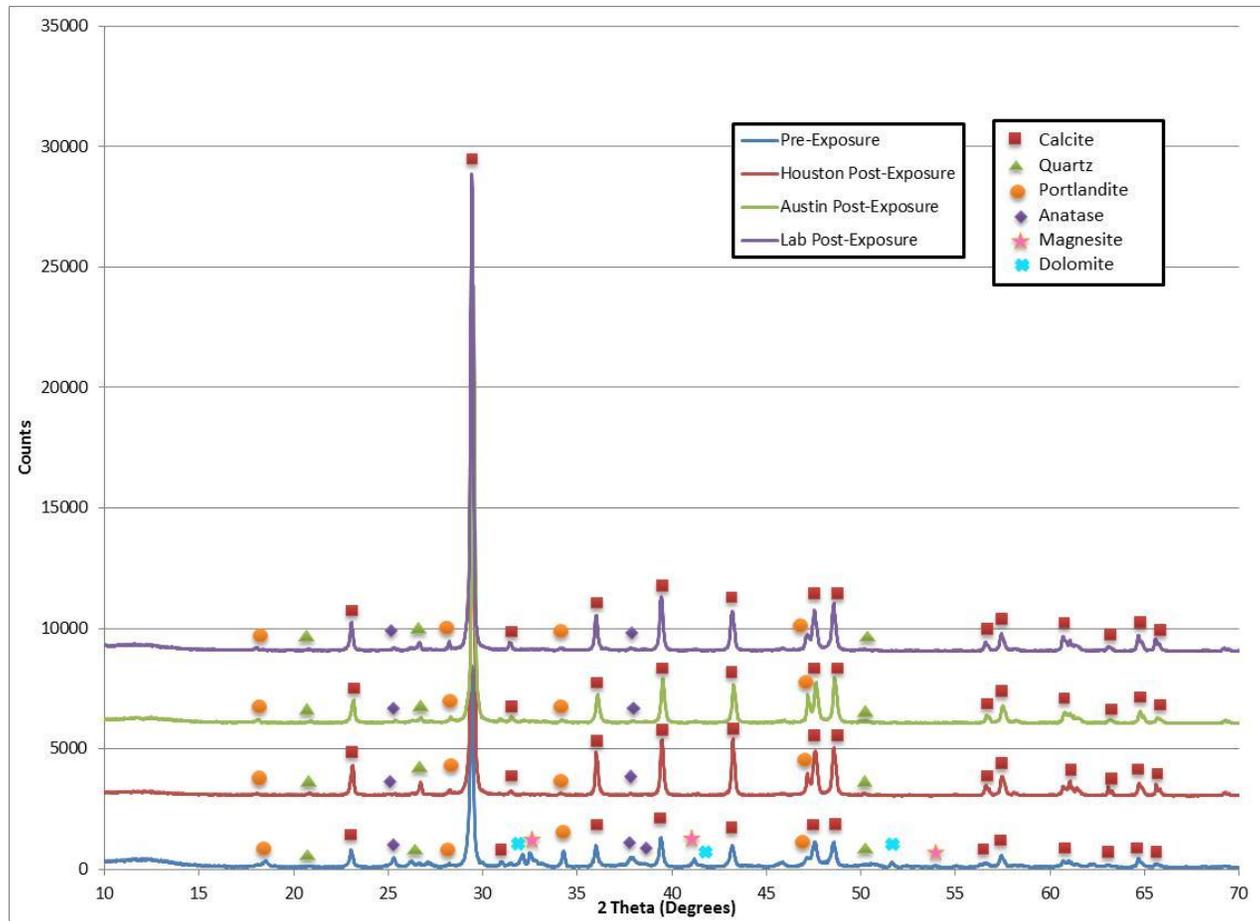
Figure 4.2: XRD Analysis of TxActive Barrier Core Before Exposure and After Exposure in Houston, Austin, and the Lab Sites

Samples were not compared quantitatively as the ratio of coating to concrete present in each sample was highly variable. However, it is evident from these data that the photocatalytic material in TxActive remains present after one year outdoor exposure.

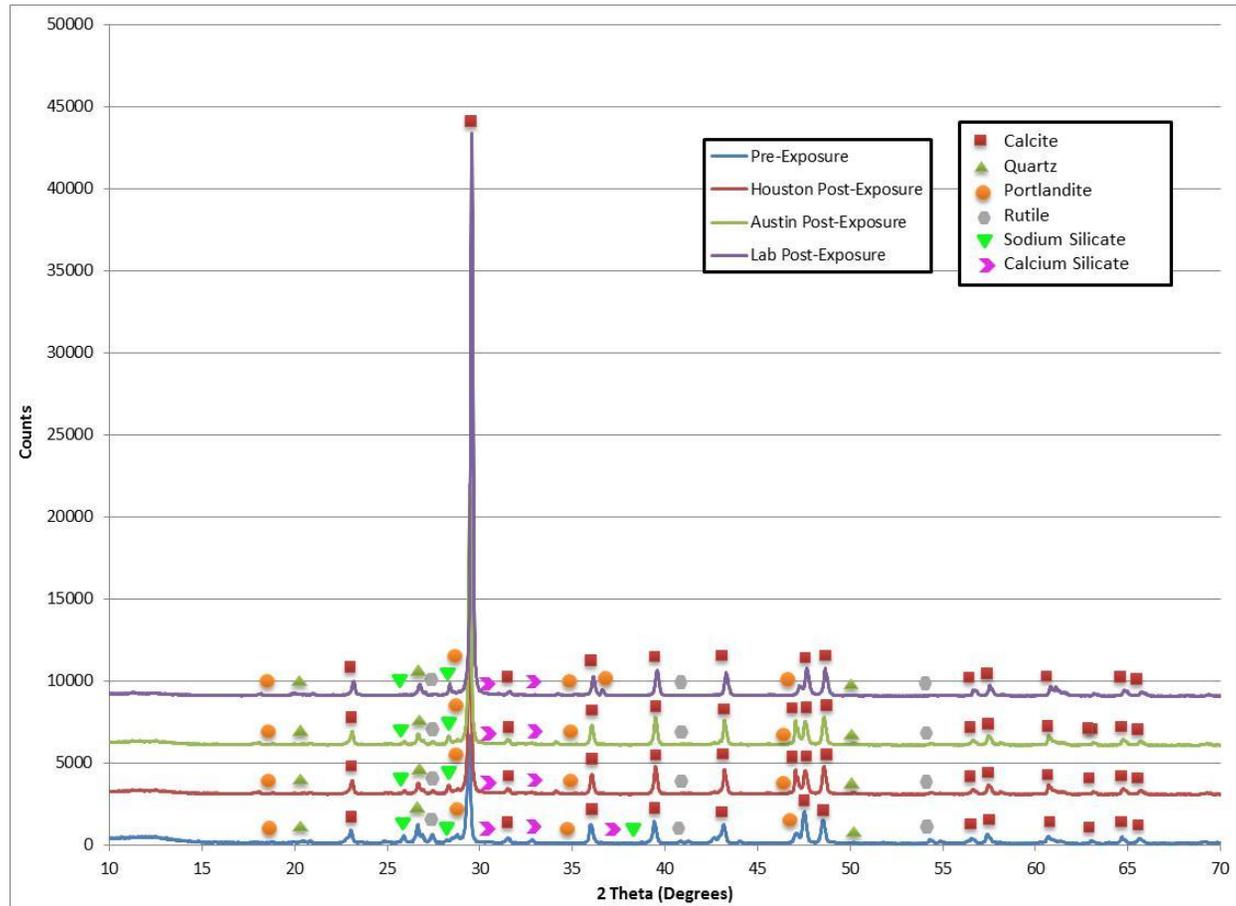
Figure 4.3: XRD Analysis of Keim Barrier Core Before Exposure and After Exposure in Houston, Austin, and the Lab Sites

Figure 4.3 shows the XRD analysis for the Keim core. In Figure 4.4, calcite is again identified, as well as quartz, portlandite, and calcium silicate. Two major components of the Keim paint were also identified, rutile and sodium silicate (waterglass). Rutile is the active photocatalytic material in this coating. Rutile was identified both before and after exposure for each of the three field sites, so it is clear that photocatalytic material remained present after outdoor exposure.

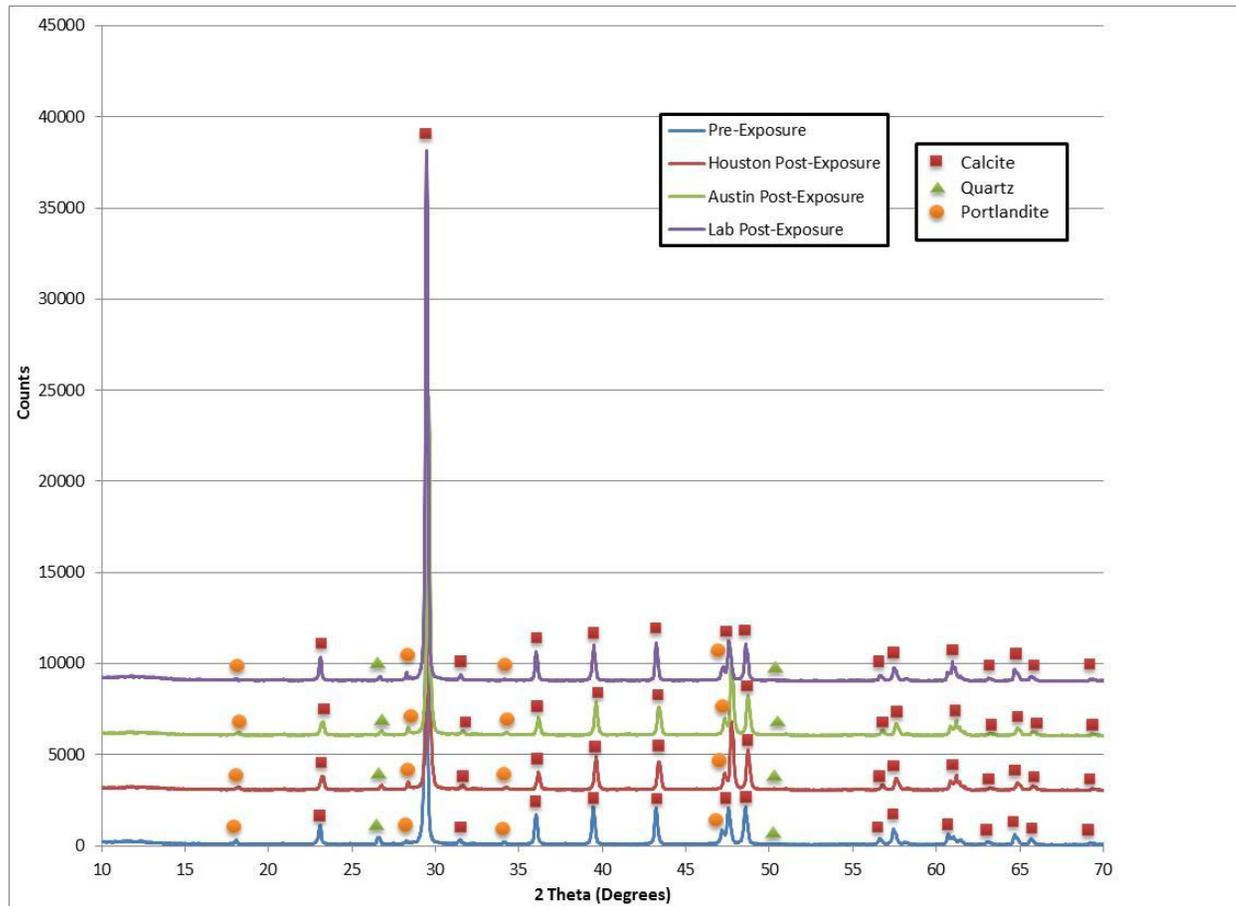
Figure 4.4: XRD Analysis of Pureti Barrier Core Before Exposure and After Exposure in Houston, Austin, and the Lab Sites

Figure 4.4 shows the XRD analysis for the Pureti specimen. Calcite, quartz, and portlandite are again identified as the major phases present in the sample. Anatase was not identified either before or after exposure. This is likely due to an inadequate percentage of TiO_2 present in the sample. The Pureti coating contains less than 1% anatase by total mass, which makes it insignificant when compared to other phases, such as those present in the concrete. Because anatase was not identified at all, it is not evident from this information whether the photocatalytic material degrades after outdoor exposure. There were no significant changes in composition after exposure for any of the field sites.

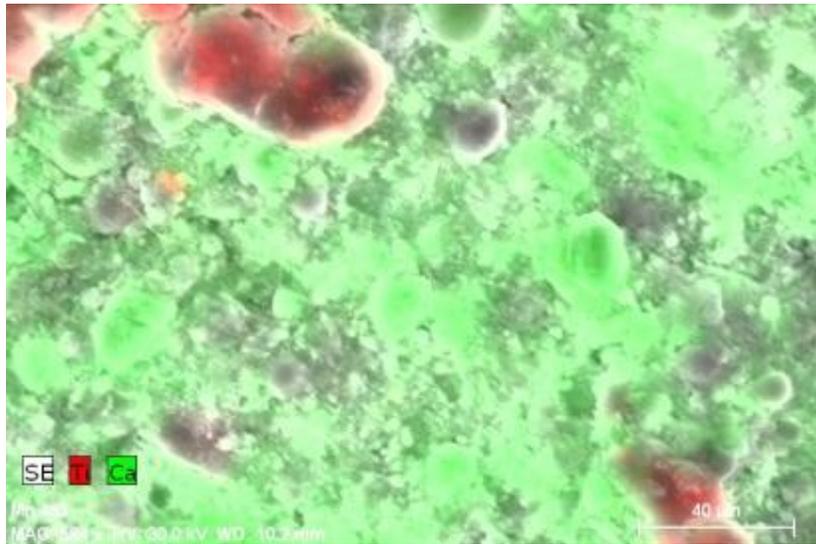
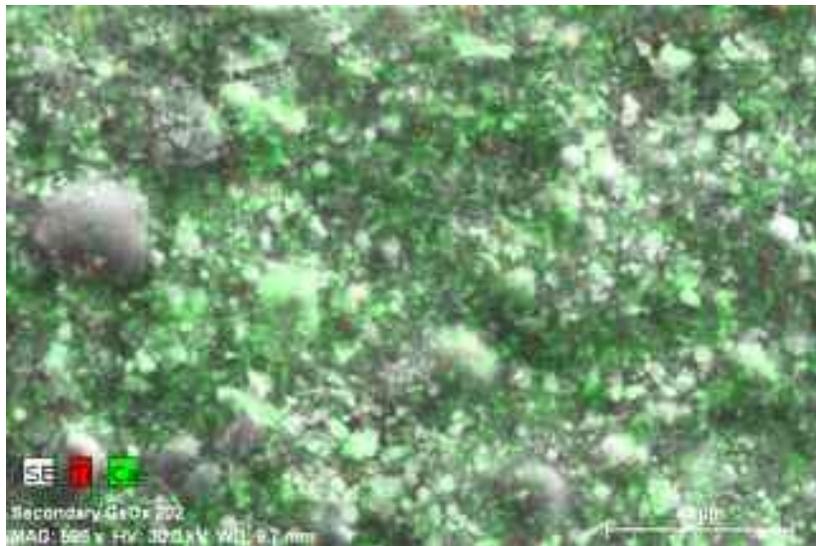
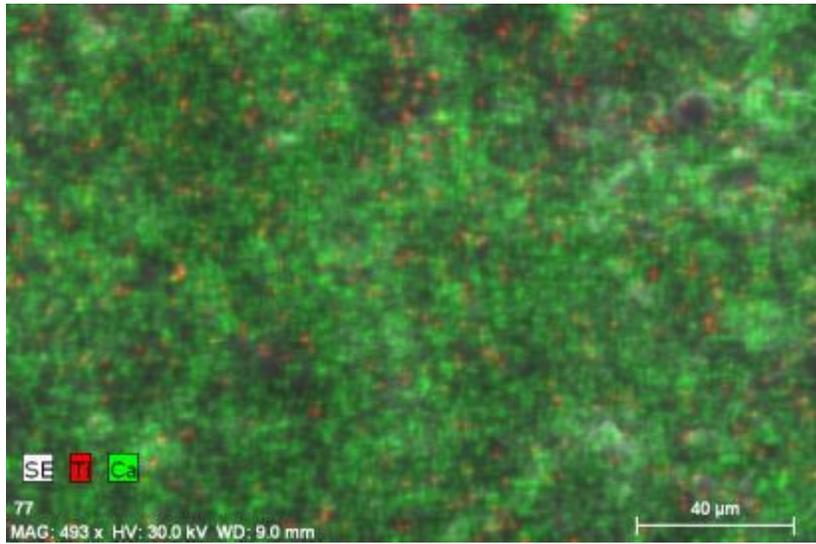
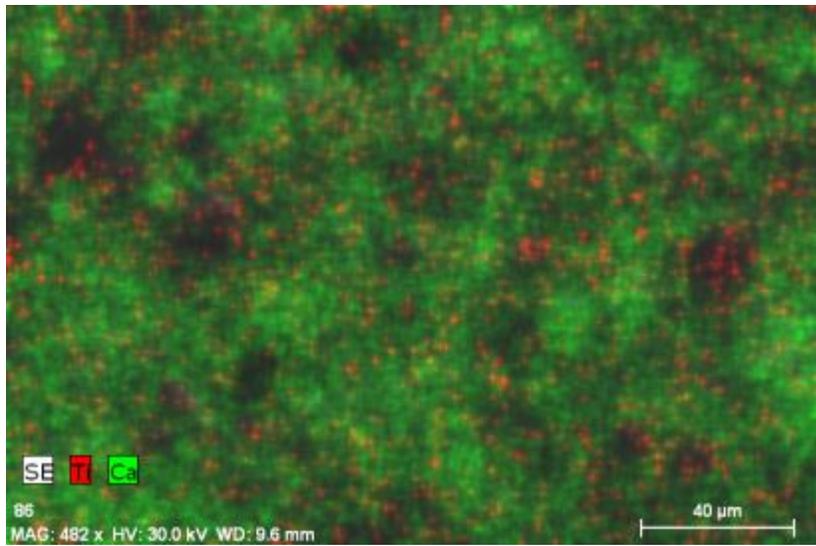
Figure 4.5: SEM Images of Control Surface (a) Before Exposure (b) After Exposure in Houston (c) After Exposure in Austin and (d) After Exposure at the Lab Site

There appears to be no significant change in the spatial distribution of TiO₂ on the uncoated section surface for any of these field site locations after the exposure period is complete.

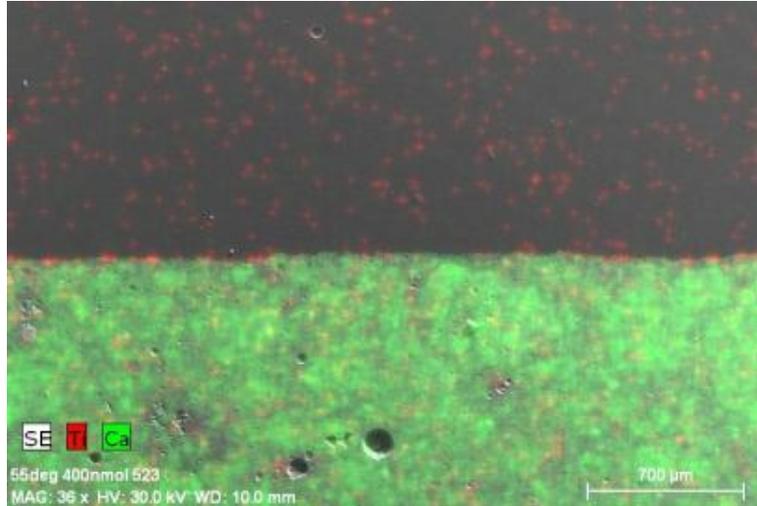
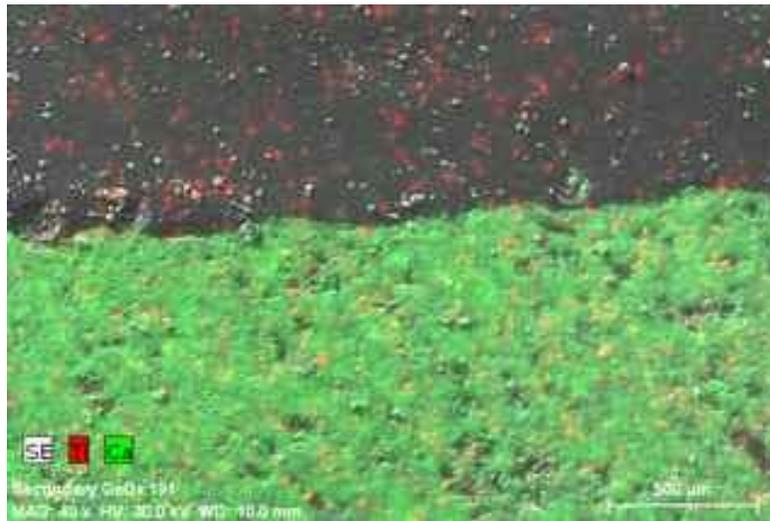
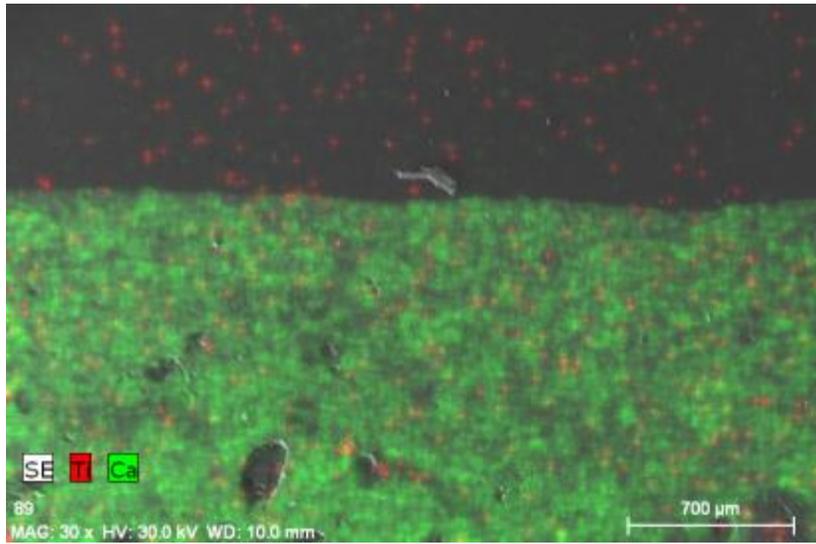
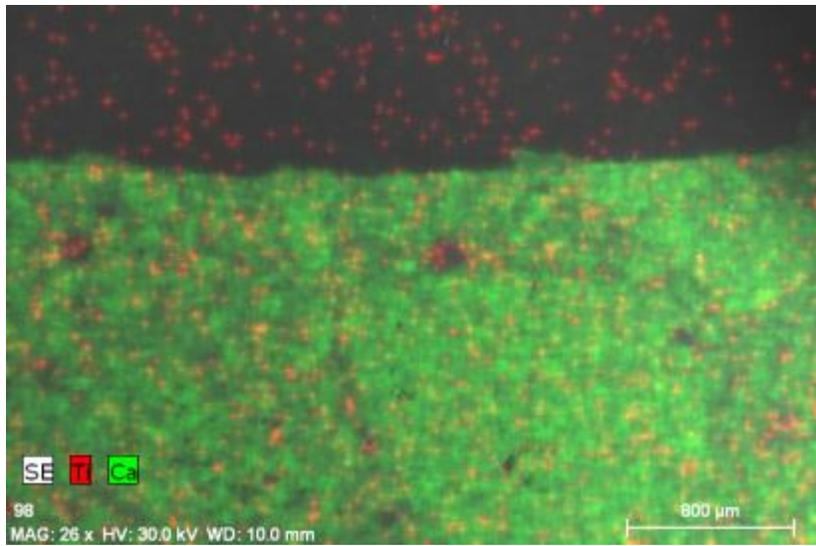
Figure 4.6: SEM Images of Control Cross Section (a) Before Exposure (b) After Exposure in Houston (c) After Exposure in Austin and (d) After Exposure at the Lab Site

applied to this section. Again, any titanium that does appear can likely be attributed to background noise associated with the imaging system.

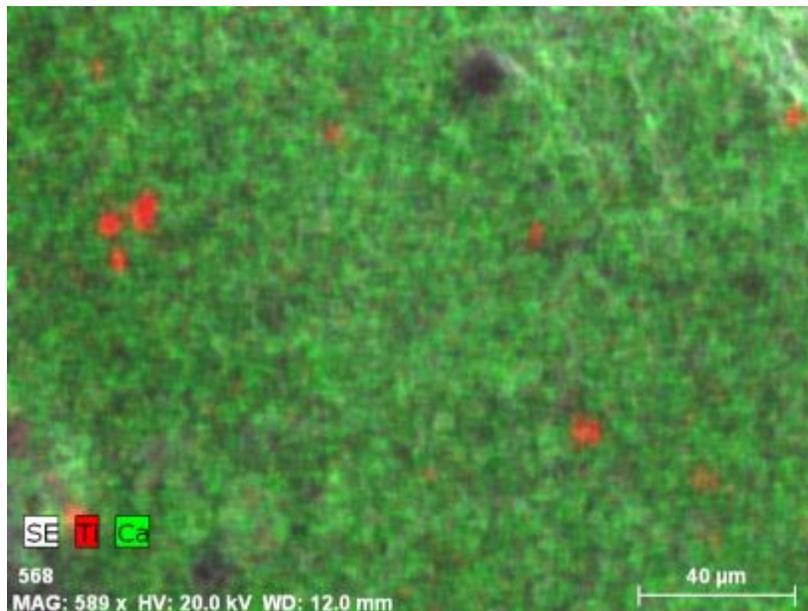
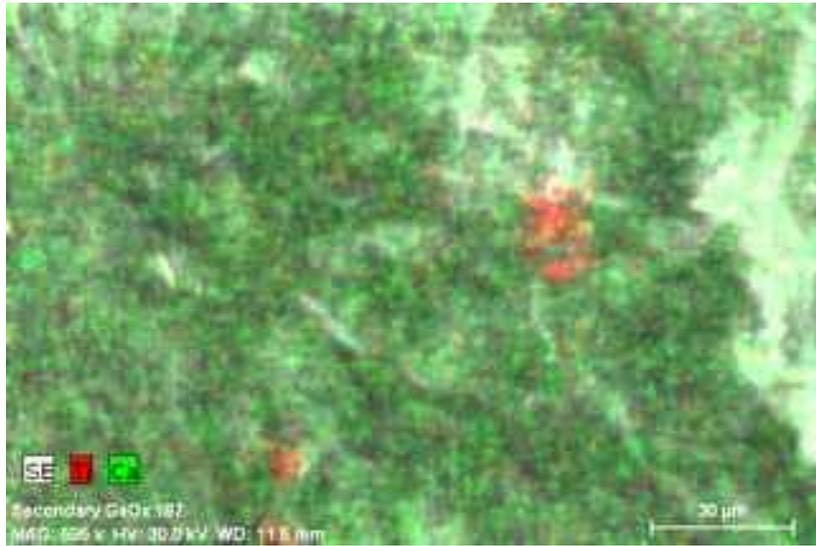
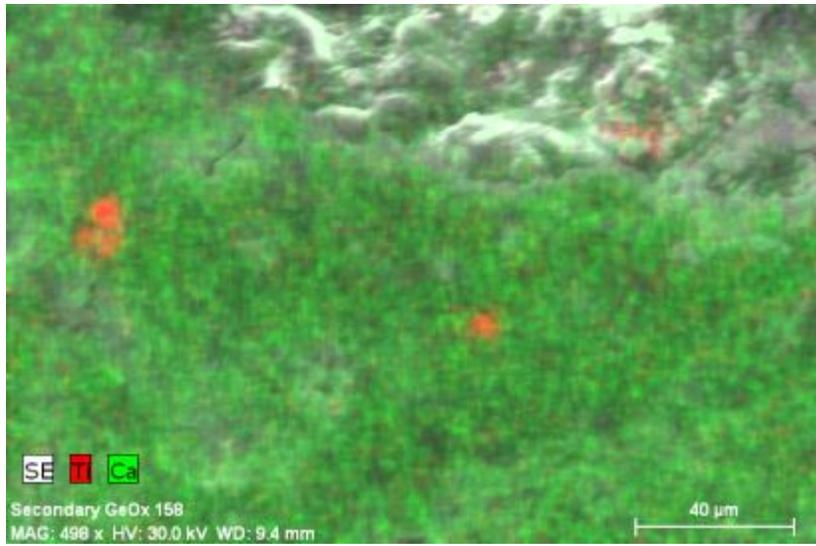
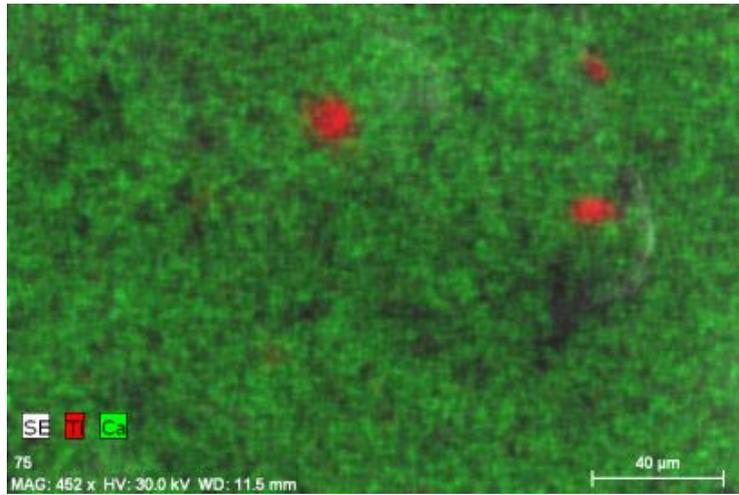
Figure 4.7: SEM Images of TxActive Surface (a) Before Exposure (b) After Exposure in Houston (c) After Exposure in Austin and (d) After Exposure at the Lab Site

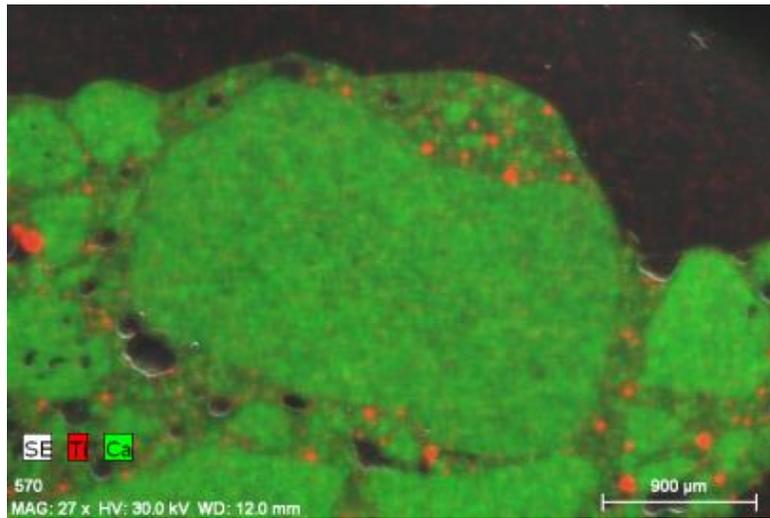
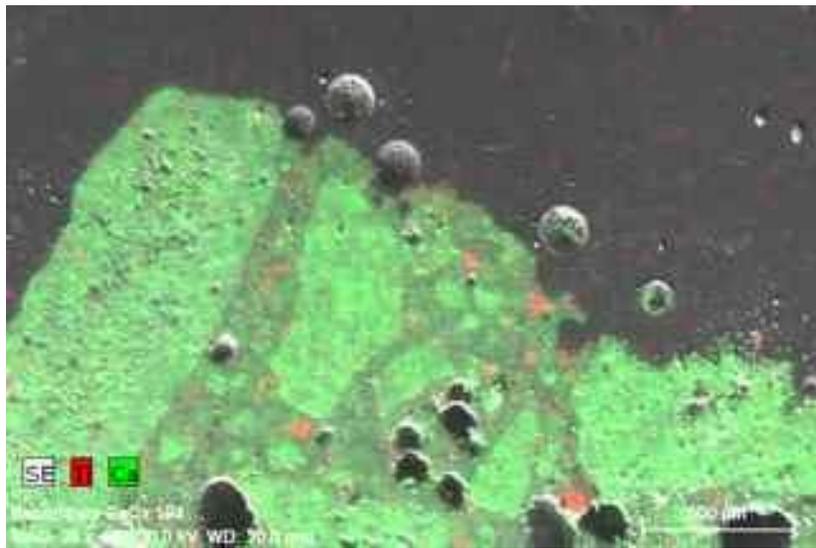
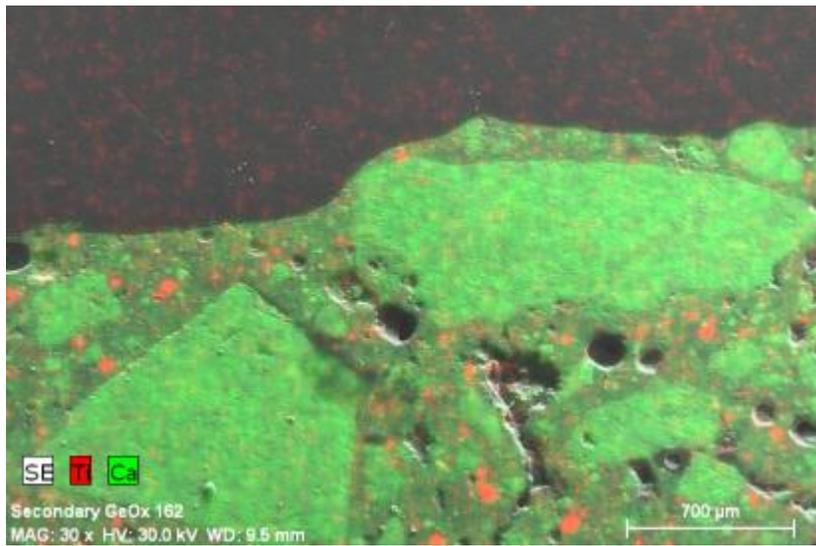
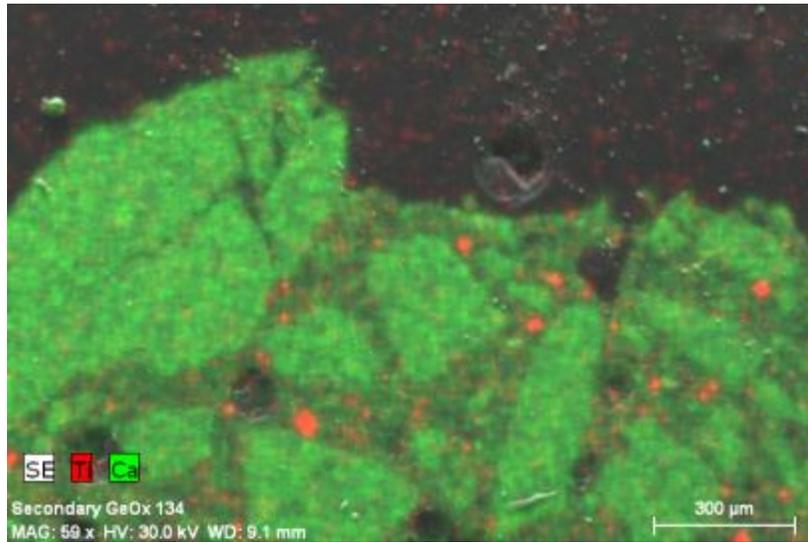
Figure 4.8: SEM Images of TxActive Cross Section (a) Before Exposure (b) After Exposure in Houston (c) After Exposure in Austin and (d) After Exposure at the Lab Site

be interspersed in small agglomerations throughout the stucco matrix, which is largely composed of limestone sand and cement. In Figure 4.8, the sand particles can be viewed as large green sections with titanium interspersed between them. There appears to be no difference in composition between the sections obtained before exposure and those obtained after exposure in any of the 3 field sites. This indicates that the TxActive stucco cement did not degrade under outdoor exposure.

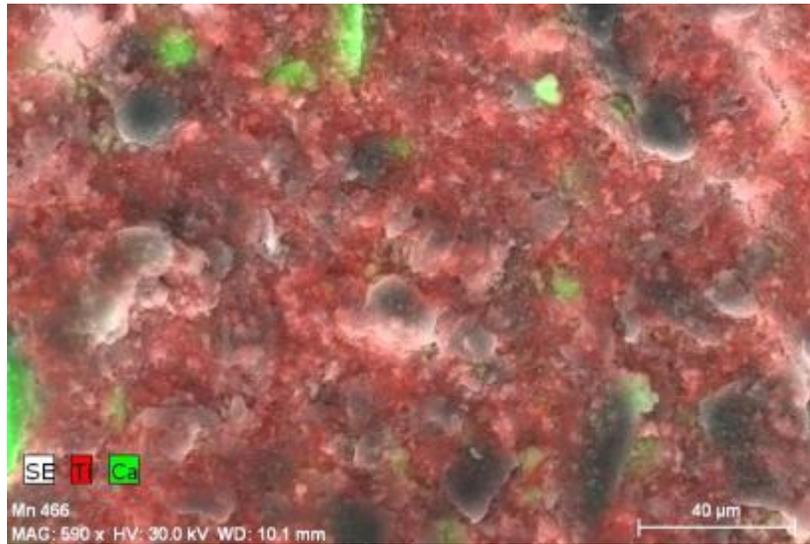
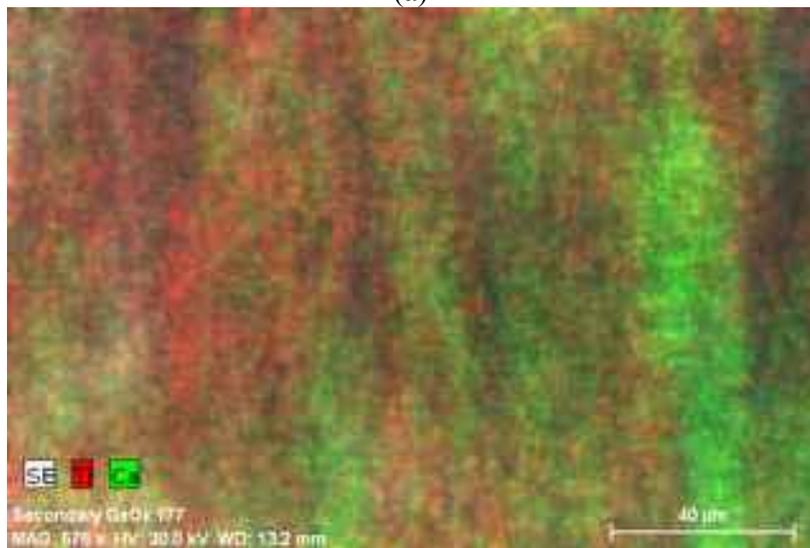
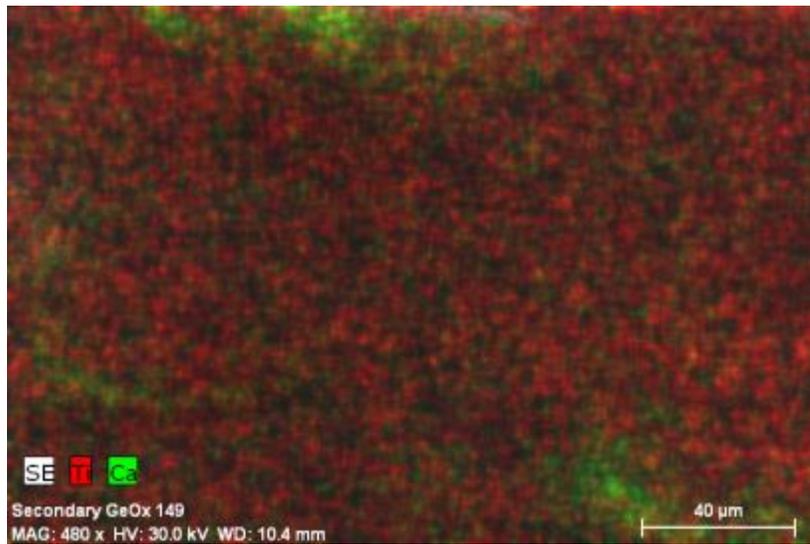
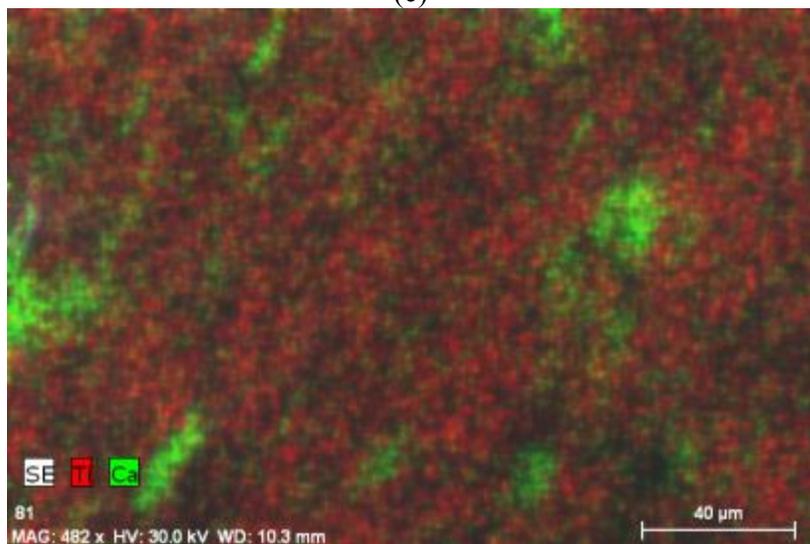
Figure 4.9: SEM Images of Keim Surface (a) Before Exposure (b) After Exposure in Houston (c) After Exposure in Austin and (d) After Exposure at the Lab Site

Figure 4.9 shows surfaces of cores obtained from the barrier sections painted with Keim Soldalit-ME both before and after outdoor exposure at each of the 3 field sites. As expected, Figure 4.9 shows that the surface composition is almost entirely titanium. This result is expected because the Soldalit-ME product is intended to cover the surface and contains no calcium. There appears to be minimal or no degradation of the titanium composition after one-year outdoor exposure, which may have been indicated by an increase in the calcium that lies directly beneath the painted surface.
