Effects of Photocatalysis on Concrete Surfaces

Thesis

The University of Texas at Austin

May 2012

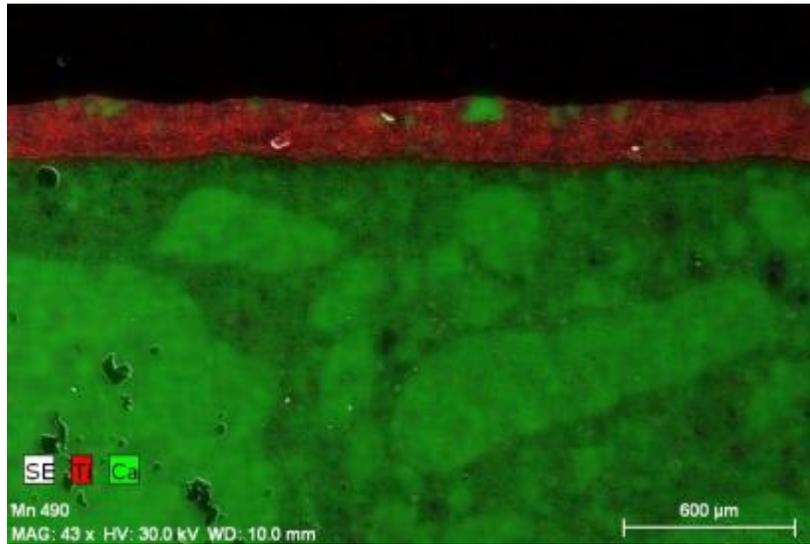
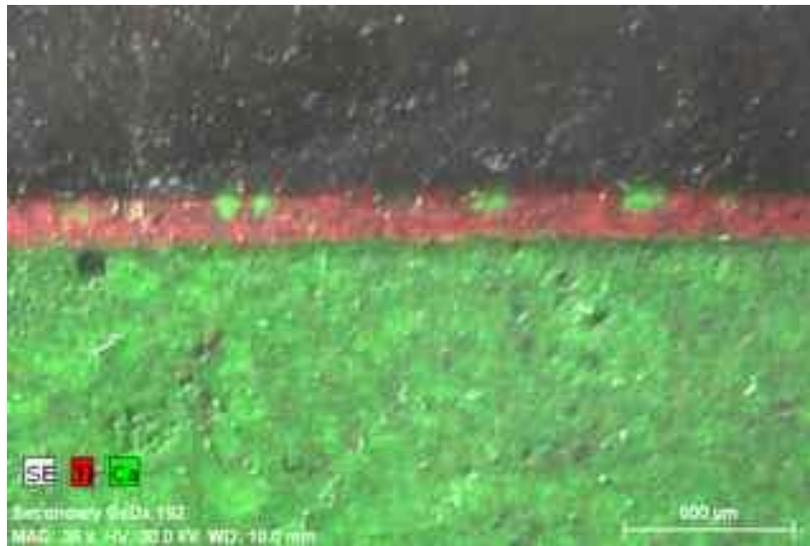
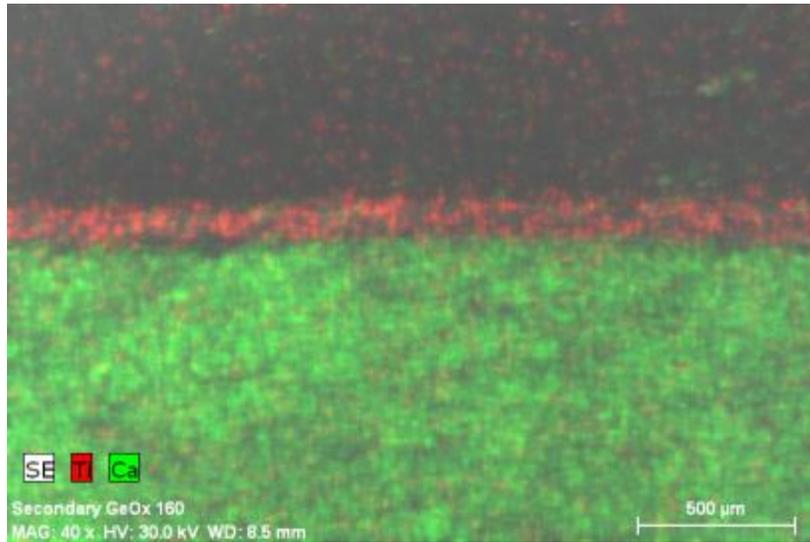
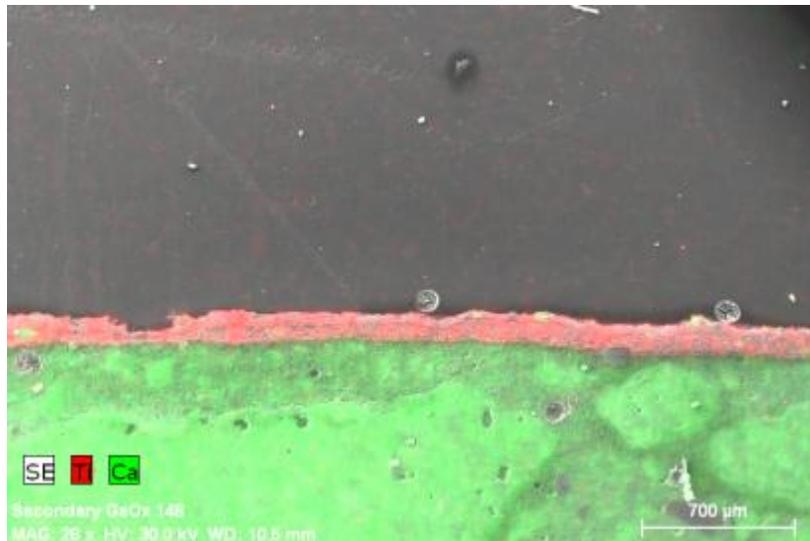
Figure 4.10: SEM Images of Keim Cross Section (a) Before Exposure (b) After Exposure in Houston (c) After Exposure in Austin and (d) After Exposure at the Lab Site

Figure 4.10 shows cross sections of the Keim Soldalit-ME coated sections. The painted coating appears as a thick layer of titanium. The layer does not appear to change decrease in any of the samples taken after exposure. Therefore, KEIM Soldalit-ME paint is durable under one year outdoor exposure.

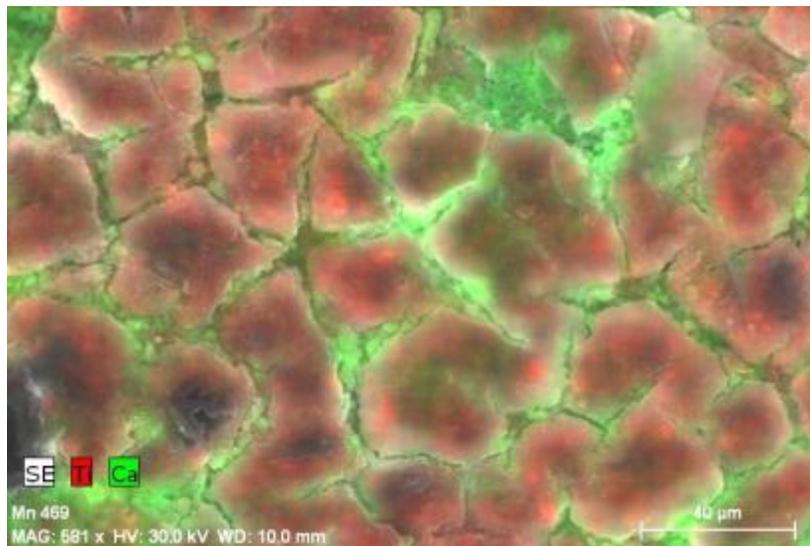
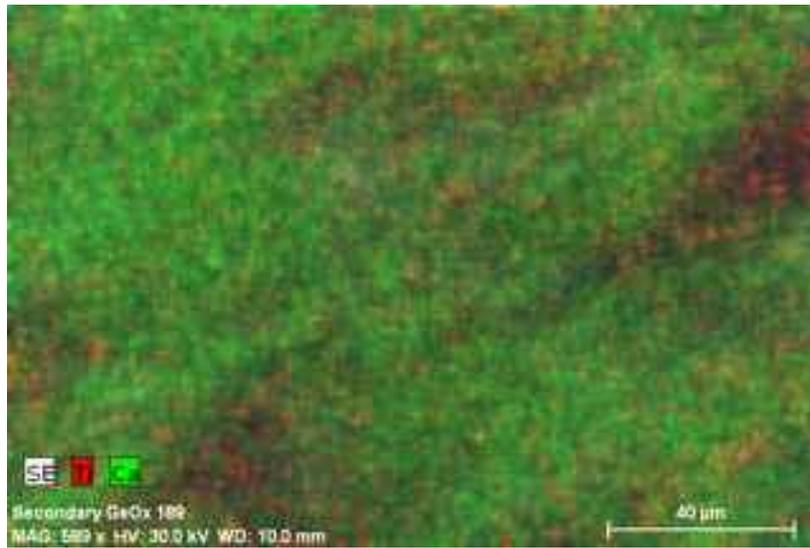
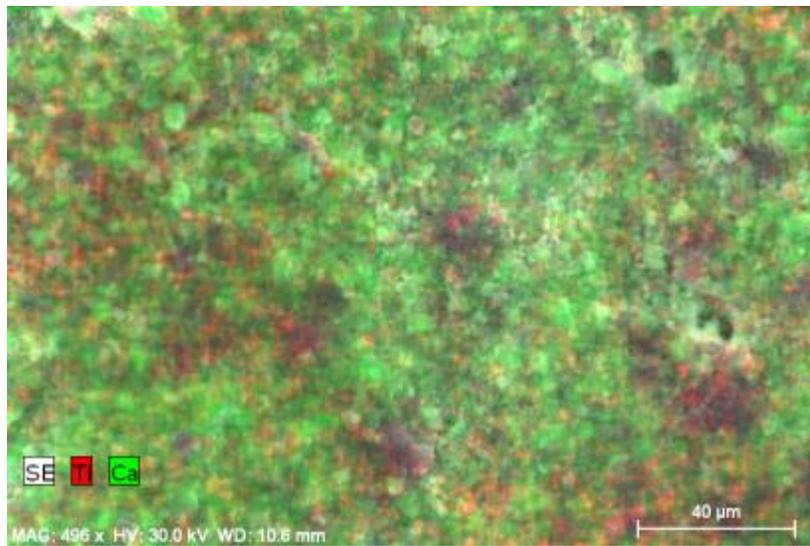
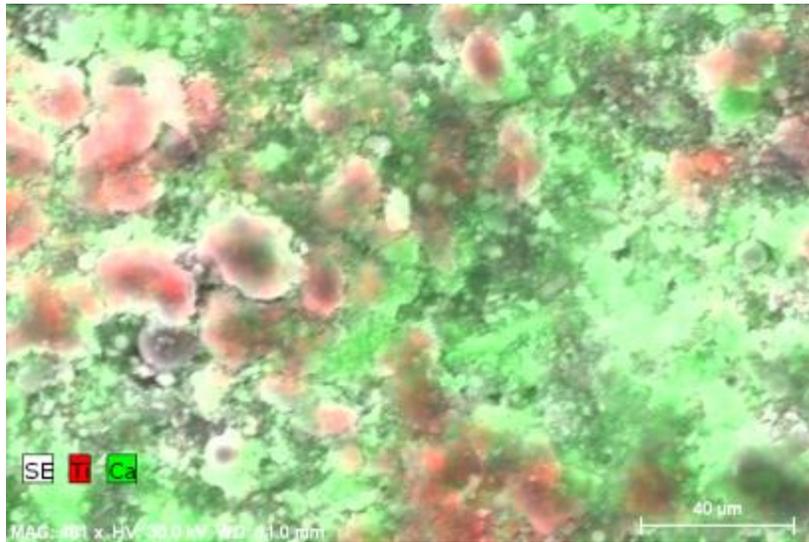
Figure 4.11: SEM Images of Pureti Surface (a) Before Exposure (b) After Exposure in Houston (c) After Exposure in Austin and (d) After Exposure at the Lab Site

toweled in a thick layer. Since the coating is not intended to saturate the entire surface, it is expected that some calcium is present on the surface of the coated section. Drying of the coating may have caused the surface pattern that is shown in Figure 4.11a. The cracks that appear in the image may have formed during this drying process. From the additional images, it is not evident whether Pureti degrades during exposure, although in some cases the patterns or amount of titanium on the surface appear to decrease.

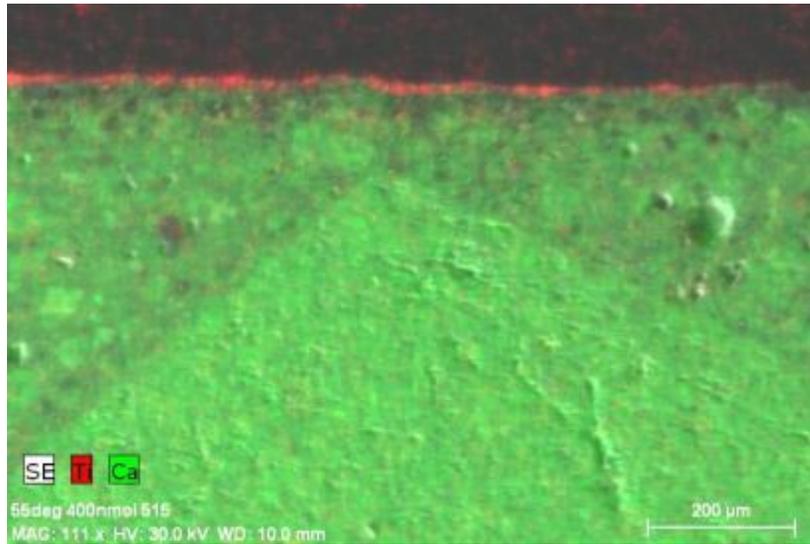
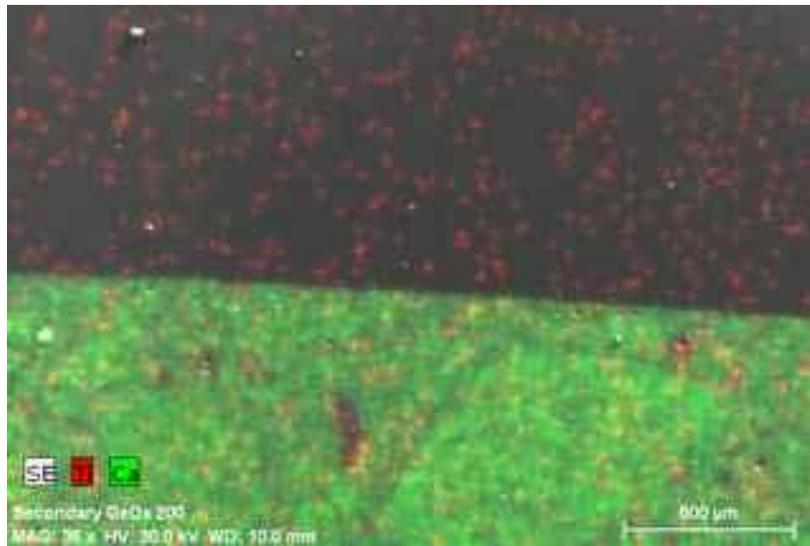
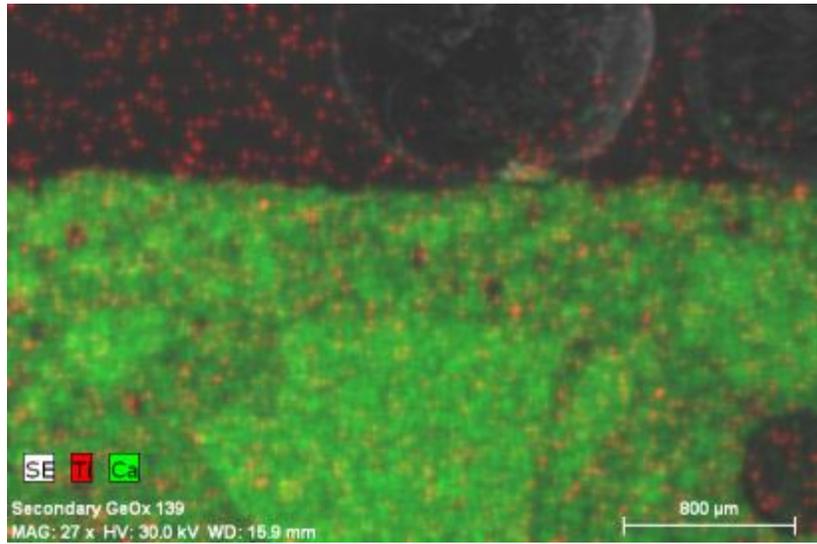
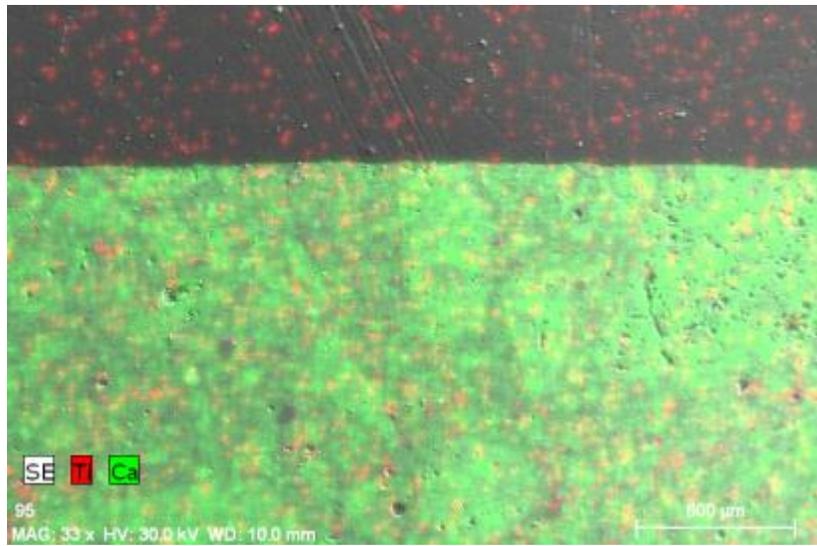
Figure 4.12: SEM Images of Pureti Cross Section (a) Before Exposure (b) After Exposure in Houston (c) After Exposure in Austin and (d) After Exposure at the Lab Site

Figure 4.12 shows cross-sections of the Pureti Clean coated sections. As expected, there is a thin layer of titanium present on the surface of the material where the coating was applied before the exposure period. However, it appears that the thin layer is diminished for all field sites after one year of exposure. Based on these data alone, it is possible that titanium dioxide contained in Pureti Clean is diminished due to outdoor exposure, although direct environmental testing of the coated specimens is necessary to confirm this result.

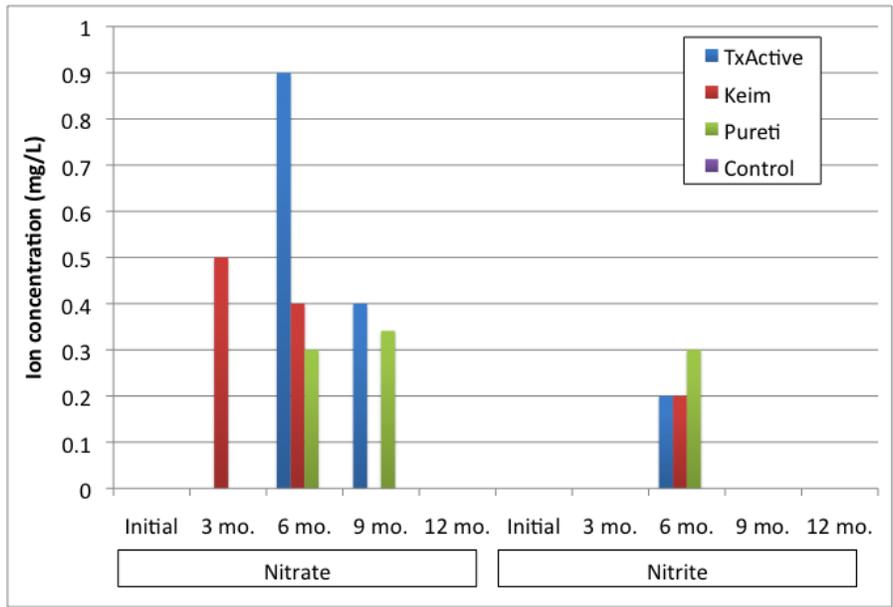
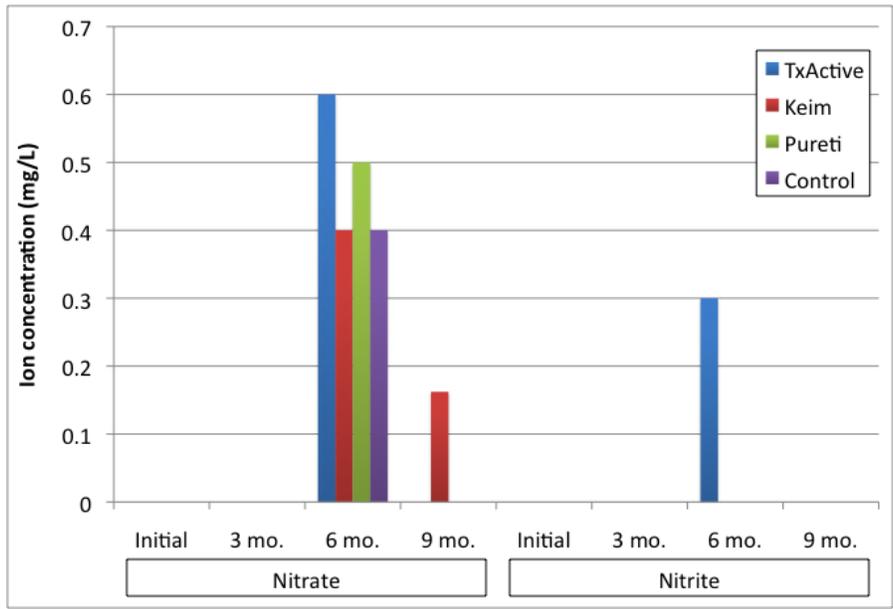
Figure 4.13 shows the ion chromatography results for the barrier and slab specimens that were placed at the Houston field site. The highest concentrations for the barrier were for the TxActive section at 6 months, which occurred after a period of 2 days from the last rainfall. The concentrations of these ions may indicate that this coating is removing pollutants successfully. The Pureti and Keim specimens show moderate concentrations of ions. The highest concentration for the slab specimen is again the TxActive specimen, with Pureti and Keim showing moderate ion concentrations.

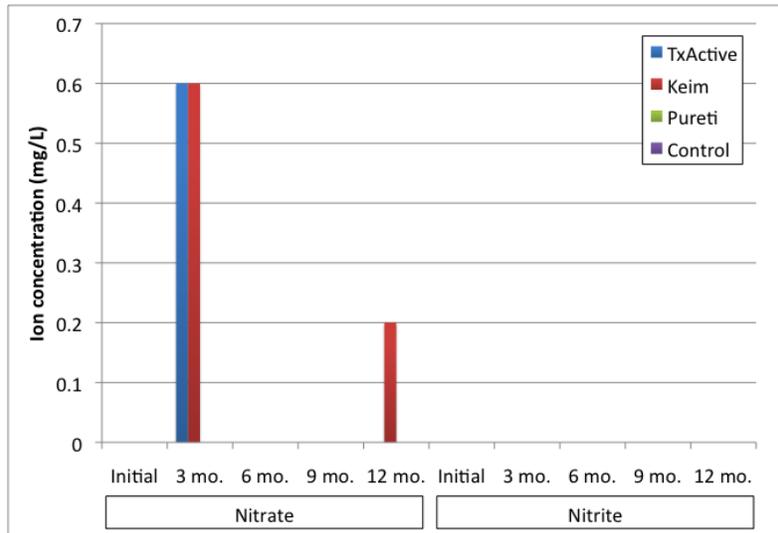
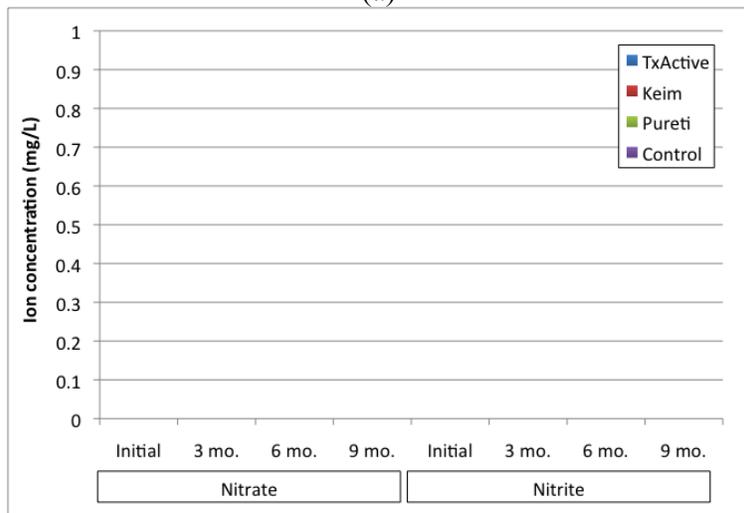
Figure 4.14 shows the ion chromatography results for the Austin slab and barrier specimens. Only the TxActive and Keim barrier sections show measurable ion concentrations for either specimen. This could be related to inadequate rainfall prior to sample collection.

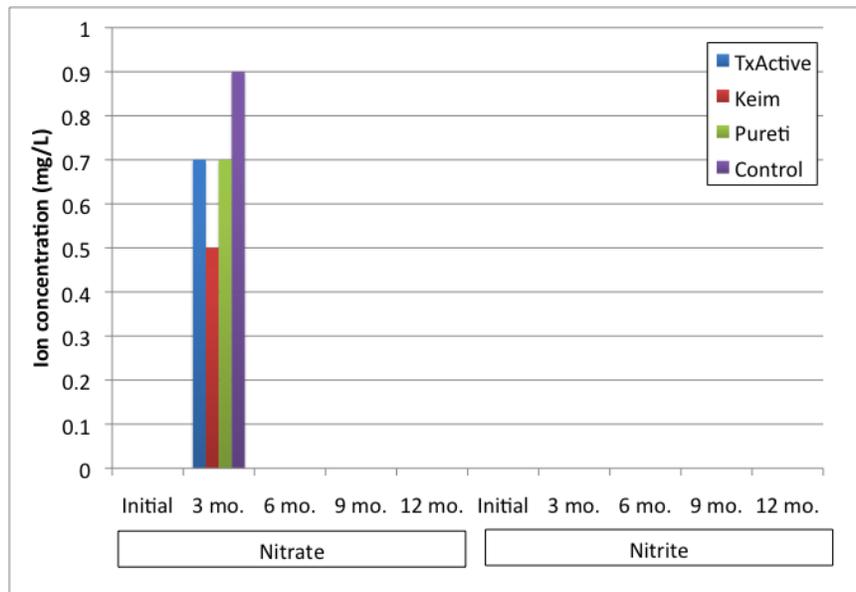
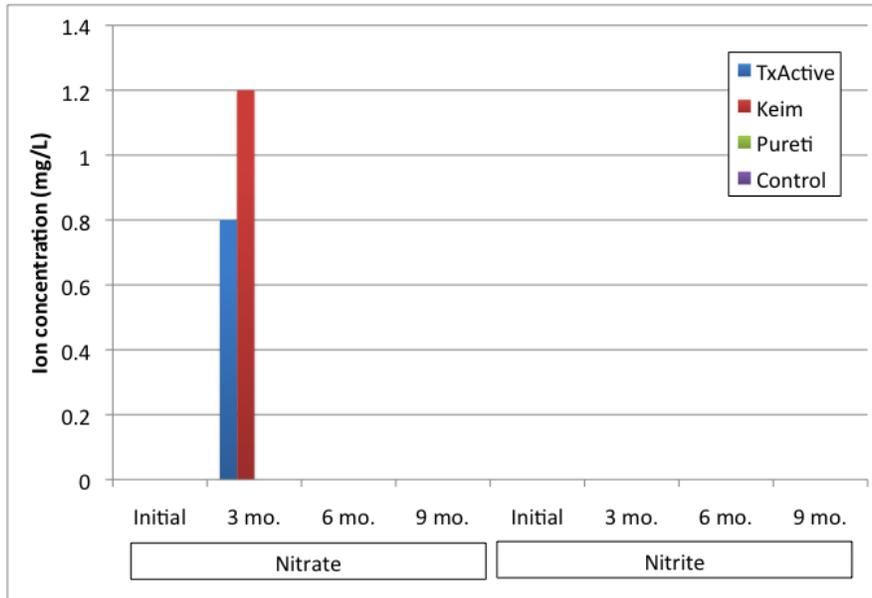
Figure 4.15: Nitrate and Nitrite Concentrations for Lab (a) Barrier Specimen and (b) Slab Specimen Wash Water

Figure 4.15 shows ion chromatography results for barrier and slab specimens for the Lab field site. For the barrier, all coatings including the control show detectable ion concentrations for the 3-month reading. That the control specimen shows measurable ion concentrations could be the result of human error or contamination from other washes. For the slab specimens, only the Keim and TxActive specimens showed measurable ion concentrations. Again, the absence of ions could be due to insignificant number of days between rainfall or another source of error.

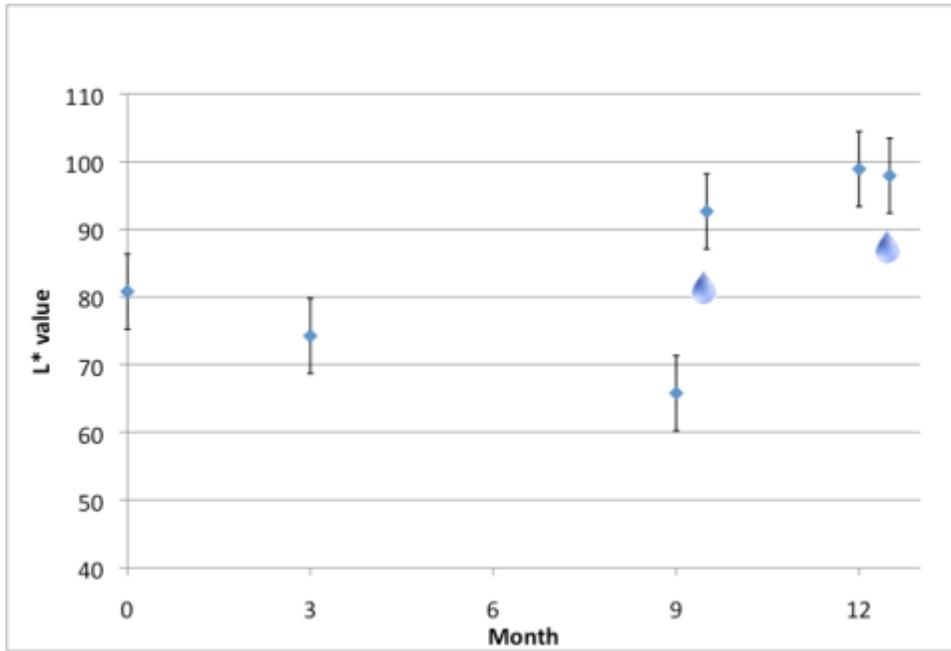
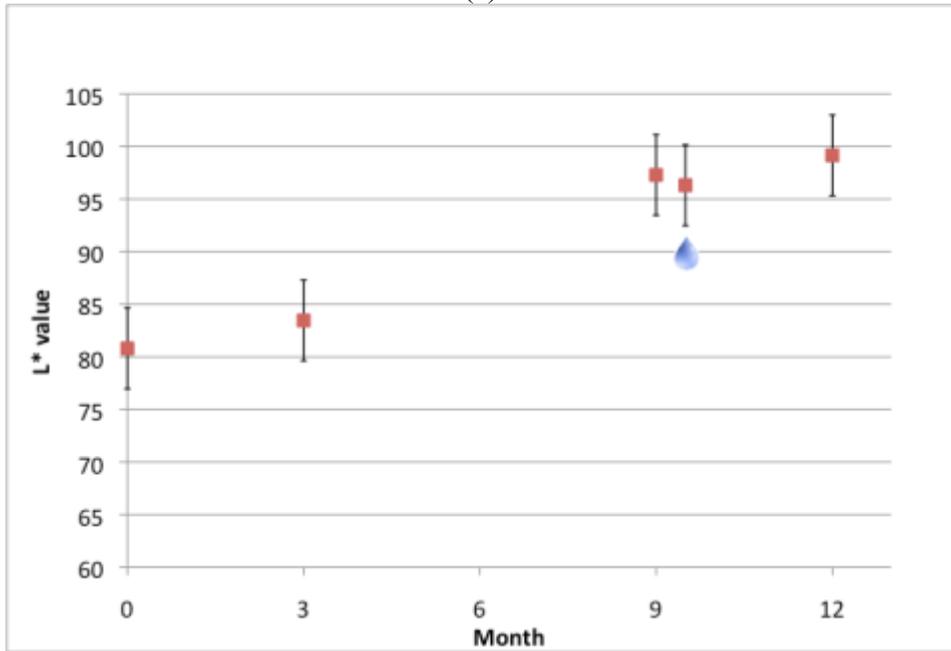
Figure 4.16 shows the spectrophotometer data for the TxActive barrier and slab specimens located at the Houston field site. The data presented here are the average of 10 L* readings for the sample. No data were available for the 6-month interval for the Houston site due to a computer malfunction.

The data in Figure 4.16 show that although the L* reading of the specimen decreased slightly over time, this brightness was restored after washing. The coated stucco is highly variable with both bright white spots and dark, shadowed areas. This variability in color may have had an effect on L* readings recorded for these specimens. Figure 4.17 shows the spectrophotometer data for the Austin TxActive barrier and slab specimens.

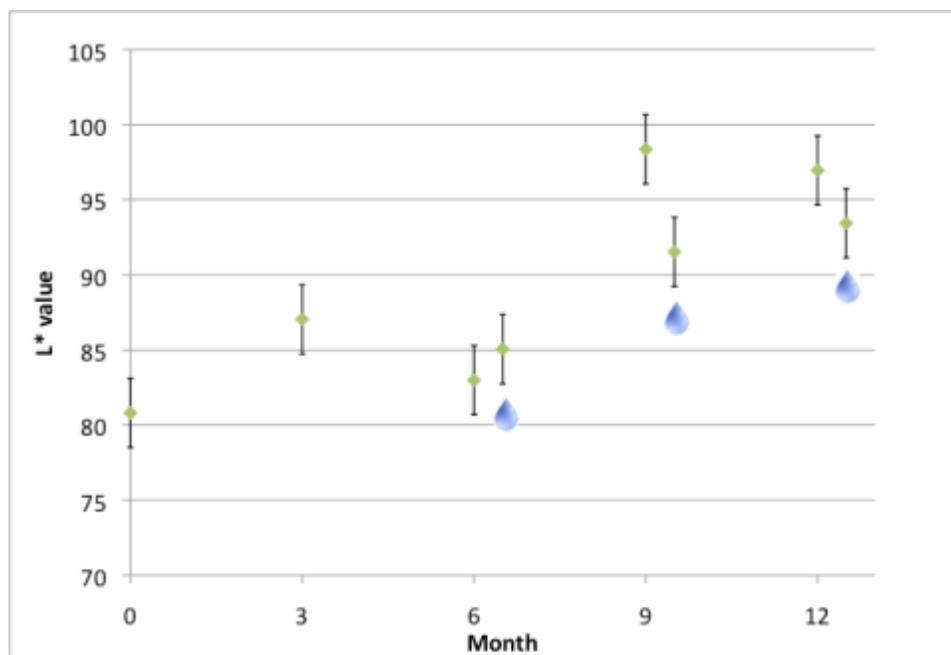
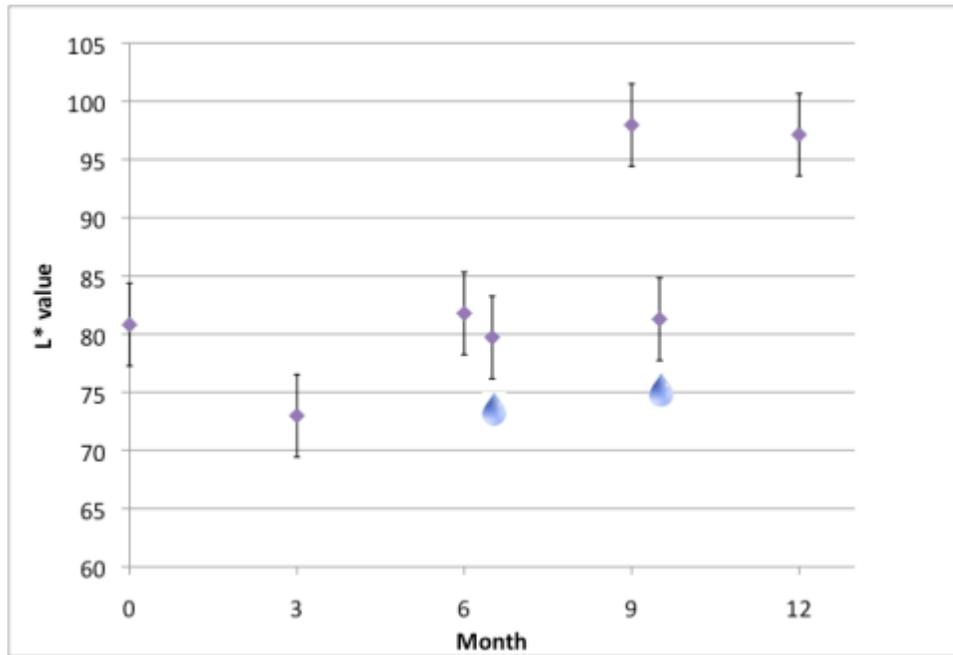
Figure 4.17: Average L* Readings for Austin TxActive (a) Barrier Specimen and (b) Slab Specimen

Figure 4.17 shows that brightness was restored after washing during the outdoor exposure period. Although the samples lost brightness during period of low rain levels, the brightness was restored ultimately through washing. Figure 4.18 shows average L* readings for the TxActive barrier and slab specimens located at the Lab site.

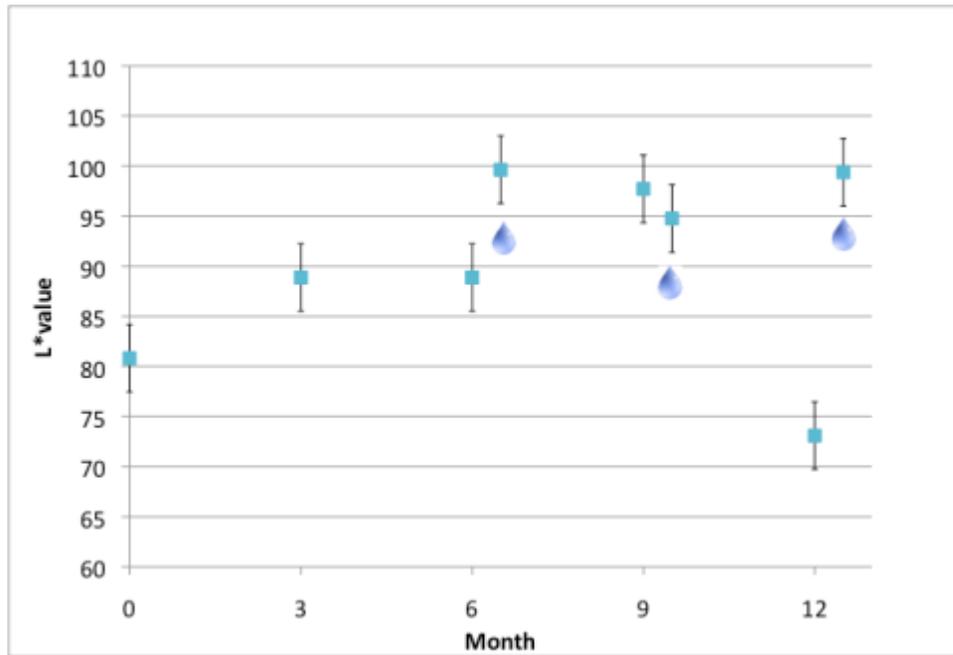
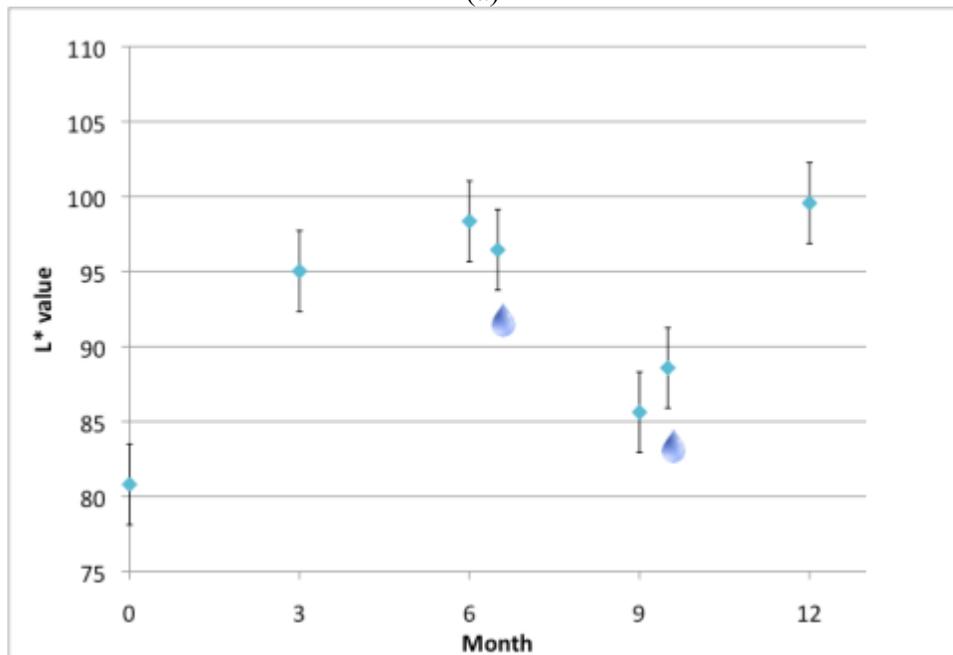
Figure 4.18 shows that final L* readings for both the barrier and slab specimens were higher than initial readings, indicating that brightness was not lost over time while the specimens were exposed outdoors. Figure 4.19 shows average L* readings for the Keim-coated barrier and slab specimens located in Houston.

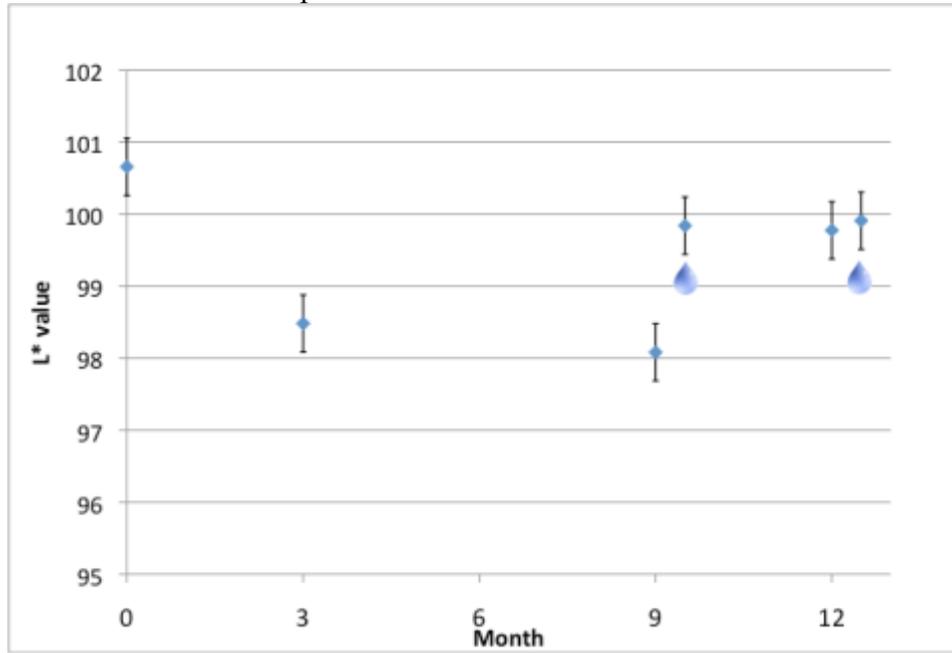
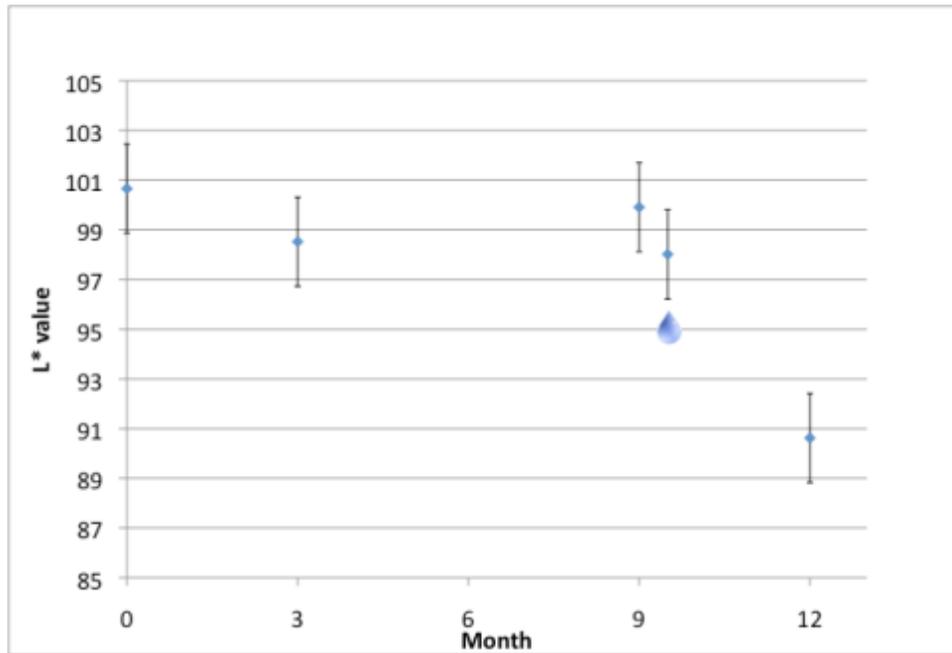
Figure 4.19: Average L* Readings for Houston Keim (a) Barrier Specimen and (b) Slab Specimen

For the Keim specimen, there is a slight decrease in brightness for the barrier specimen, although the final reading is within the error range of the initial reading. The final reading for the slab specimen is significantly lower than the initial reading, to the point of being outside the margin of error of the initial reading, indicating that the specimen did collect surface contaminants which darkened the specimen. From these data, it can be concluded that photocatalytic activity may be decreased due to the accumulation of these contaminants. Figure 4.20 shows average L* readings for the Keim barrier and slab specimens located at the Austin field site.

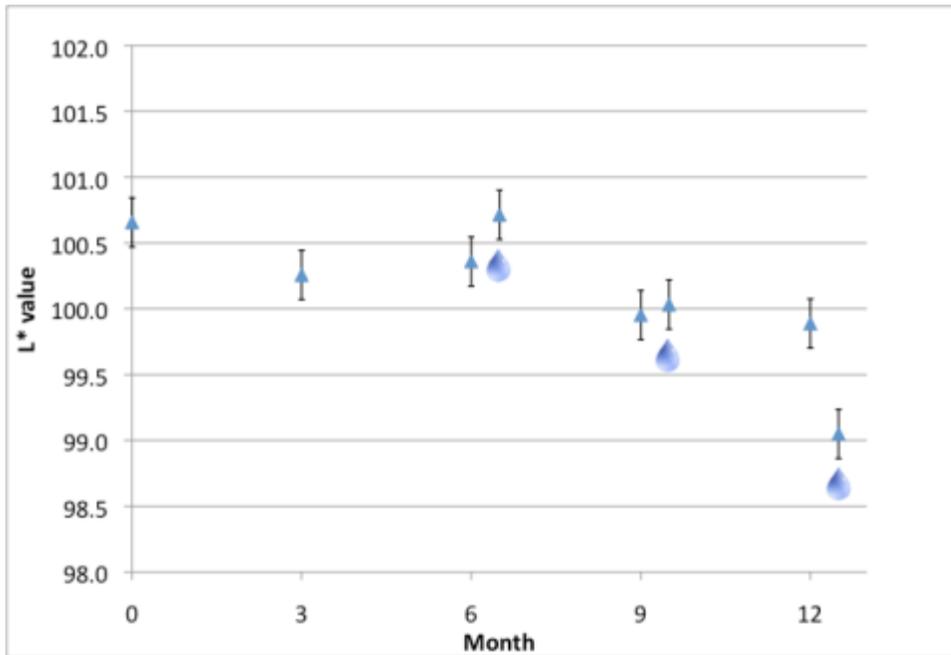
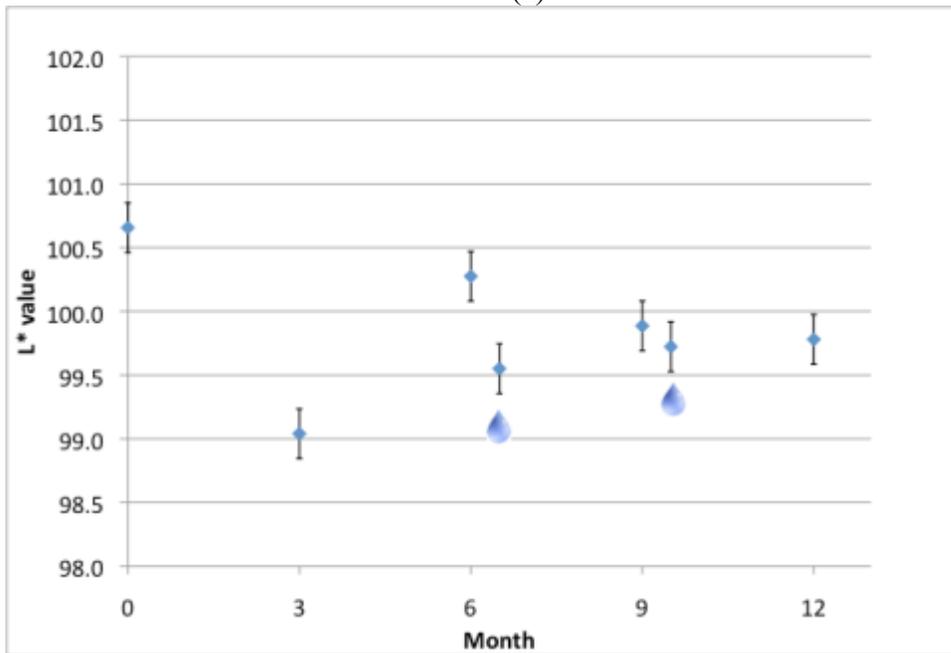
For the Austin field site, both the Keim-coated barrier and slab specimens showed decreased L* readings for the final site visit. These decreases were outside the margin of error for both cases. This indicates that significant contaminants had accumulated on the surface, reducing the brightness of the white Keim coating. Figure 4.21 shows the L* readings over the one year exposure period for the Keim-coated barrier and slab specimens placed at the Lab site.

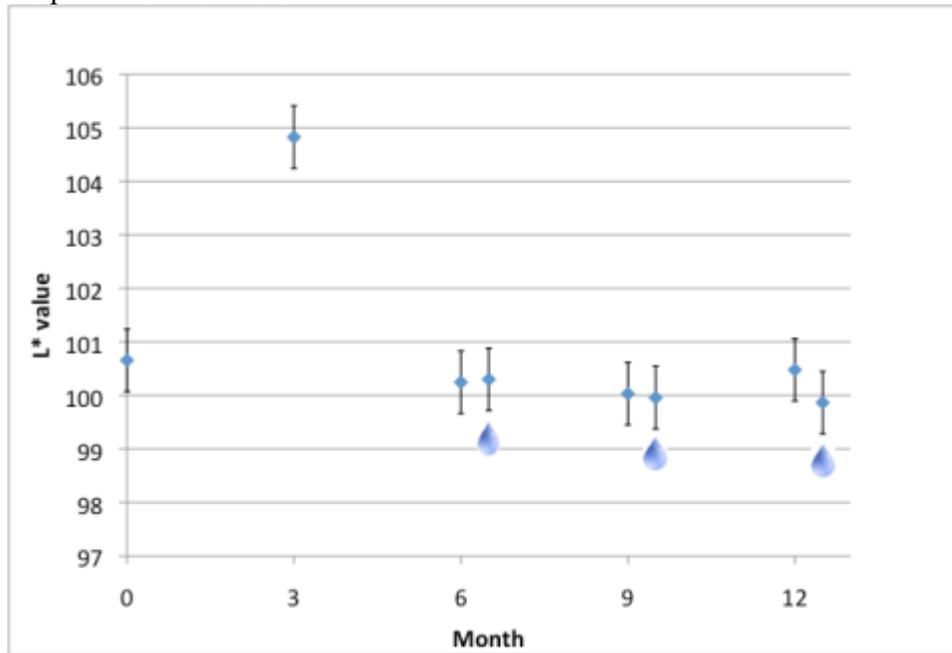
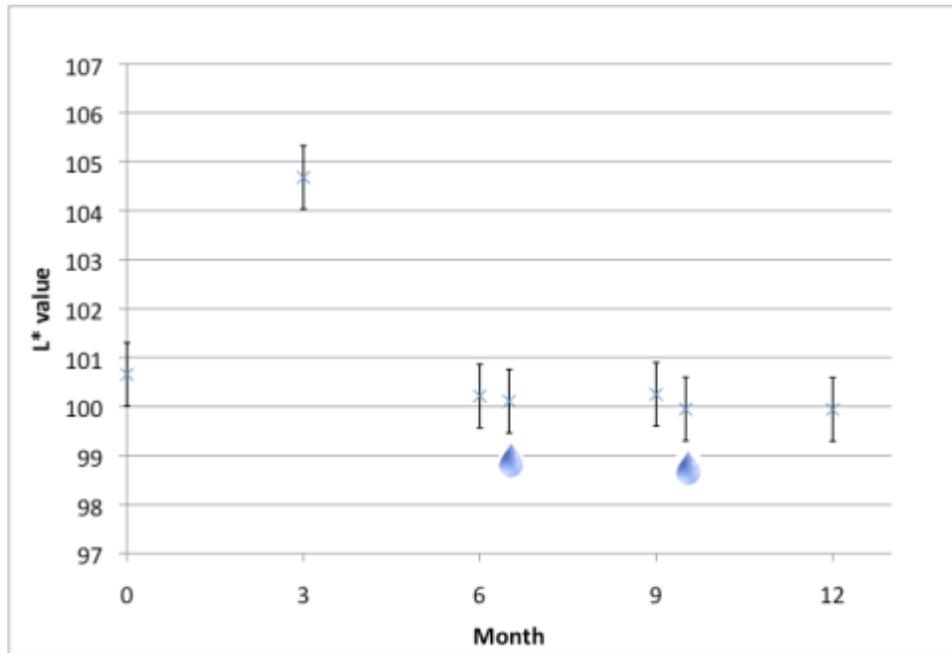
Figure 4.21: Average L* Readings for Lab Keim (a) Barrier Specimen and (b) Slab Specimen
