ARCHITECTURAL SURVEY

SITES IN CAMPECHE

1988 FIELD SEASON

GEORGE F. ANDREWS

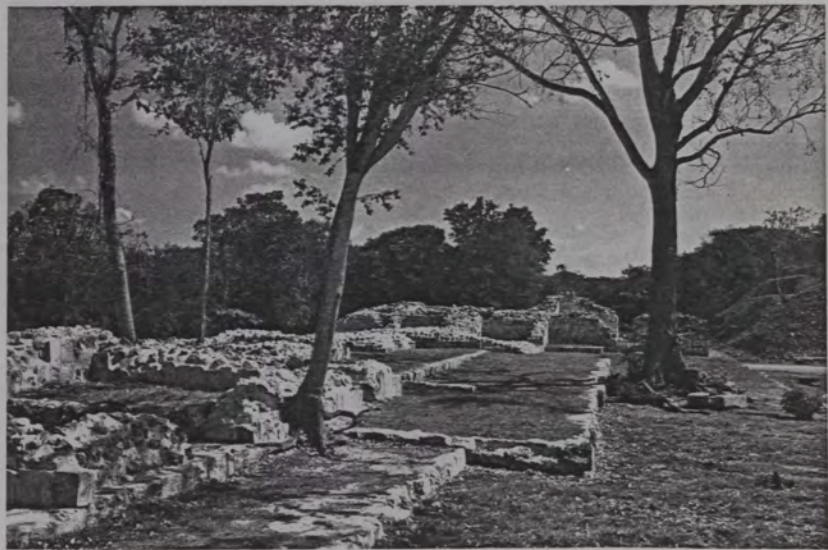
EDZNA, COMPLEX VI (Los Cuchillos). South side of platform.

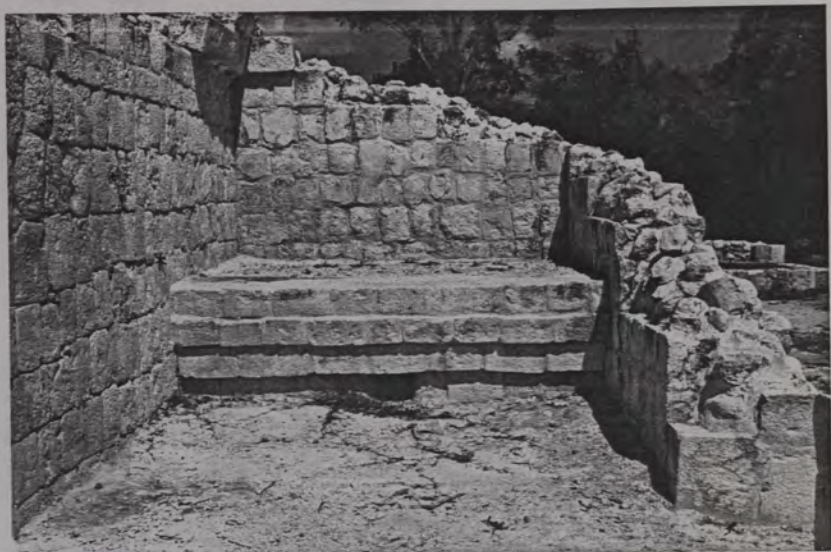
EDZNA, COMPLEX VI. Detail of bench in Structure U8-13.

Platforms: Large bench in north end of room - .70 m. high, 1.85 m. deep. 3-member molding at top with projecting central member. Overall height 3 members is .50 m. Central member is .14 m. high. Niche in lower portion of face of bench; overall width .63 m., depth .44 m. Partly rounded colonnettes both sides with .24 m. opening in center.

OBSERVATIONS: Large bench in north end of room is reminiscent of large benches seen in many Rio Bec buildings.

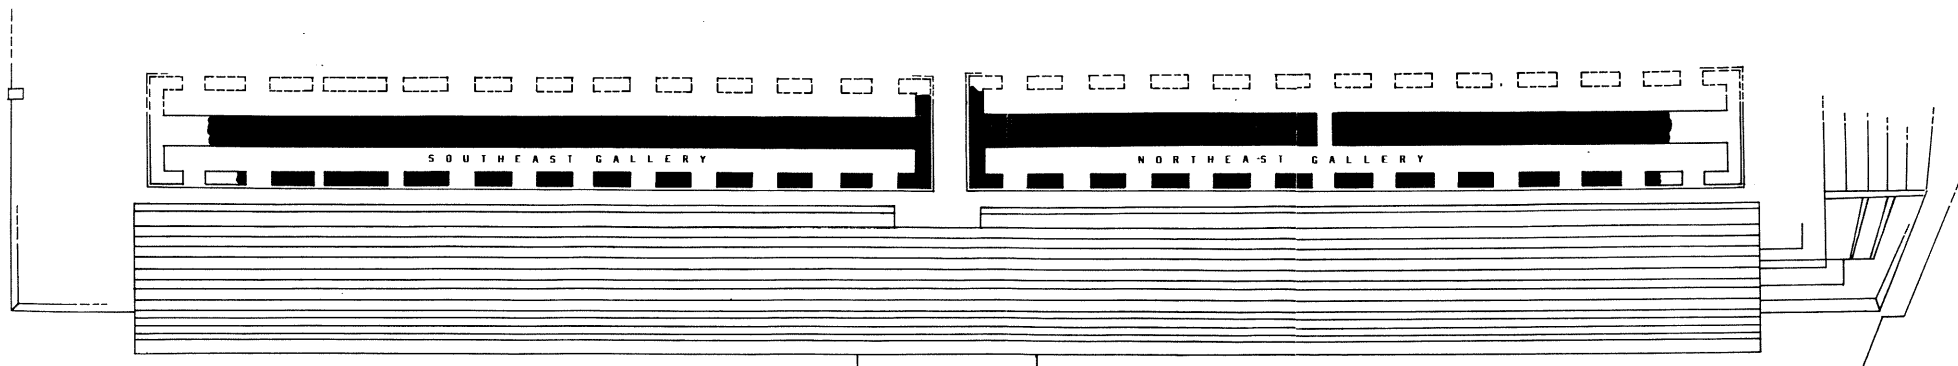
EDZNA
Structure UB-3 (Naholna)
Plan
G.F. Andrews, 1988

The superstructure of U8-3 consists of two long gallery-type buildings, separated by a narrow passageway running east-west (see plan). Each of these buildings has two parallel galleries running north-south, separated by a thick medial wall, with doorways opening to both the east and west. Only small portions of the western galleries have been excavated but the eastern galleries have been cleared of debris and the remaining portions of walls and piers consolidated. There are no openings in the dividing wall between the east and west galleries of the south wing but a narrow passageway in the dividing wall of the north wing does provide direct access from the eastern gallery to the western gallery. The eastern galleries of both wings have 12 doorways, with wide piers between, opening toward the great Plaza and from what can presently be seen, the western galleries had a similar number of doorways.

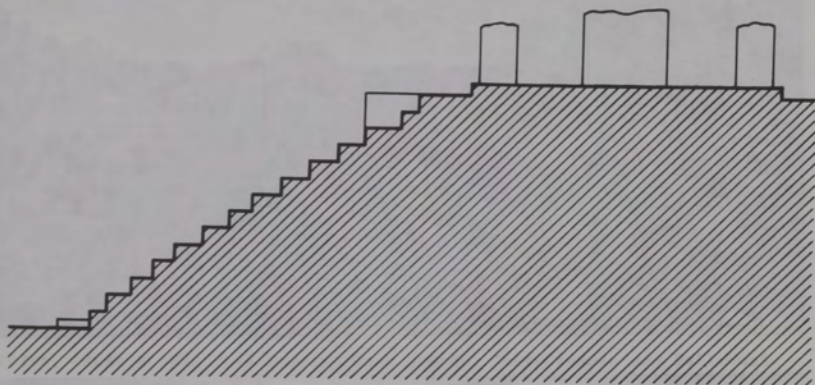
EDZNA
Structure U8-3 (Naholna)
Section - looking South
G.F. Andrews, 1988

The substructure of Structure U8-3, which measures about 128.5 m. in length overall, appears to have had stepped sides although most of its outer surfaces have been stripped off and its profile is uncertain. The north end of the platform is particularly confusing since the recent excavations have revealed a number of angular walls whose larger form is not clear (see plan). Most of the east side of the platform is taken up with a monumental stairway, about 113 m. long, which has 13 treads; at the plaza level, and roughly centered, is an additional projecting step about 12.5 m. wide and .86 m. deep. At the top of the main platform, directly in front of the central passageway between the two superstructures, is a projecting platform about 6.0 m. wide. This secondary platform might be interpreted as a kind of "speaker's platform" or "stage", providing a prominent position for anyone wishing to address a crowd gathered in the Great Plaza below.

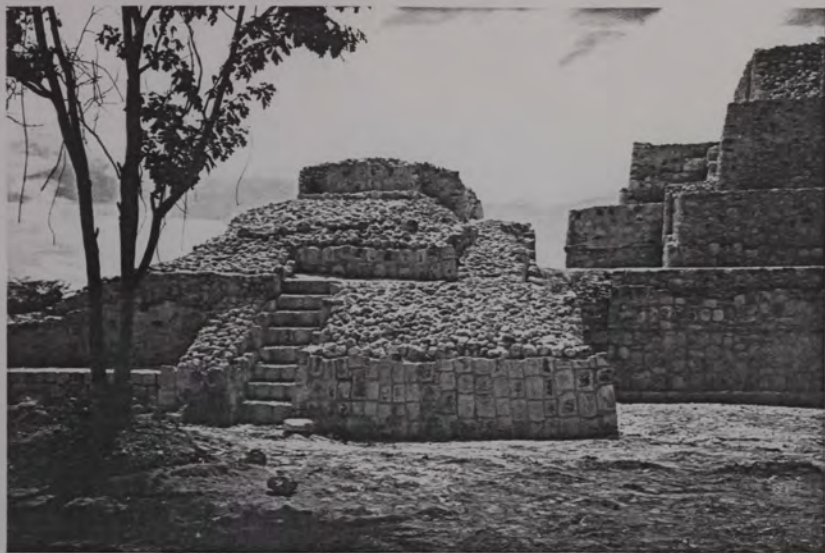
EDZNA, Ballcourt and South temple. Stairway at north end of Ballcourt.

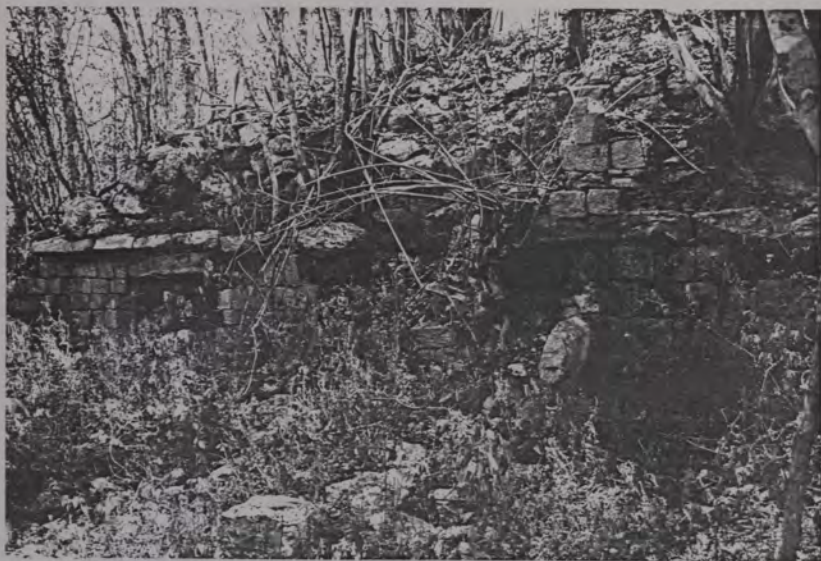
KANKI, MAIN GROUP, South Building. Portion of north facade.

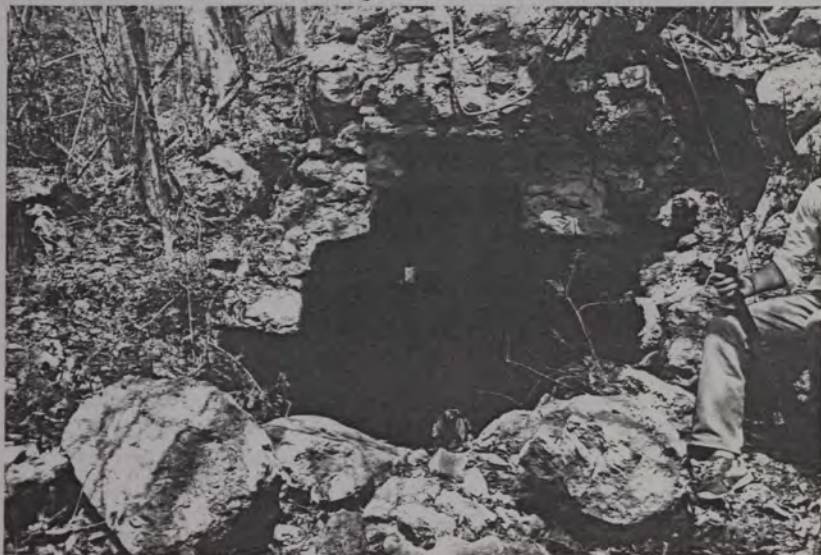
KANKI, MAIN GROUP, South Building. Detail of stepped vault, Room 1.

ARCHITECTURAL STYLE: Uncertain. Facades on both levels differ from those seen on typical Puuc buildings of any style, early or late. Vaults show classic Puuc forms and stonework but doorways with round columns are found in both Early Puuc and Classic Puuc structures. Moldings do not conform to any particular style although they differ considerably from those of the earlier styles. More data required to make an accurate classification.

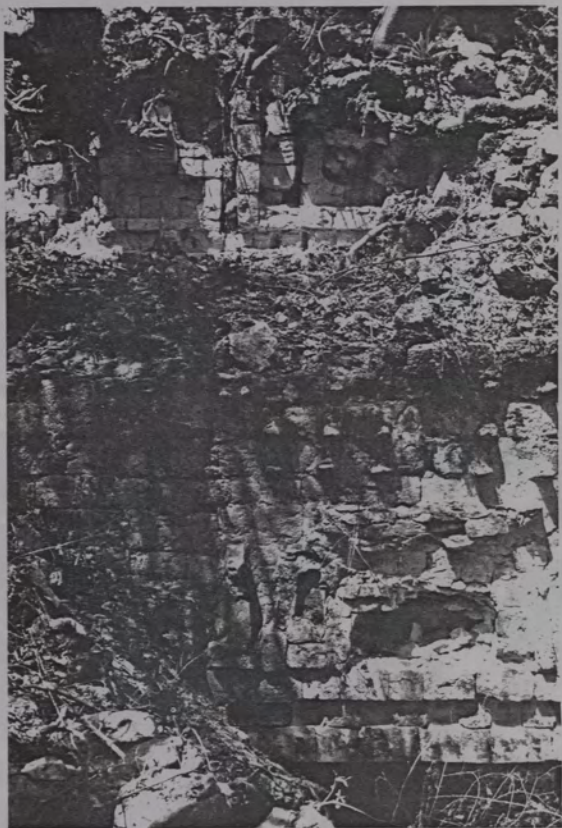
KANKI, Structure 2. Exposed portion of lower and upper facades.

OBSERVATIONS: I believe that the rooms and facades described above were recently exposed by looters.

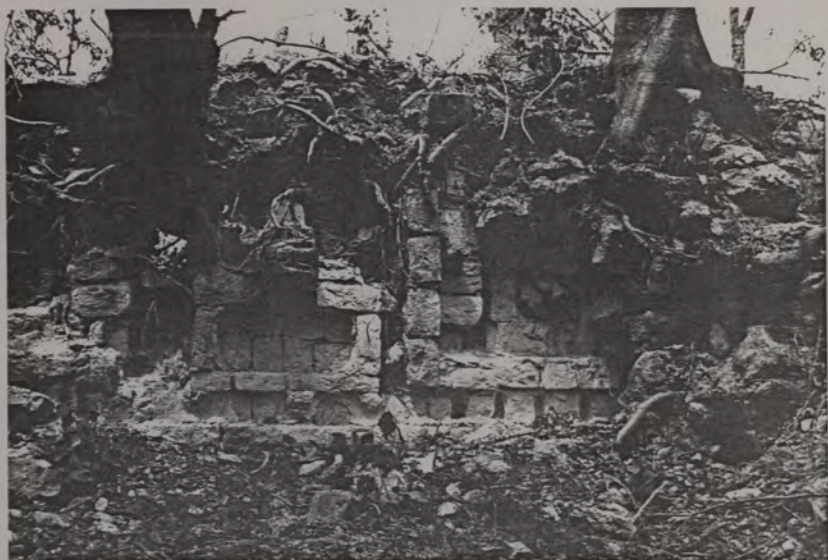
KANKI, Structure 2. Detail of upper facade.

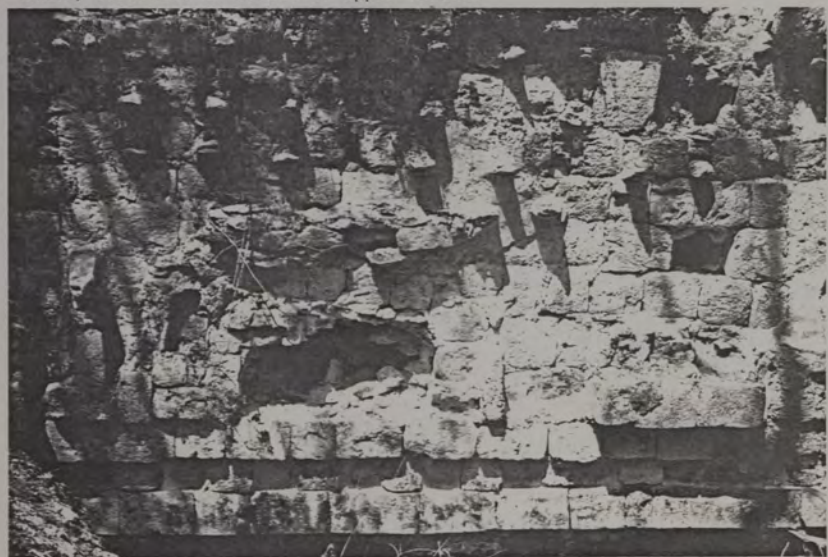
KANKI, Structure 2. Detail of lower facade.

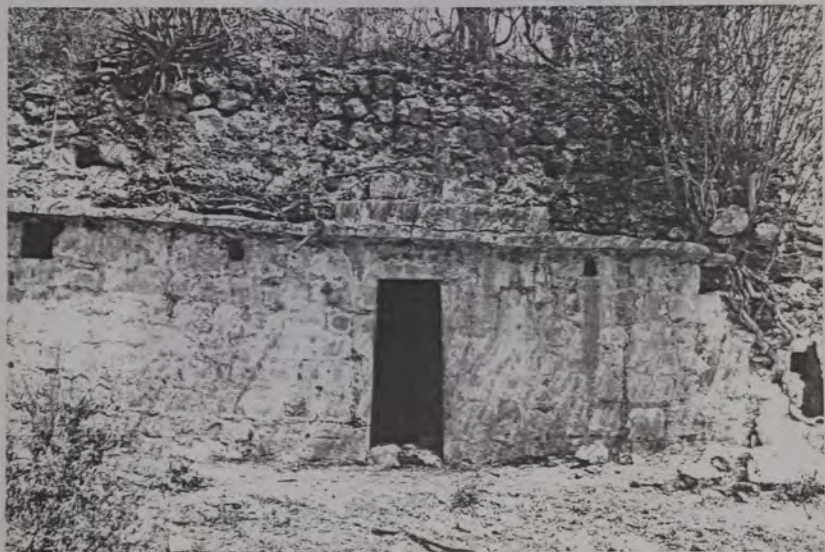
XUELEN, Structure 1. Detail of south facade.

ARCHITECTURAL STYLE: Tentatively Proto-Puuc. This classification based on crude stonework, heavy medial molding, and seeming lack of base molding.

OBSERVATIONS: Construction and stonework rather crude throughout. Surfaces irregular as is edge of medial molding.

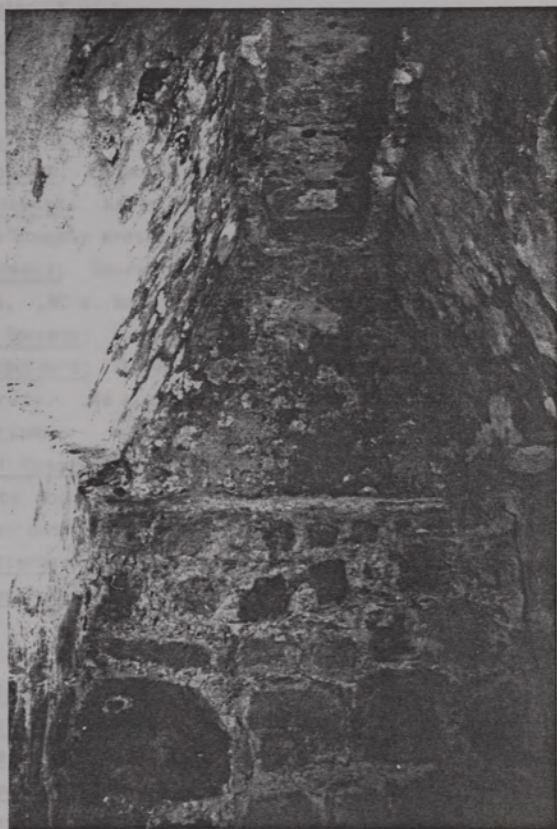
XUELEN, Structure 1. Detail of vault.

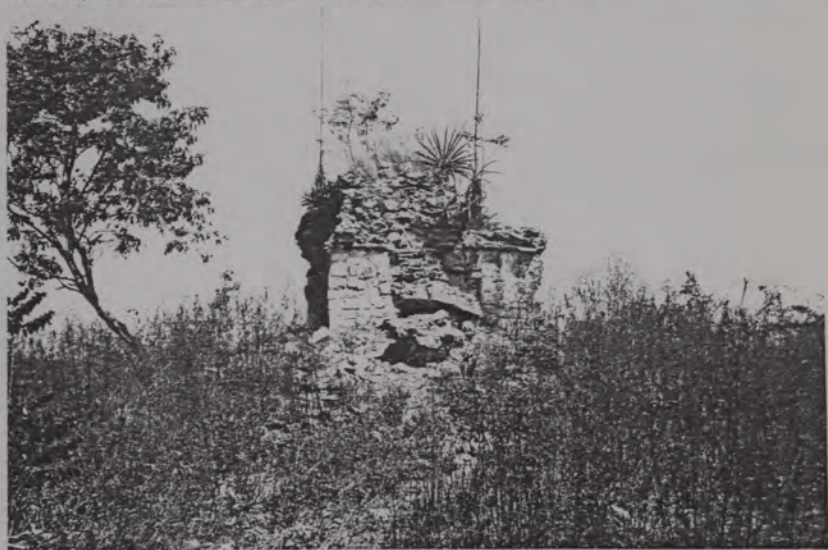
XUELEN, Structure 2. South side.

OBSERVATIONS: Structure 2 stands on a low platform about 1.5 m. high and is oriented at right angles to Structure 1.
