**Experimental Investigation of the Delamination Behavior of Curved  
Post-Tensioned Concrete Structures without Through-Thickness  
Reinforcement**

**Thesis**

**The University of Texas at Austin  
December 2016**

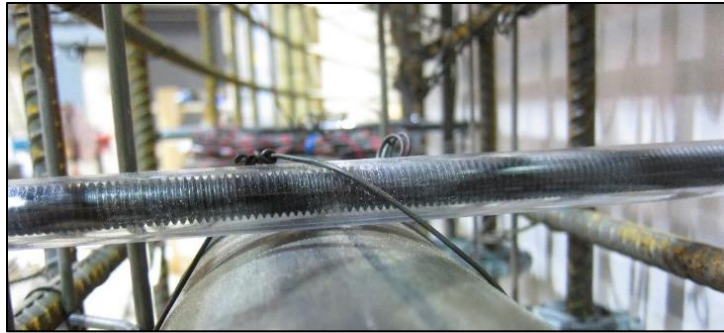
Figure 2-5: Threaded Rod Form Tie Inserted into Cellulose Tubing

7/16-in. diameter threaded rods were used as form ties for the wall sections to prevent bursting failure of the formwork from the large lateral pressures during the concrete casting. Since the curved wall specimens were intended to have no through-thickness reinforcement, the threaded rods were encased in clear cellulose tubes (outer diameter 0.625 in. and inner diameter 0.50 in.) so that they could be removed after casting and before testing, as seen in Figure 2-5. The tubes had good impact resistance in order to withstand the falling concrete during casting, but had poor tensile properties so they would not provide any form of through-thickness reinforcement for the curved wall specimens. 4x4 lumber was used as wales for the formwork, and holes were drilled in them for the form ties.

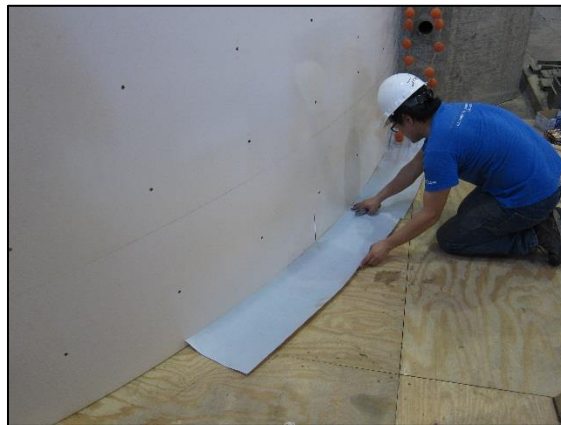
Figure 2-6: Placement of the Teflon Sheets

Prior to the assembly of the reinforcing bar cage for the curved wall section and the dead-end anchor block, two layers of Teflon sheet were placed on the wooden platform to create a frictionless surface for the test specimens to move on during testing, as shown in Figure 2-6. The bottom layer of Teflon sheet was epoxied to the wood platform so it would not move during the concrete casting and testing of the specimens.

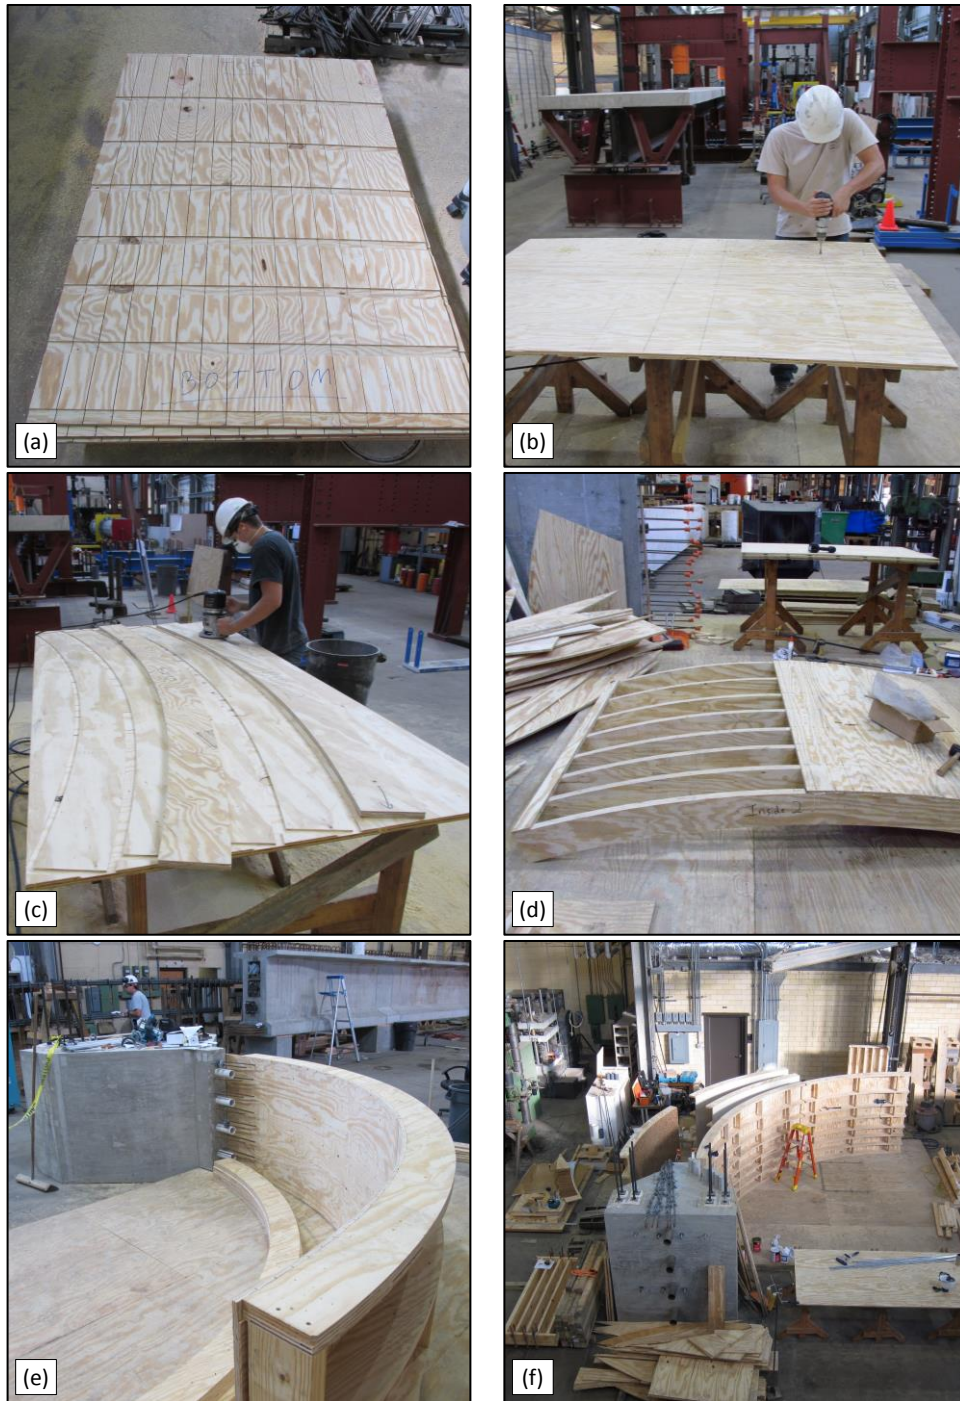
Figure A-7: Fabrication of Curved Wall Formwork Showing: (a) Kerfed Plywood Sheathing with Grooves for Studs, (b) Drilling Holes for Form Ties, (c) Making Curved Plywood Studs, (d) Assembling Formwork, (e) Finished Outside Face Formwork for Specimen 1 (f) Finished Formwork for Specimen 2

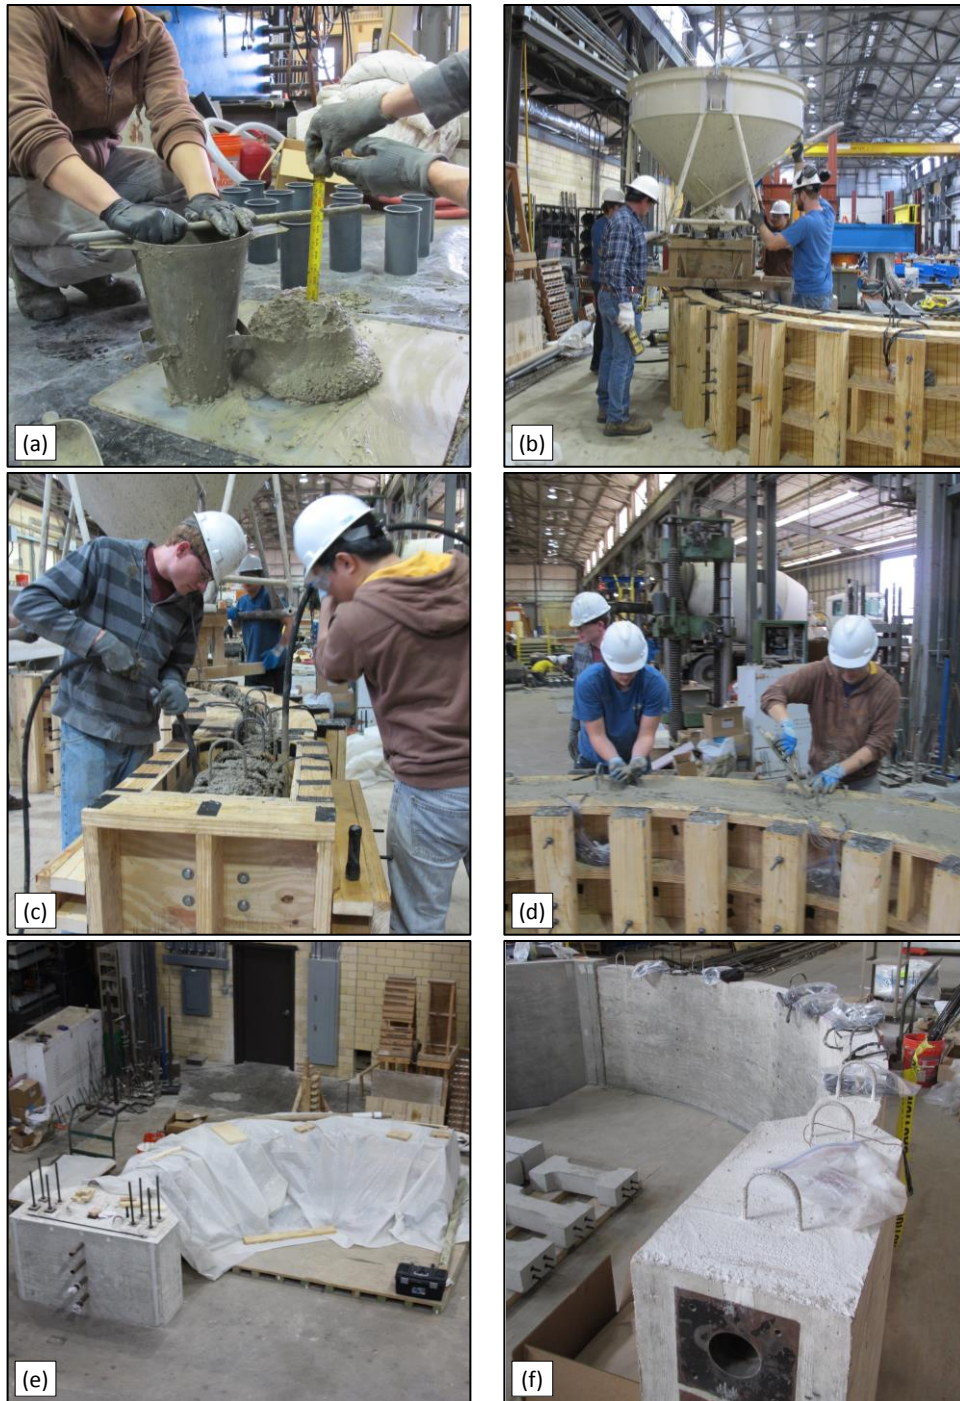
Figure A-10: Concrete Casting Operations for Specimen 1 Showing: (a) Slump Test, (b) Placement of Concrete, (c) Internal Vibrating, (d) Finishing of Surface, (e) Curing of Specimen, (f) Completed Specimen

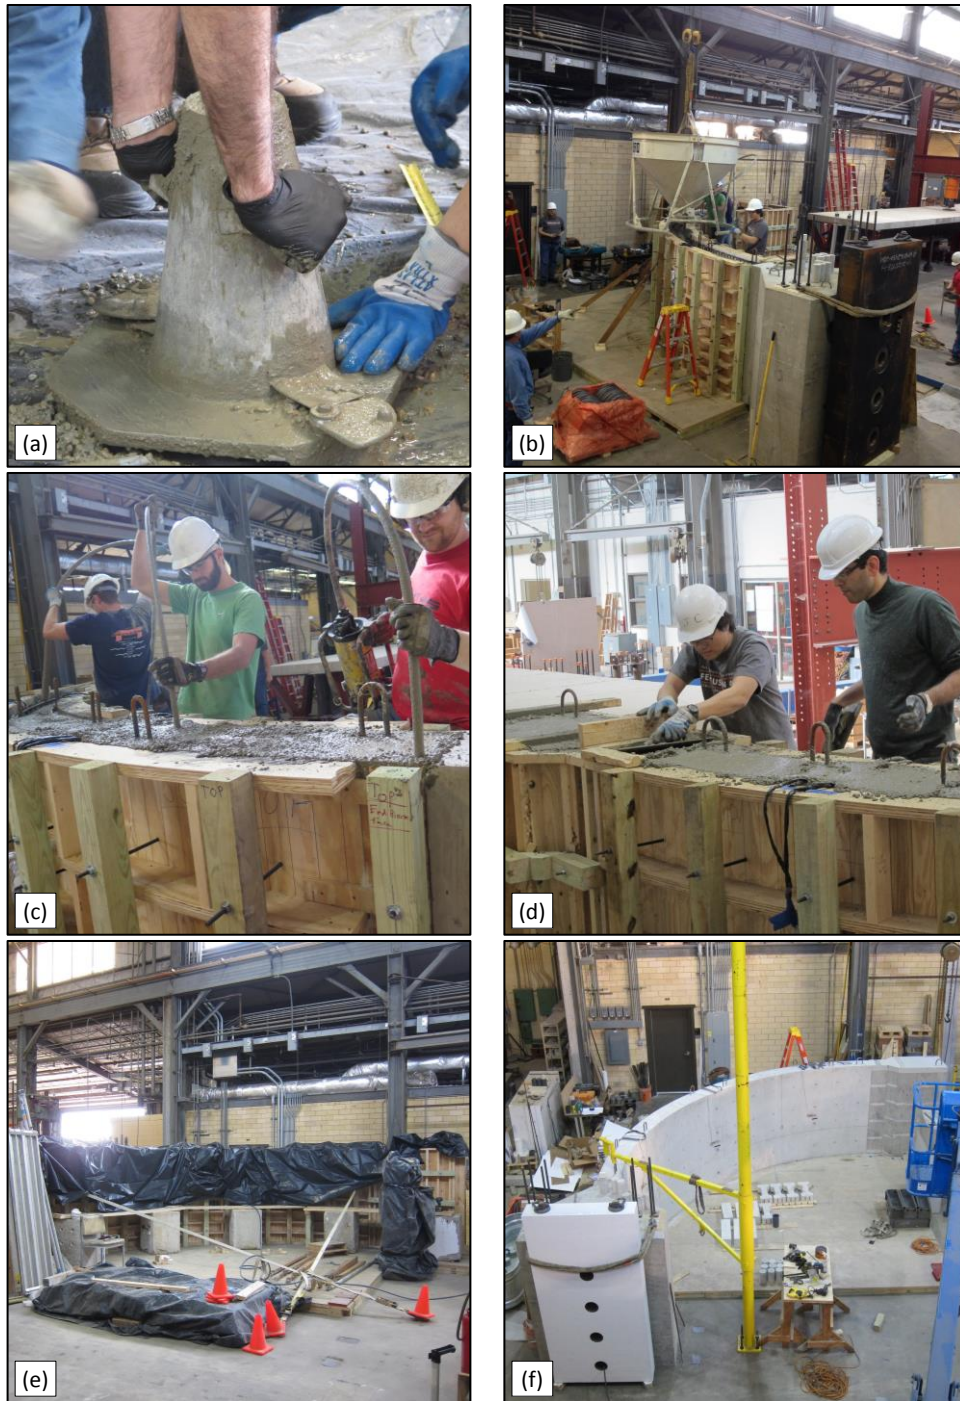
Figure A-11: Concrete Casting Operations for Specimen 2 Showing: (a) Slump Test, (b) Placement of Concrete, (c) Internal Vibrating, (d) Finishing of Surface, (e) Curing of Specimen, (f) Completed Specimen

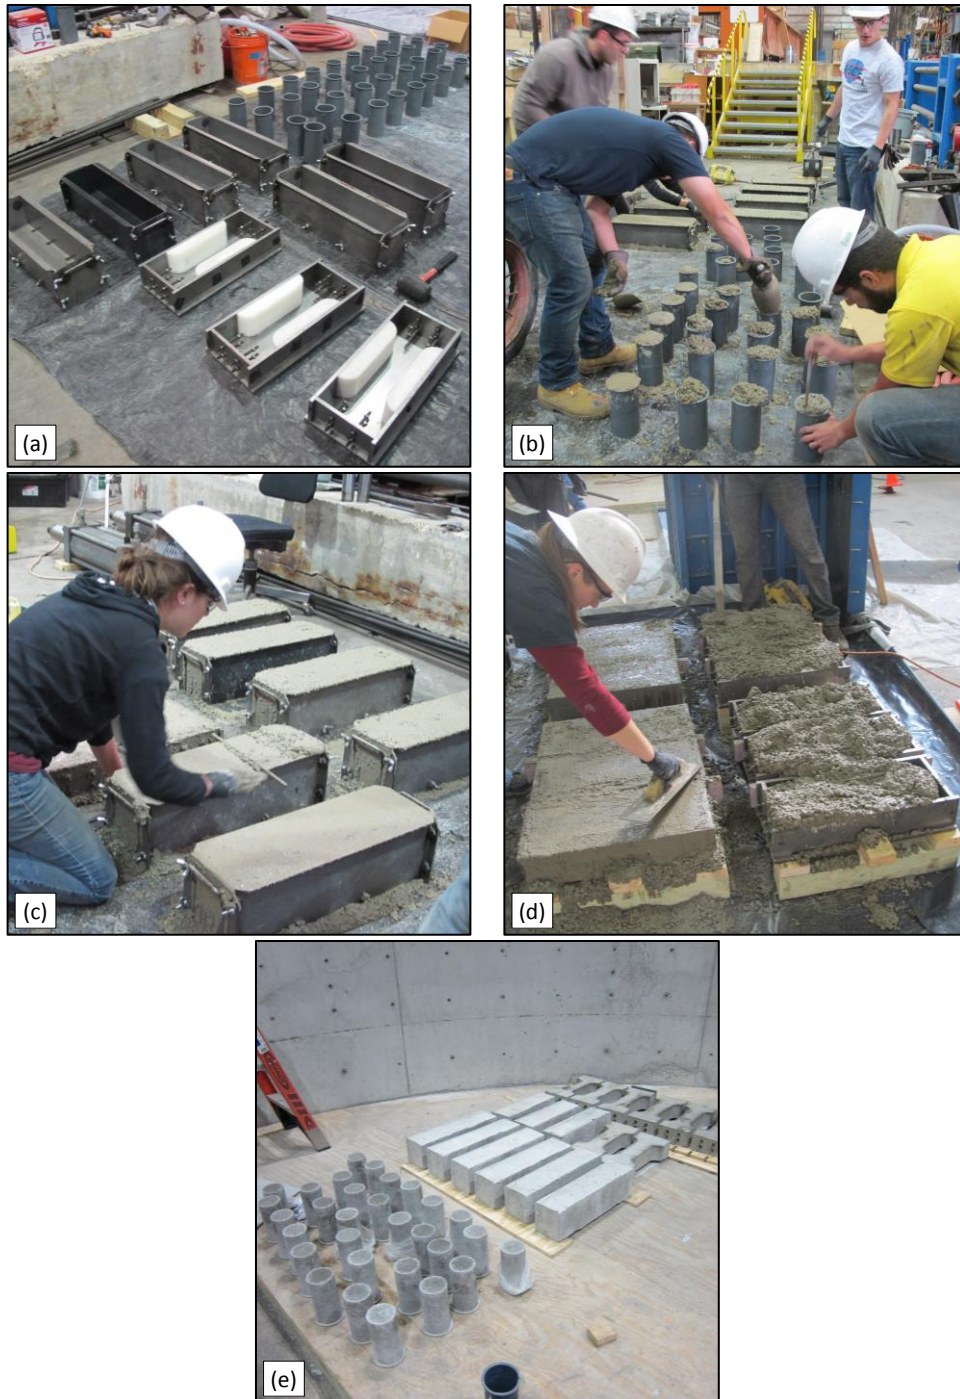
Figure A-12: Typical Concrete Casting Operations for Material Test Specimens Showing:  
 (a) Material Test Specimen Molds, (b) Cylinders, (c) Concrete Prisms, (d) Dog-Bone  
 Specimens, (e) De-Molded Material Test Specimens
