**Shear Performance of ASR/DEF Damaged Prestressed Concrete
Trapezoidal Box Bridge Girders**

Dissertation

The University of Texas at Austin

August, 2010

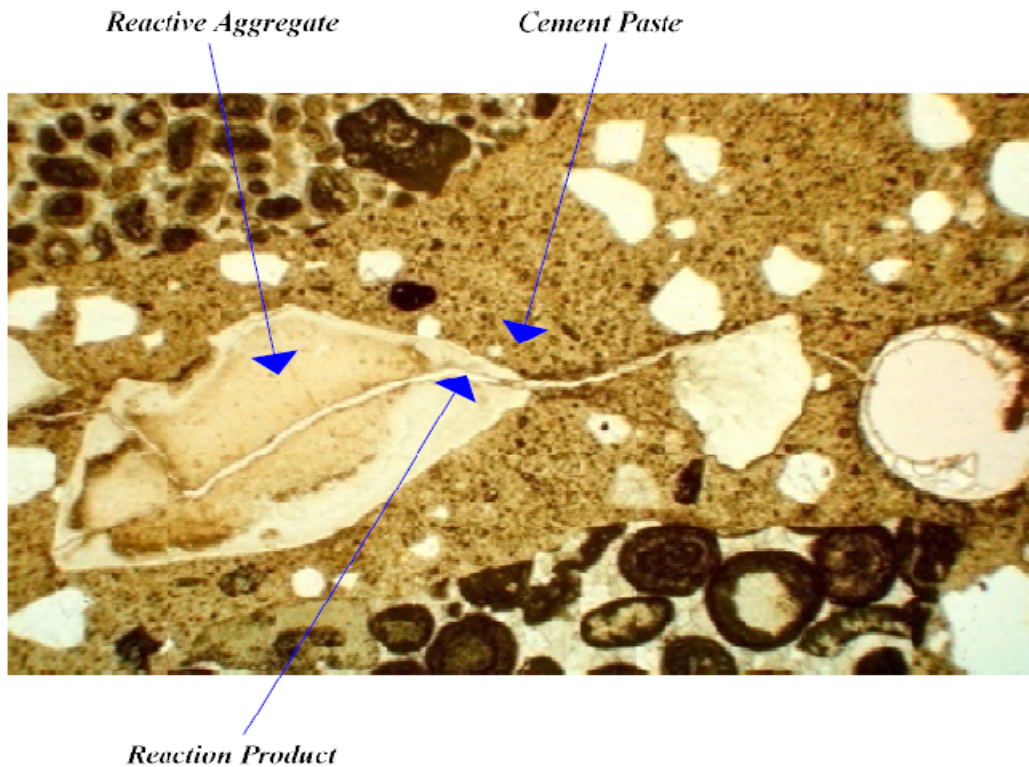
***Figure 2.1 Thin section image, showing some typical diagnostic features
(Folliard, 2007)***

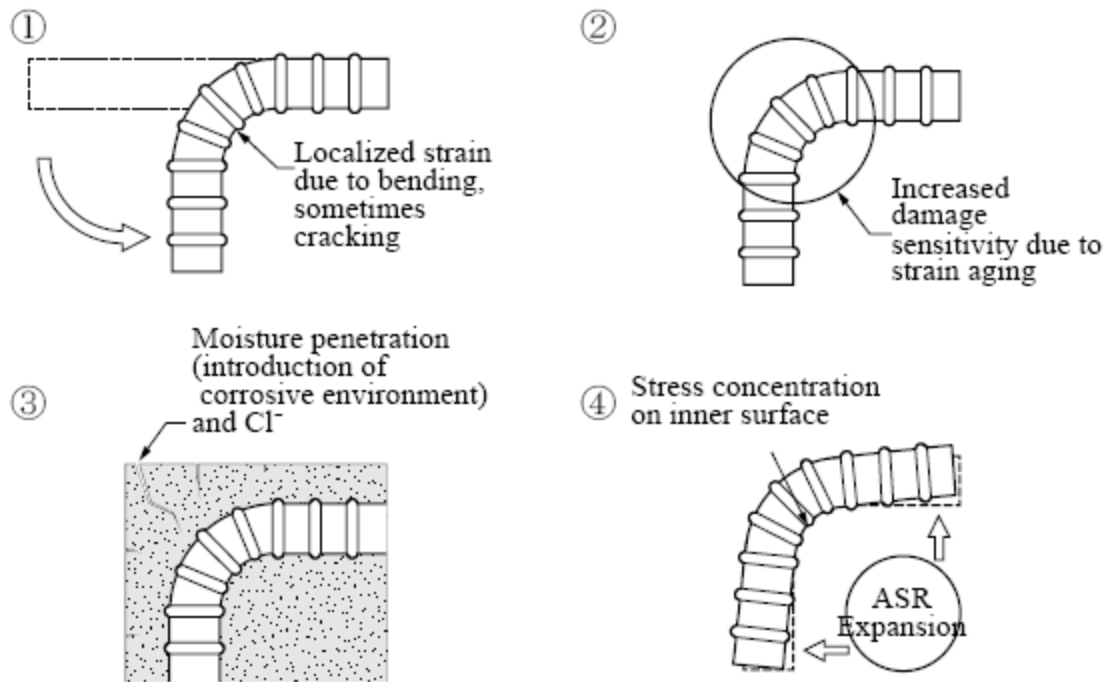
Figure 2.5 Presumed mechanism of damages to steel bars (Miyagawa 2006)

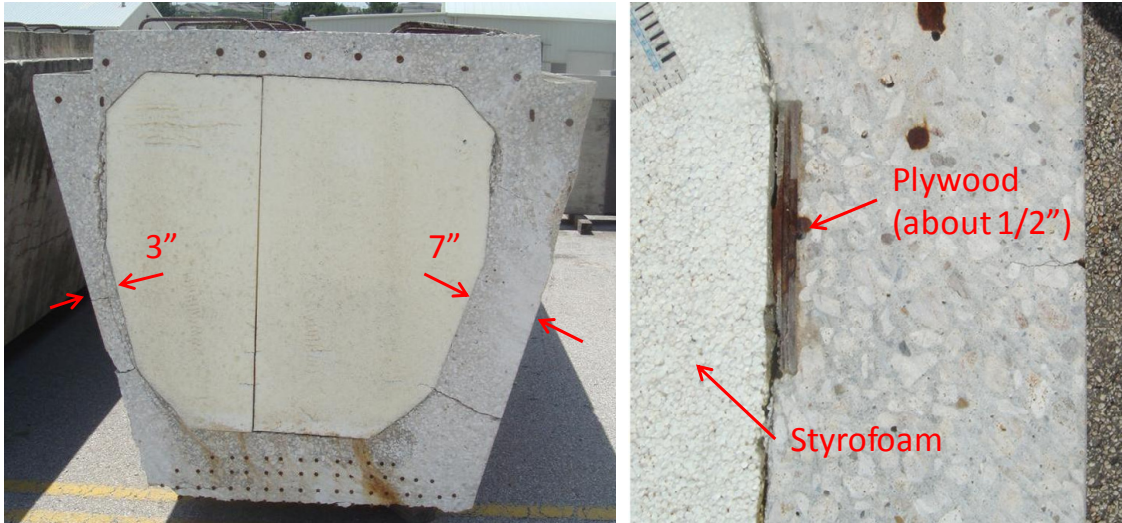
Figure 3.6 (a) Void floatation in RF-3R-12-C (b) Plywood

moved in the beam. Besides, the thickness (about 1/2 in.) of the plywood itself decreases the thickness of the web. Therefore, RF-3R-12-C was not selected to be tested.

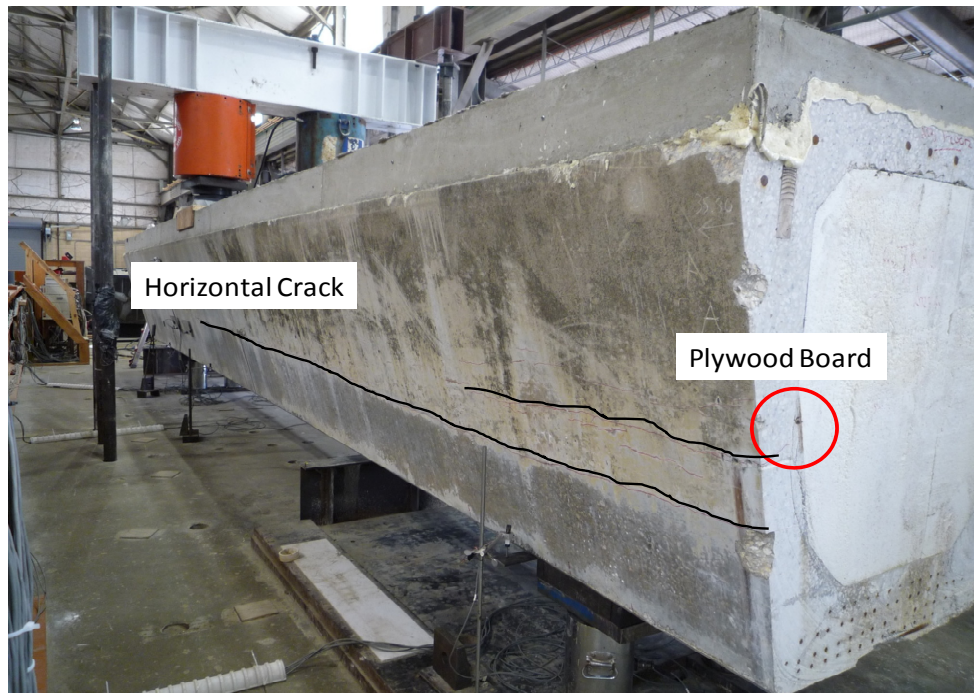
Figure 3.7 Longitudinal crack in the web portion

A longitudinal crack close to the location of the plywood can be found in most beams (Figure 3.7). Some longitudinal cracks extended through the length of the beams. The cause of the longitudinal crack may be attributed to a cold joint or expansion due to ASR and/or DEF. Generally, most cracks were concentrated at the end region. The only significant longitudinal cracking was found in or near the web portion.

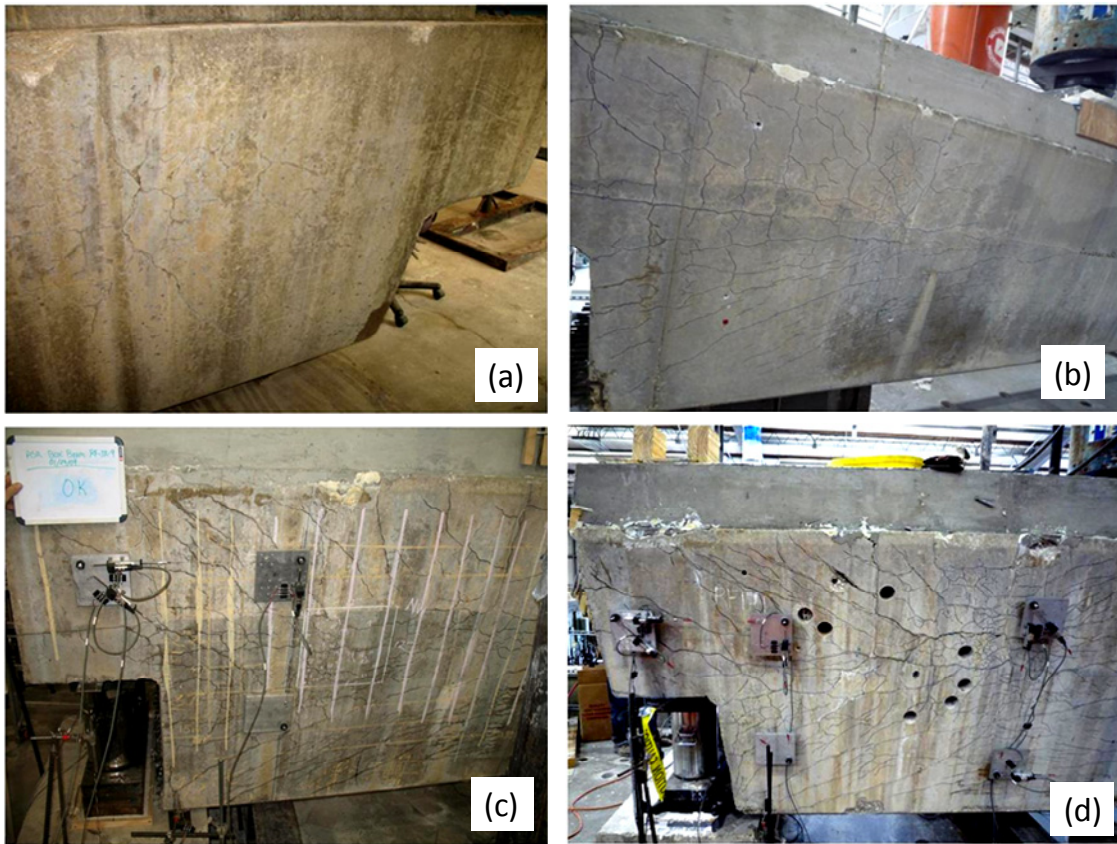
Figure 3.8 Cracking level (a) Negligible (b) Light (c) Moderate (d) Heavy

In Table 3.7, air temperature corresponding to the casting days is shown. The maximum air temperature was 100°F during the casting of the beam with heavy cracking (RF-1R-1) and was only 77°F during casting of the beam with the negligible cracking (MLL-9-34). The air temperature correlated well with the cracking levels determined by the visual inspection. DEF will occur when concrete curing temperature is greater than 158°F; for the beams cast in summer, the concrete temperature was likely to exceed the threshold value (158°F), causing more extensive cracking than the beam cast in late fall.

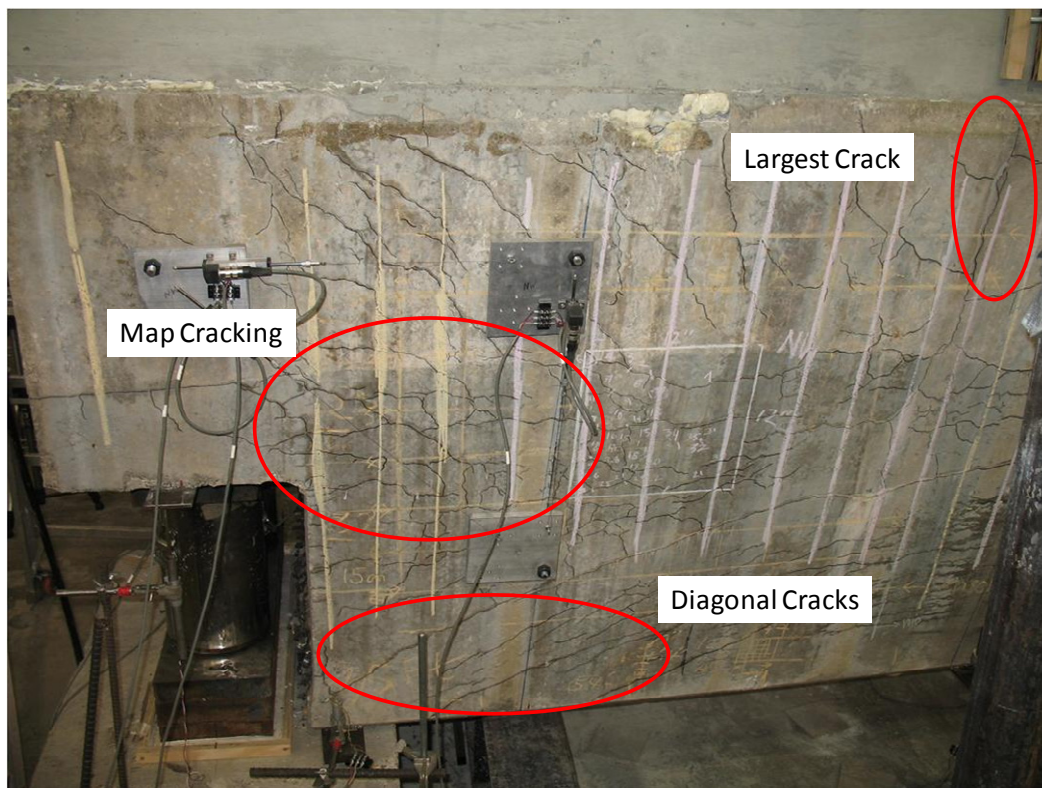
Figure 3.11 Moderately damaged end region of RF-3R-9-A

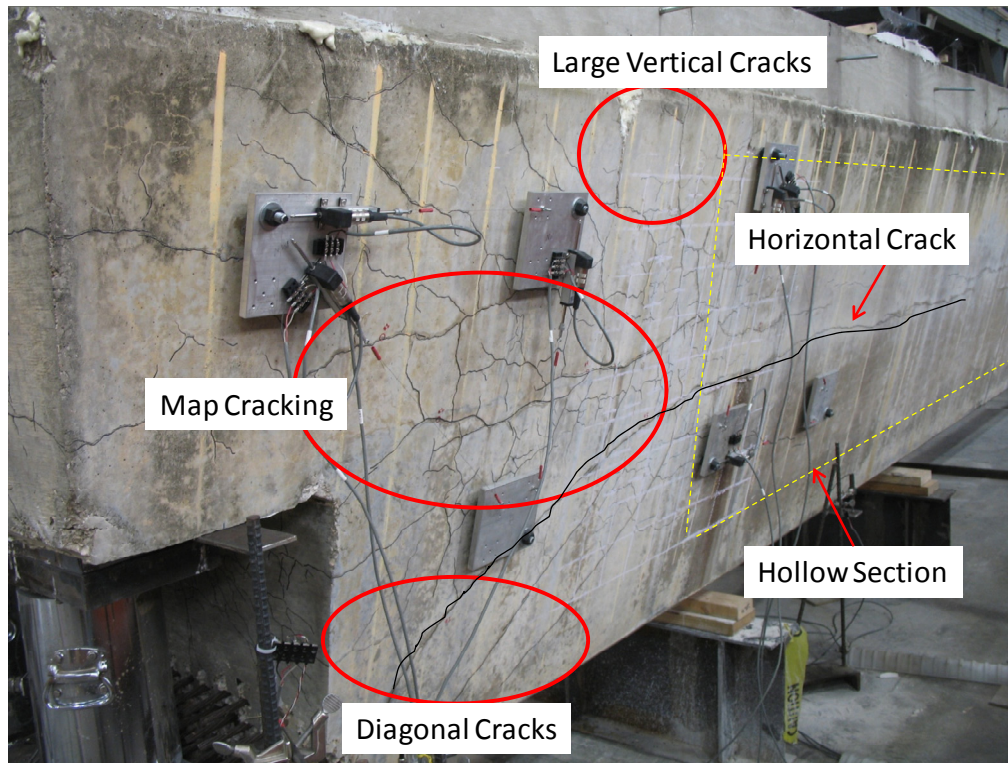
Figure 3.14 Moderately damaged end region of RF-3R-9-C

A visual inspection revealed that the specimen also had moderate cracking (Figure 3.14). Similar to RF-3R-9-A, map cracking was extensive in the end region and varied from hairline to 0.06 in. with horizontal cracks continuing into the hollow section. Diagonal cracks radiated from the bottom corner of the beam toward the mid-depth of the beam. The angle of the crack gradually became horizontal. Vertical cracks were also observed across the top of the beam. Both sides of the beams showed a similar crack pattern. A dapped end shear test and a web shear test were conducted on RF-3R-9-C.

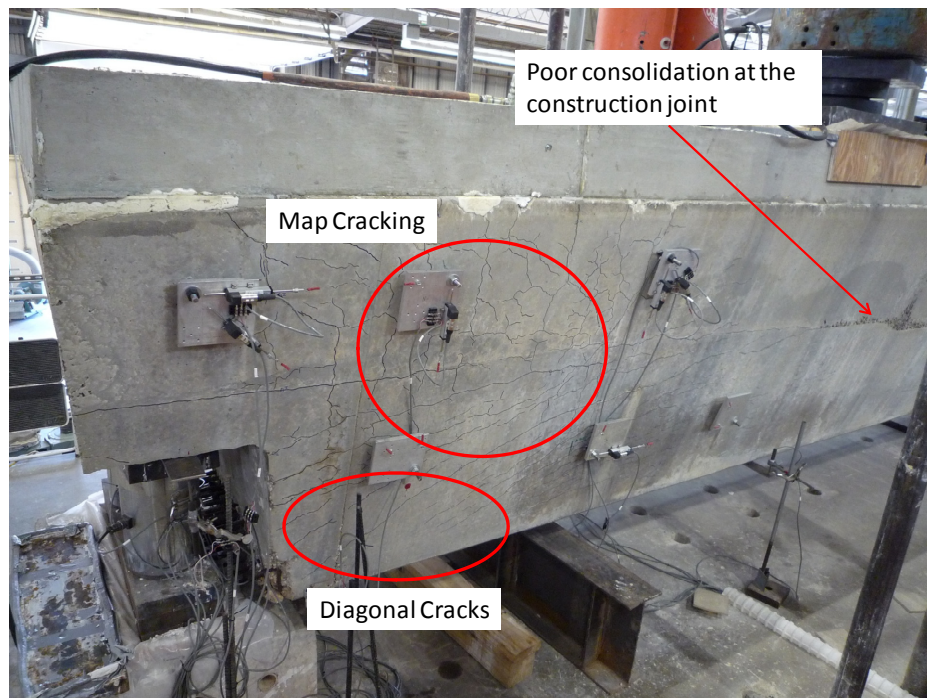
Figure 3.16 End region of RF-3R-12-A

From inspection of RF-3R-12-A, the cracking pattern was similar to the previous beams but noticeably less map cracking was observed in the end region and fewer diagonal cracks radiated from the bottom corner of the beam (Figure 3.16). The cracking level was determined as light. Poor consolidation of the concrete at the horizontal crack in the hollow section was observed. This poor consolidation at the construction joint may be due to insufficient vibration during construction. A horizontal crack propagated through the thin web section where plywood was used to position the Styrofoam. Poor consolidation during construction created a weak plane in the specimen (Figure 3.17), especially where the plywood holding the Styrofoam reduced the web thickness further. A dapped end shear test and a web shear test were conducted on RF-3R-12-A.

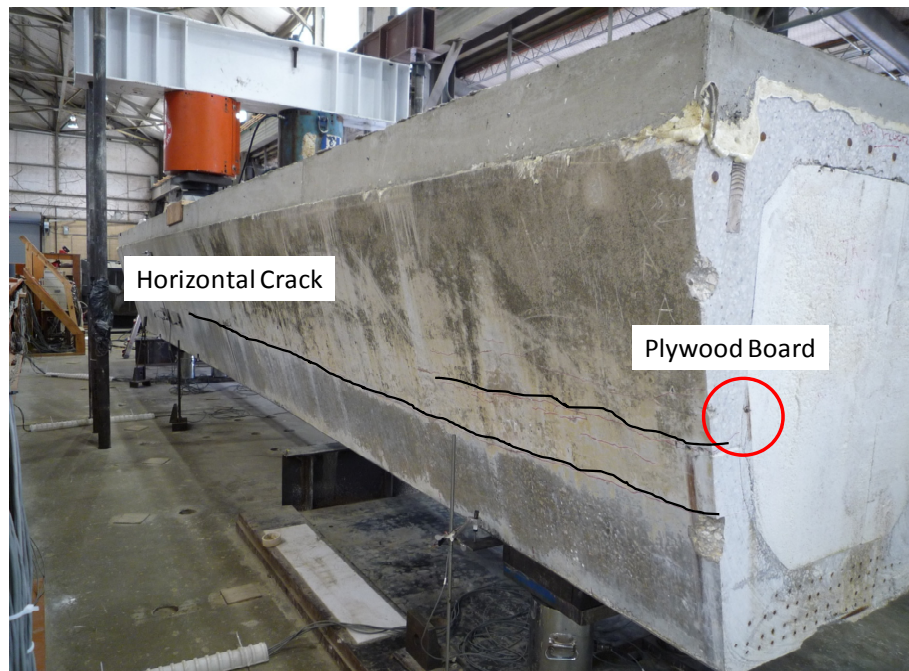
Figure 3.17 Horizontal crack propagating from plywood

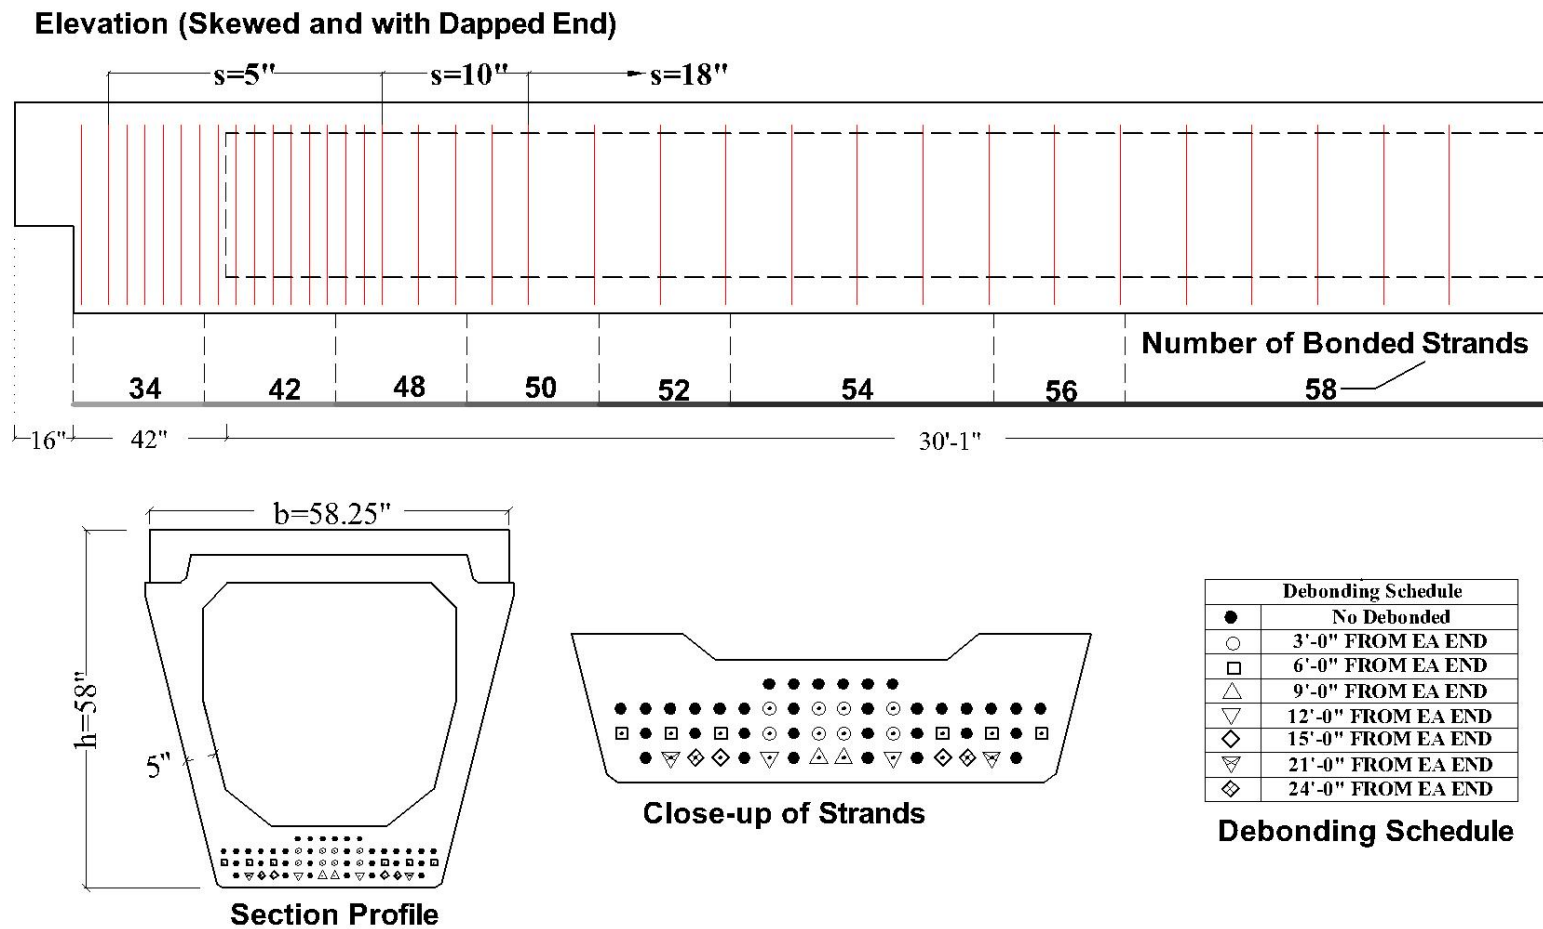
Figure 3.19 Layout of transverse reinforcement and prestressing strands (MLL-9-34-A)

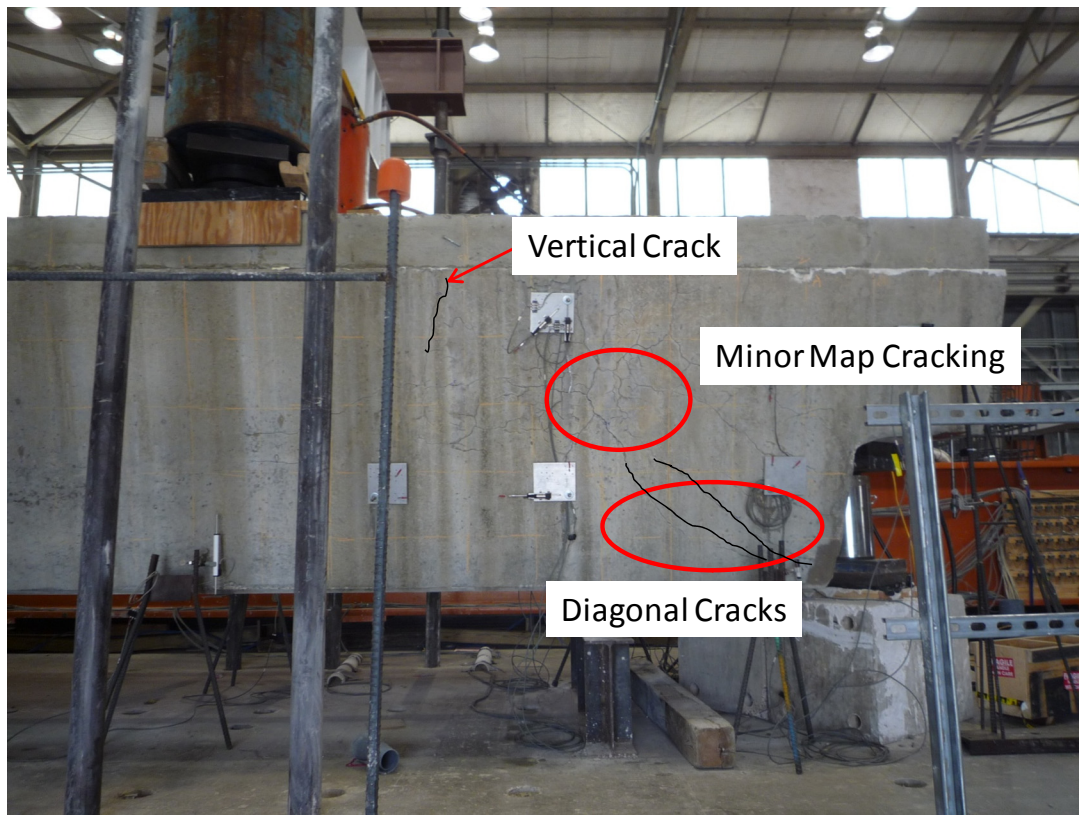
Figure 3.20 *Minor cracking condition on MLL-9-34-A*

A condition survey reveals that MLL-9-34-A had only negligible cracking (Figure 3.20). Minimal map cracking was concentrated in the east region, and only a couple of diagonal cracks radiated from the bottom corner of the beam on the east side. Minor horizontal cracks, observed in the previous specimens, were found at the mid-depth of the beam. Large vertical cracks were also observed (0.04 to 0.05 in.). However, due to minimal map cracking and significantly fewer diagonal cracks than all the previous specimens, MLL-9-34-A was taken as a control specimen (negligible cracking). Again, a dapped end shear test and a web shear test were conducted on this specimen.

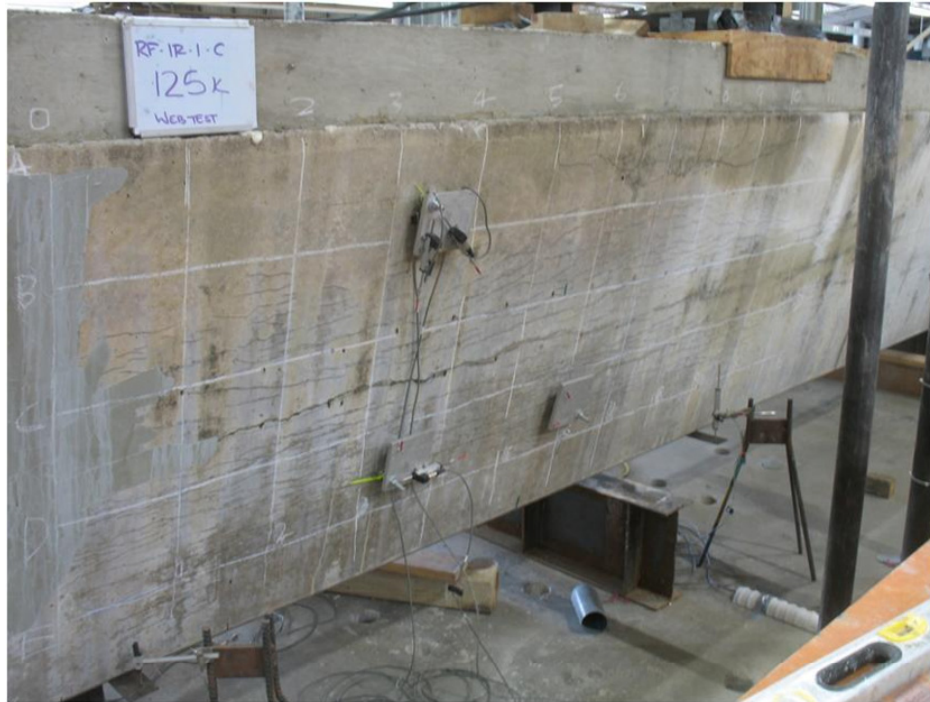
Figure 3.24 Horizontal cracks in the testing region

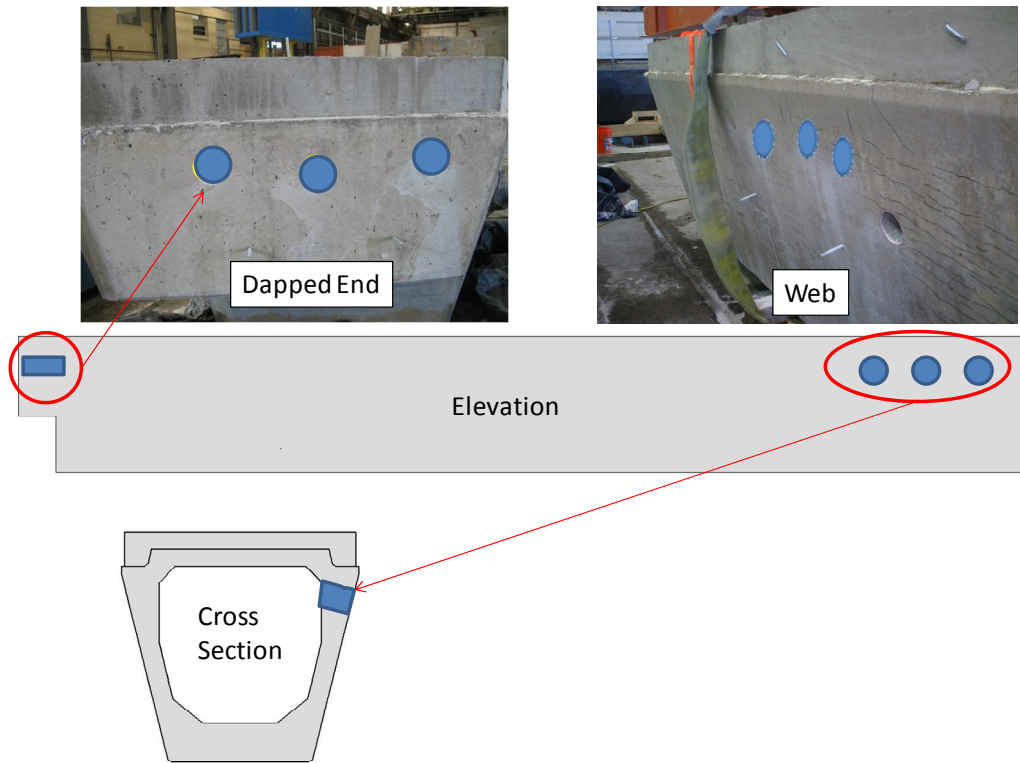
Figure 3.25 Core locations at dapped end and web

In order to maintain an aspect ratio of 1 to 2, the length of the extracted cores had to be greater than 7.5 inches. Any additional length was removed to obtain the desired aspect ratio. The dapped end of a beam is generally a heavily reinforced zone. Only the end face of the dapped end provides enough space between bars to extract a core with a desired dimension (Figure 3.25). The web portion is relatively unobstructed, but concrete damaged during the shear tests has to be avoided. Therefore, the cores extracted at webs were located on side face of the far end. All the cores were extracted from the end face of the dapped end or side face of the far end to represent concrete in ASR and/or DEF damaged zone and minor ASR and/or DEF damaged zone respectively. According to recommendation by ASTM C42, core tests having an average of 85 percent of the specific strength are realistic. It is not practical to expect core tests equivalent to specific strength since differences in size of specimens, conditions of curing, and procedures of extracting cores make equivalent values impossible. Furthermore, extraction removes the confinement of the cores and increases the micro cracks in the cores. Therefore the average of “original” core strength (f'_{core}) is divided by 0.85 to represent specific strength. This value ($f'_{core}/0.85$) will be used for evaluation of shear capacity of the beams in Chapter 6. The results of compression tests are summarized in Table 3.9. Seven-day required and measured strength are also included in the table for comparison purpose.

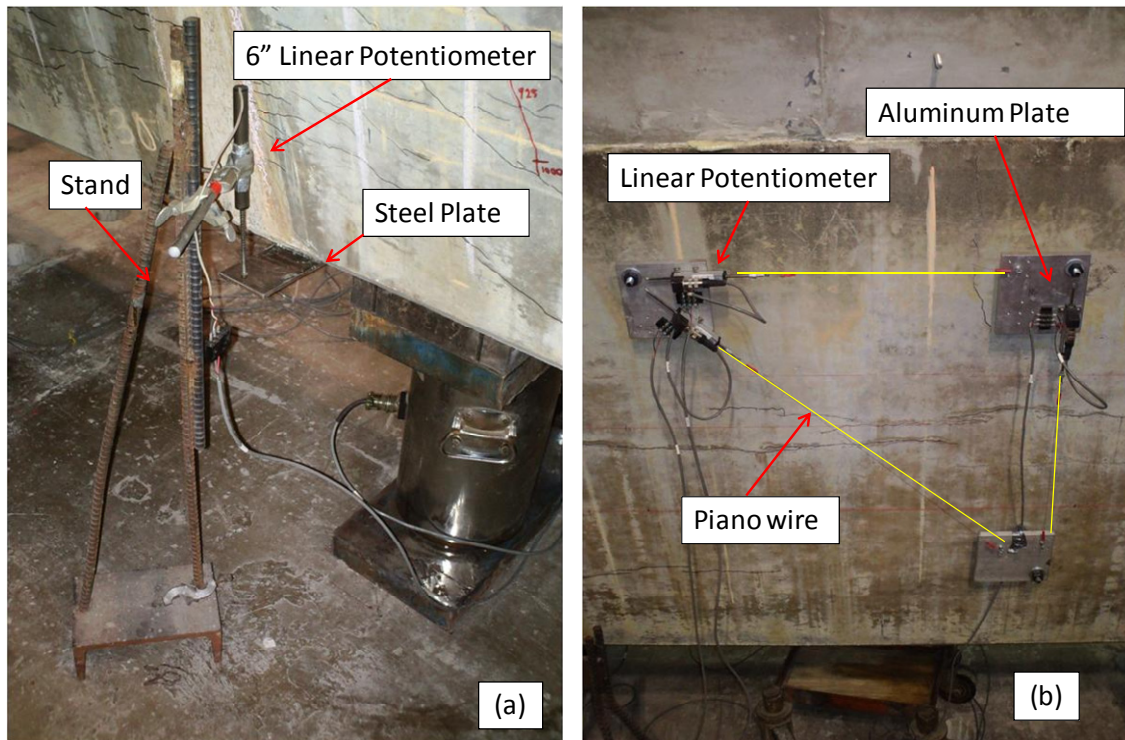
Figure 4.8 Linear potentiometer (a) At support (b) At surface of the beam

transducers were in a plane parallel to the surface of the beam. Then piano wire was attached to the plates and the linear potentiometers to form a 45-degree triangle. The complete assembly is shown in Figure 4.8(b). Using this method, relative movements between any two rods was captured, and crack opening across vertical, horizontal or diagonal wires could be measured by the linear potentiometers. The same setup was attached to each side of the beam.

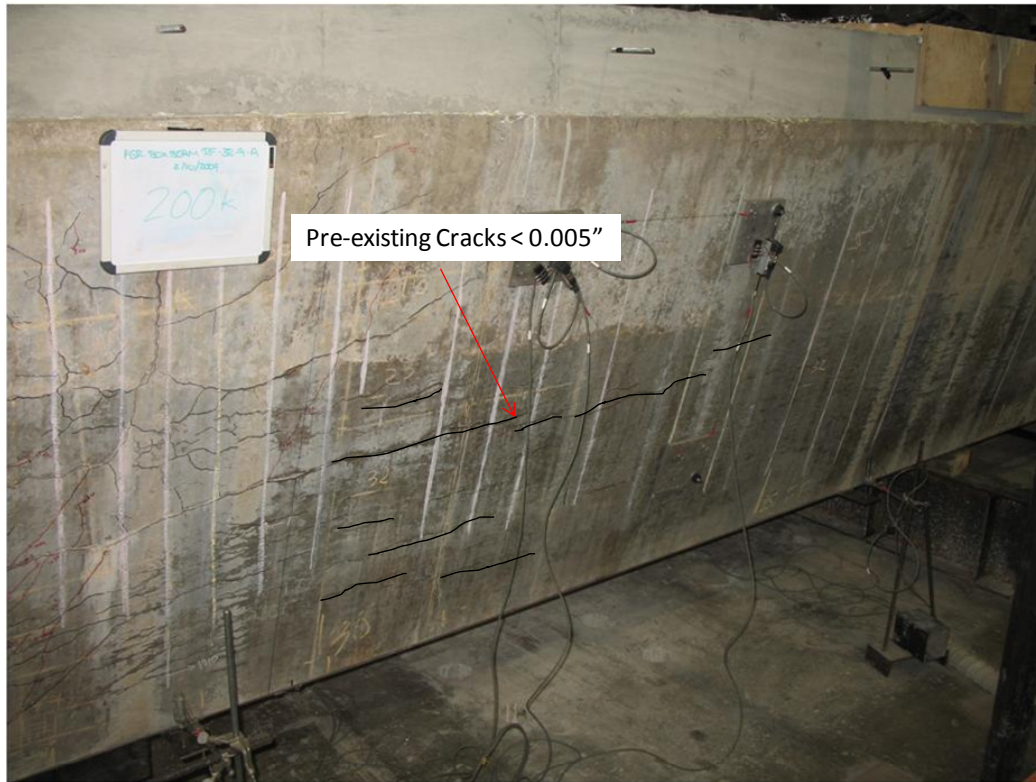
Figure 5.4 RF-3R-9-A pre-existing cracks (west side)

Beam RF-3R-9-A was considered subjected to moderate cracking due to ASR and/or DEF. The shear span-to-depth ratio is 1.85. Because this was the second test on the beam (the dapped end was tested first), the test region was selected to avoid any influence of the cracks caused by the dapped end test. Most cracks existing before testing were horizontal and the maximum width was smaller than 0.005 inches (Figure 5.4). Concrete cracking could be heard and when the first new diagonal crack (width of 0.016 in.) appeared on the east side (Figure 5.5(a)) at a shear of 314 kips. When the shear reached 373 kips, a new diagonal crack (0.013 in. width) appeared in the west face and connected with existing horizontal cracks (Figure 5.6). This diagonal crack was considered the main diagonal crack because only few new diagonal cracks were observed after the first diagonal crack appeared. When the applied load was increased, the diagonal and existing horizontal crack widths expanded. The maximum measured width of the diagonal crack and existing horizontal crack was around 0.04 inches and 0.025 inches respectively. In addition, the diagonal crack extended in both directions toward the load point and the support. When the applied load reached 600~618 kips, some concrete spalled from the west side, and faulting (an offset across the crack) was observed (Figure 5.5(b)). Finally, the strand slip was observed and the concrete started crushing at the bottom of the east side (Figure 5.5(b)) at a shear of 676 kips, beyond which, load on the beam could not be increased. The failure mode of RF-3R-9-A was determined to be compression strut crushing.

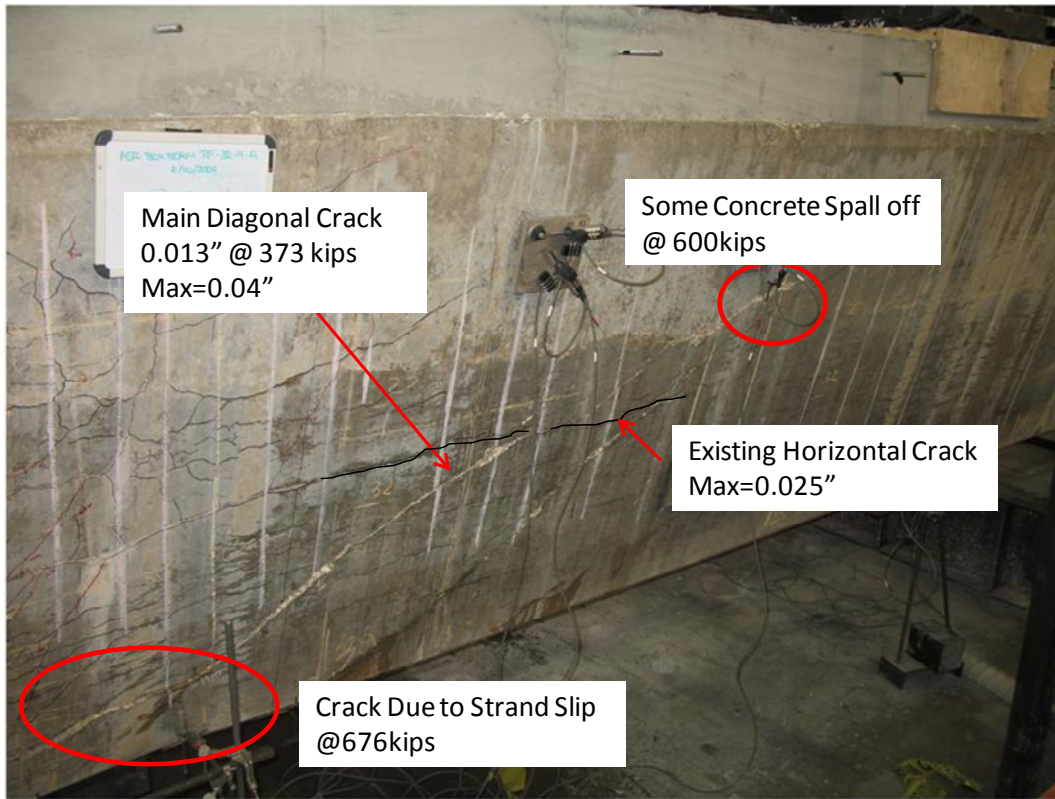
Figure 5.6 West side of RF-3R-9-A

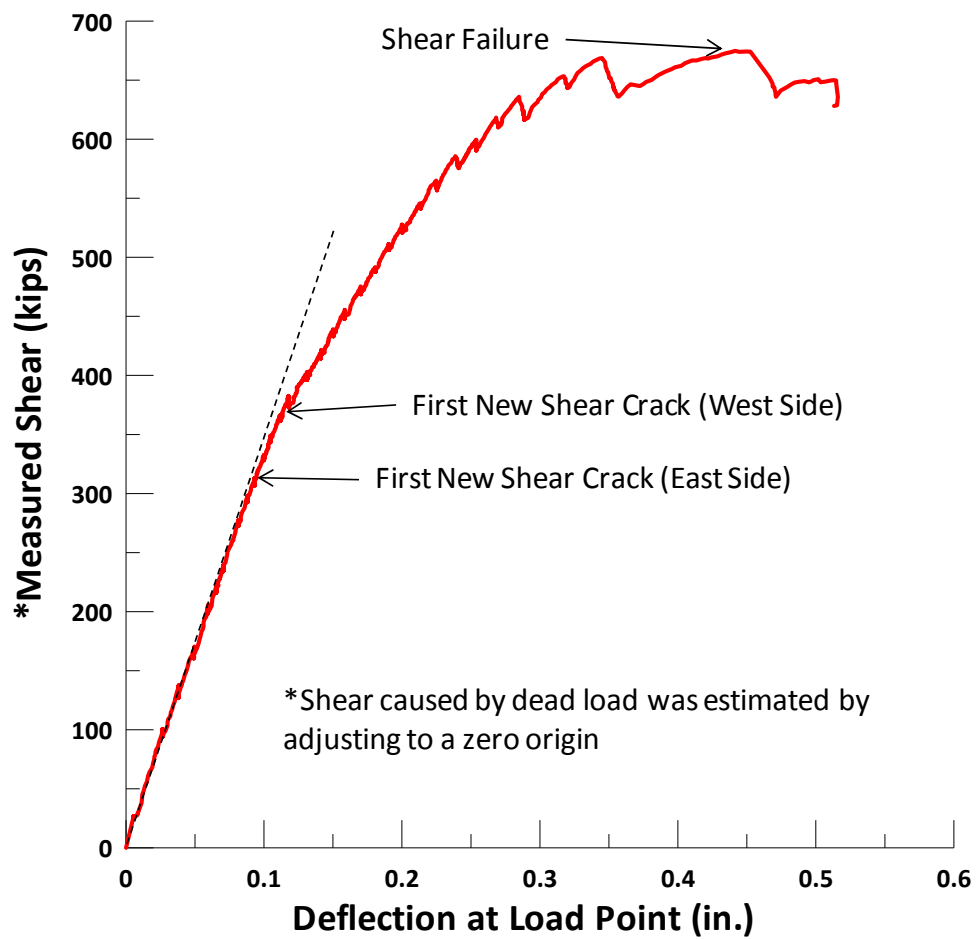
Figure 5.7 RF-3R-9-A load-deflection plot

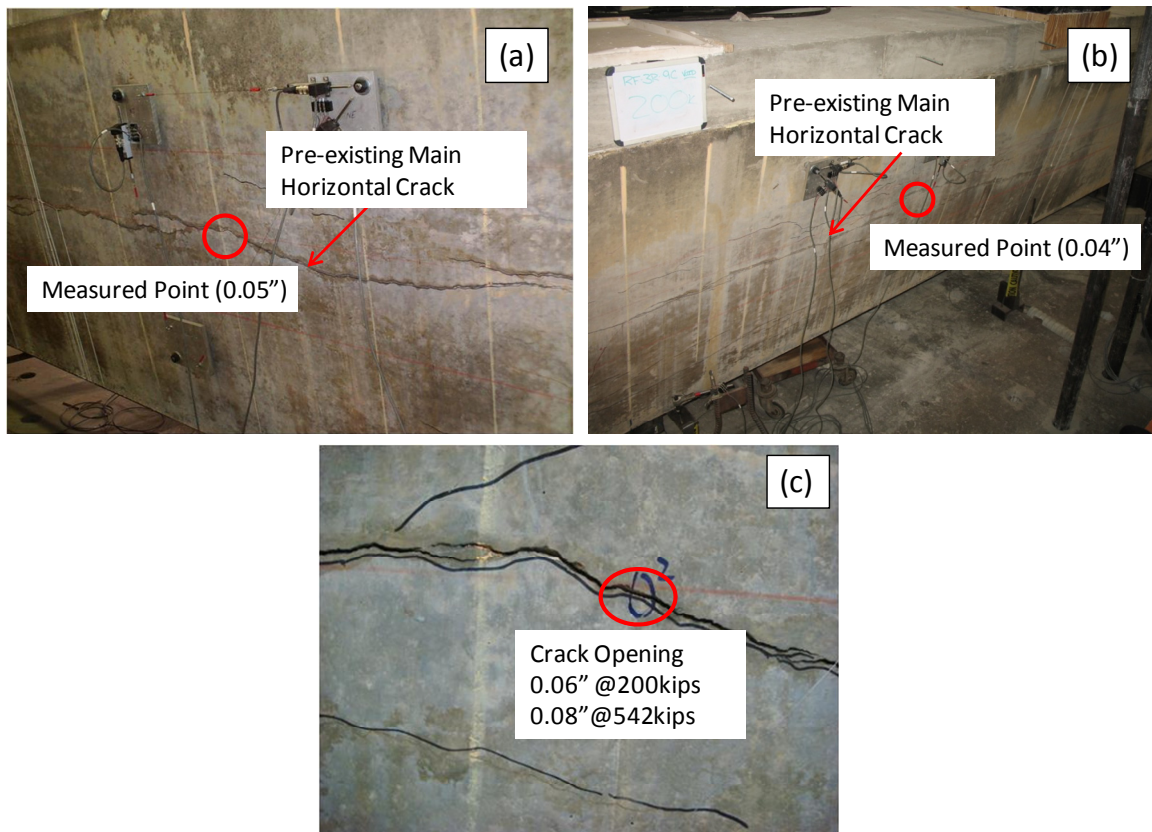
Figure 5.10 Horizontal cracks (a) East side (b) West side (c) Crack opening on east side

increased while that on the west side did not change significantly. The first new diagonal crack of 0.005 in. appeared on the west and east side at a shear of 326~342 kips (Figure 5.11). These diagonal cracks were considered as the main diagonal cracks because very few new diagonal cracks were found after the first one appeared. The diagonal cracks widened gradually to 0.05 in. and connected with the main horizontal cracks, extending toward the load point and support as the shear increased to 542 kips. At the same time, the primary horizontal crack on the east side widened to 0.08 in. After this load, the crack widths were not measured for reasons of safety. Loading continued until the beam failed suddenly and loudly when the shear reached 660 kips. A couple of new diagonal cracks appeared at failure (Figure 5.12). Unlike beam RF-3R-9-A, no concrete crushing occurred, and the failure mode was denoted as a shear tension failure.

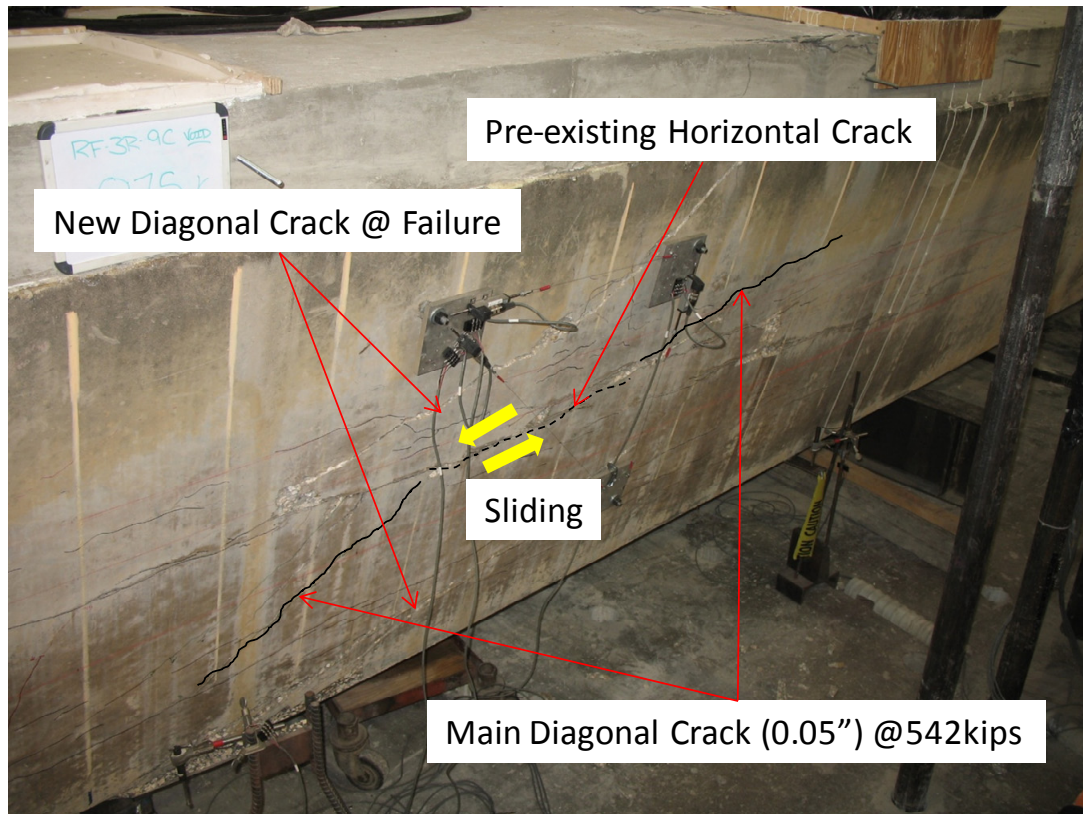
Figure 5.12 Diagonal cracks at failure (west)

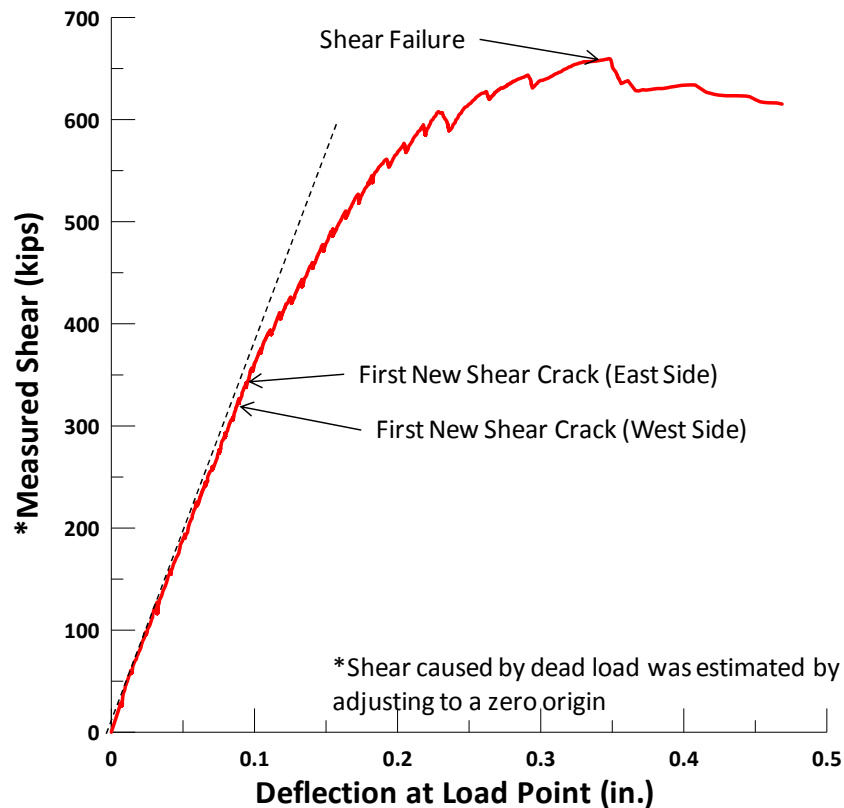
Figure 5.13 RF-3R-9-C load-deflection plot

appeared, the stiffness of the beam decreased gradually until failure. The deflection at maximum shear was about 0.35 in. Similar to RF-3R-9-A, the shear-concrete strain relationship (Figure 5.14) showed that the average horizontal strain was much smaller than the average diagonal and horizontal strain. The increases in horizontal strain that occurred about 520 kips may be due to sliding of the beam. Significant change in the vertical and diagonal strain indicates the opening of the horizontal and diagonal cracks. The average vertical strain was greater than the nominal yield strain of the stirrup, stirrup yielding is likely to have occurred before failure. Shear strains (Figure 5.15) exhibited similar trends.

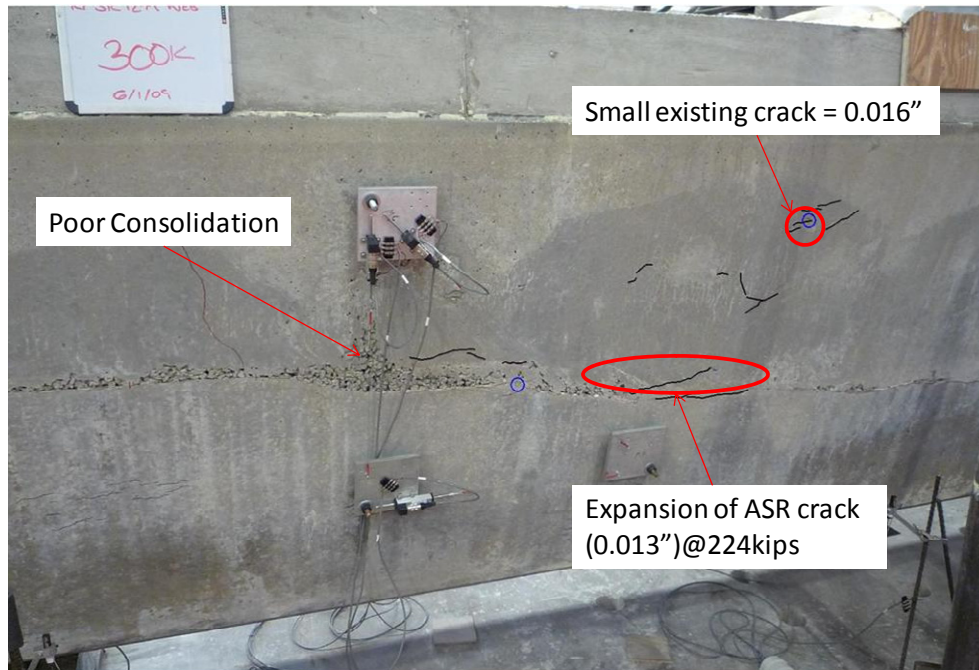
Figure 5.16 Shear span of RF-3R-12-A (west side)

The first new diagonal crack was found on both west and east side with an inclination of about 20 degrees when the shear reached 260 kips. Unlike RF-3R-9-A and RF-3R-9-C, more new diagonal cracks propagated after the first one appeared (Figure 5.18). When the shear reached 358 kips, sliding and a small amount of concrete spalling at the cold joint on the west side was observed. When the shear reached 509 kips, more concrete at the cold joint spalled. The diagonal cracks near the cold joint had a maximum width of up to 0.04 in. at this load (Figure 5.18). As load increased, several pieces of concrete spalled off at the cold joint. When the shear reached a maximum of 573 kips, there was no significant failure but the load began to drop. Therefore, RF-3R-12-A was denoted as a cold joint failure. After the test, a large concrete segment separated near the cold joint, and a slightly bent stirrup due to the sliding of the cold joint was observed (Figure 5.19).

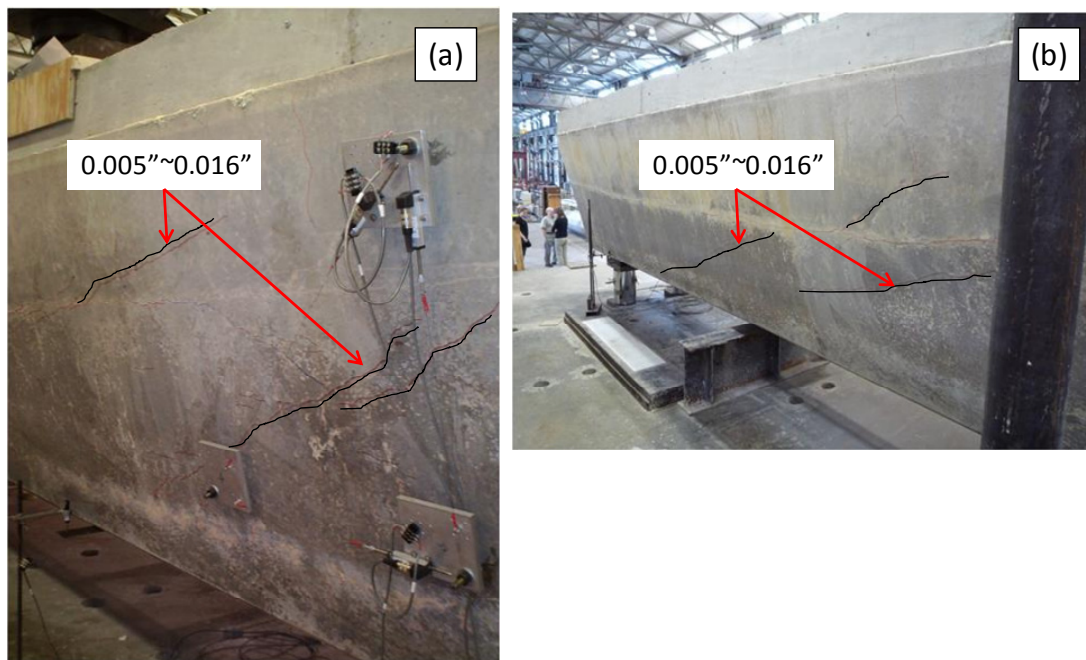
Figure 5.17 Cracks caused by dapped end tests (a) North end (b) South end

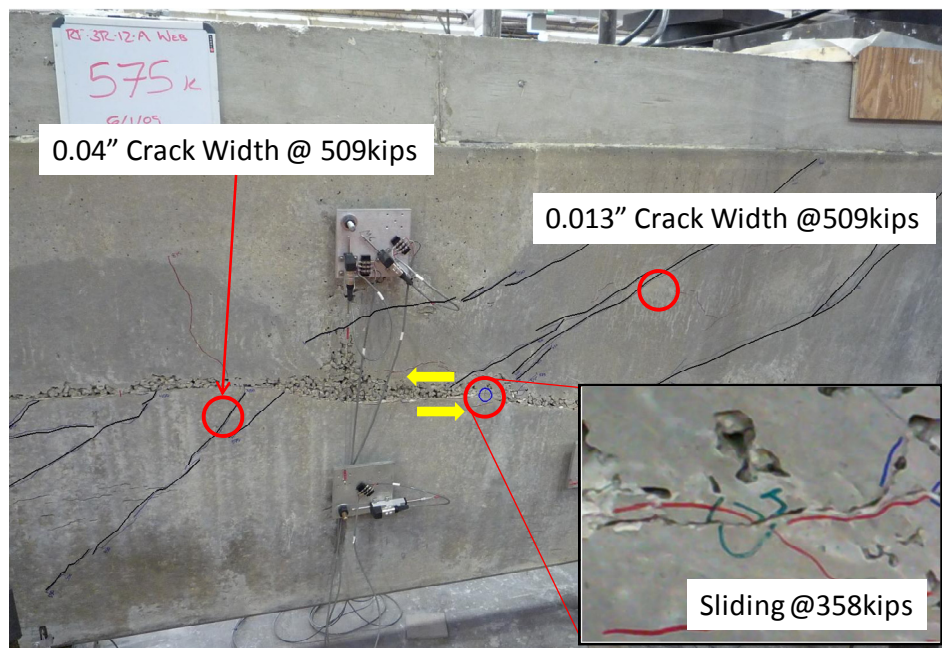
Figure 5.18 Diagonal cracks and cold joint sliding

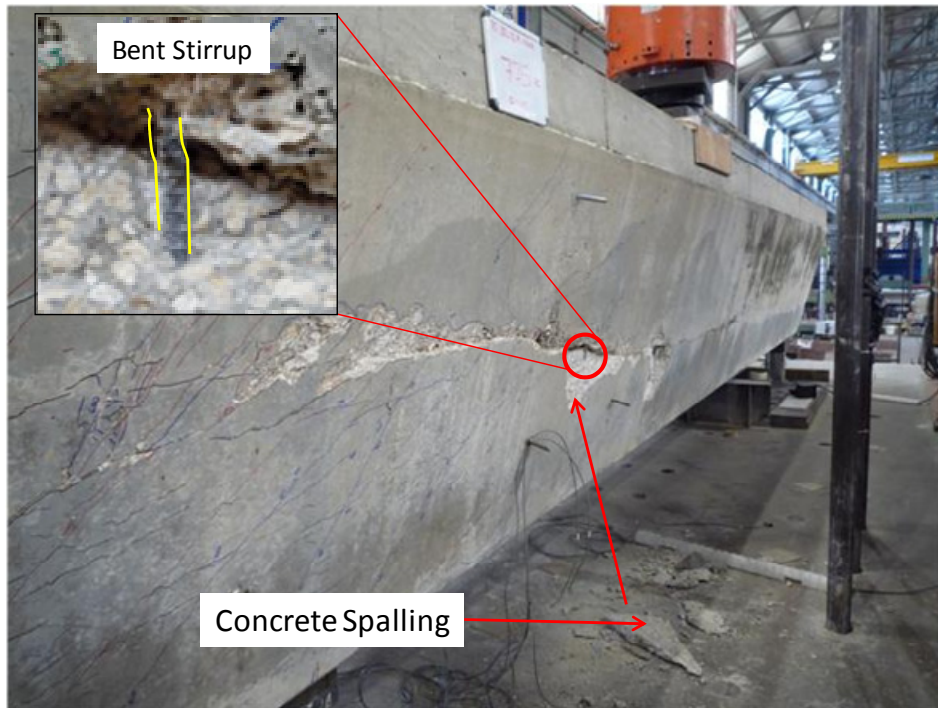
Figure 5.19 Concrete spalling and bent stirrup at failure

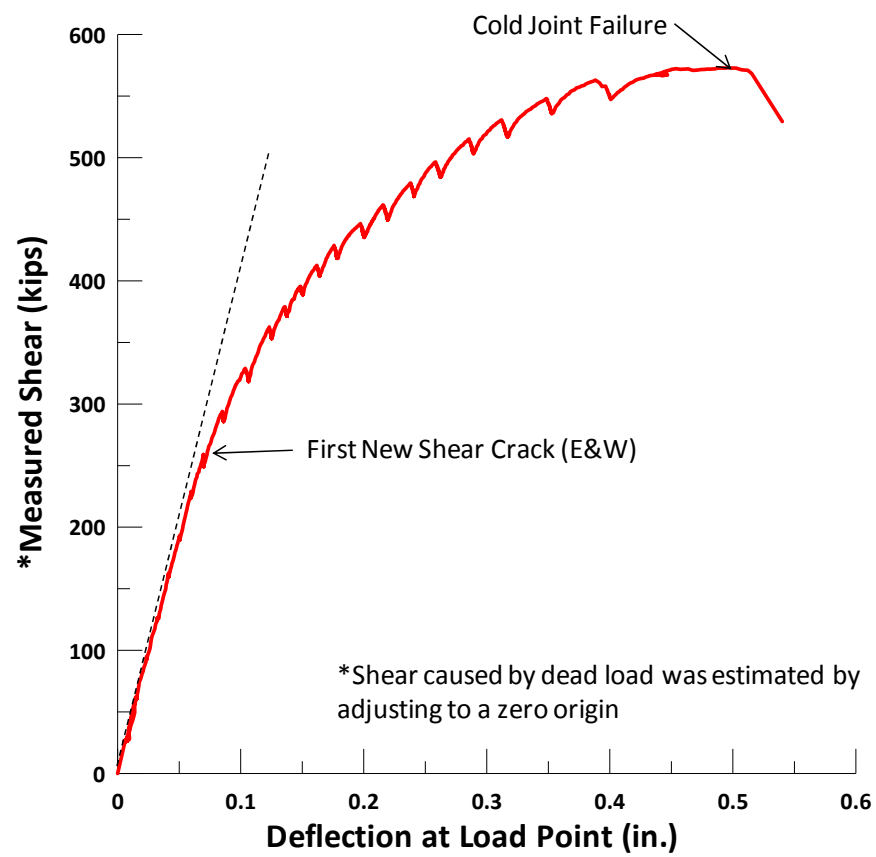
Figure 5.20 RF-3R-12-A load-deflection plot

In Figure 5.20, the relationship between applied shear and load point deflection of RF-3R-12-A is shown. It can be noticed that the beam stiffness decreased before the first shear crack appeared probably due to the sliding along the cold joint. The ultimate shear (573 kips) was smaller than that of RF-3R-9-A and RF-3R-9-C, indicating that the cold joint may have reduced the shear strength even though this beam did not have as many ASR and/or DEF cracks as RF-3R-9-A and RF-3R-9-C. In Figure 5.21, average measured concrete surface strains are shown. Diagonal and vertical strain in the west side was larger than the east side because the cold joint weakened the west side of the beam. Average vertical strains greater than 0.002 indicates stirrups likely yielded before failure. Larger shear strain was revealed on the west side as can be seen in Figure 5.22.
