**Shear Performance of ASR/DEF Damaged Prestressed Concrete
Trapezoidal Box Bridge Girders**

Dissertation

The University of Texas at Austin

August, 2010

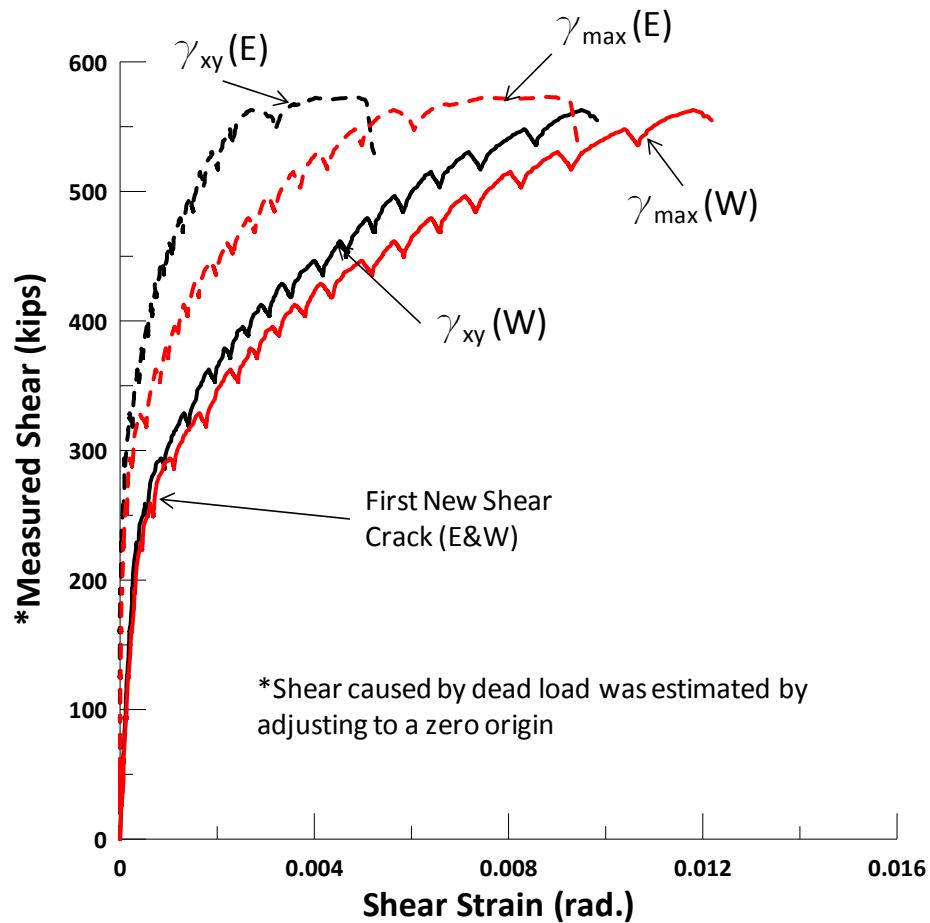
Figure 5.22 RF-3R-12-A shear strain (γ) vs. measured shear

In Figure 5.20, the relationship between applied shear and load point deflection of RF-3R-12-A is shown. It can be noticed that the beam stiffness decreased before the first shear crack appeared probably due to the sliding along the cold joint. The ultimate shear (573 kips) was smaller than that of RF-3R-9-A and RF-3R-9-C, indicating that the cold joint may have reduced the shear strength even though this beam did not have as many ASR and/or DEF cracks as RF-3R-9-A and RF-3R-9-C. In Figure 5.21, average measured concrete surface strains are shown. Diagonal and vertical strain in the west side was larger than the east side because the cold joint weakened the west side of the beam. Average vertical strains greater than 0.002 indicates stirrups likely yielded before failure. Larger shear strain was revealed on the west side as can be seen in Figure 5.22.

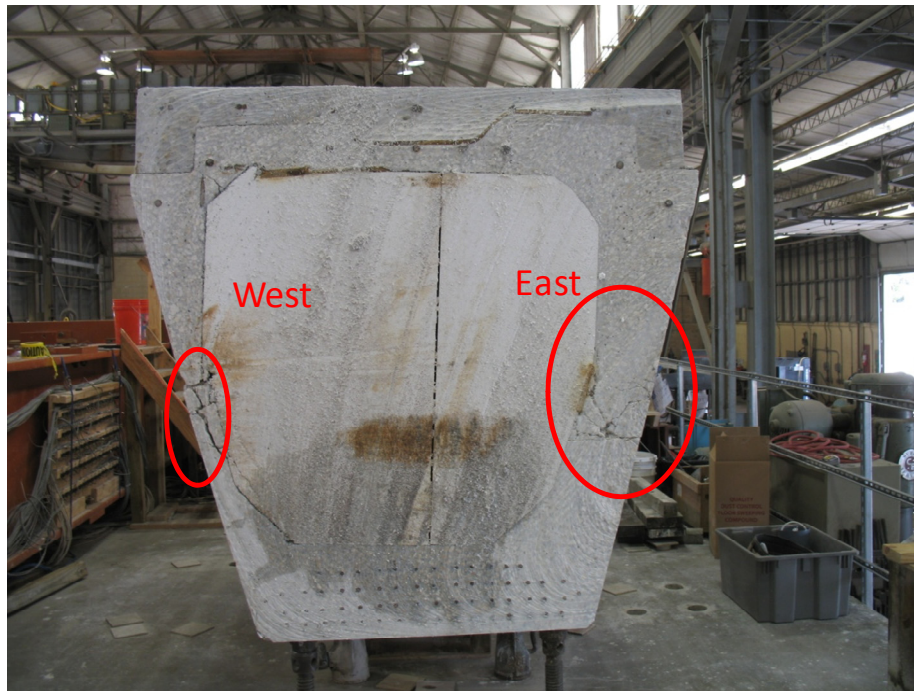
Figure 5.23 Cut section of RF-3R-12-A

After testing, the beam was cut in half for removal from the laboratory. From the cut section shown in Figure 5.23, it was found that the web thickness (2.5 in.) in the west side was much thinner than the east side (7.5 in.). However, a pretest survey did not indicate such a huge difference between the thicknesses of the two sides. It is apparent that the void floatation was not the same along the beam and helps to explain why strains in the west side were greater than those in the east side.

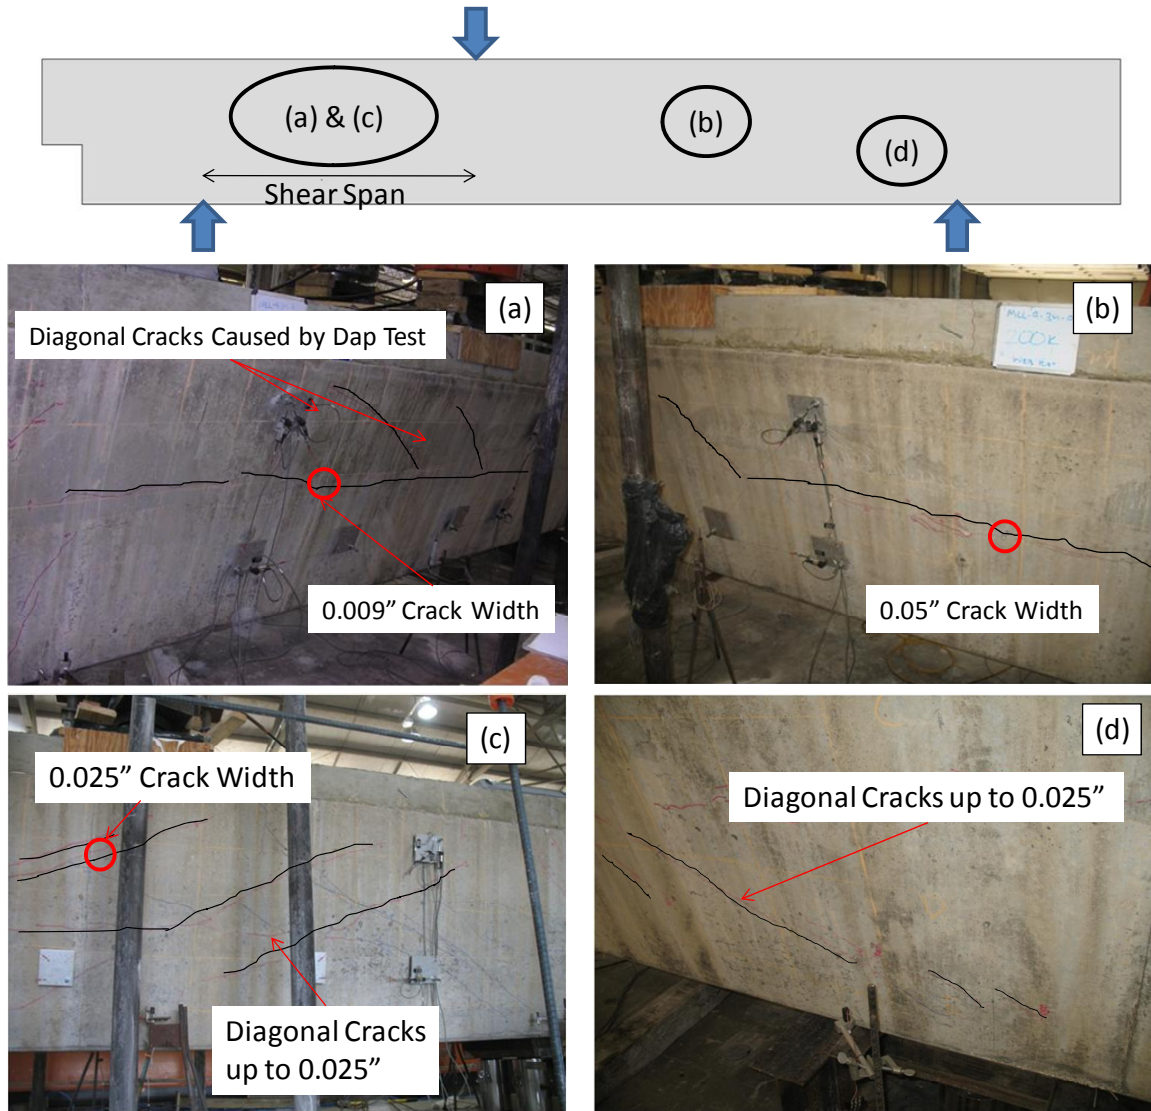
Figure 5.24 Pre-existing crack conditions (a) Horizontal cracks in test region (west), (b) Long span (west), (c) Diagonal cracks in test region (east), and (d) Long span (west)

MLL-9-34-A was defined as a beam with negligible cracking before testing. A main horizontal crack can also be found near the mid-depth of the test region, but cracking (width of 0.009 in.) was not as severe as RF-3R-12-A. The horizontal crack was larger (width of 0.05 in.) in the long span (Figure 5.24(a) and (b)). The beam had a skewed end and the length of the side was different. Besides, the previous dapped end test also caused some diagonal cracking in the test region and the long span of the beam. The crack width of these diagonal cracks was up to 0.025 in. in east side (Figure 5.24(c) and (d)). To monitor the cracks and shear strains in the long span, one more set of linear potentiometers was installed in each side of the beam as shown in Figure 5.24(b).

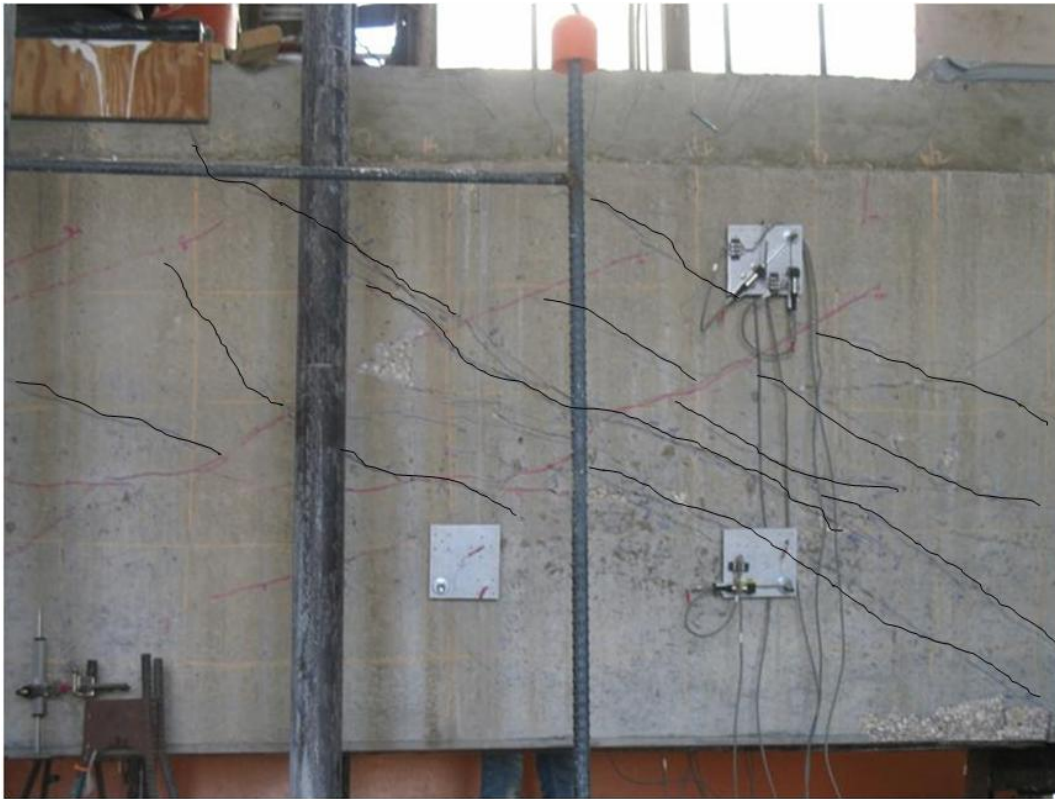
Figure 5.26 Crack Pattern at failure (east)

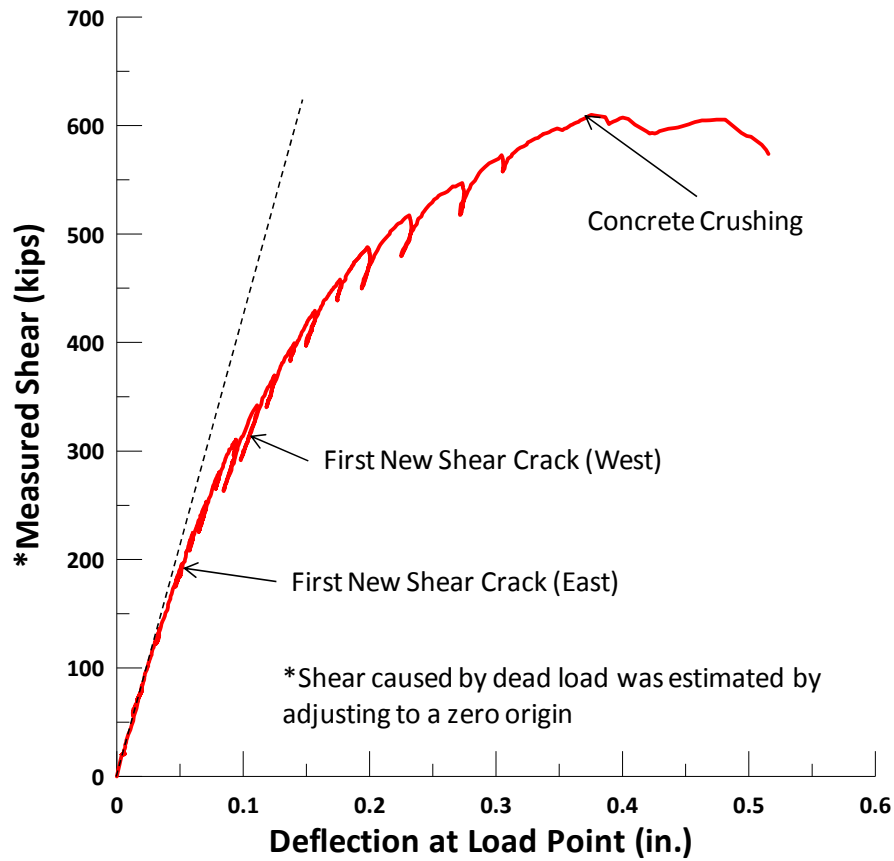
Figure 5.27 MLL-9-34-A load-deflection plot

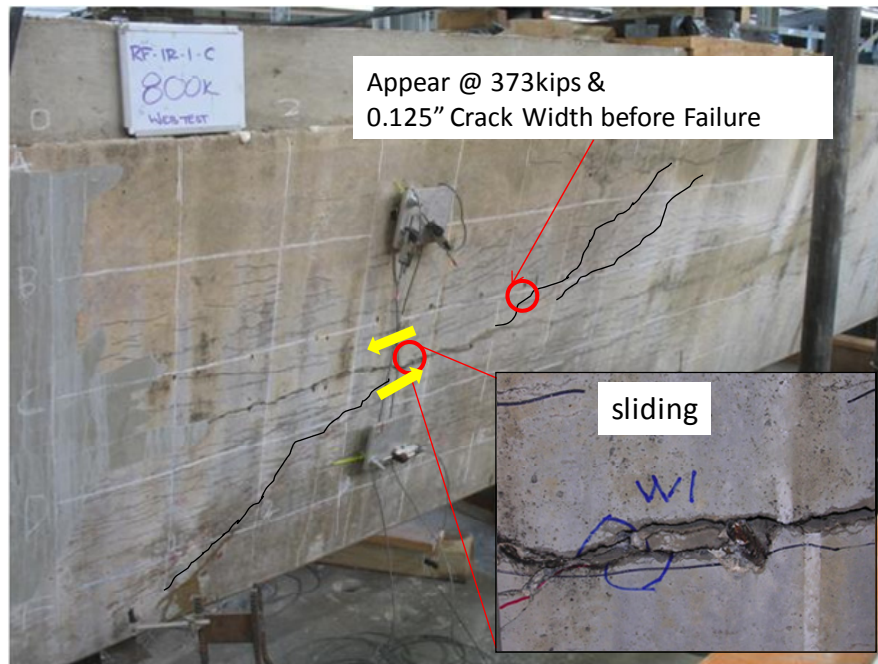
Figure 5.33 Prefailure crack pattern (west)

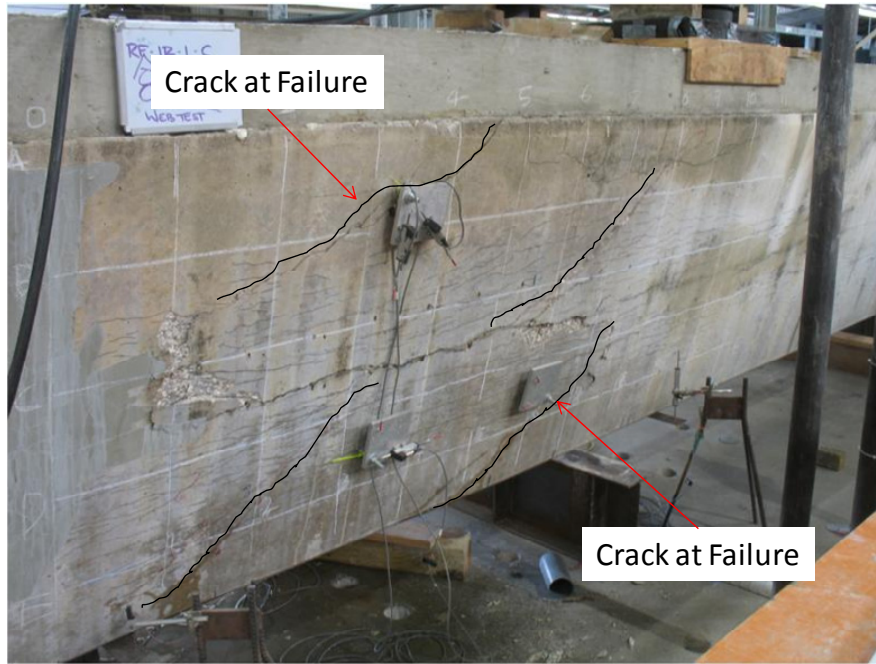
Figure 5.35 Crack pattern at failure (west)

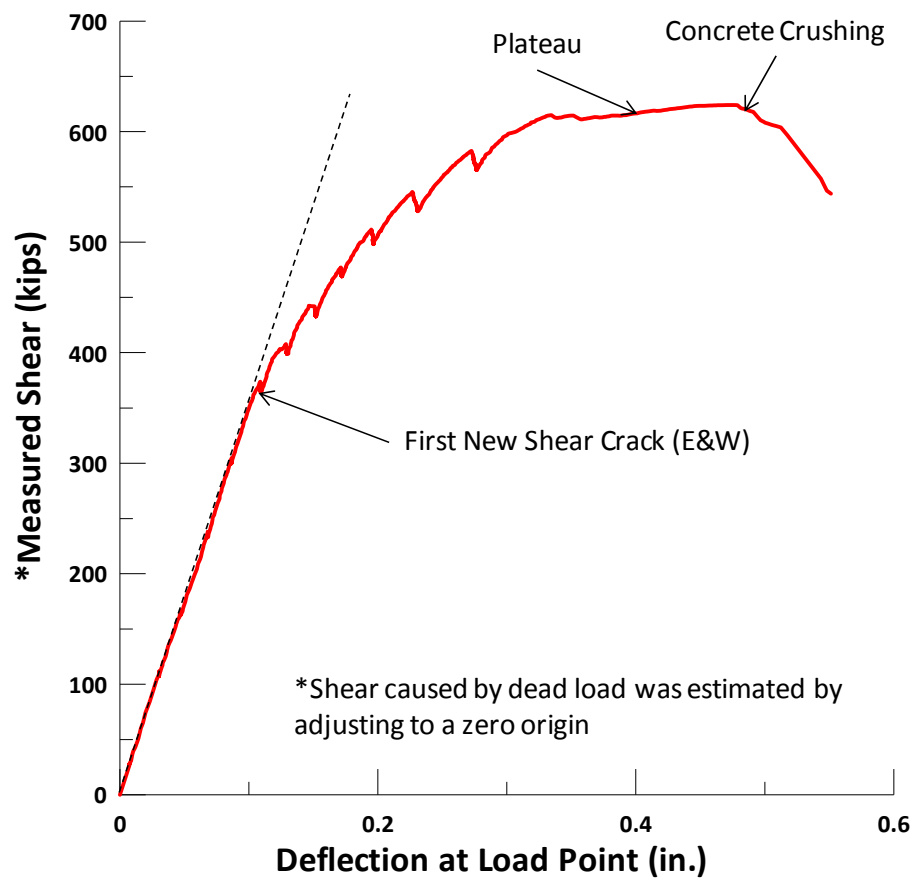
Figure 5.36 RF-1R-1-C load-deflection plot

In Figure 5.36, the relationship between applied shear and load point deflection of RF-1R-1-C is shown. Stiffness was slightly reduced before the first new diagonal crack occurred as a result of expansion of pre-existing cracks. The deflection plateaued before failure. In Figure 5.37, average concrete surface strains are shown. Average horizontal strain was still small throughout the test. Diagonal and vertical strain changed slightly before the first new diagonal crack appeared due to expansion of the pre-existing cracks. The average vertical strain also exceeded 0.002, indicating likely yielding of the stirrup before failure. Similarly, shear strains did not change significantly before the first new diagonal crack occurred (Figure 5.38).

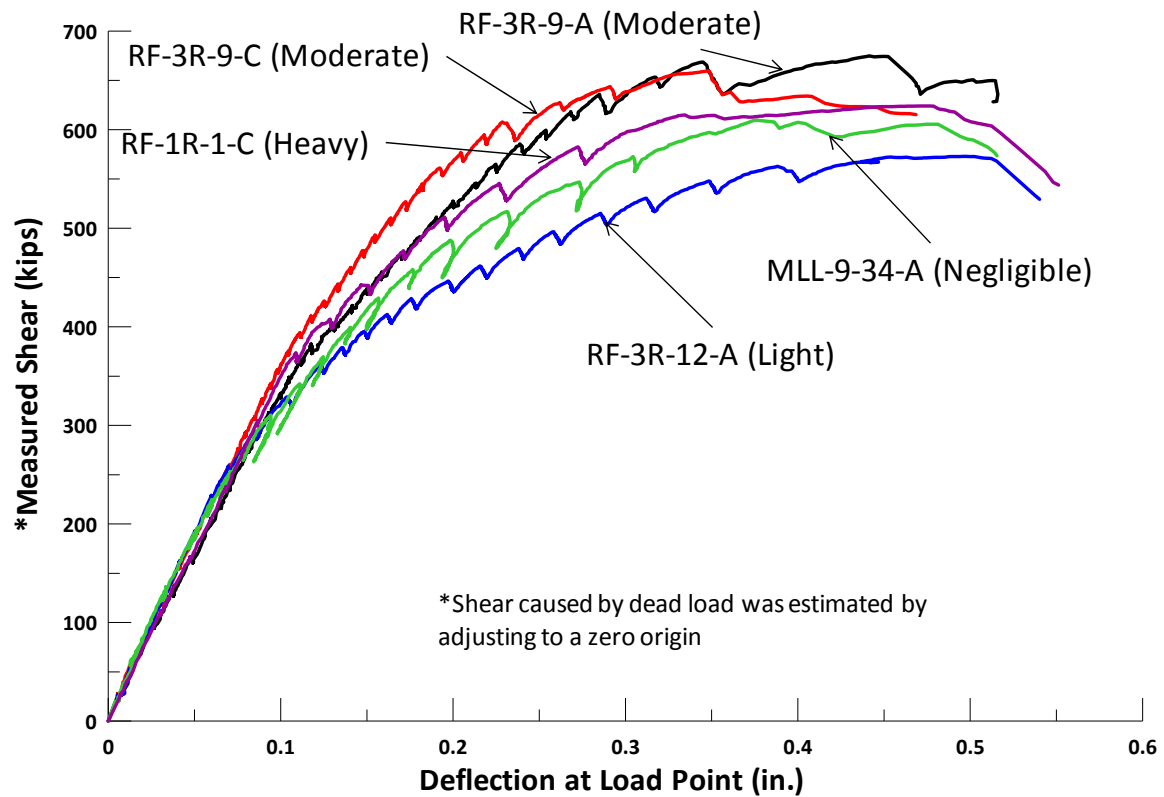
Figure 5.39 Comparison of load-deflection relationship

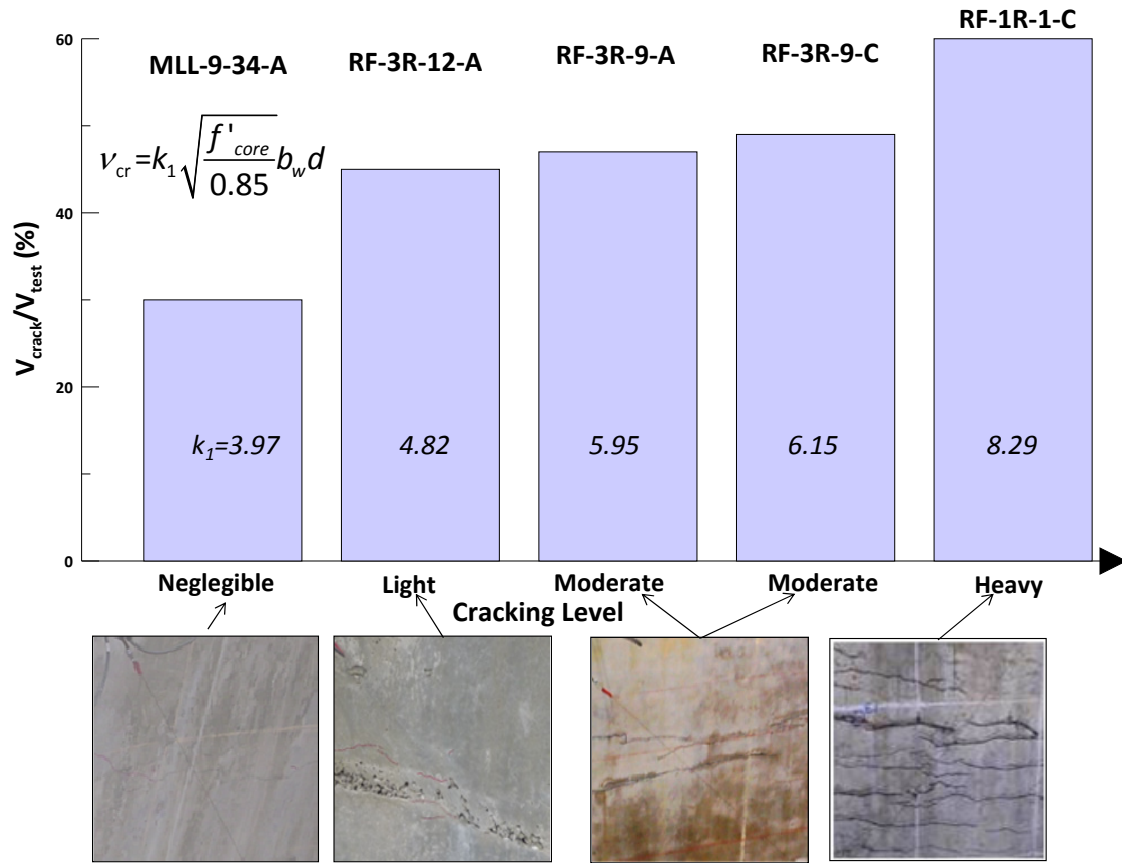
Figure 5.40 Relationship of V_{crack}/V_{test} vs. damage level

In Table 5.2, the shear load (V_{crack}) at “new” visible cracking is compared with the ultimate shear load (V_{test}). The beam with heavy cracking (RF-1R-1-C) had a higher ratio of “new” visible cracking load to ultimate shear load (V_{crack}/V_{test}). The relationship between cracking level and V_{crack}/V_{test} is summarized in Figure 5.40. The results indicate the more ASR and/or DEF cracking, the higher the ratio of V_{crack}/V_{test} . The more ASR and/or DEF cracking, the higher the shear before new diagonal cracks form. In the more highly cracked beams, existing cracks are opening before new cracks form. Beams with a high ratio of V_{crack}/V_{test} gave little warning of failure. According to the report by Deschenes (2009), ASR and/or DEF deteriorations induce tensile strains and stresses in reinforcement. The stresses in the reinforcement provide prestress force and cause compression in the concrete due to a self-equilibrated system. Therefore ASR and/or DEF induced compression in the concrete causes a delay in new diagonal cracking. The test results in the current study further substantiate this finding and indicate that defined cracking levels are proportional to ASR and/or DEF induced compression. The results also indicate that defined cracking levels are proportional to severity of ASR and/or DEF deteriorations as implied by first visible cracking load.

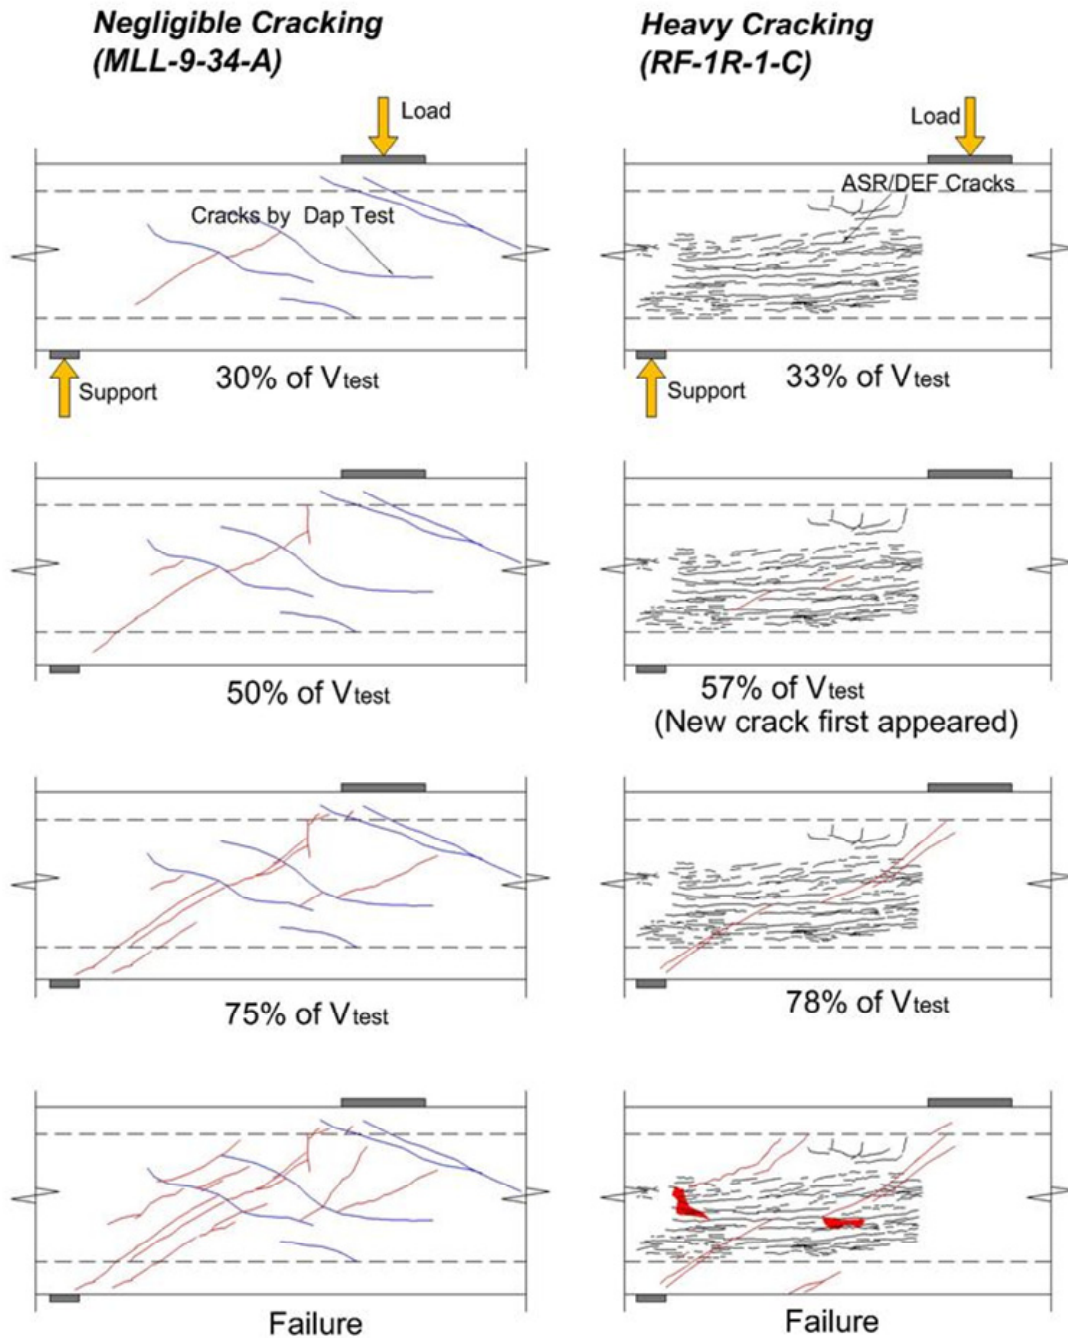
Figure 5.41 Comparison of crack patterns

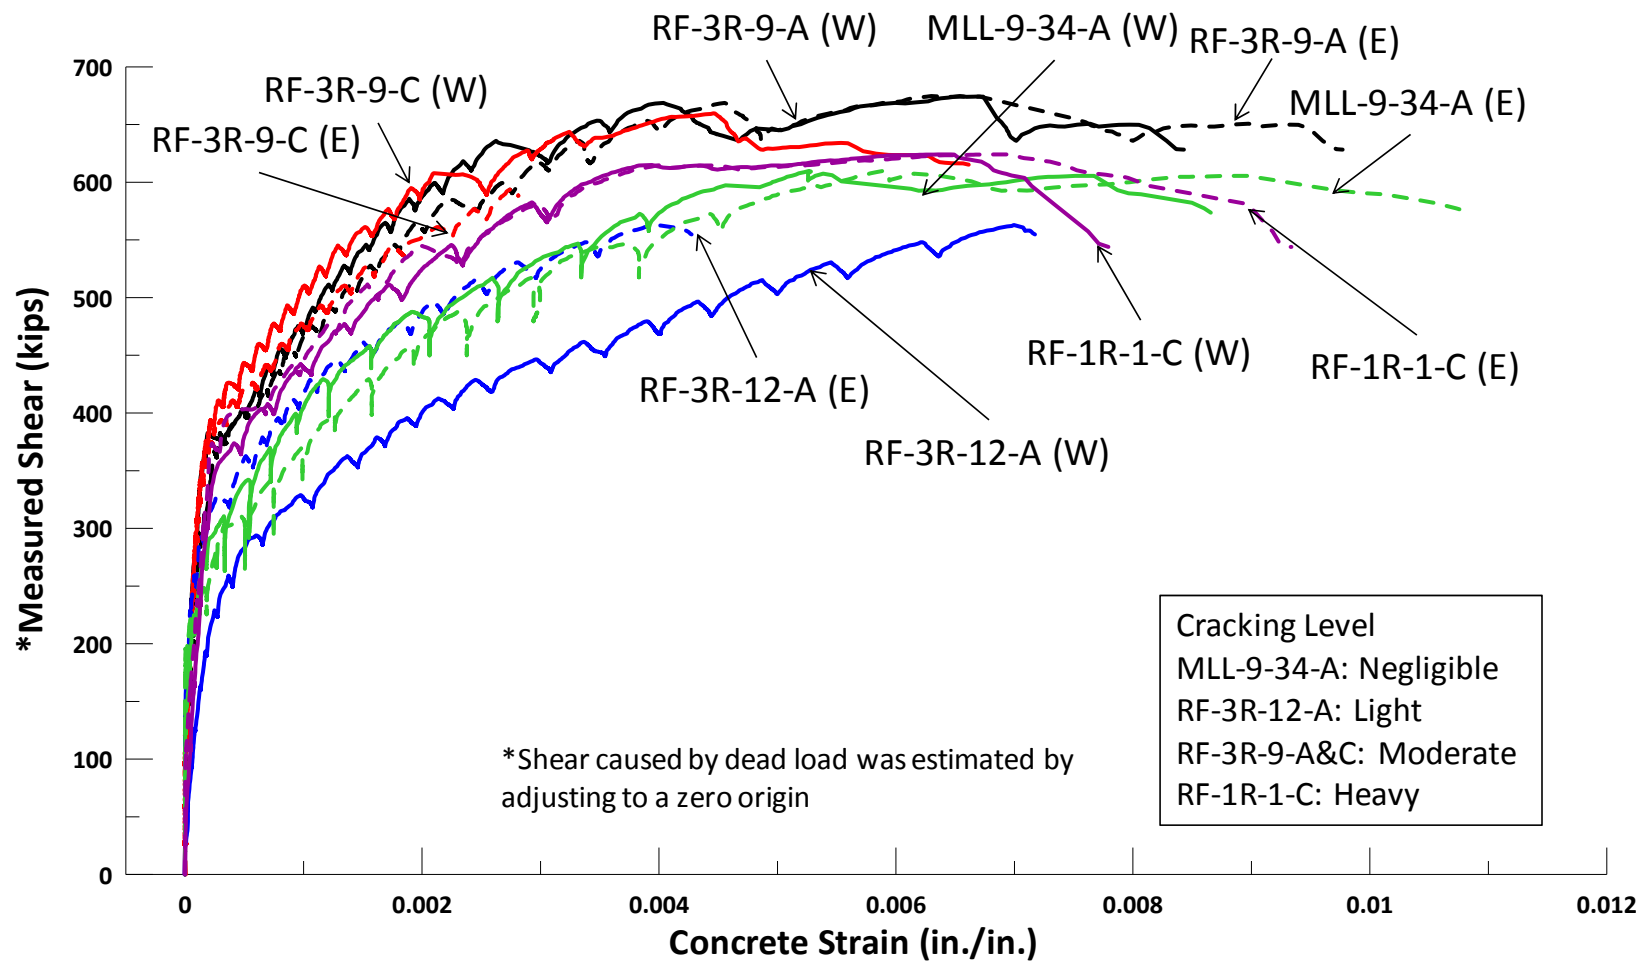
Figure 5.42 Comparison of average diagonal strains

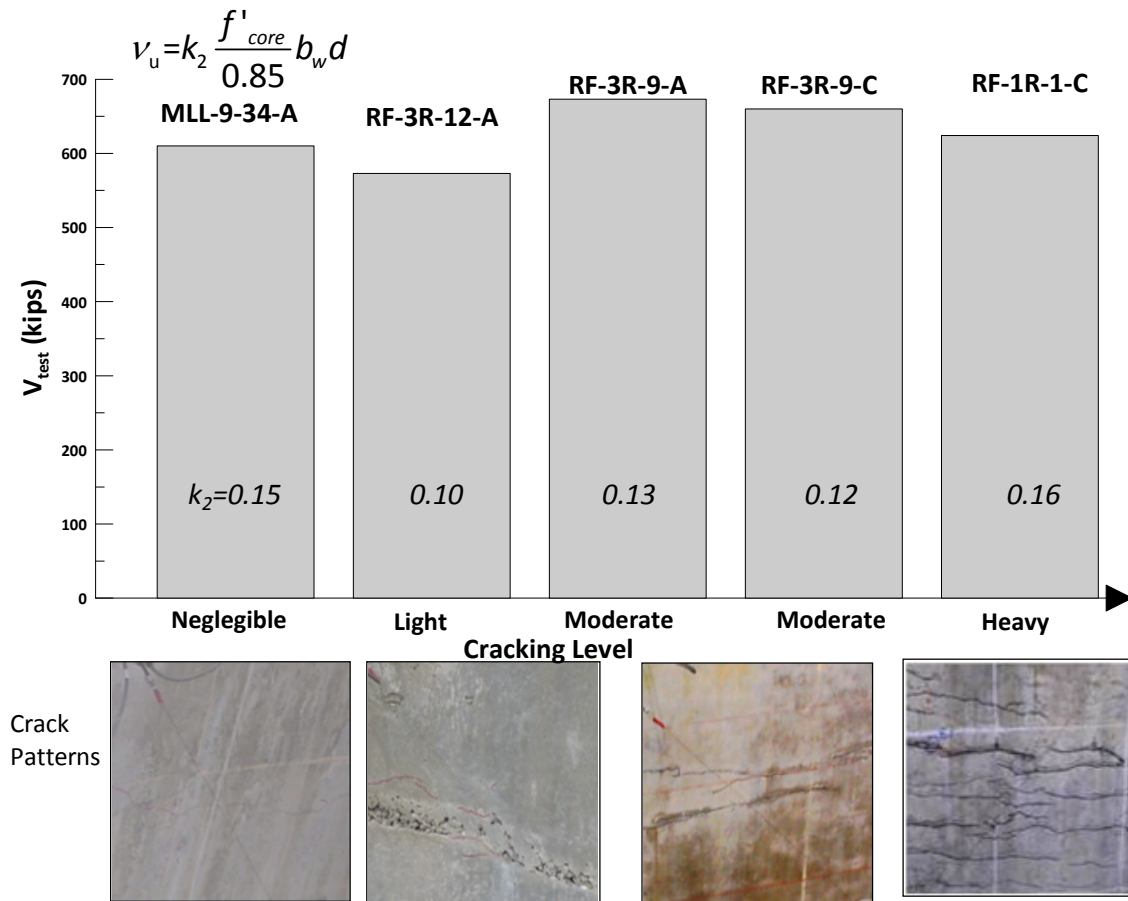
Figure 5.44 Relationship of V_{test} vs. cracking level

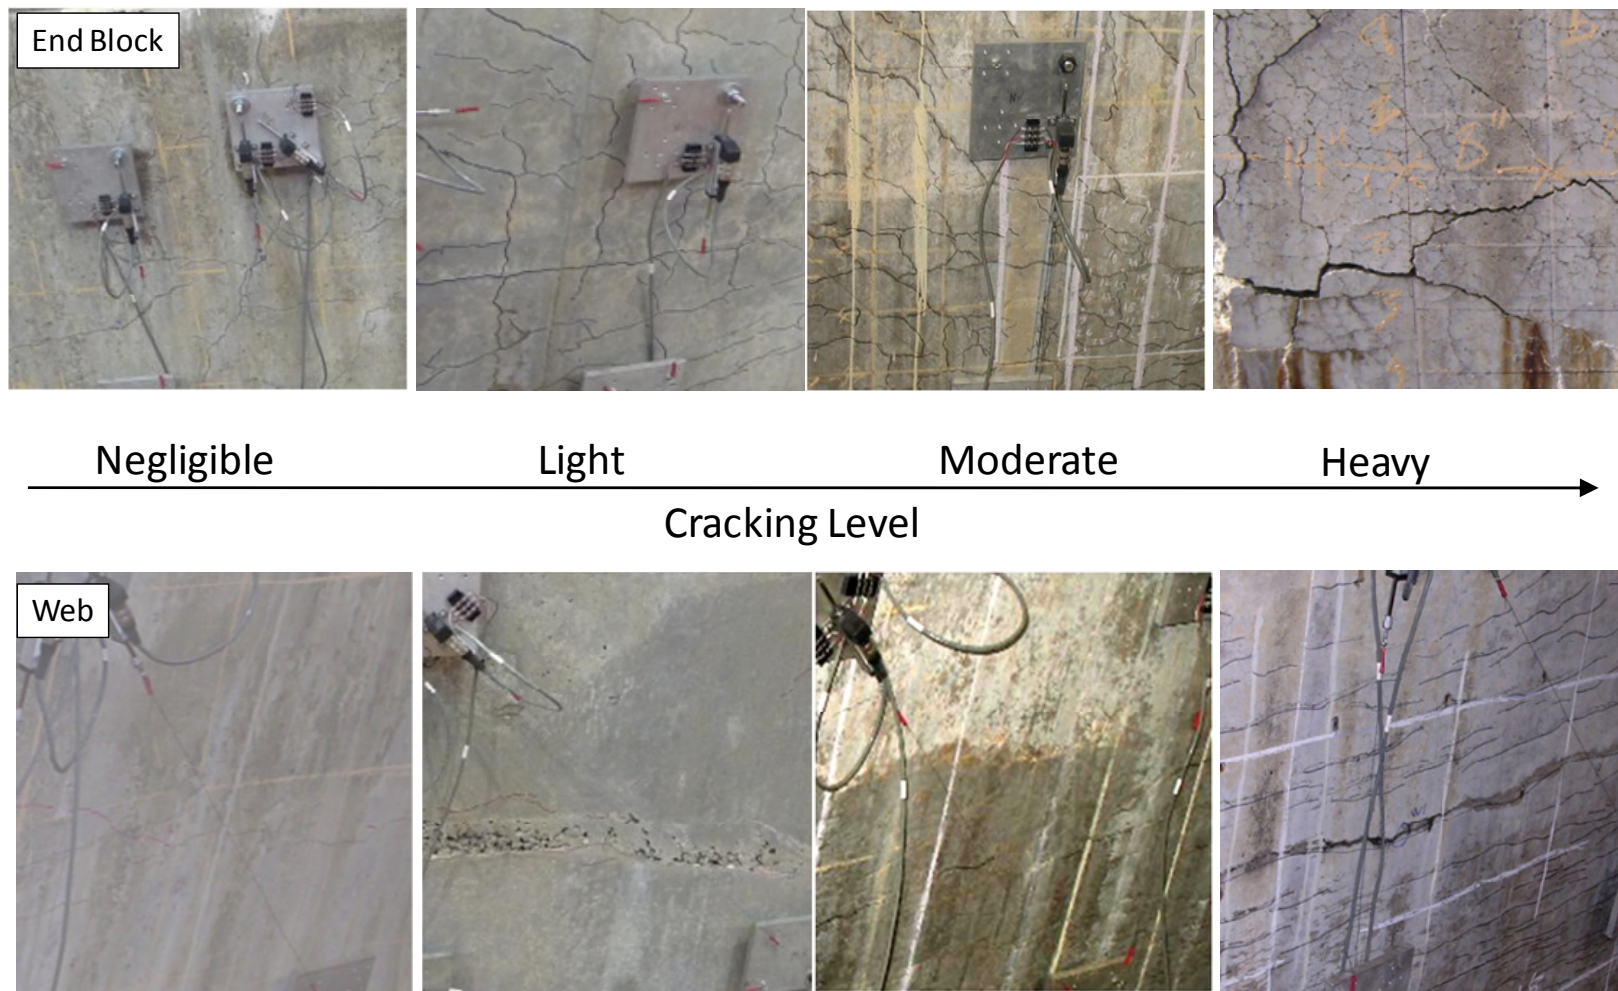
Figure 5.45 Cracking pattern in end block and web

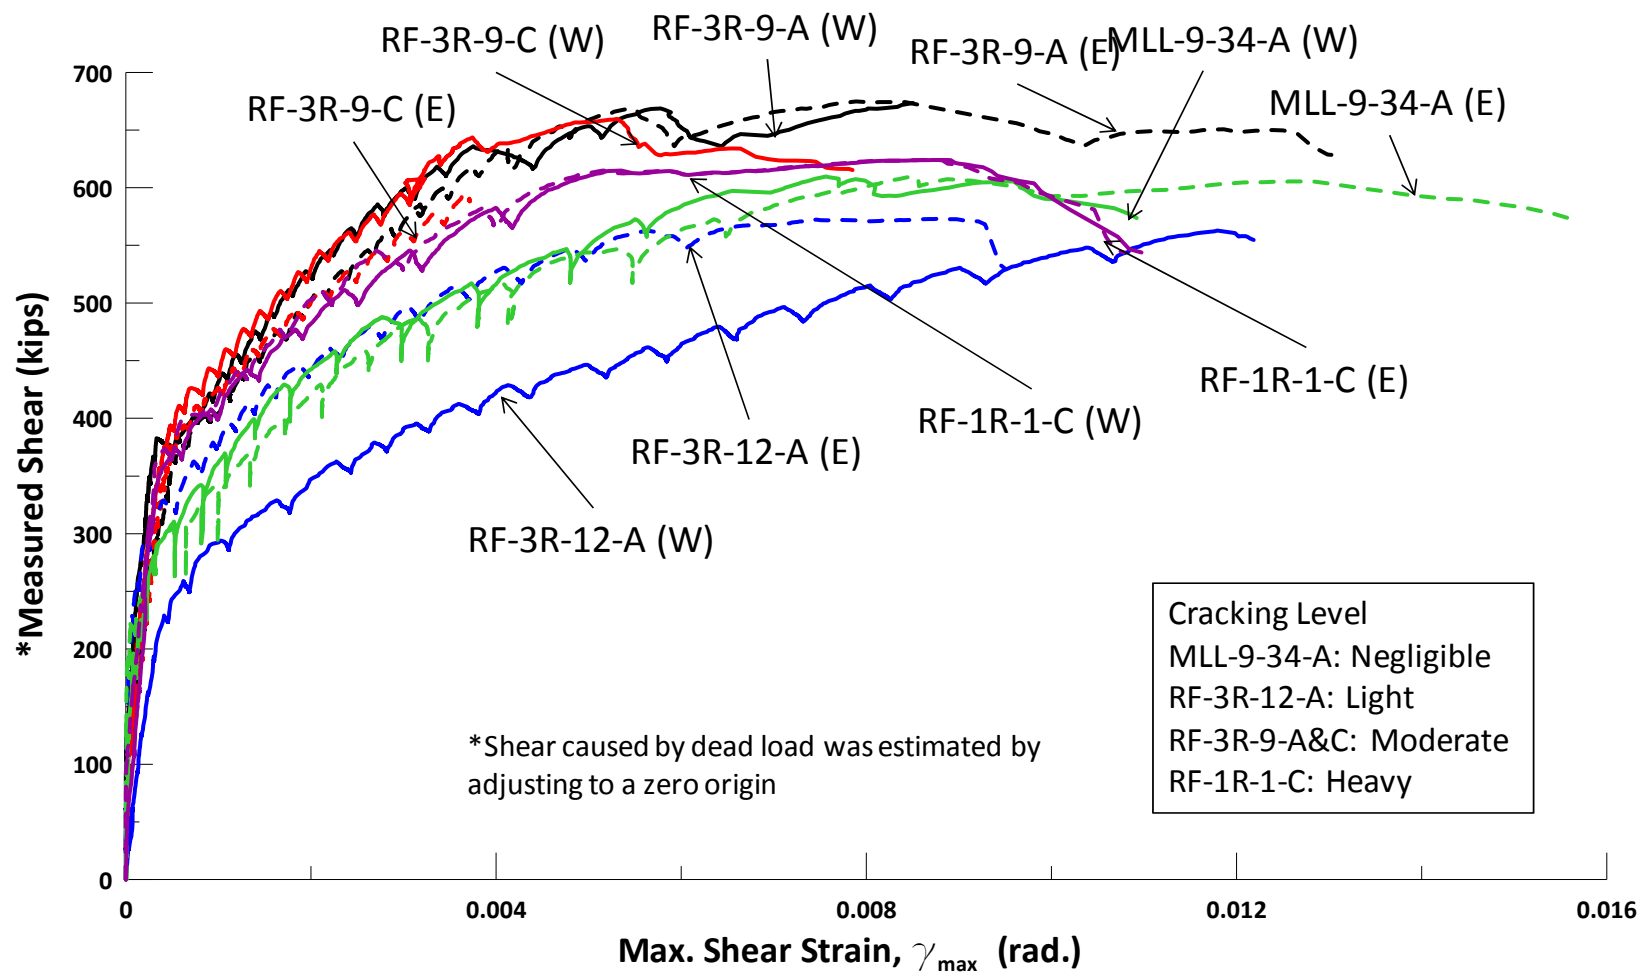
Figure 5.46 Comparison of maximum shear strains (γ_{max})

From Figure 5.46, it can be observed that RF-3R-12-A exhibited the most deformation, indicating that the cold joint significantly affected the behavior of the beam. The two beams with lower cracking (RF-3R-12-A and MLL-9-34-A) exhibited larger deformation than the other three beams with moderate cracking to heavy cracking.

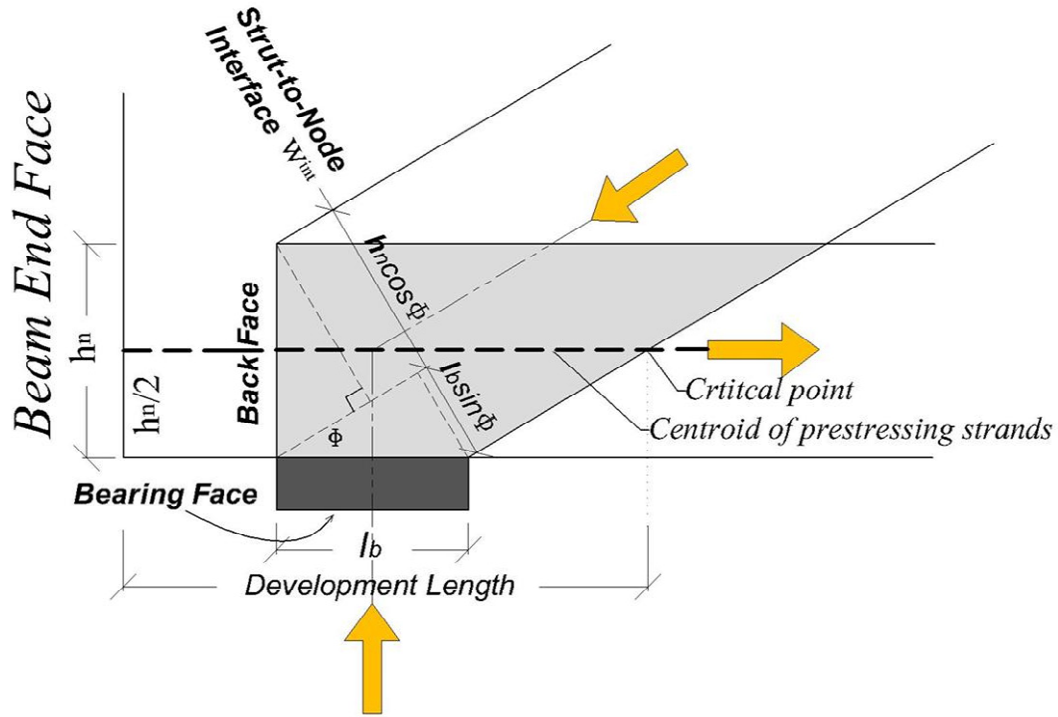
Figure 6.7 CCT node

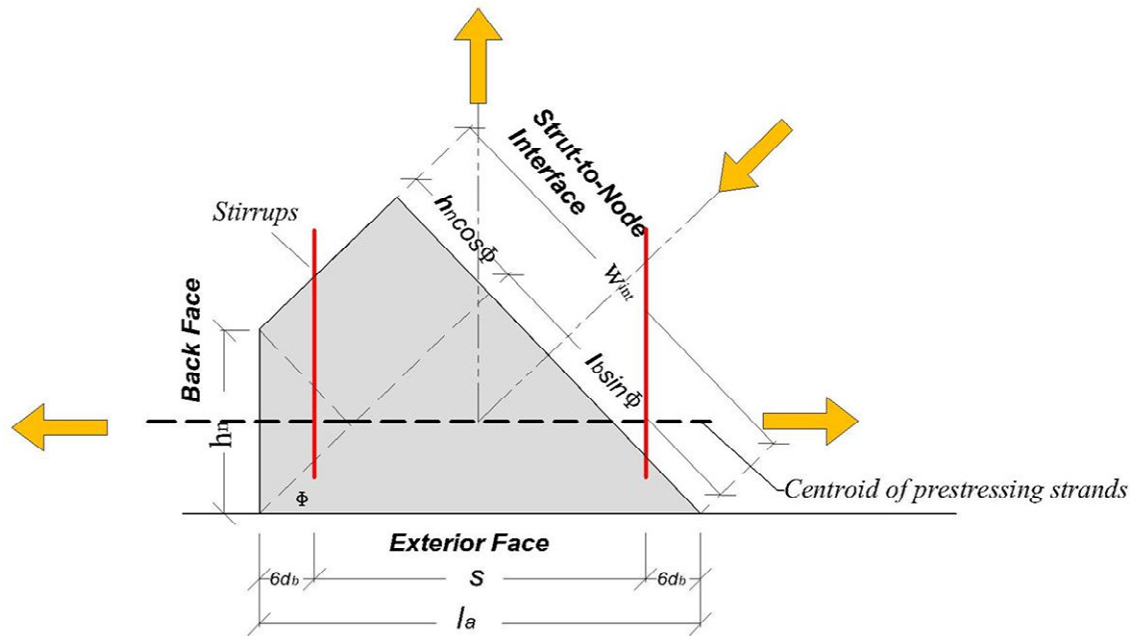
Figure 6.10 CTT node

The CTT node shown in Figure 6.2 is magnified and presented in Figure 6.10. This type of node is also an interior node, which is not bounded by a bearing plate. To proportion such a node, the number of the stirrups can be first determined in the same way as was done for the interior CCT node. After determining the number of the stirrups involved, the dimension of the exterior face, l_a , can be determined as the distance between two outermost stirrups plus $12d_b$ as recommended by AASHTO LRFD (2008), where nominal d_b is the diameter of the stirrup. The back face, h_n , of the node is calculated the same way as for an end support CCT node. Finally, the width of the strut-to-node interface can be determined as the CCC and end support CCT nodes. In fact, the CTT node is an interior node. Forces from the compression field fan out or smear and are equilibrated by vertical and horizontal tension ties. Therefore, as long as the strength of the stirrups is sufficient, the CTT node can be considered as a smeared node and does not need to be checked.

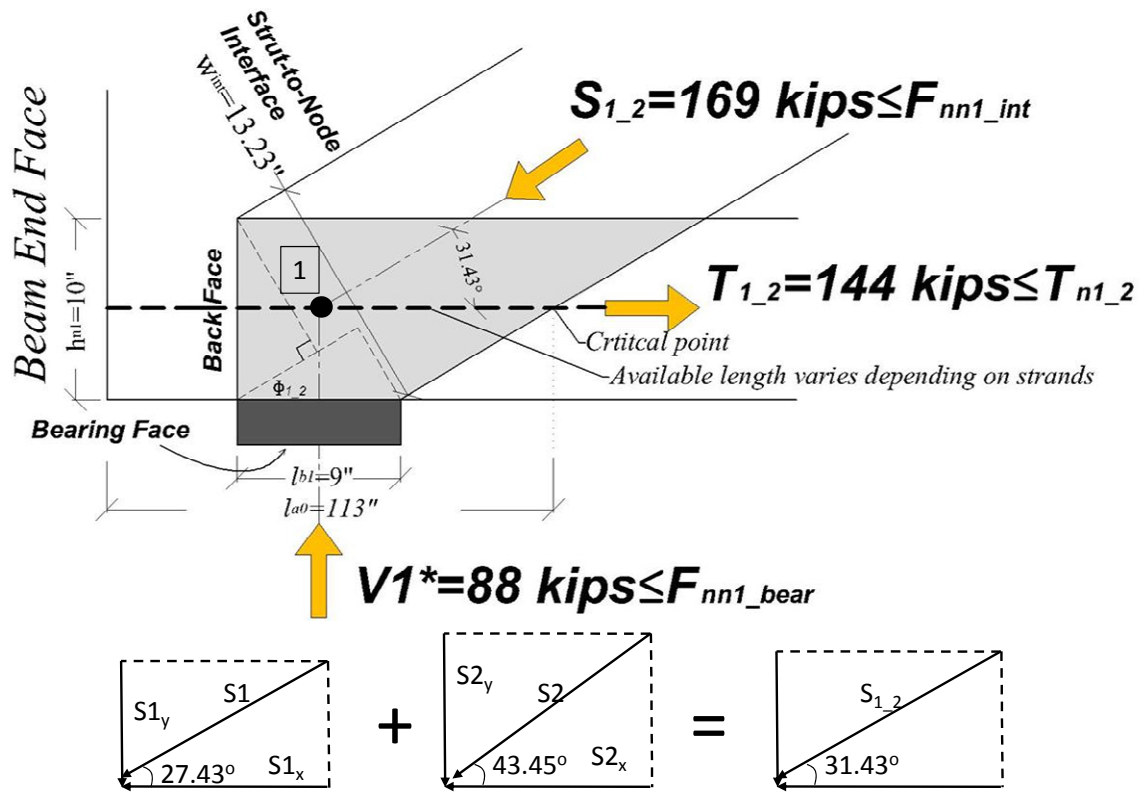
Figure 6.24 A close-up for the Node 1

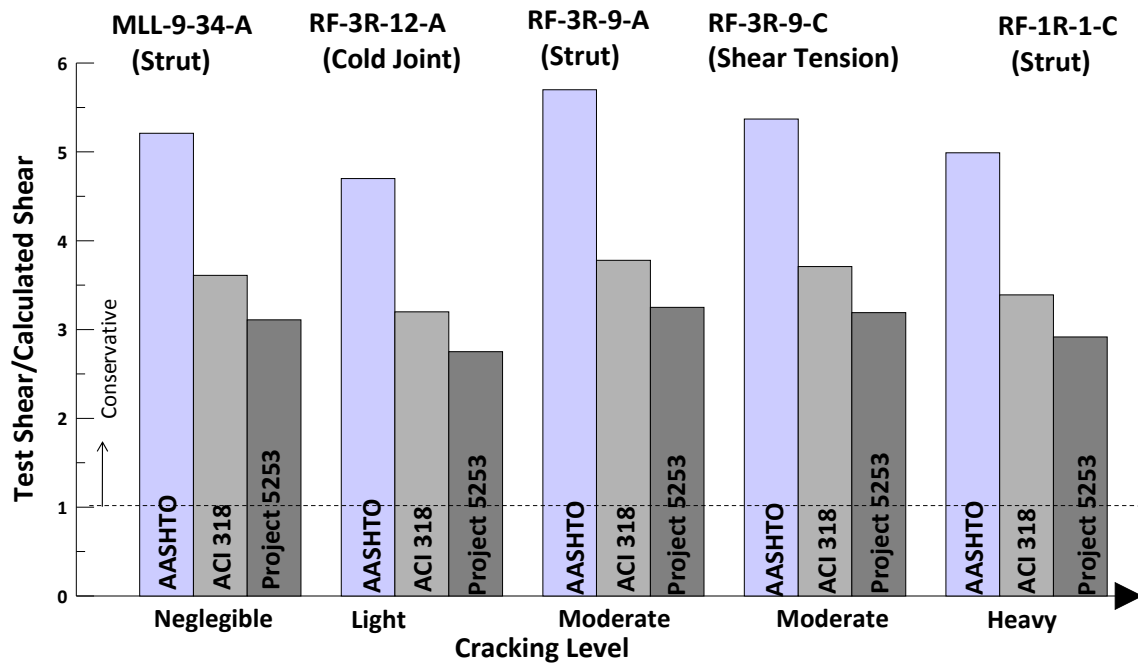
*All predicted failure modes are Strut Crushing.
Failure modes in parentheses are test failure modes.

Figure 6.29 Comparison of test to computed shear capacities using design strength

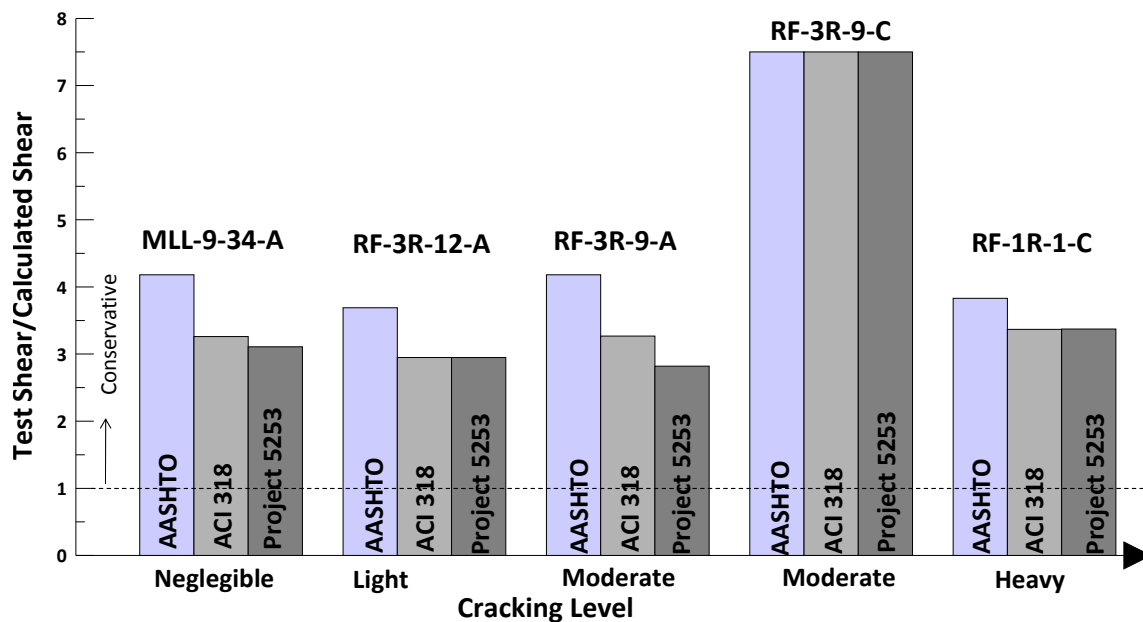
Figure 6.31 Comparison of test to computed shear capacities using design strength

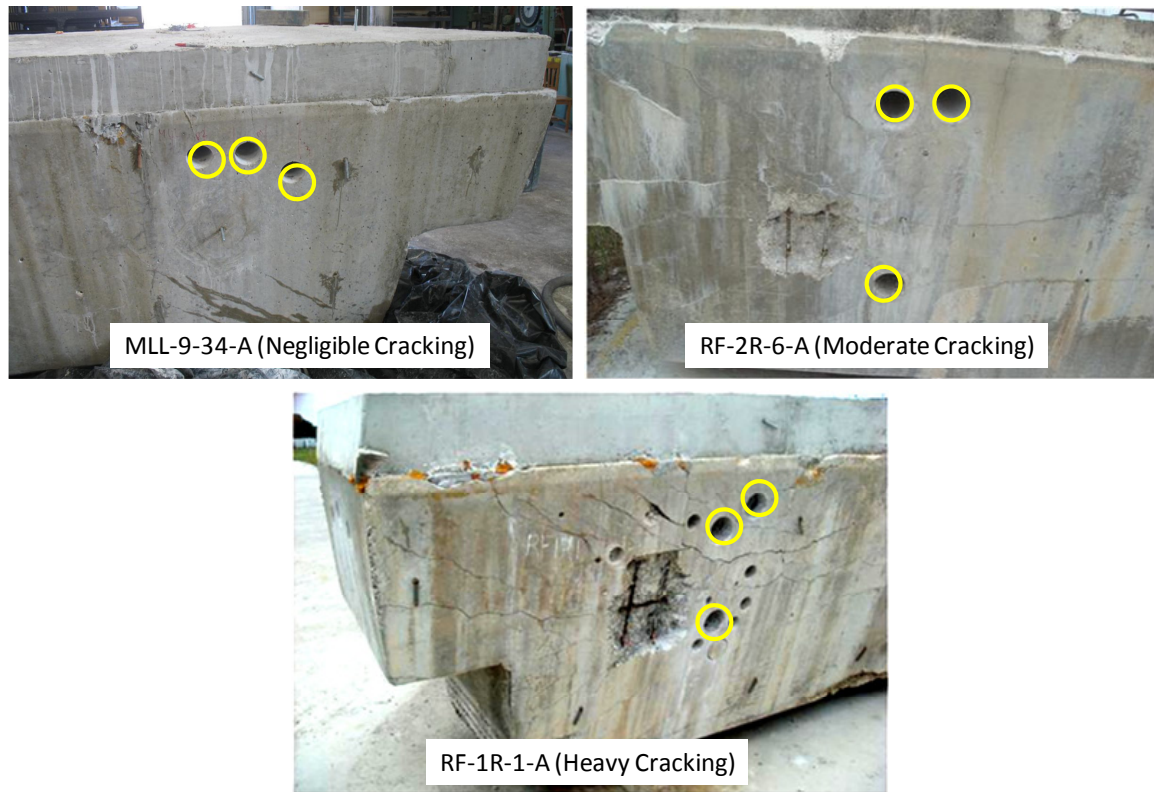
Figure 7.1 Location of the cores
