**Shear Performance of ASR/DEF Damaged Prestressed Concrete
Trapezoidal Box Bridge Girders**

Dissertation

The University of Texas at Austin

August, 2010

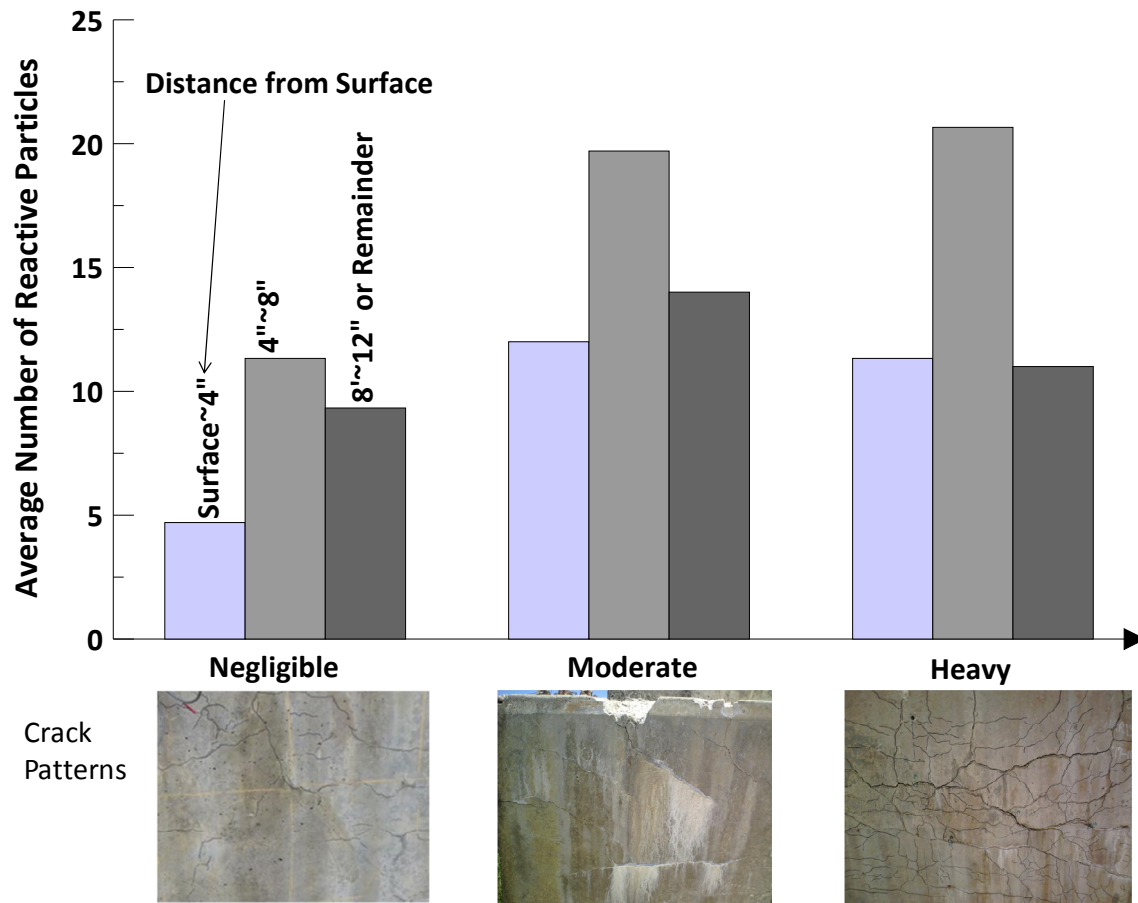
Figure 7.5 Comparison of reactive particles throughout the length of the cores

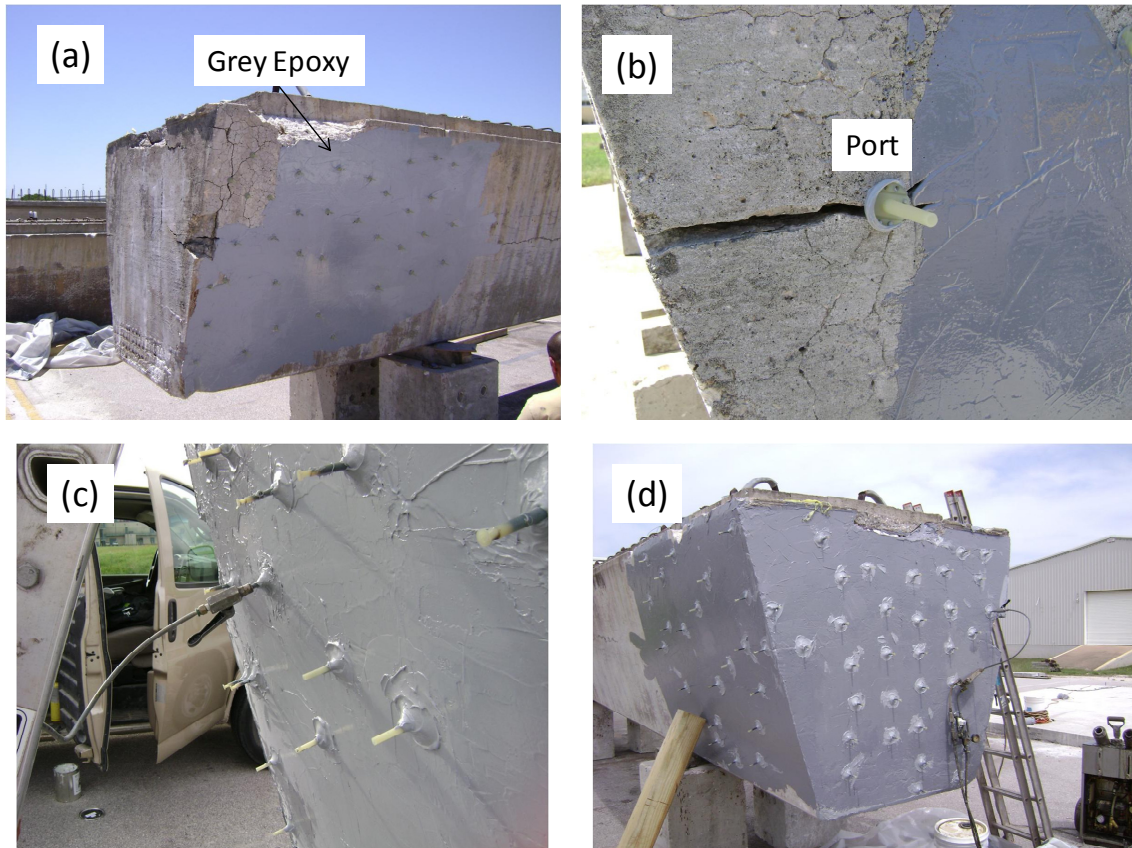
Figure 7.6 (a) Grey epoxy coating (b) Port at the large crack (c) Epoxy injection (d) Finished overview

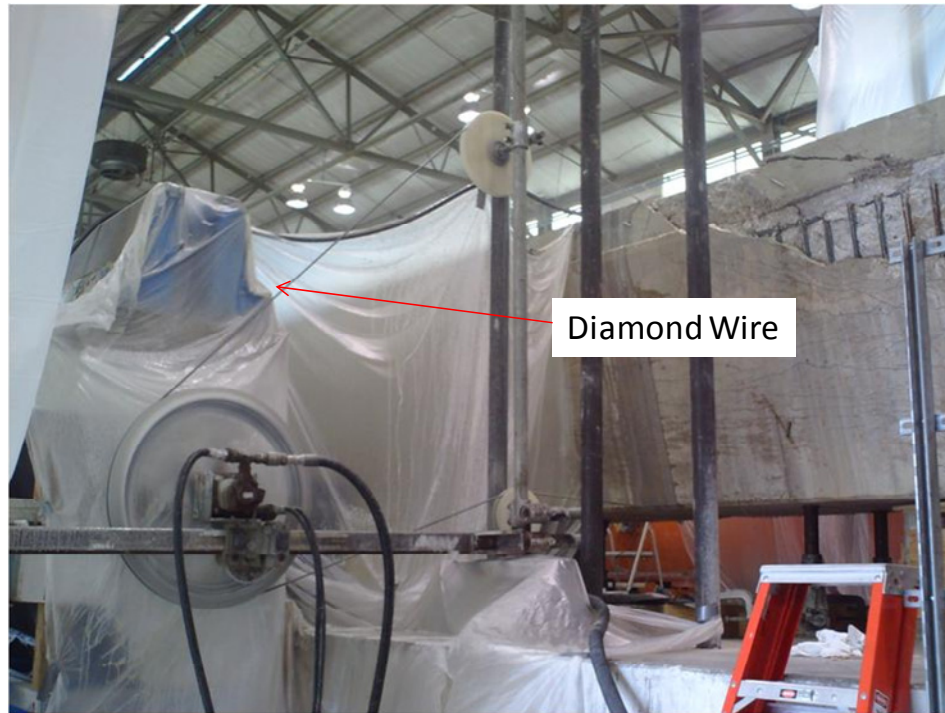
Figure 7.7 Diamond wire saw

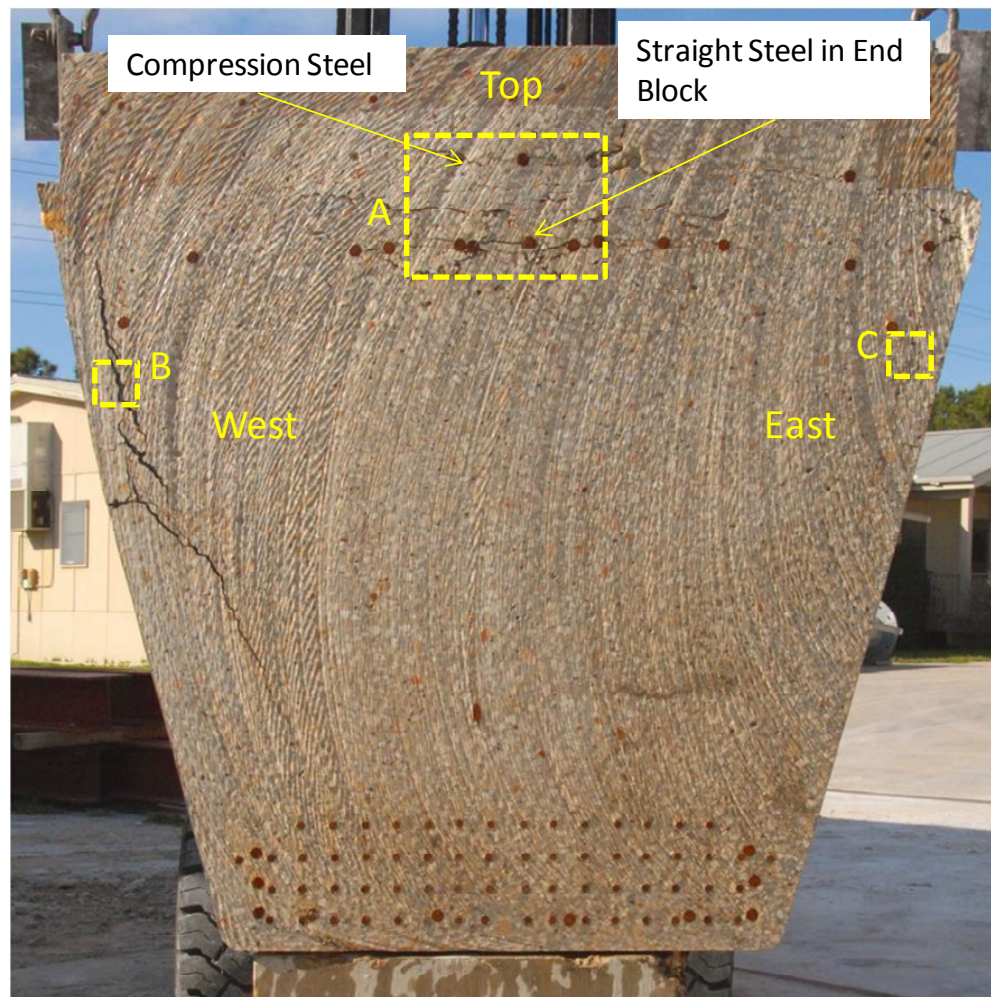
Figure 7.9 Overview and details of Section A

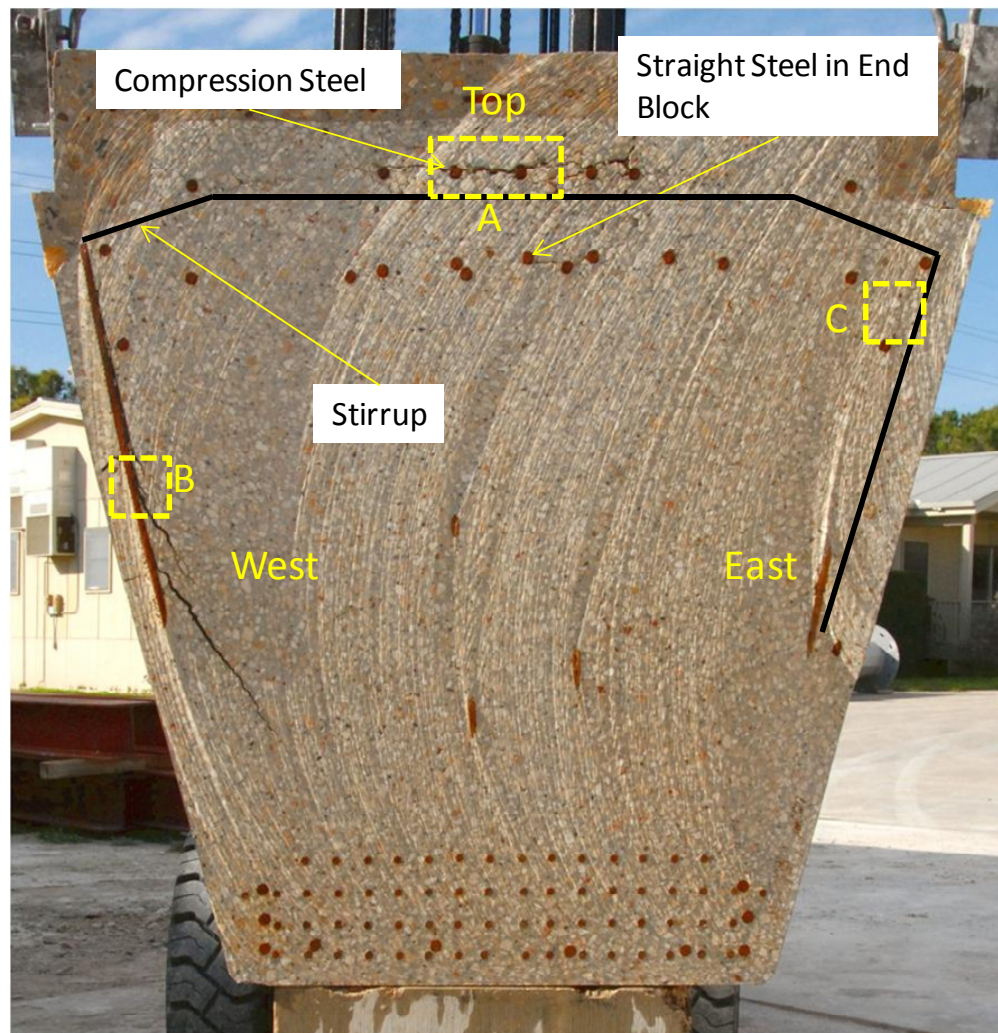
Figure 7.11 Overview and details of Section B

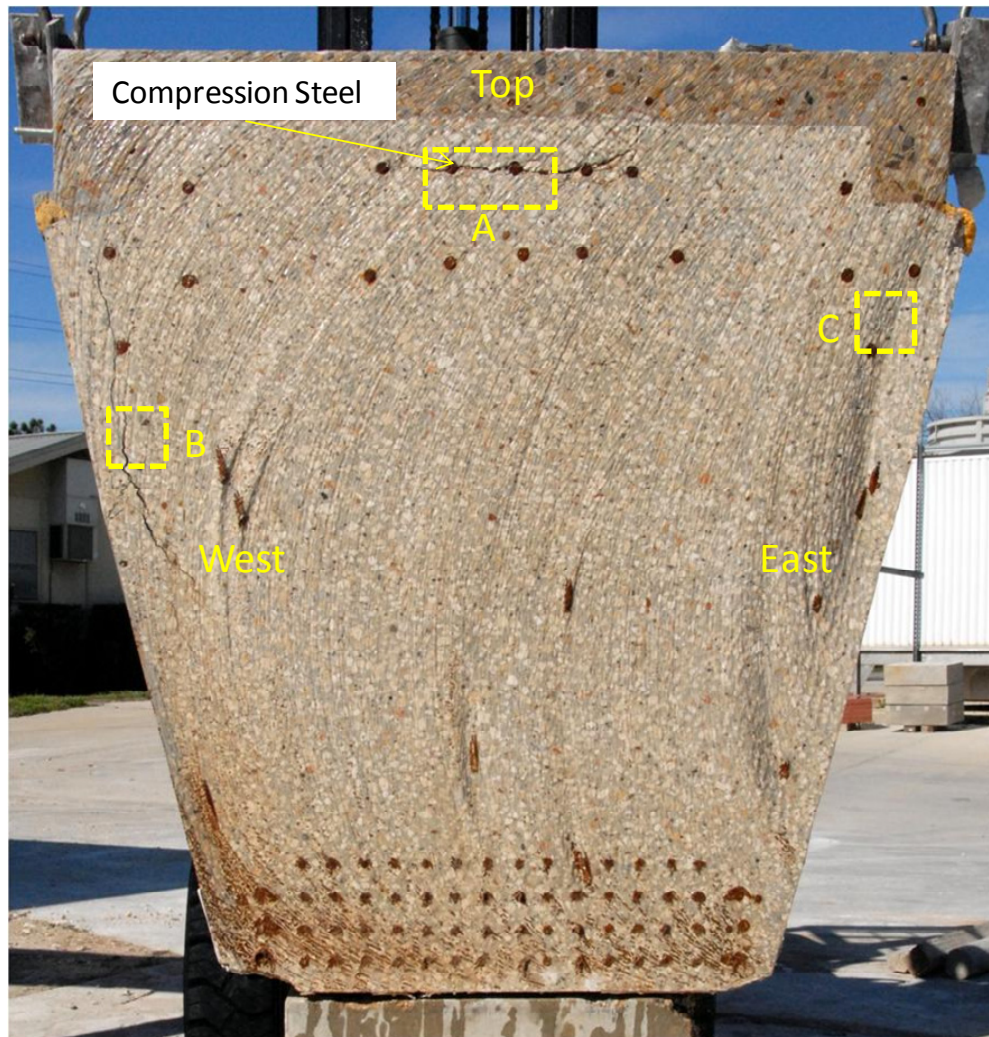
Figure 7.12 Overview and details of Section C

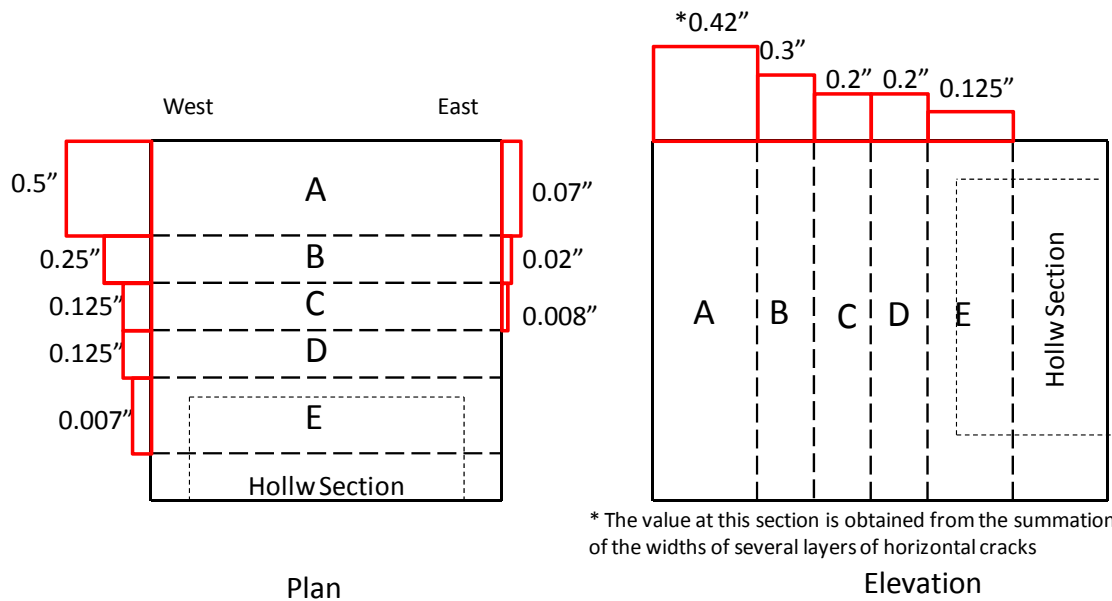
Figure 7.15 Summary of the crack widths

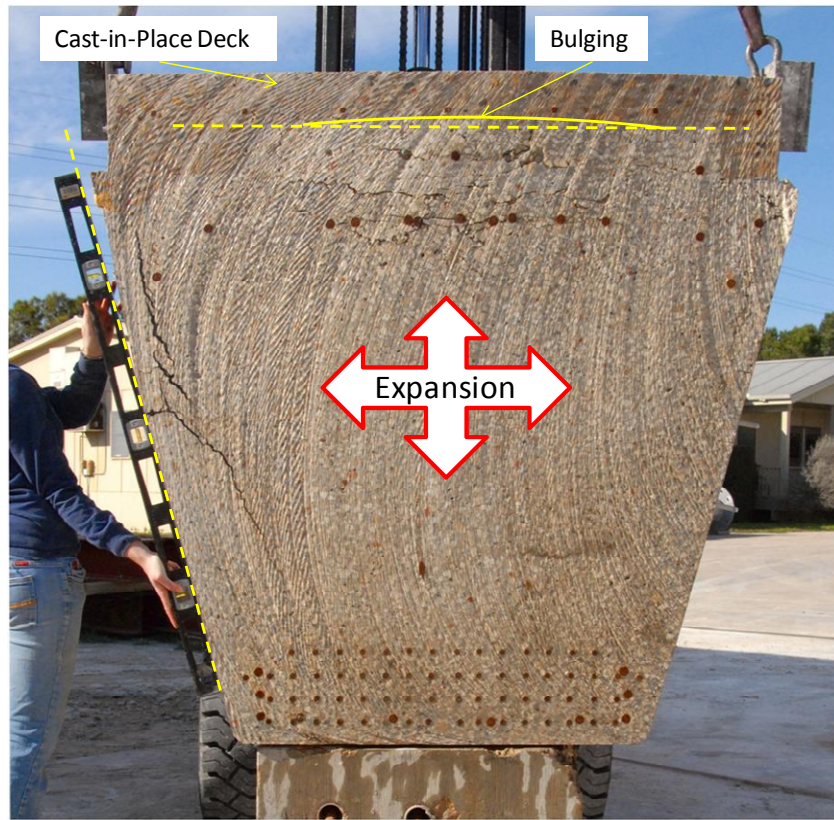
Figure 7.16 Bulging in Section A

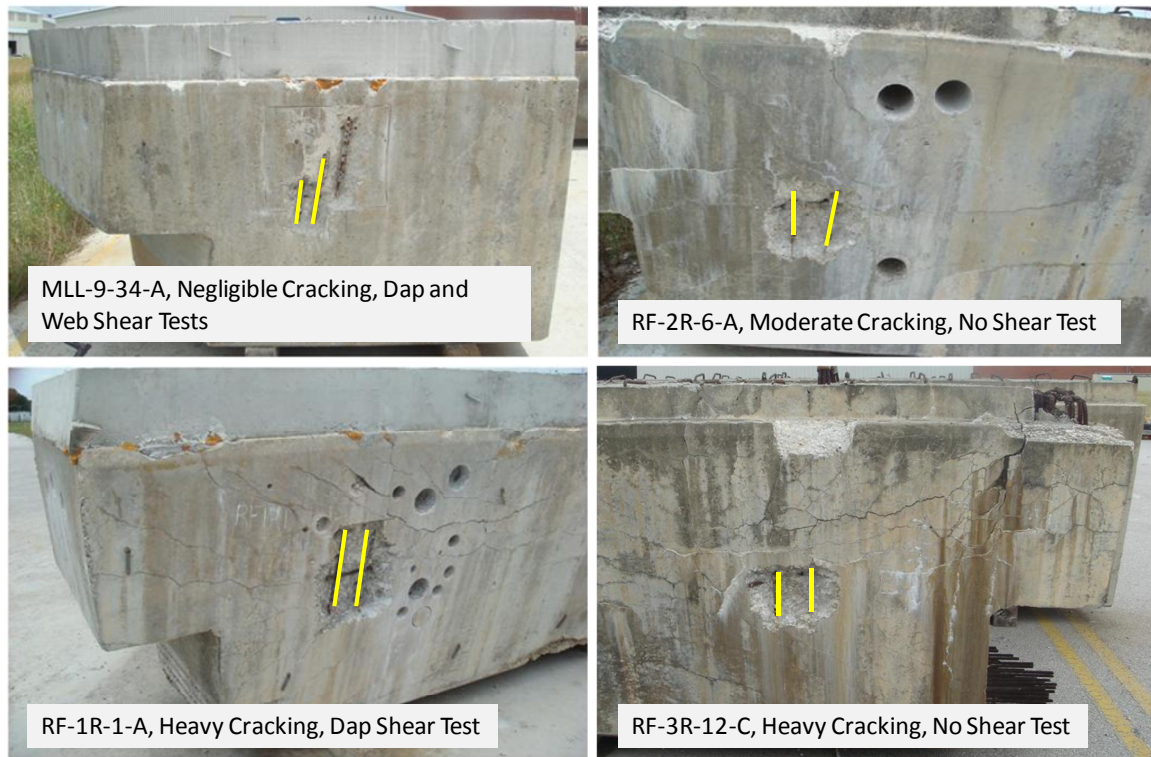
Figure 7.20 Locations of tested steel and cracking condition

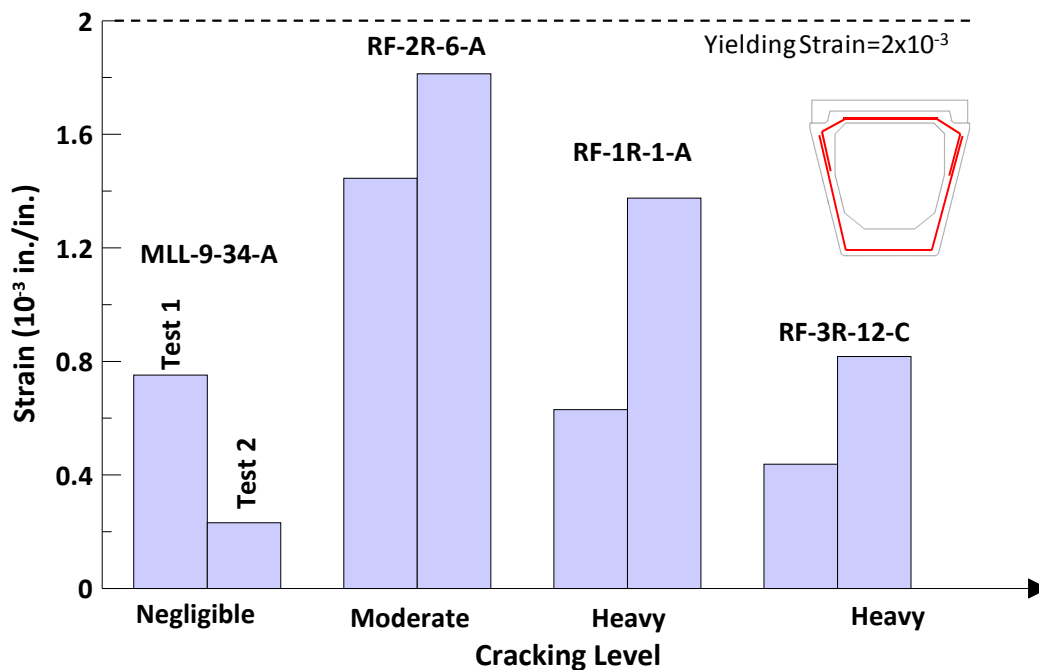
Figure 7.21 Comparison of results from elastic rebound tests

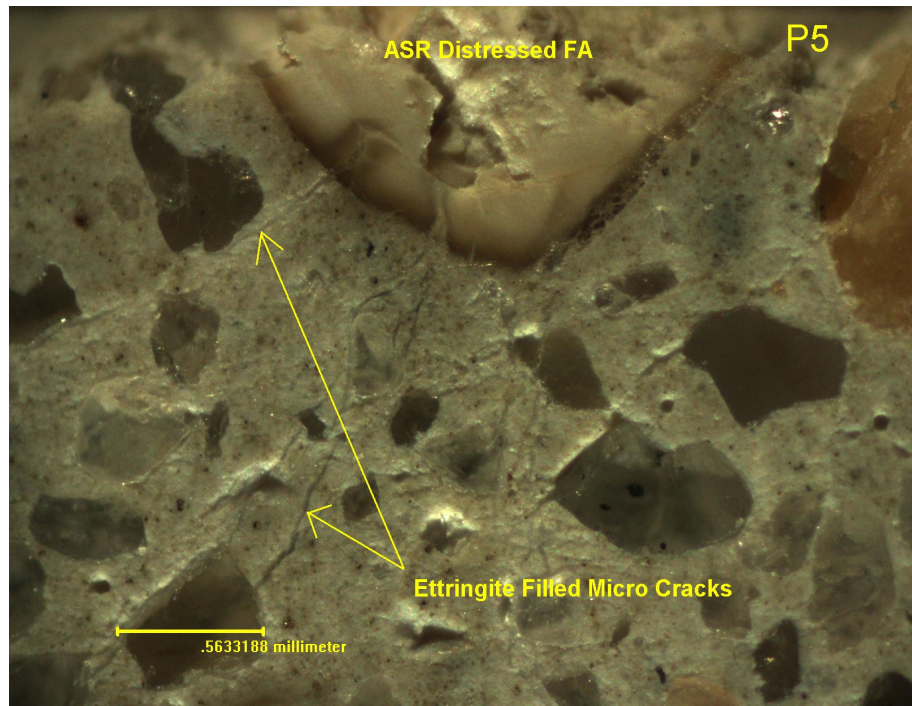
image illustrating ettringite filled gap surrounding fine aggregate

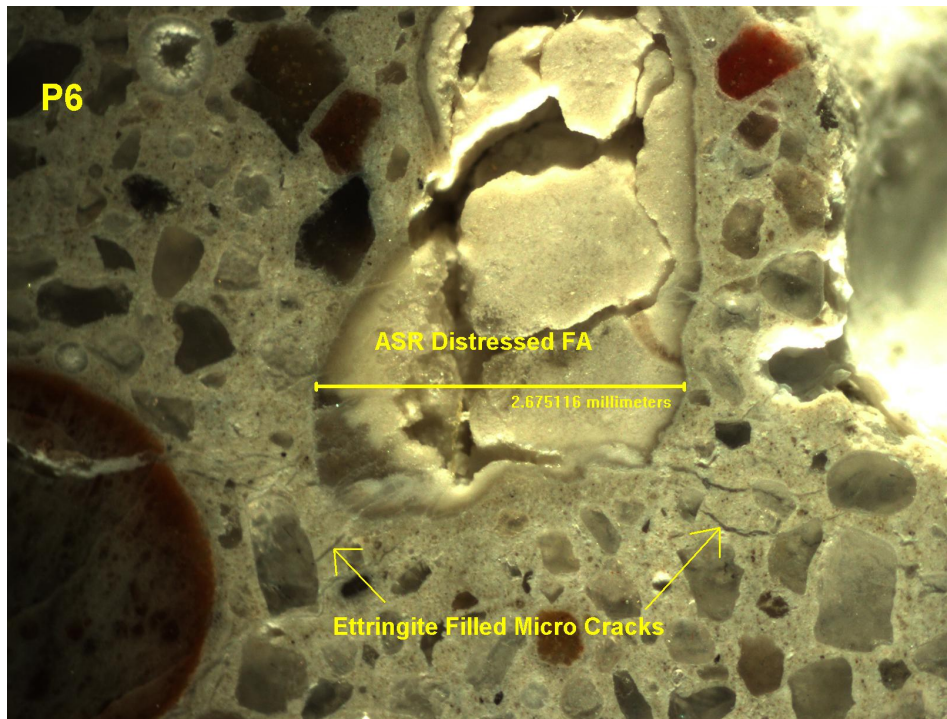
Image illustrating fine network of ettringite filled micro cracks and ASR distressed fine aggregate

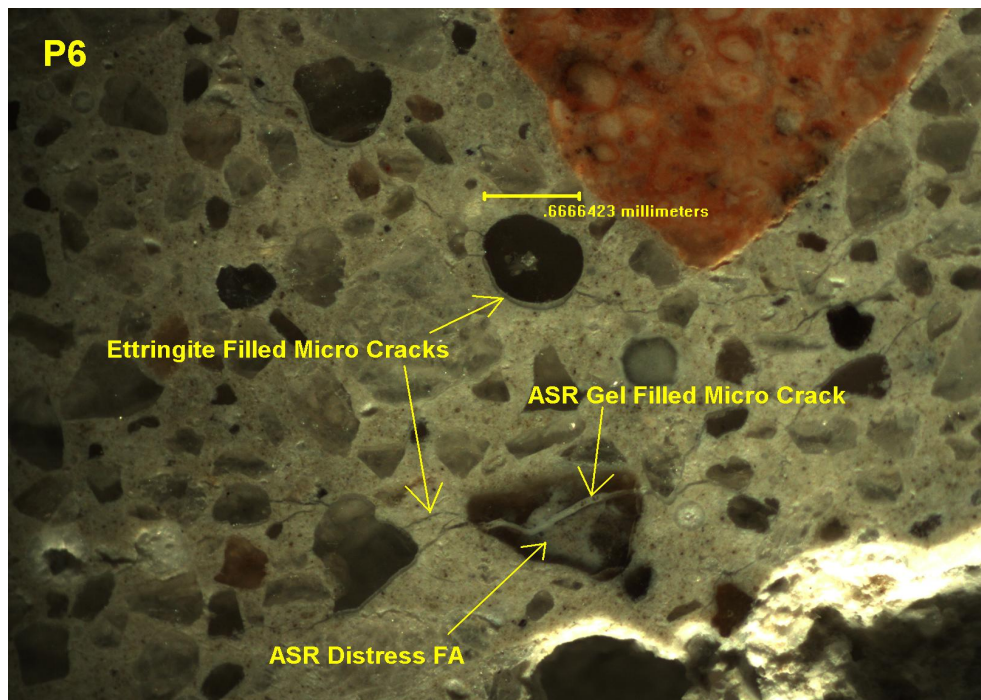
Image illustrating ettringite filled micro cracks

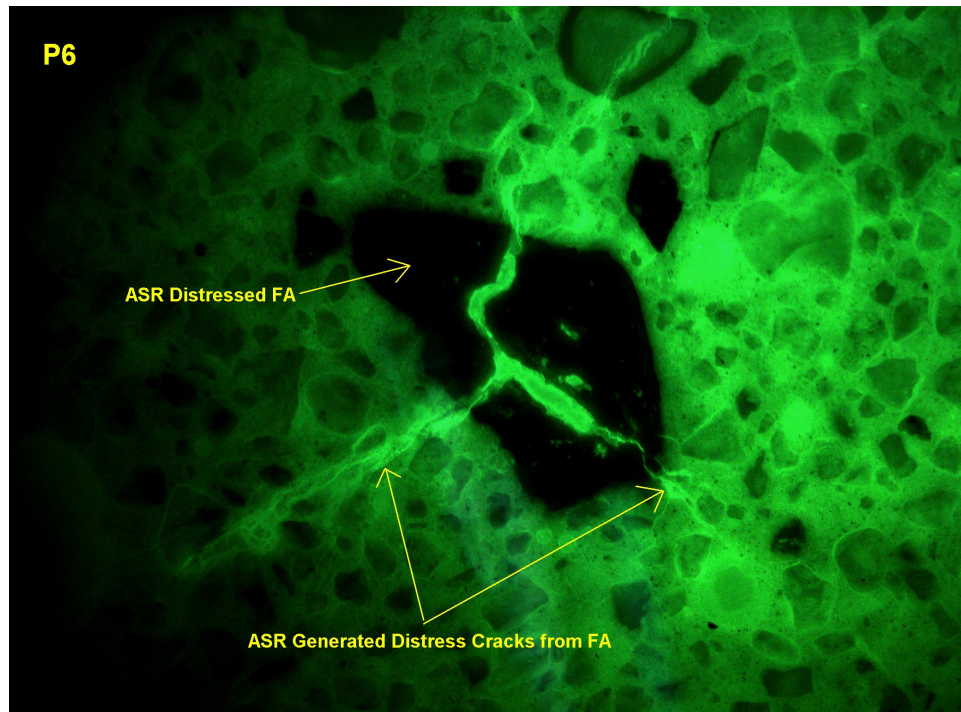
ASR distress fine aggregate

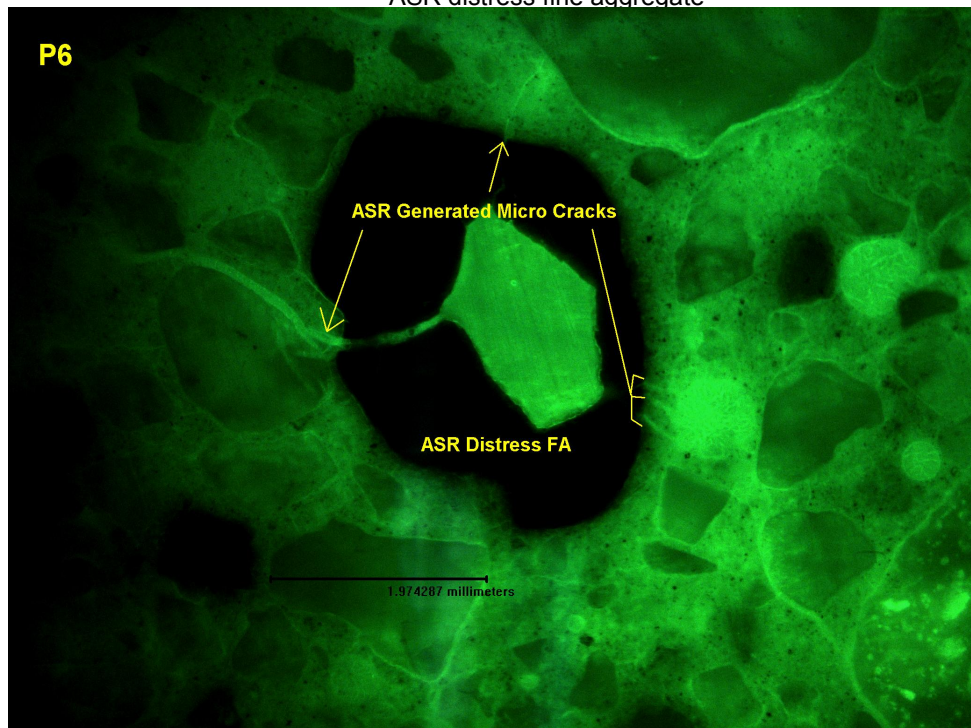
Highly distressed fine aggregate illustrating radial distress cracking

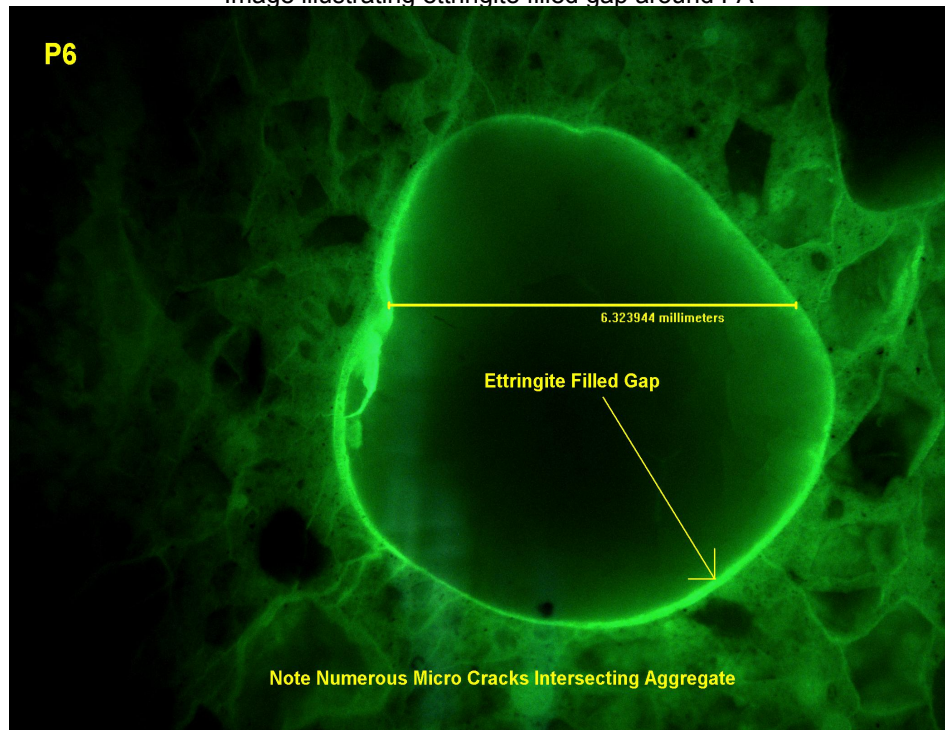
Image illustrating intersection of ettringite filled micro cracks

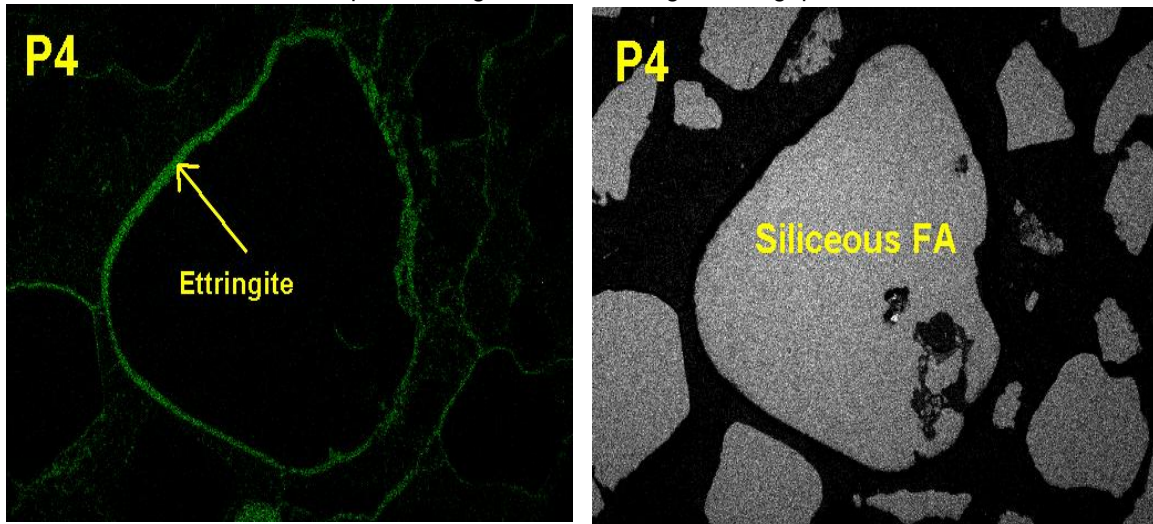
Image illustrating numerous ettringite filled micro cracks
