**Investigating the Causes of Missing Field Detected Issues from BIM-
Based Construction Coordination Through Semi-Structured Interviews**

Thesis

The University of Texas at Austin

May 2021

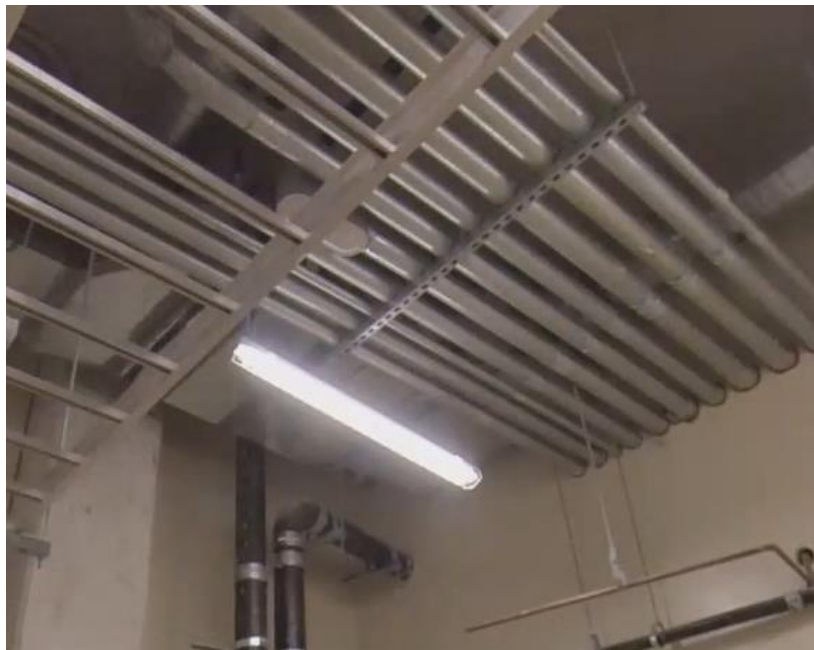
Figure 7: Electrical conduits that preventing the accessibility to the air handling unit.

Example: The AC unit, which is the element in light blue in Figure 6, requires maintenance accessibility, so the red box is supposed to provide the clearance required for the air handling unit; however, because of the electrical lines below that clearance a technician can't access that AC unit. Figure 7 shows an actual photo of that after construction and figuring out it is an issue. Hence, the project team had to fix this by lowering the air handling unit below the level of electrical conduits.

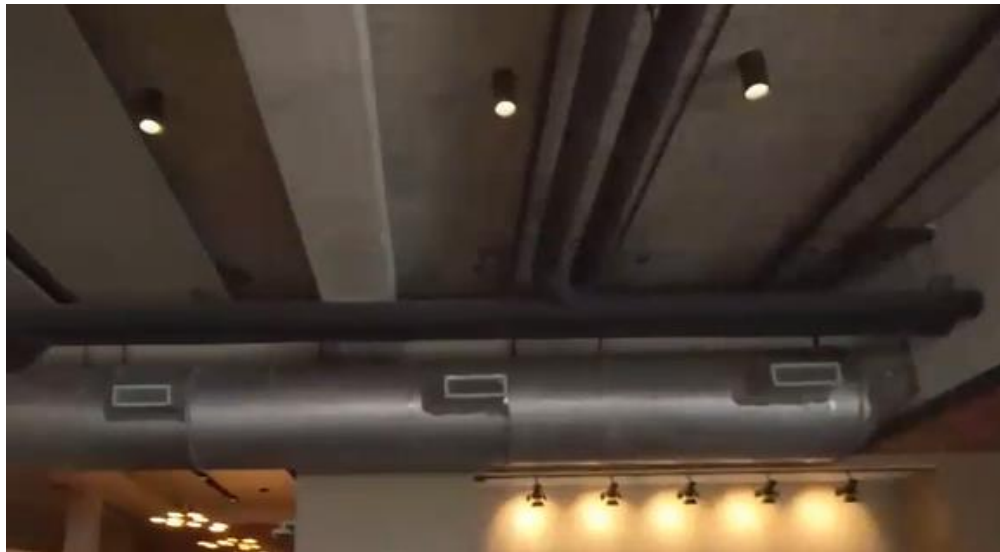
Figure 8: The lighting from light fixtures is blocked by an HVAC duct.

Example 1: Mechanical ductwork was found blocking the lighting from the light fixtures above it, as shown in Figure 8. This was not an issue that can be found in the automatic clash detection process, it was caught only when the duct was installed. To resolve this, they had to change the location and the type of light fixtures so they can be hanged in pendants to bring them below the ductwork, and since the lights were planted in the concrete floor they had to chip and expose the wires to move the lights to the new location.

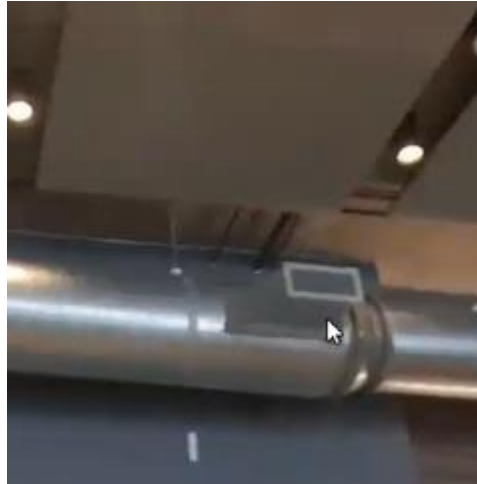
Figure 10: Ceiling fabric system moved away from the hangers.

Example: Duct hangers were clashing with ceiling fabric, as can be seen in figure 9, which was neglected because typically hangers clash with the ceiling. But because the ceiling material was fabric, this clash was not easily fixed in the field. The subcontractors ended up moving the fabric to allow the hangers through, as depicted in figure 10, by cutting the plywood used for the fabric
