**Experimental Testing of a Steel Gravity Frame with a Composite Floor
under Interior Column Loss**

Thesis

The University of Texas at Austin

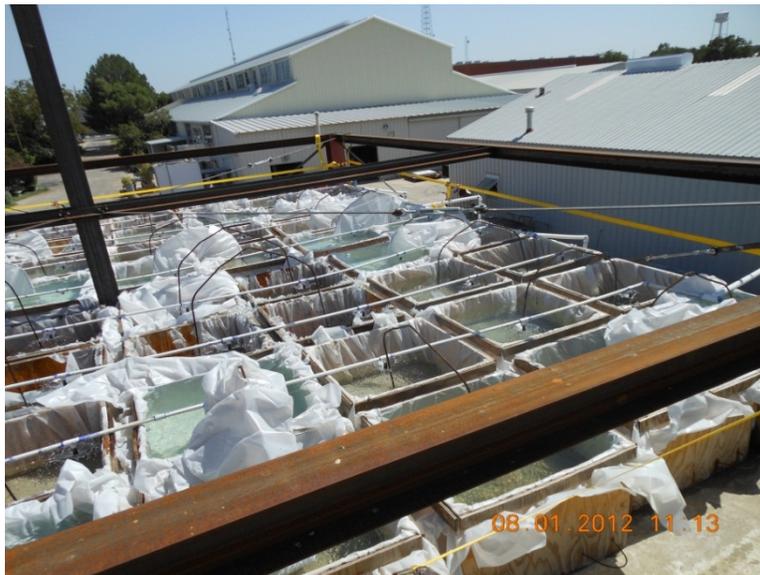
Figure 3-3: View of Loading Buckets at Completion of Test 1

It can be seen in Figure 3-3 that some buckets have reached their full capacity and are beginning to overflow while the water level in others is several inches below the top.

The buckets were stored outdoors in the months before testing and the waterproof lining in some buckets was damaged by the exposure, resulting in the problems with leakage.

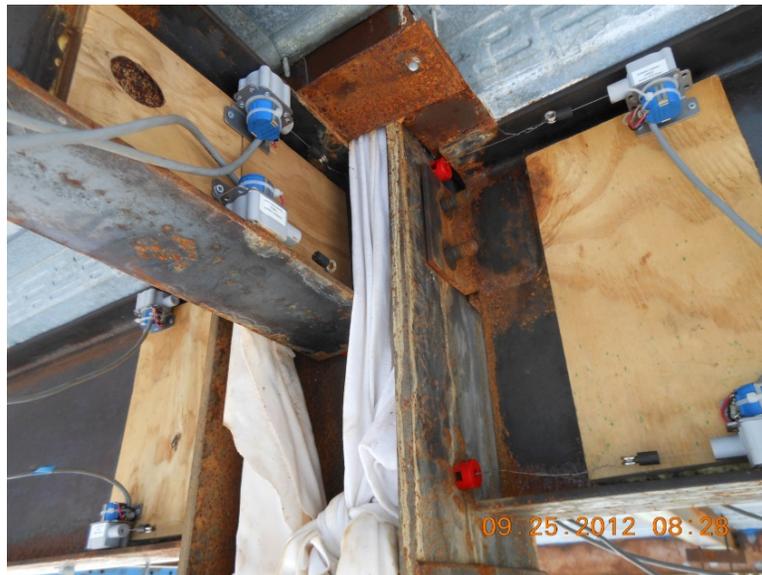
Figure 3-6 - Girder-Column Connection with Nuts Removed

Figure 3-6 shows the girder-to-column connection after removal of the nuts.

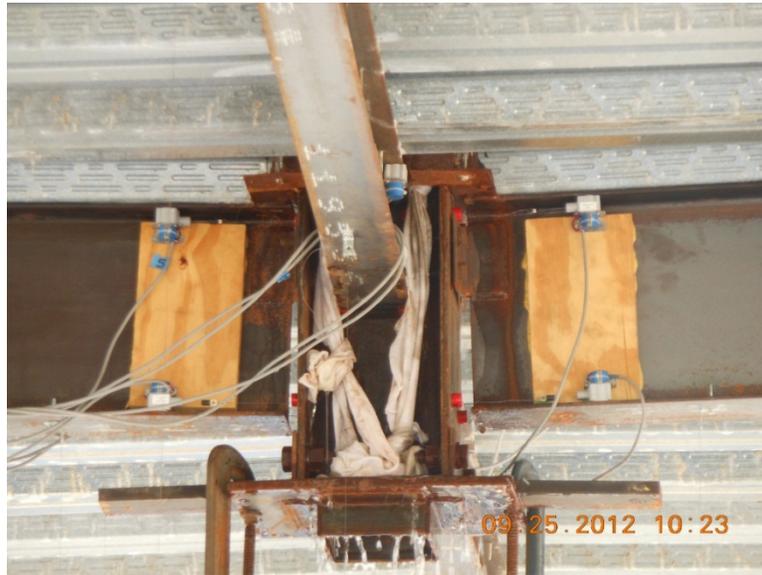
Figure 3-7 - Central Connection during Test 3

Figure 3-7 shows how little separation occurred between the angles and the column despite the removal of the nuts. The beam and girder rotations measured in each test are discussed in the next chapter.

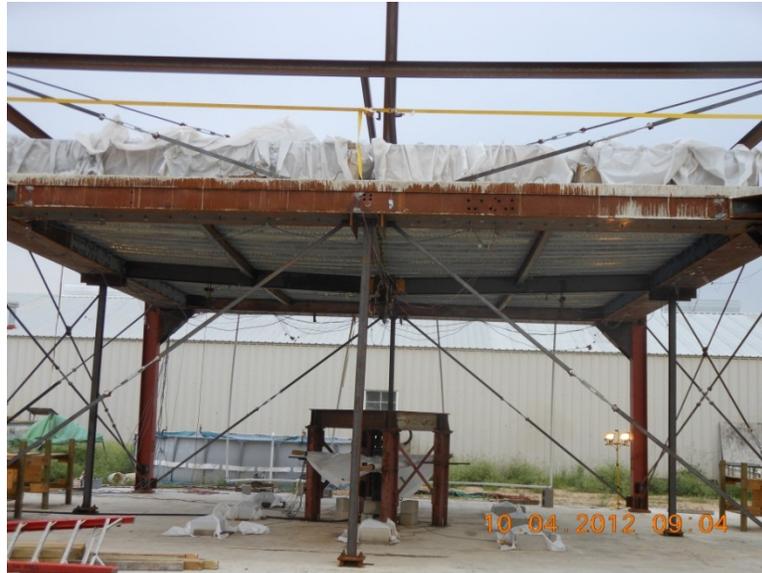
Figure 3-8 - Test Specimen before Test 4

Figure 3-8 shows the structure just before water loading began for Test 4. The actuator has already been fully retracted and the floor system can be seen visibly sagging in the center.

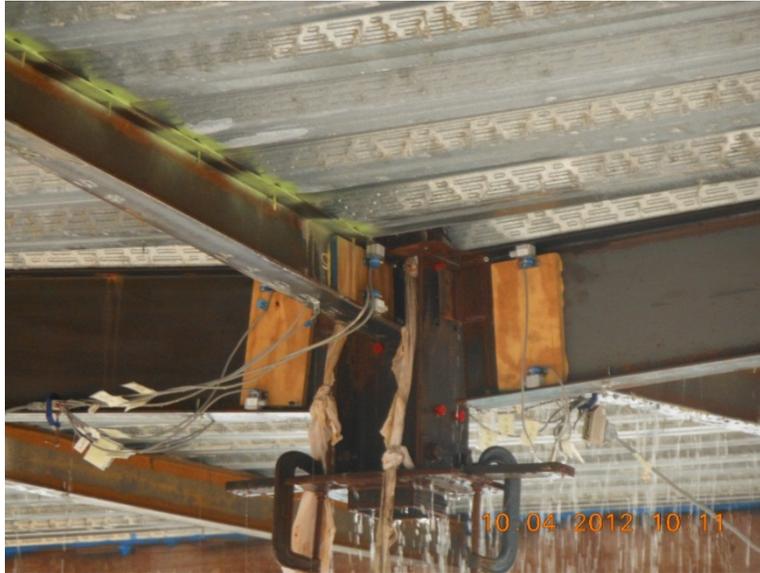
Figure 3-9 - Central Connection during Test 4

Figure 3-9 shows a photo taken only minutes before the final collapse. The rotation of the framing members at the central connection indicates the high level of displacement. The beams appear to be undergoing primarily rigid body motion. The proportion of rigid body motion and flexural deformation is investigated further in Chapter 4 using the data collected by beam instrumentation.

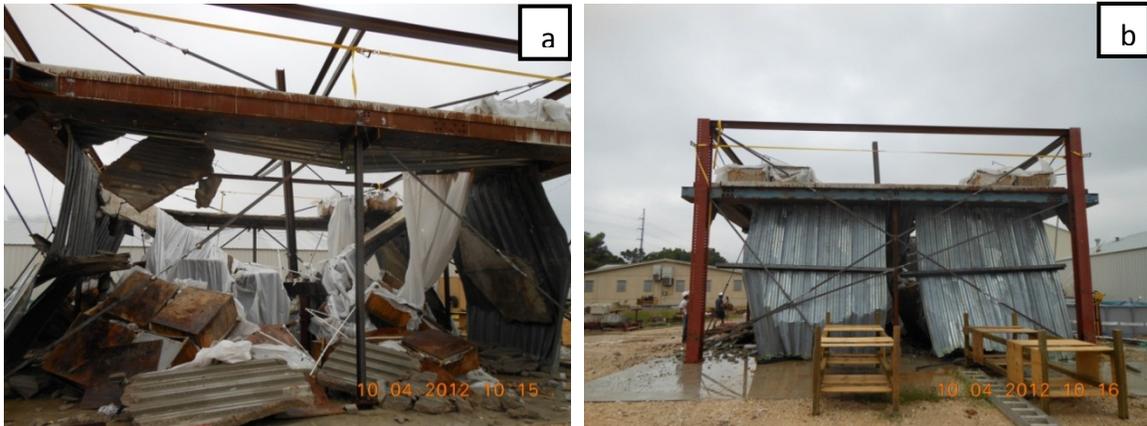
Figure 3-10 - Test Specimen after Collapse

initiated by tear out at a longitudinal seam of the corrugated steel decking. Collapse was essentially instantaneous after this failure.

Figure 3-10 shows the structure after total collapse. The lack of damage to the corrugated steel decking suggests that it failed along the longitudinal seam. Close examination of the video footage of the failure supports this interpretation. In Figure 3-10a, the steel decking appears to have torn along a side lap during collapse. The secondary beams can be seen hanging from the steel decking in Figure 3-10b.

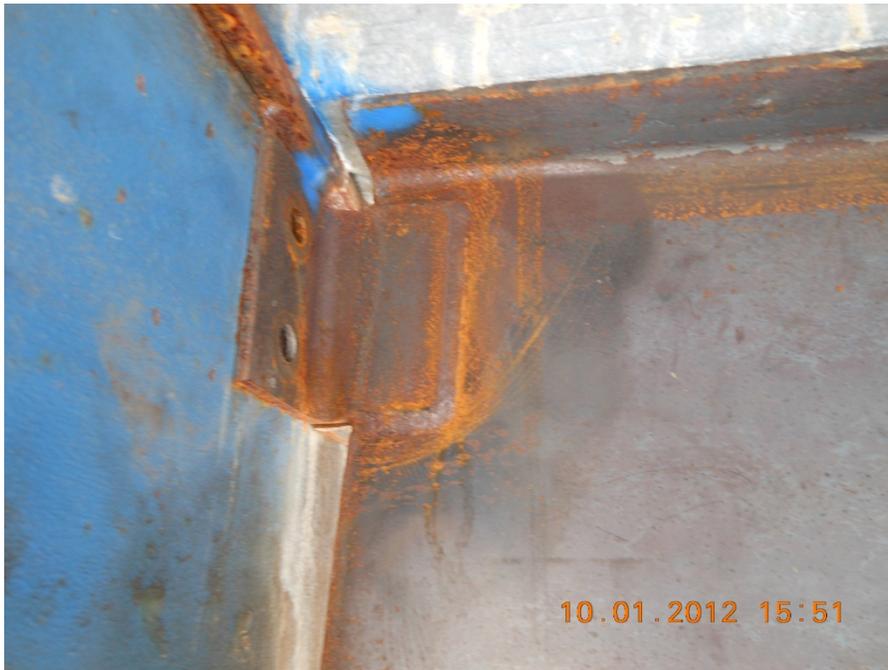
Figure 4-41: Girder to Ring Beam Connection after Test 3

This inconsistency may indicate some problems in the measurements or calculations of rotation. Slip in the decking system may also be contributing to unexpected deformation in the specimen. Figure 4-41 shows the connection of the girder to the ring beam after the completion of the third test. The slip at the top flange of the girder is visible. Further experimental research is necessary to investigate this behavior.

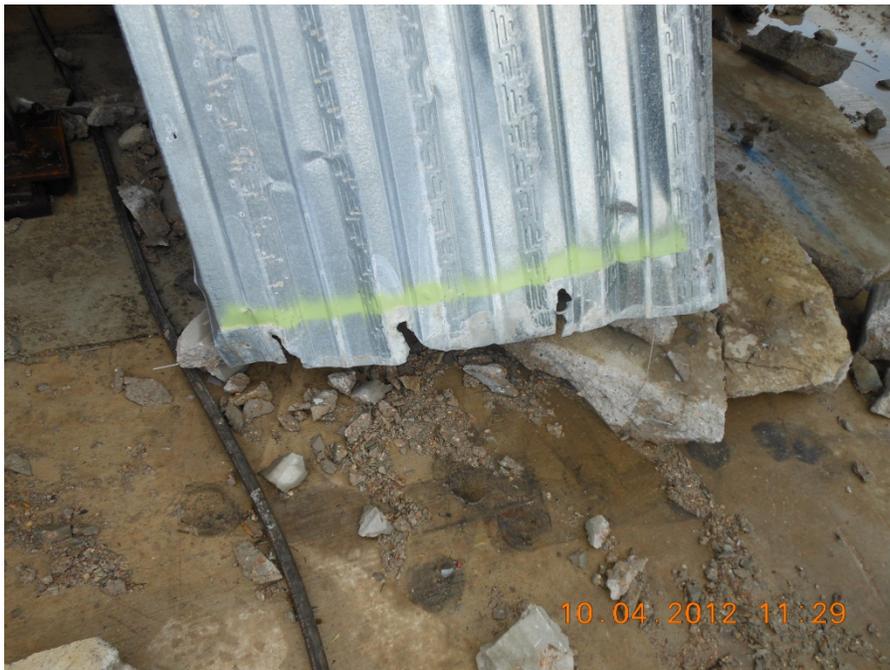
Figure 4-59: Corrugated Decking Tear-Out at Longitudinal Seam

The yellow paint seen along the end of the corrugated decking in Figures 4-58 and 4-59 marks the placement of the longitudinal seam. The two sheets of corrugated decking were attached with a 4 inch overlap and welded to the primary beams with a single row of shear studs. The tear out of the shear studs is clearly visible in Figures 4-58 and 4-59.

Based on the available data and the video observation of the testing, the collapse of the test specimen appeared to be initiated by failure of the longitudinal seam of the steel decking. As previously discussed, the longitudinal seams in this specimen were attached with a 4-inch overlap and shear studs welded directly through both sheets to the top flange of the primary beams. This observation suggests that the longitudinal seams in the decking play an important role in collapse resistance. Further research is necessary to better define the role of these seams in the structural system behavior and to evaluate the capacity of different longitudinal seam details.

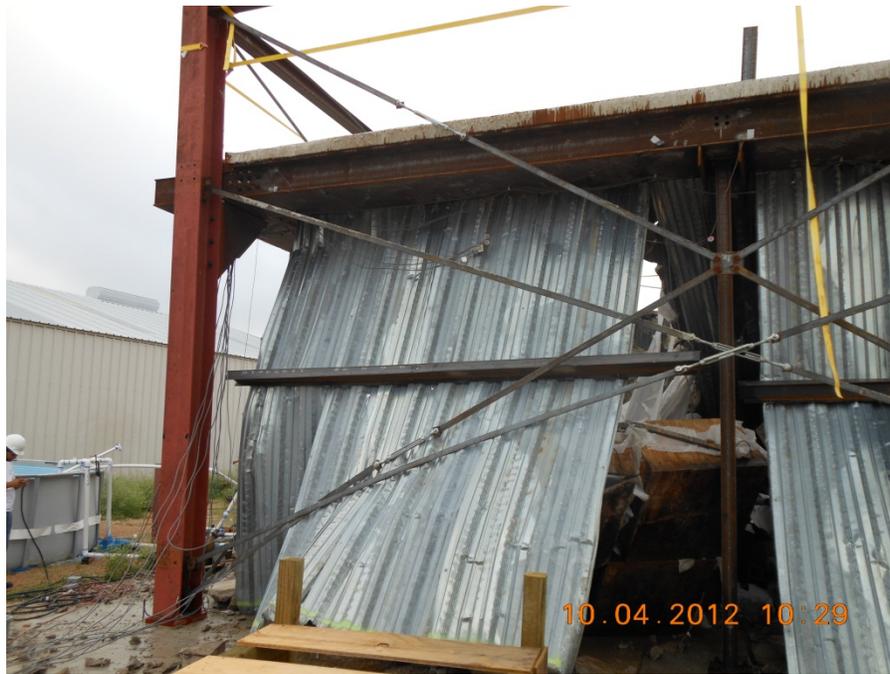
Figure 4-60: View of Collapsed Specimen from North

Figures 4-60 and 4-61 show that the secondary beams remained mostly undamaged by the collapse. Since the bolts and nuts were removed from the shear tab connections, the beams were simply hanging from the composite floor system.

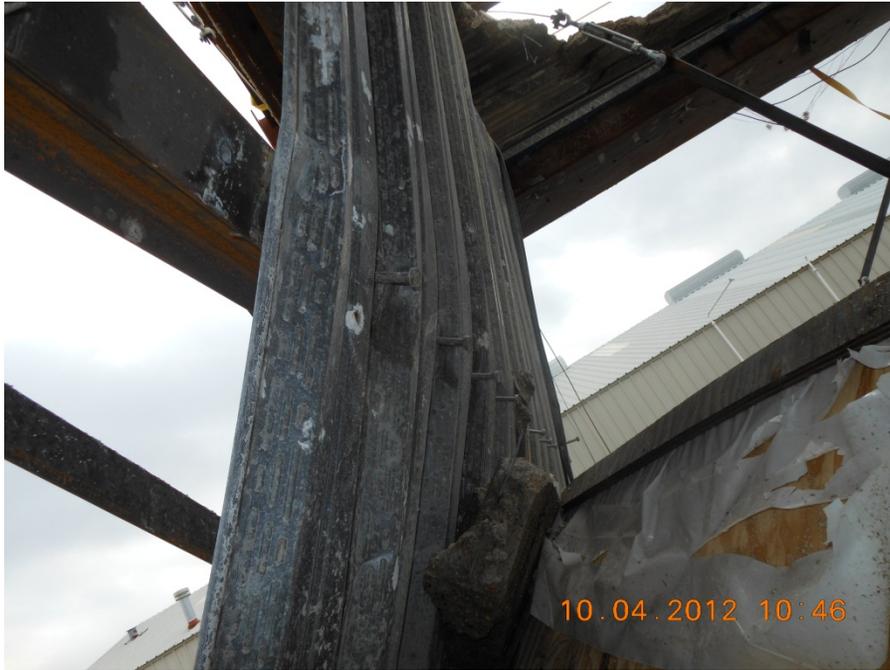
Figure 4-62: Shear Studs after Collapse

Along the length of each member, different failures were observed in the composite floor. In some cases, the shear stud tore out of the concrete and remained attached to the beams. In other locations, the shear stud was torn off of the beam. Figure 4-62 shows the condition of the shear stud attachment along the length of one beam. Along the east and west perimeter of the floor system, the side lap attachments failed and the sheets of corrugated decking separated during collapse, as seen in Figure 4-63. However, the failure of the side lap connections in the decking appears to be a consequence of collapse and not a cause.
