INSULATOR TESTS IN A HIGH PERFORMANCE, SQUARE-BORE RAILGUN

D. A. Weeks and W. F. Weldon

Presented at the
Electromagnetic Launcher Association
Pomona, California

Publication No. PN-106
Center for Electromechanics
The University of Texas at Austin
Balcones Research Center
EME 1.100, Building 133
Austin, TX 78758-4497
(512)471-4496

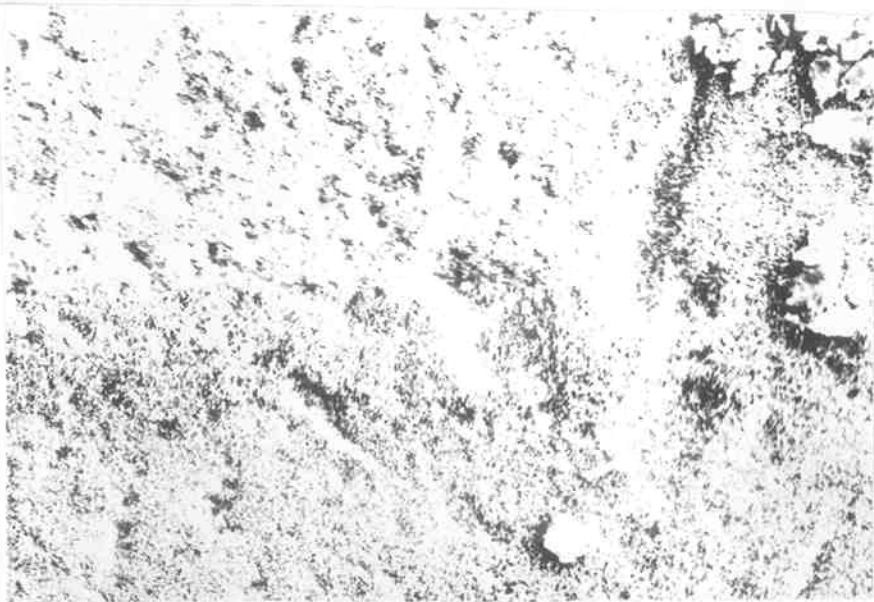
c. Honed soda-lime glass prior to shot

Figure 6. Soda lime glass SEM photos (300x) after 350 kA shot

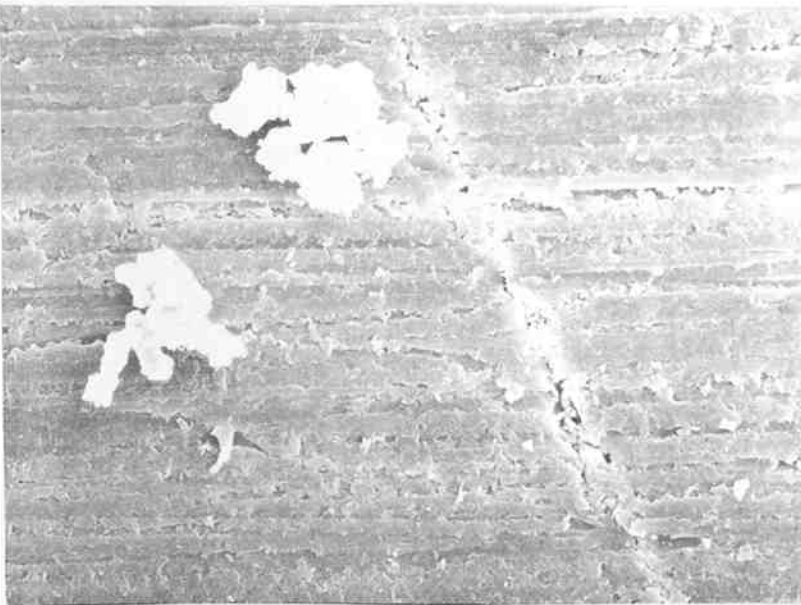
c. Honed polycarbonate prior to shot

textured surface of honed glass (fig. 8). The post shot appearance of the polycarbonate is smooth and features some craters indicating that the surface was probably melted by the arc.

Figure 8. Polycarbonate SEM (300x) after 350 kamp shot
