Photographic field reconnaissance of bayous between Green Lake and Mission Lake in the Guadalupe River Estuary

Ben R. Hodges¹

Center for Research in Water Resources
The University of Texas at Austin

February 25, 2013

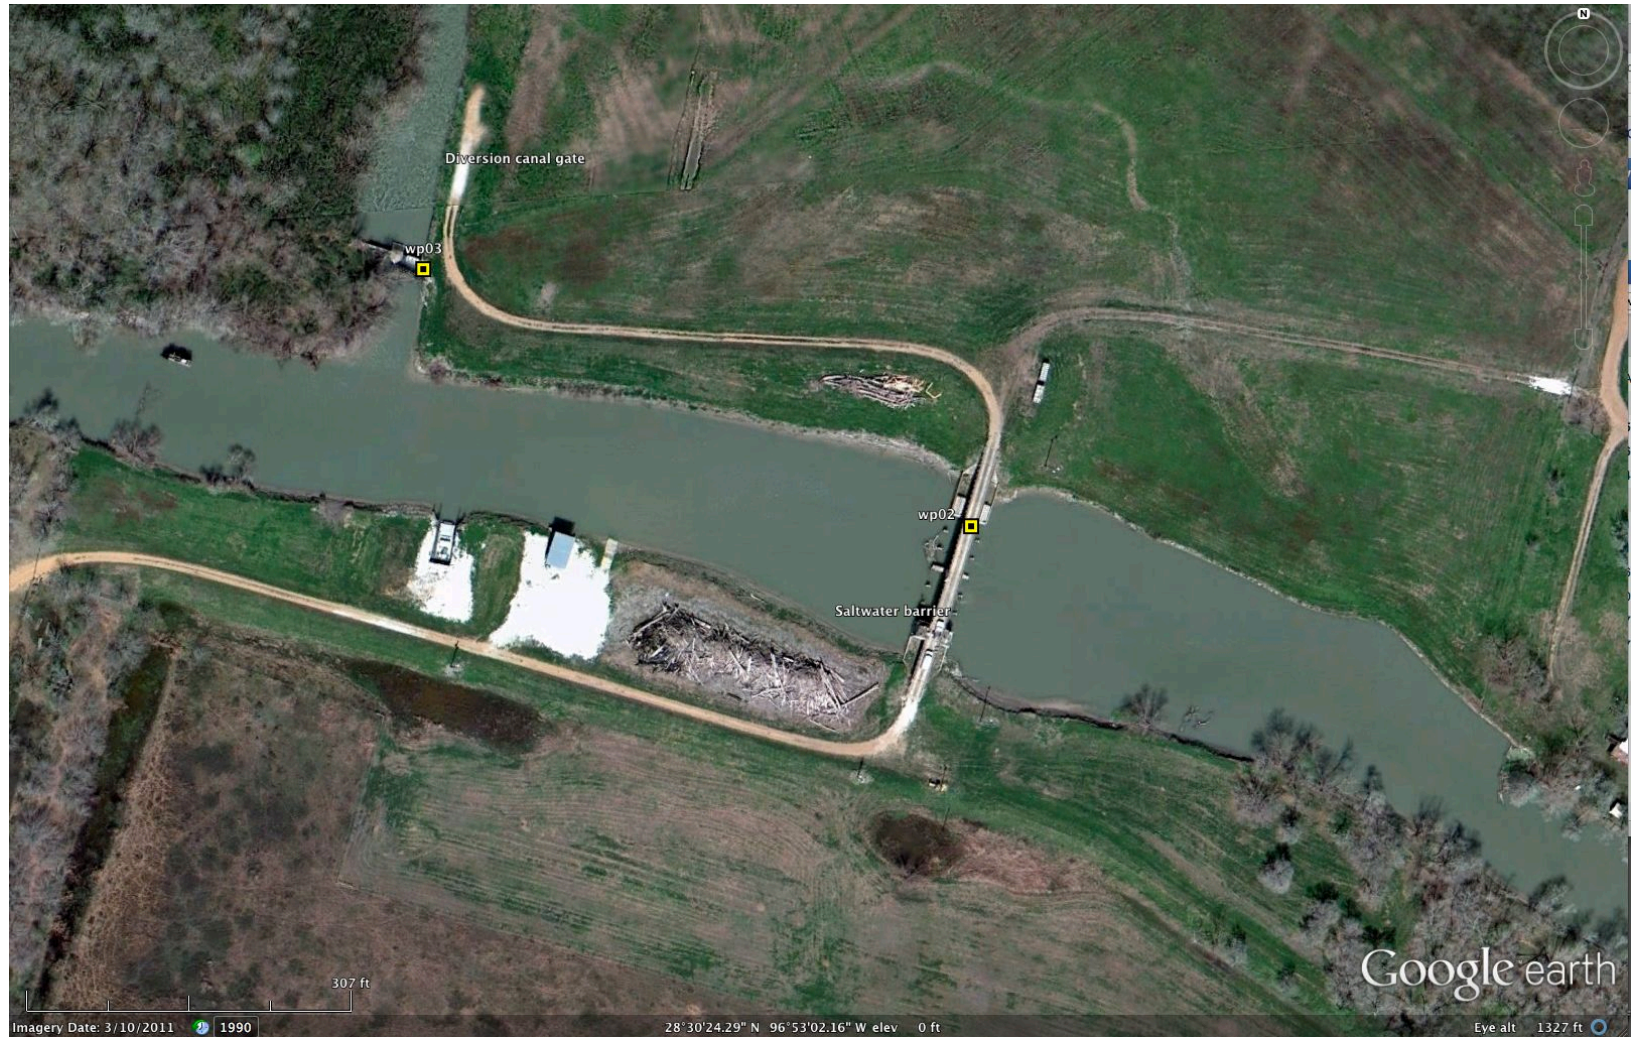
Figure 2 shows the relationship between the saltwater barrier and the freshwater diversion canal that is used to carry water across the top of the bayous and supply industrial users across the Victoria Barge Canal. Figure 3 shows the flow over the saltwater barrier during the morning of January 10, 2013 (after more than 1.5 inches of rain upstream during the previous day). Figure 4 provides a view of the Guadalupe River looking upstream from the saltwater barrier.

Figure 2. Saltwater barrier on Guadalupe River (wp02), with freshwater diversion channel and gate (wp03). Guadalupe River flows from left to right. The lack of any significant color difference in the river is an indication that there was likely significant flow over the saltwater barrier and through the diversion channel at this time. Imagery from Google Earth dated 3/10/2011.

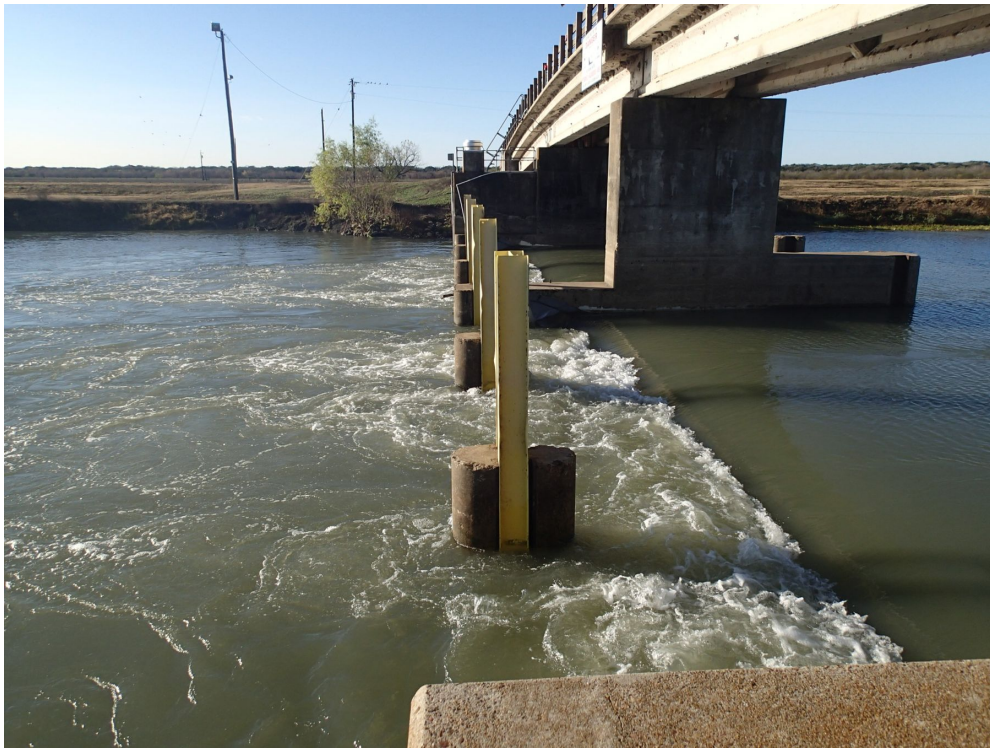
Figure 3. Saltwater barrier viewed from northern bank of Guadalupe River, looking southwest (wp02). Photograph by Ben R. Hodges, ©2013. File wp002 bSW GuadalupeSaltBarrier i017.

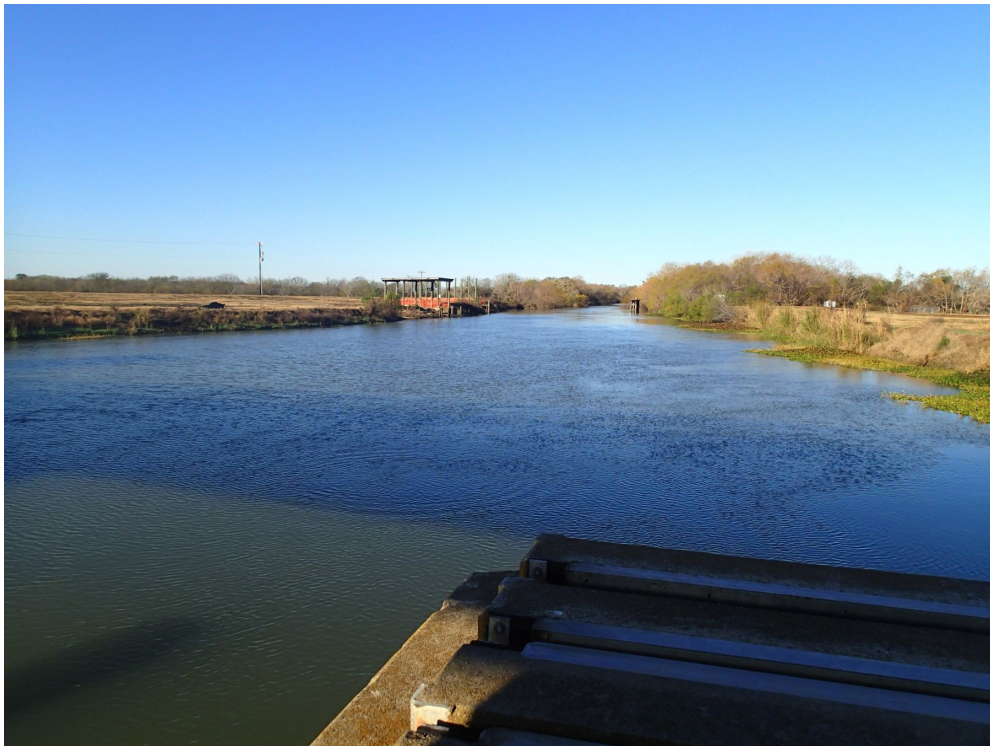
Figure 4. Looking upstream from the saltwater barrier on the Guadalupe River (wp02). Gate structure for freshwater diversion canal (wp03) is just visible on right of frame as grey rectangle. Photograph by Ben R. Hodges, ©2013. File wp002 bW GuadalupeSaltBarrier i015.

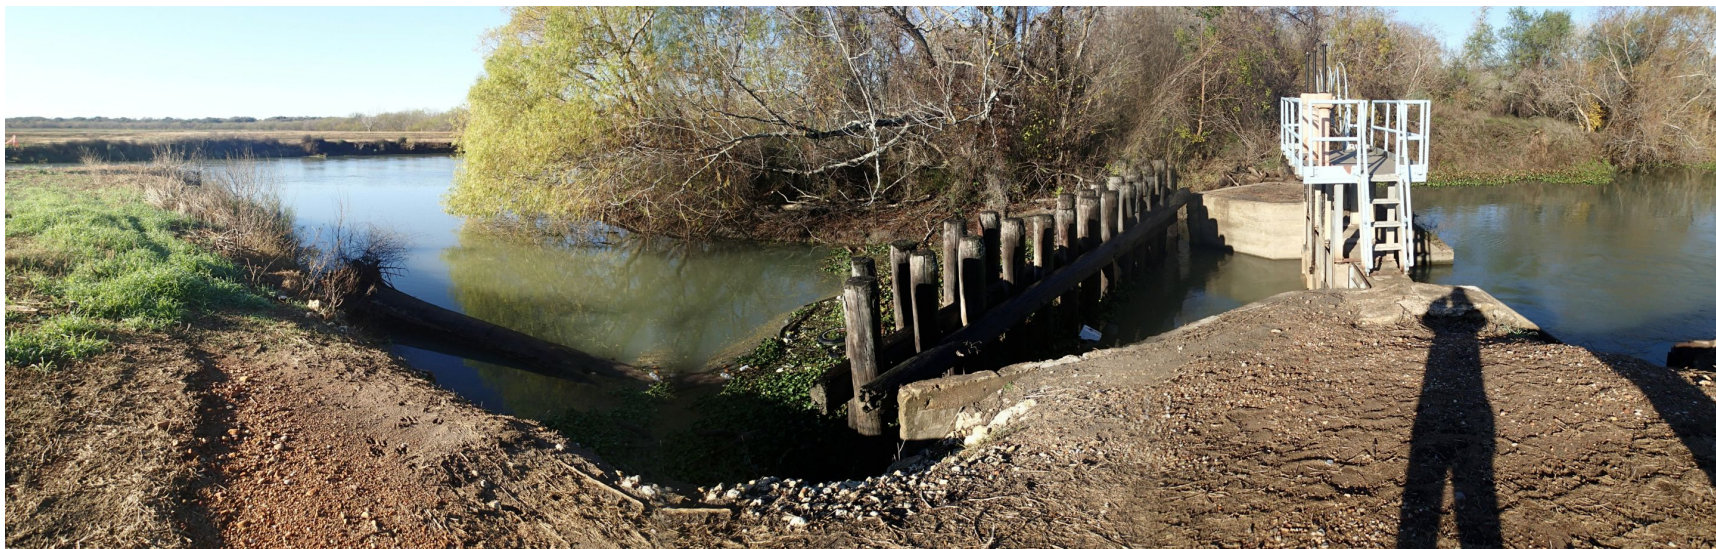
Figure 5 shows the entrance to the freshwater diversion canal, which uses wooden pilings to prevent floating debris from jamming the gates. Figures 6 and 7 provide upstream and downstream view from the gate structure.

Figure 5. Diversion canal upstream of the saltwater barrier (wp03). Guadalupe River is to the left. Diversion canal flow is from left to right. Wooden pilings prevent river flotsam from clogging gates, which are part of concrete structure on right. Composite panorama photo using DoubleTake software distorts linear relationships. Photograph by Ben R. Hodges, ©2013. File wp003 bSWtoWNW UpstreamDiversionChannelGate p022to24.

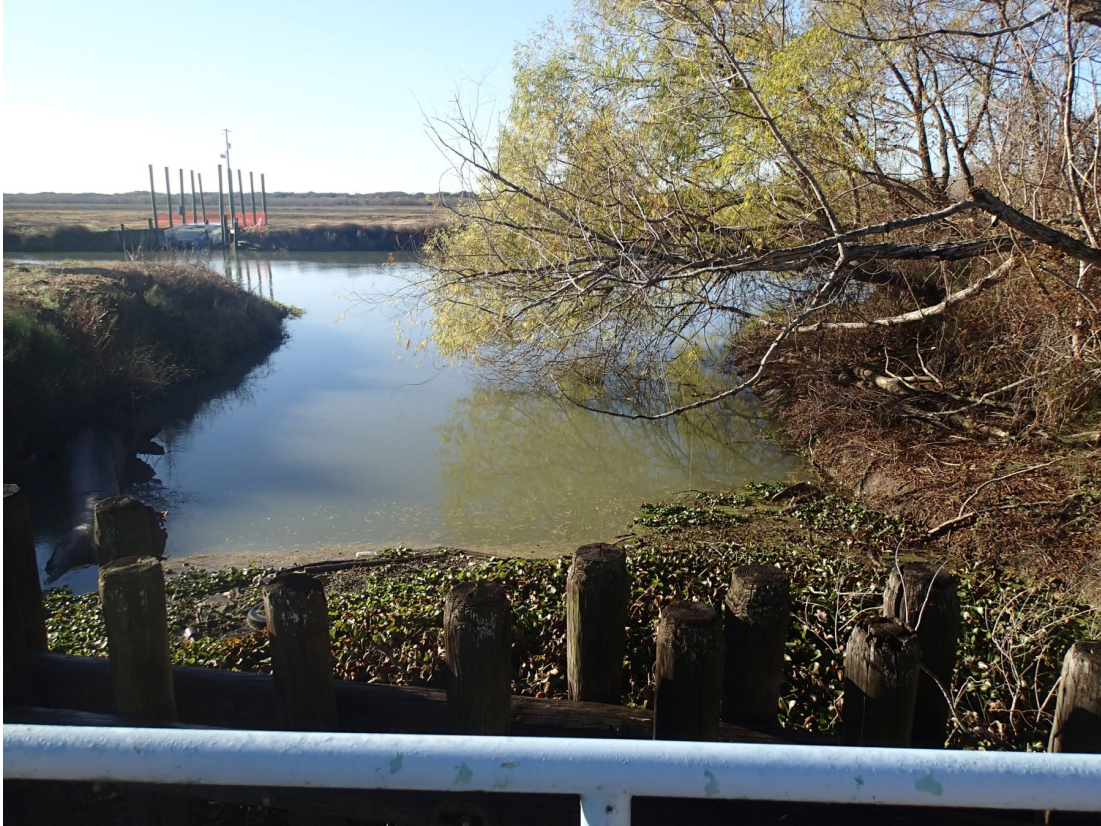
Figure 6. View upstream towards the Guadalupe River from the gates of the diversion canal (wp03). Photograph by Ben R. Hodges, ©2013. File wp003 bS UpstreamDiversionChannelGate i030.

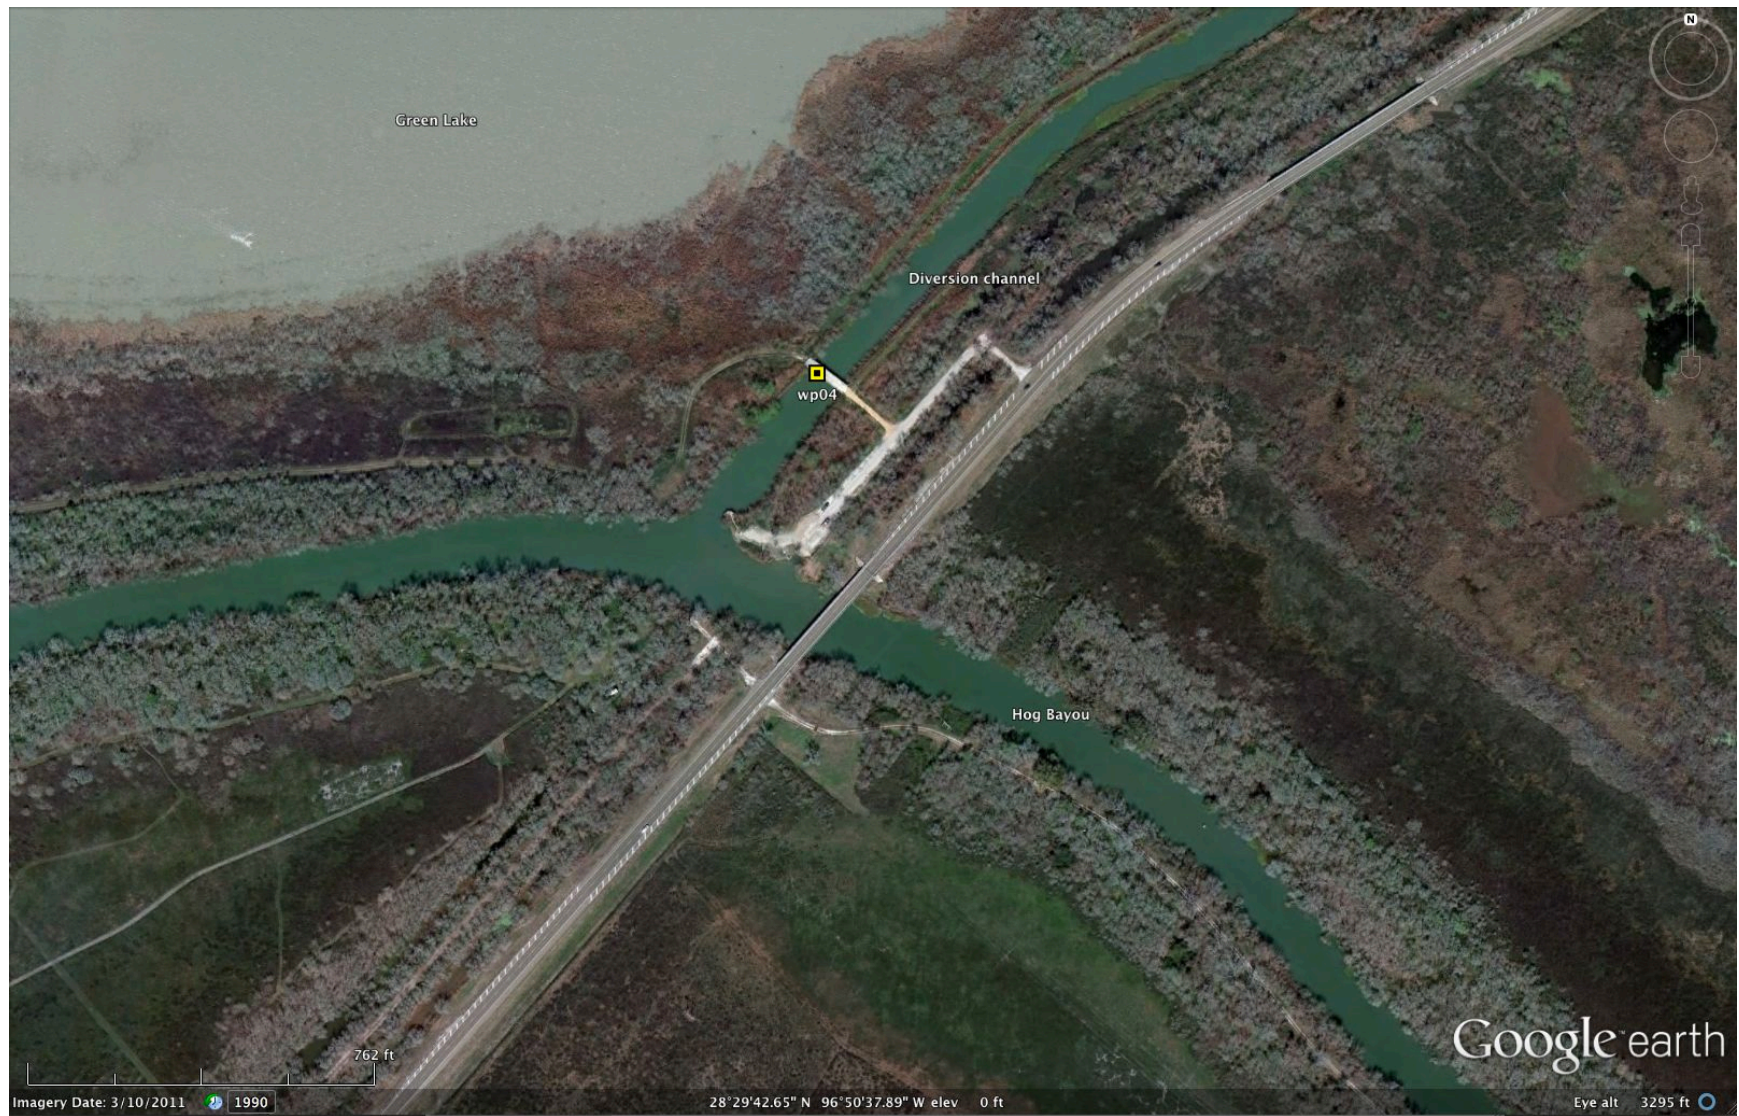
The connection between Hog Bayou is shown in greater detail in Figure 9. Figures 10 and 11 show the view upstream and downstream on the diversion canal at wp04 on the morning of January 10, 2013. The channel was completely blocked with plants (apparently water hyacinth), in both directions. Figure 12 shows the water level gage at the bridge. During our visit to the bridge, a worker from GBRA came by to make a water depth measurement.

Figure 9. Connection of Diversion canal and Hog Bayou near wp04. Upstream in the canal is to the left, which connects to the Guadalupe River upstream of the saltwater barrier. Imagery from Google Earth dated 3/10/2011.

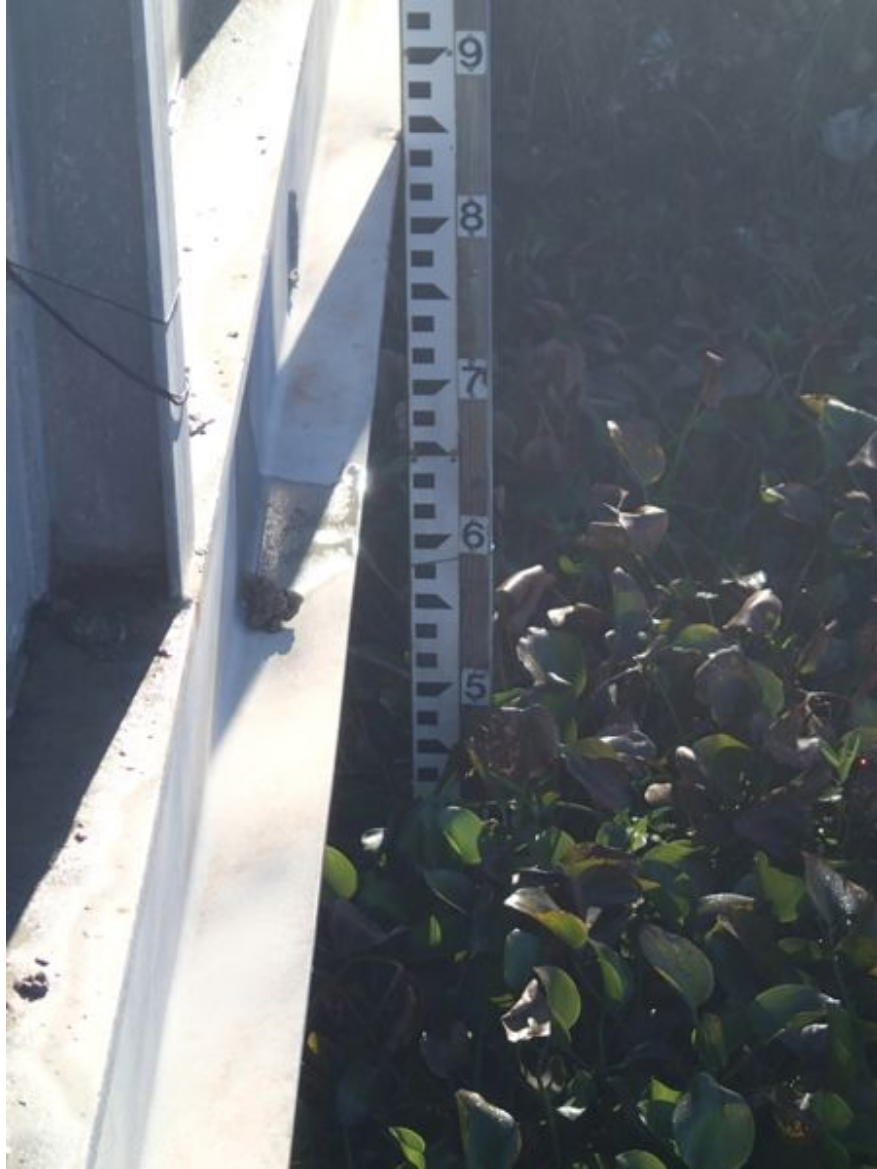
Figure 12. Water level gage on diversion canal from bridge that is accessible off TX-35 (wp04). Photograph by Ben R. Hodges, ©2013. File wp004 bSSE BridgeOverDiversionChannel i038.

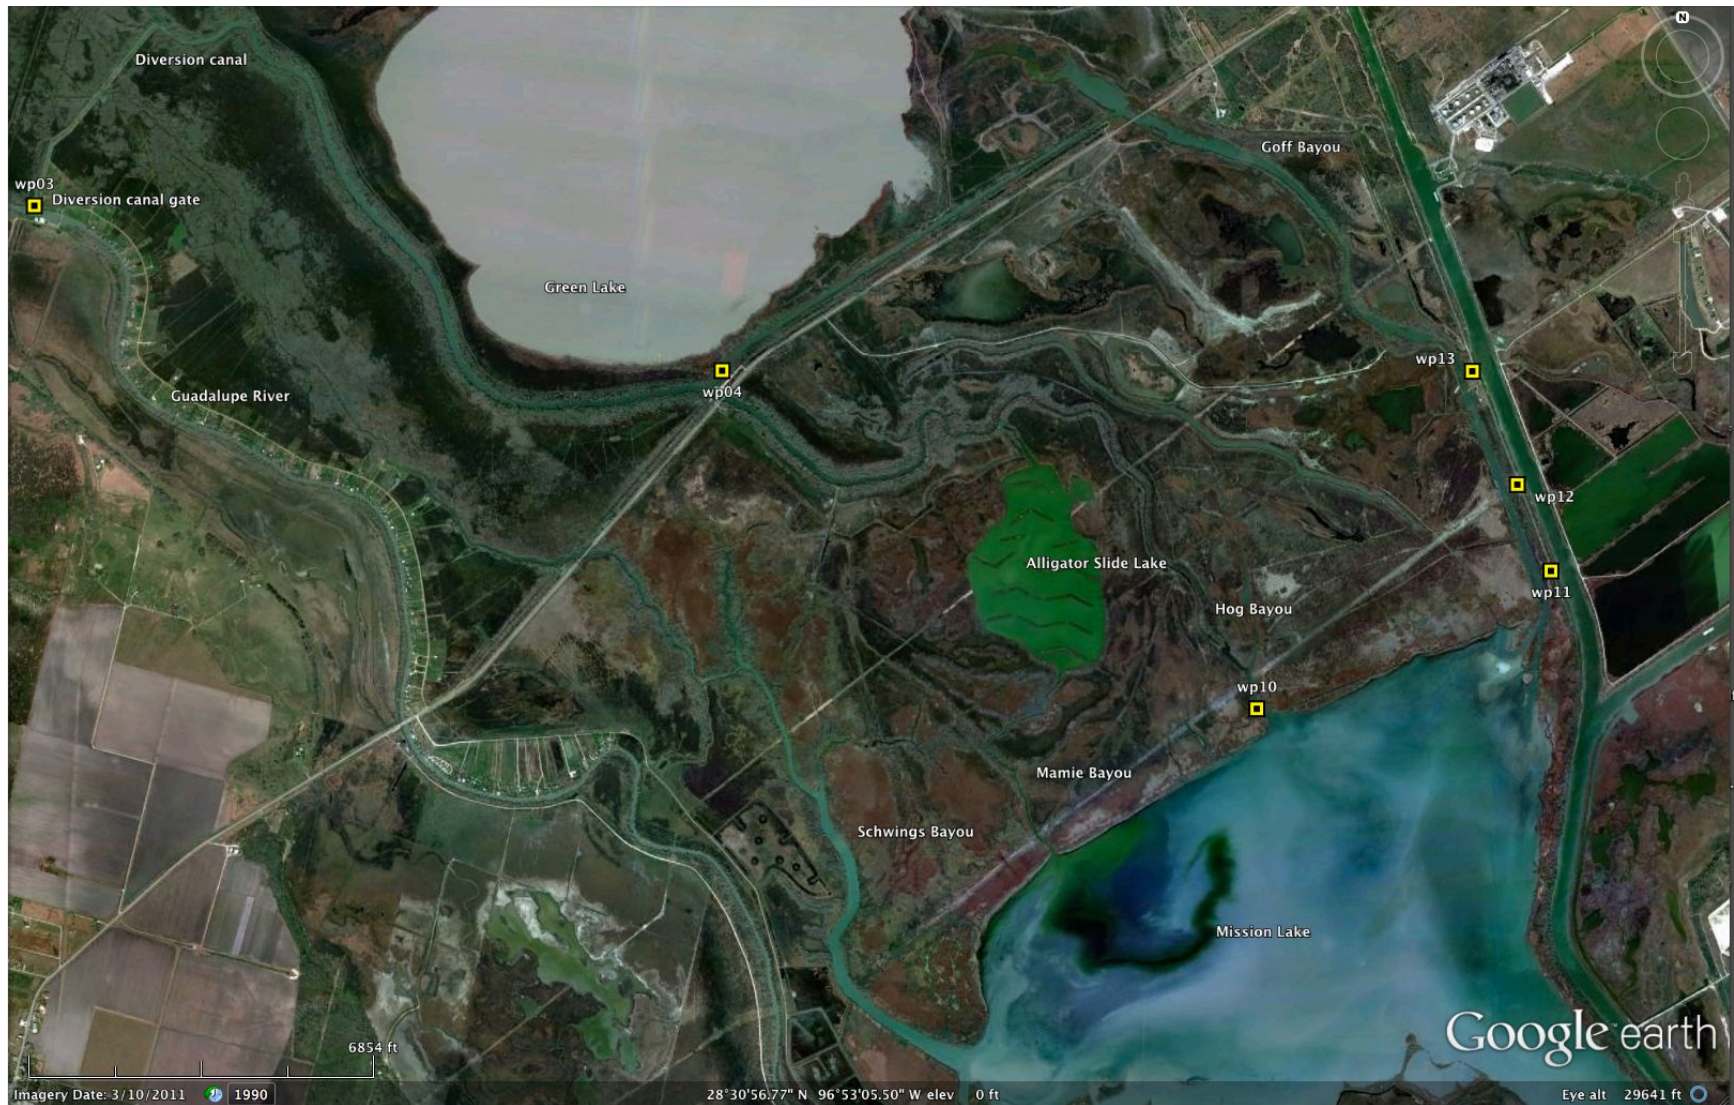
Proceeding from west to east, there are four main bayous between the Guadalupe River and the Victoria Barge Canal: Schwings Bayou, Mamie Bayou, Hog Bayou, and Goff Bayou. These are labeled in Figure 13. Between Green Lake and Mission Lake (which is really part of the Guadalupe estuary rather than a lake), the largest water body is Alligator Slide Lake. The obviously man-made revetments in this lake were designed to reduce wind-driven wave action and improve duck habitat. The Google Earth satellite imagery of Figure 13 is striking as the highly productive water of Alligator Slide Lake takes on a bright green color that can be readily traced through Mamie Bayou into Mission Lake.

Figure 13. Overview of bayous. The road running southwest to northeast is TX-35. Note the significant color difference between water in Schwings Bayou and Alligator Slide Lake and the exit from Mamie Bayou. Imagery from Google Earth dated 3/10/2011.

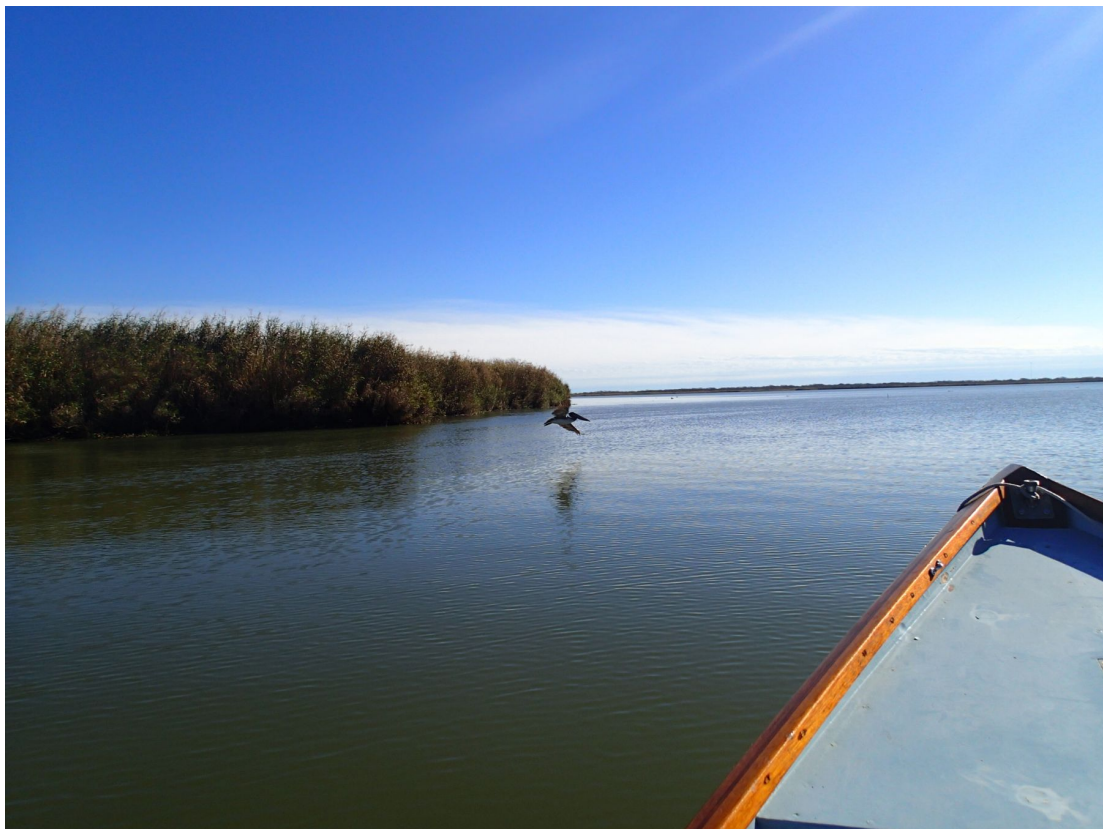
Where Hog Bayou connects with the estuarine waters of Mission Lake (Figure 18), the bayou has been blocked by revetments. It is not clear from these photos whether there are any gates or culverts providing connectivity between the fresh water on the upstream side and the marine waters on the downstream side. Figure 19 shows that the mouth of Hog Bayou was choked by plants on January 10, 2013. Figure 20 shows that the Hog Bayou entrance south of the plant mats was relatively clear.

Figure 20. Looking to the southeast into Mission Lake at entrance to Hog Bayou (wp10). Photograph by Ben R. Hodges, ©2013. File wp010 bESE HogBayouMouth i072.

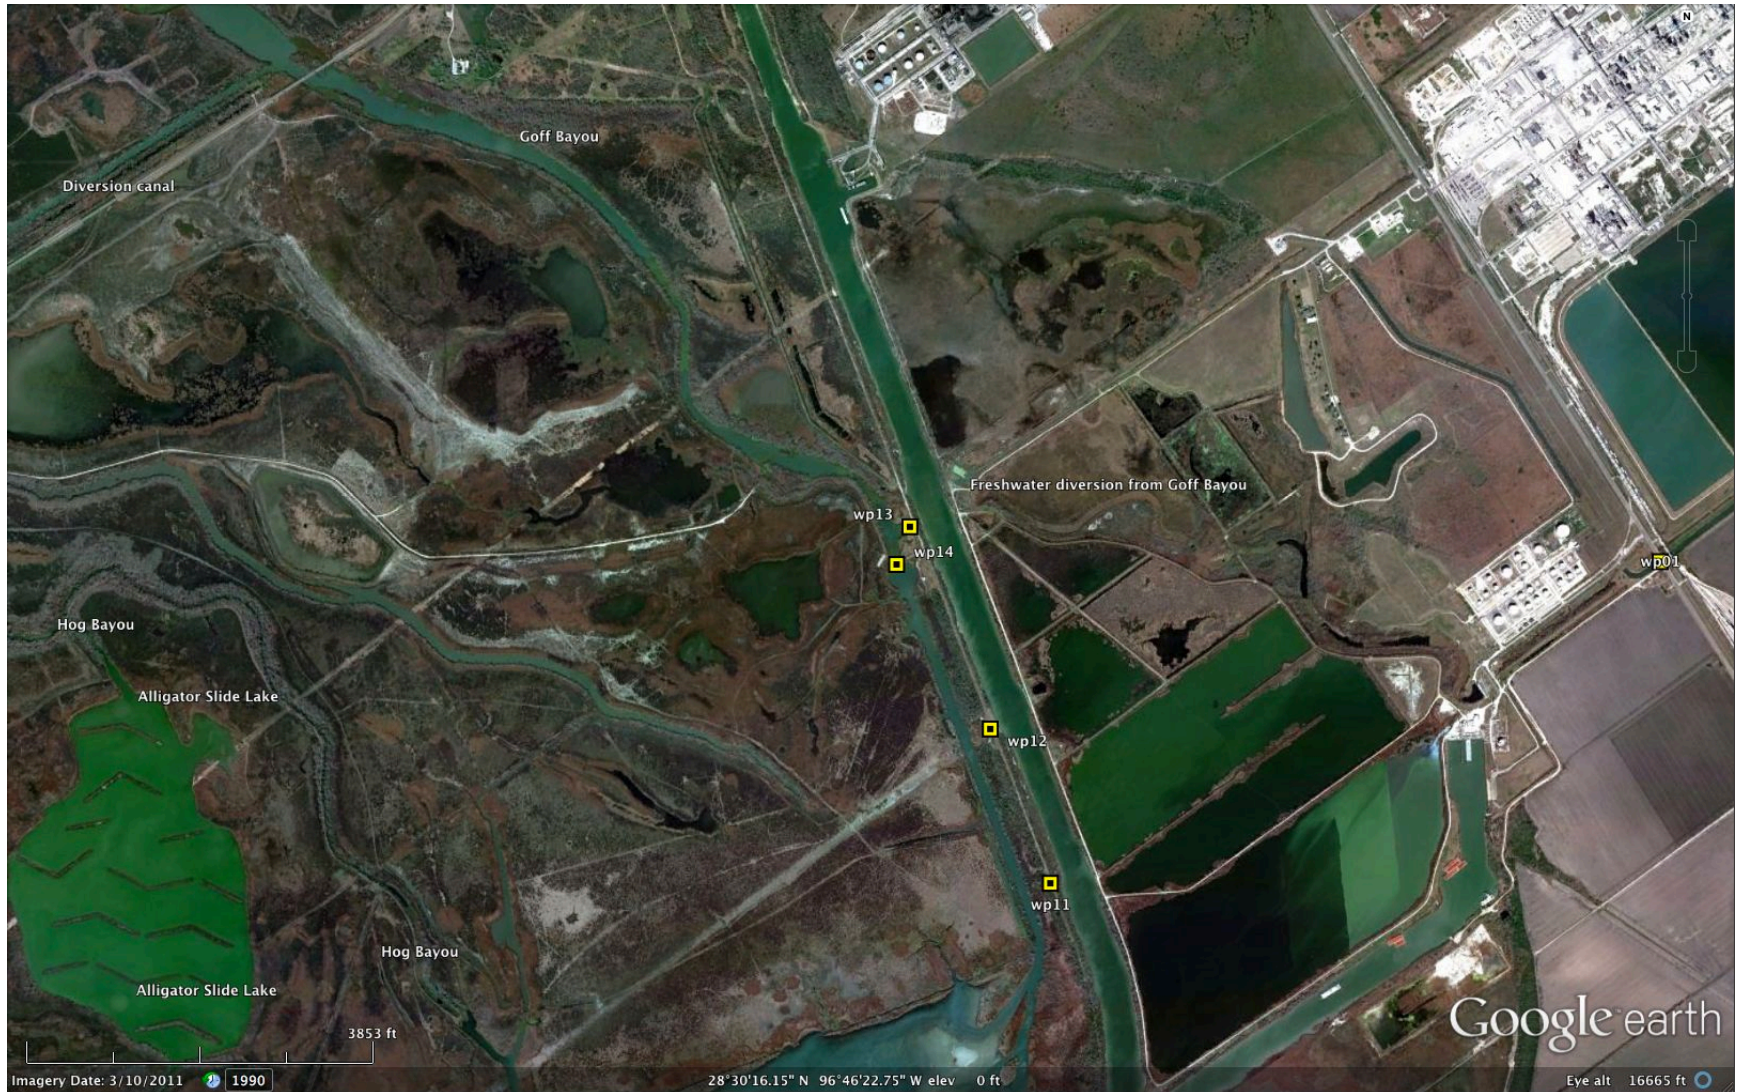
As shown in Figure 21, Goff Bayou extends from the freshwater diversion canal in the north and runs southward parallel, but just to the west of, the Victoria Barge Canal. Figures 22-24 show views from the embankment separating the two channels at wp11, wp12 and wp13.

Figure 21. Goff Bayou connection with diversion canal and Mission Lake. Note the freshwater diversion from wp13 goes underneath the Victoria Barge Canal and connects to industrial supply canals to the east of the barge canal. Imagery from Google Earth dated 3/10/2011.

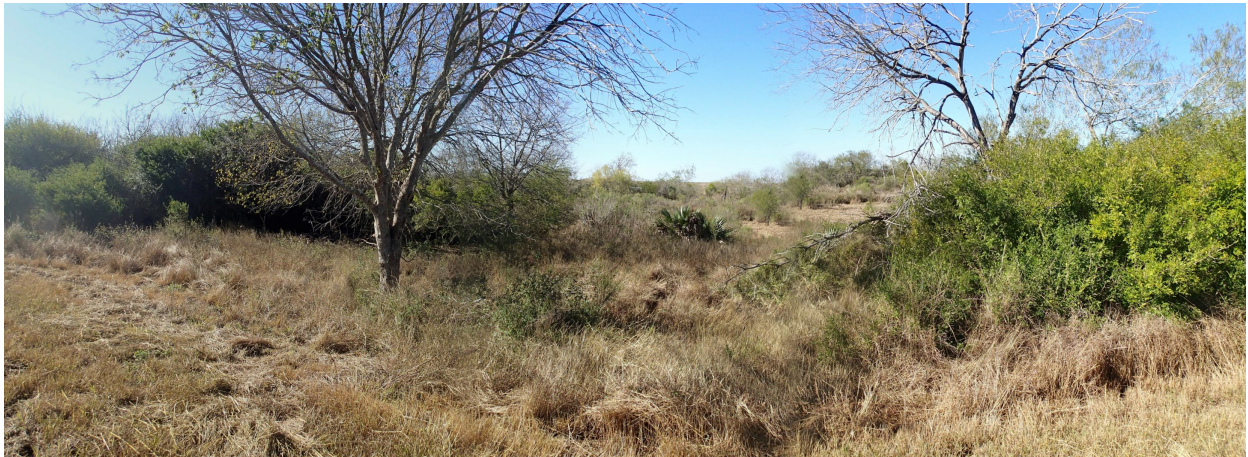
Figure 22. View to the southwest from wp11 on the embankment between the Victoria Barge Canal and Goff Bayou. Goff Bayou is not visible. Composite panorama photo using DoubleTake software distorts linear relationships. Photograph by Ben R. Hodges, ©2013. File wp011 bSSWtoW NearGoffBayou p077to079.

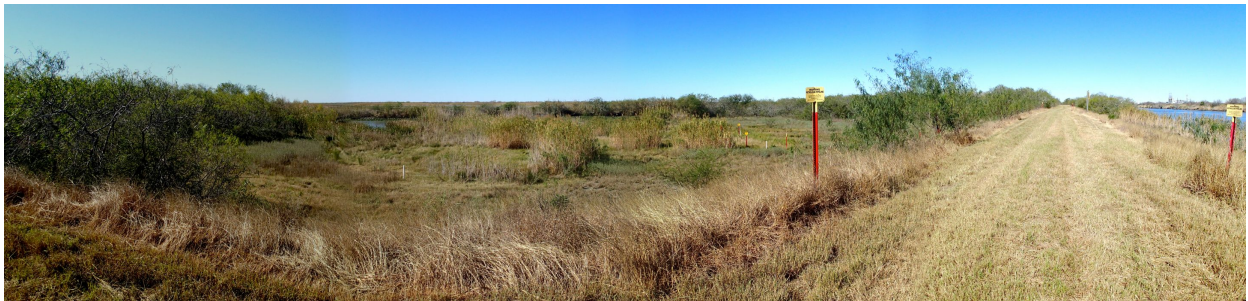
Figure 23. Panoramic view to the west from wp12 on the embankment between the Victoria Barge Canal and Goff Bayou. Goff Bayou is just visible to center left. Composite panorama photo using DoubleTake software distorts linear relationships. Photograph by Ben R. Hodges, ©2013. File wp012 bSWtoWNW NearGoffBayou p081to084.

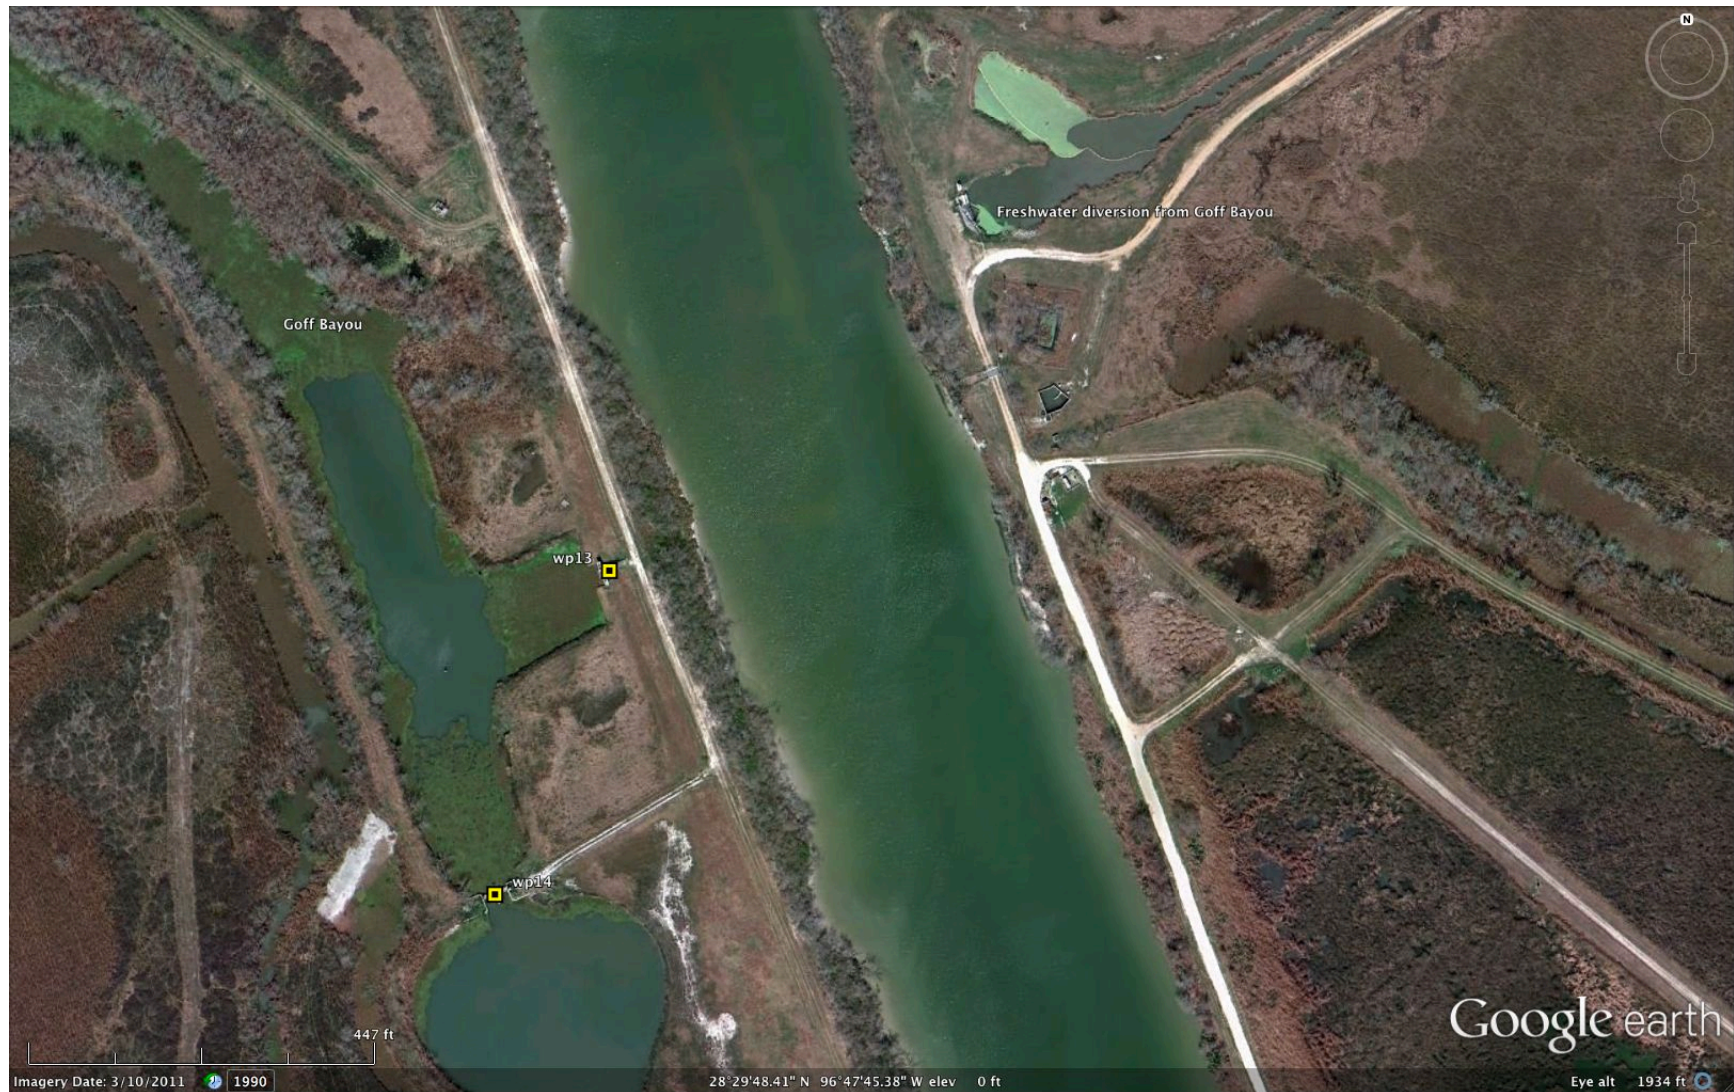
Waypoints 13 and 14 are critical locations in Goff Bayou, shown in greater detail in Figure 25. At wp13, a set of gates (open on Jan. 10, 2013) connect Goff Bayou to a culvert that runs beneath the Victoria Barge Canal, providing a freshwater source for the industrial canals to the east (Figure 26). At wp14, a set of gates (closed on Jan. 10, 2013) separates the freshwater upstream segment of Goff Bayou from marine waters in the lower segment (Figures 27-30).

Figure 25. Overview of gates connecting to industrial canals on east bank of the Victoria Barge Canal (wp13) and the gates separating upstream freshwater from downstream marine water in Goff Bayou (wp14). Imagery from Google Earth dated 3/10/2011.

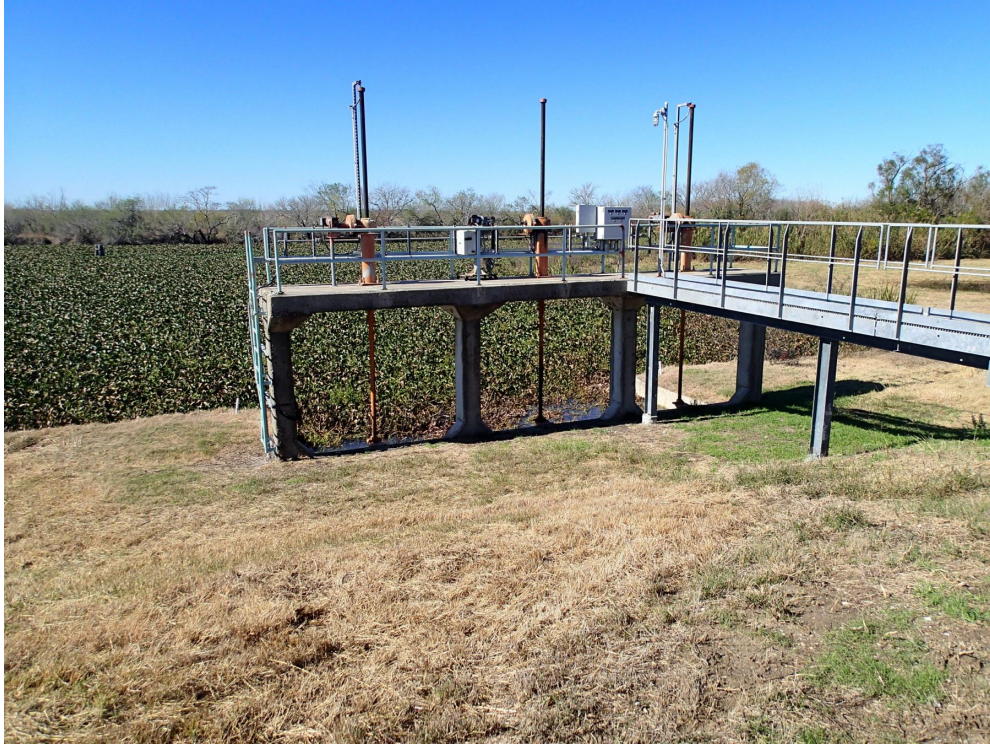
Figure 26. Gates at wp13 connecting Goff Bayou with industrial canals on the opposite side of the Victoria Barge Canal. Photograph by Ben R. Hodges, ©2013. File wp013 bW GoffBayouGates i085.

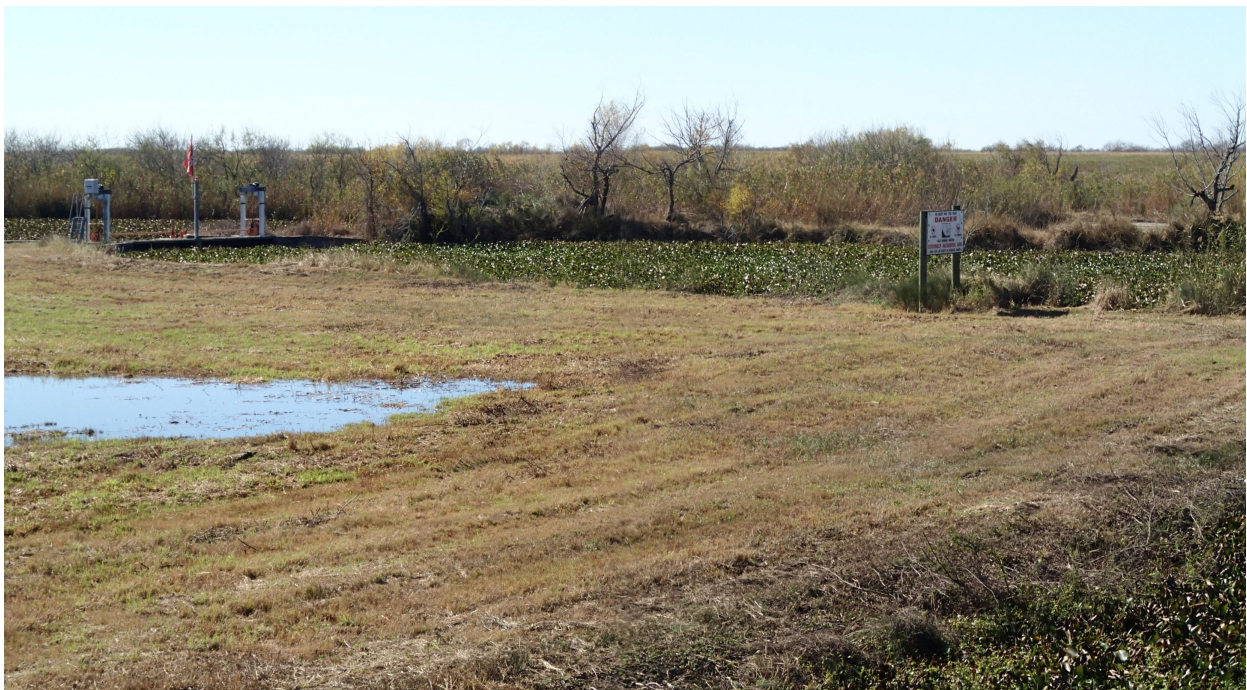
Figure 27. Downstream gate on Goff Bayou (wp14) separating downstream water (to left of gate) from upstream water (to right), as view from wp13 with telephoto lens. Composite panorama photo using DoubleTake software distorts linear relationships. Photograph by Ben R. Hodges, ©2013. File wp013 bSW GoffBayouGates p090to091.

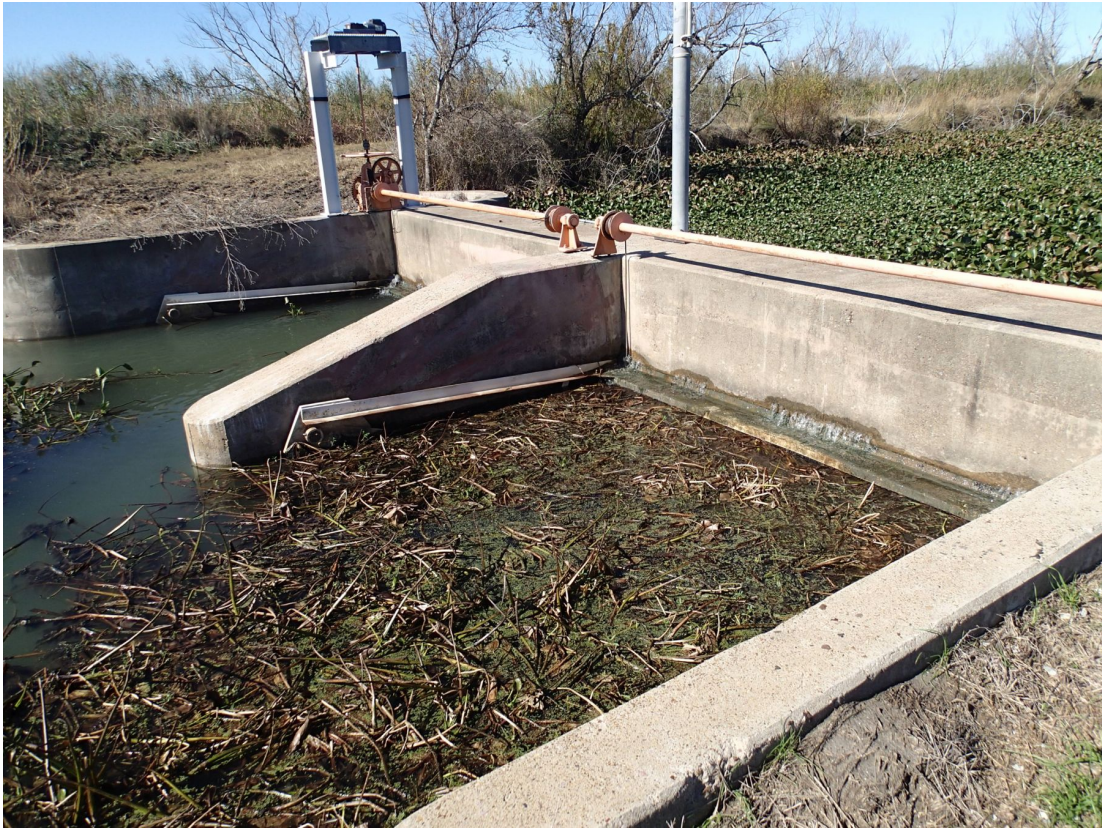
Figure 30. Close gates separating upstream and downstream sections of Goff Bayou at wp14. Photograph by Ben R. Hodges, ©2013.
