**Testing of Emergency Wood Shoring Towers for use in Urban Search
and Rescue Operations**

Thesis

The University of Texas at Austin

May 2012

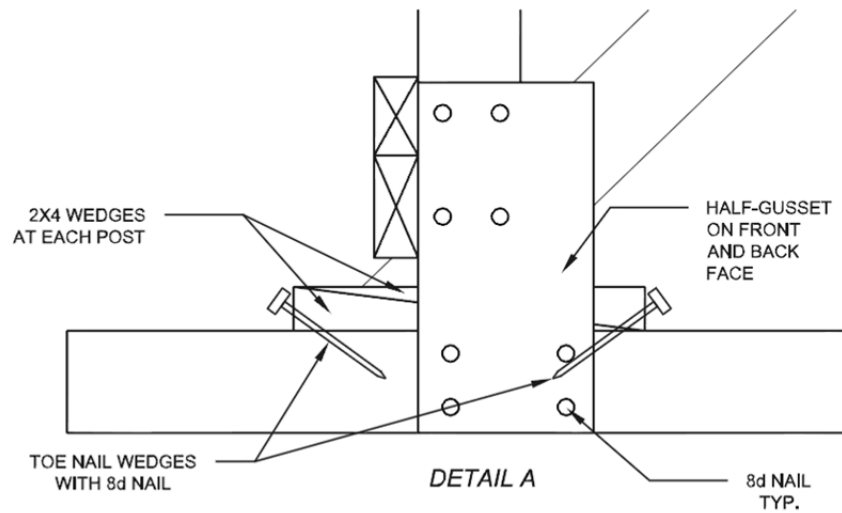
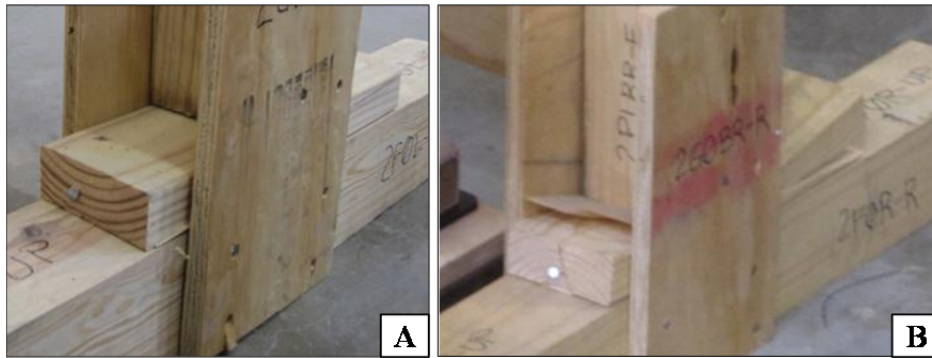
Beneath each post in a laced post system are a set of 2x4 wedges. These wedges are specifically designed to create a tight fit for the shore between the floors above and below. However, as loads on the shore increase, these wedges can be seen bending upwards (cupping) under the bearing load of the post. This is a very noticeable sign of overload and typically the more extreme the cupping, the higher the load on the shore. Figure 2.10 presents the design of the wedges and provides an example of a wedge cupping under high vertical loads.

Figure 2.10 Wedge Design Details and Photographs A) Installed Wedge with No Load B) Installed Wedge Cupping Under Load

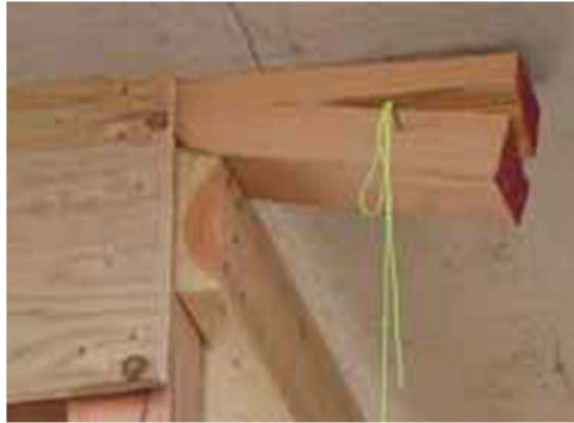
Another visual fuse is the splitting and cracking of headers or soles (4x4 members on top or bottom) due to bearing loads. As the posts resist the applied load, the bearing stress applied perpendicular to the grain of the 4x4 header/sole can cause the fibers to split under internal tensile loads. These forces cause the fibrous layers of the 4x4 member to separate and crack. This can be simulated by a bundle of plastic straws. A compressive force applied about an internal section causes the ends of the straws to separate, thus the fibers at the ends of the members separate. Figure 2.11 shows an example of header splitting during previous testing conducted by US&R.

Figure 2.11 Split Header Due to Overload, (*FEMA StS2 Summary- Testing of Laced Post & Plywood Laced Posts, 2011*)

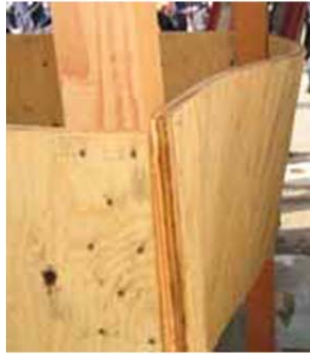
Brace dimensions typically involved either 12in or 24in wide braces and were installed at varying spaces along the posts. The amount of intermediate braces was also a variable in the test specimen configuration (see Figure 2.16). As the amount of load increased on the plywood laced shores, lateral torsional buckling of the plywood braces was observed (see Figure 2.17).

Figure 2.17 Lateral Torsional Buckling of Plywood Braces (*FEMA StS2 Summary- Testing of Laced Post & Plywood Laced Posts, 2011*)

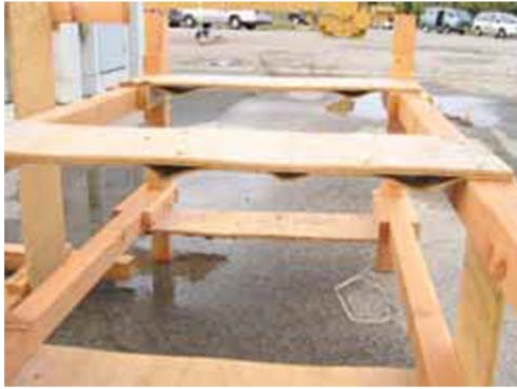
Plywood sheets are strongest in the orientation of the grain on the outer plies (Forest Products Laboratory, USDA Forest Service, 2010). In bending, this strength comes from the increased moment of inertia of the outer plies that are oriented in the longitudinal direction. In axial loading, this is due to the larger number of plies oriented with the grain in the direction of loading (longitudinal) because wood is strongest when loaded parallel to the grain. Plywood orientation typically corresponds to the 8ft dimension of a 4ft x 8ft sheet of plywood; therefore all braces should be installed such that the direction of the grain is left to right in the direction of the brace between posts. PLP-32 was fabricated with the strong direction of the plywood braces oriented up and down, reducing its capacity to brace the posts. As seen in Figure 2.18, individual plies in the plywood brace buckled under the loading. PLP-32 failed at a lower load than similar configurations with their respective plywood braces oriented in the correct direction (see results tables in *Section 2.7.4*).

Figure 2.18 Buckling of Individual Plies in Plywood Braces (*FEMA StS2 Summary- Testing of Laced Post & Plywood Laced Posts, 2011*)

After these two series of tests, it was determined that 12in. wide plywood braces did not provide adequate lateral bracing for laced post shores. Compared to the standard LP shores, the PLP shores with 12in. braces had a capacity on average of 17 to 37 percent less. Larger plywood braces would have to be used to provide more stiffness and support.

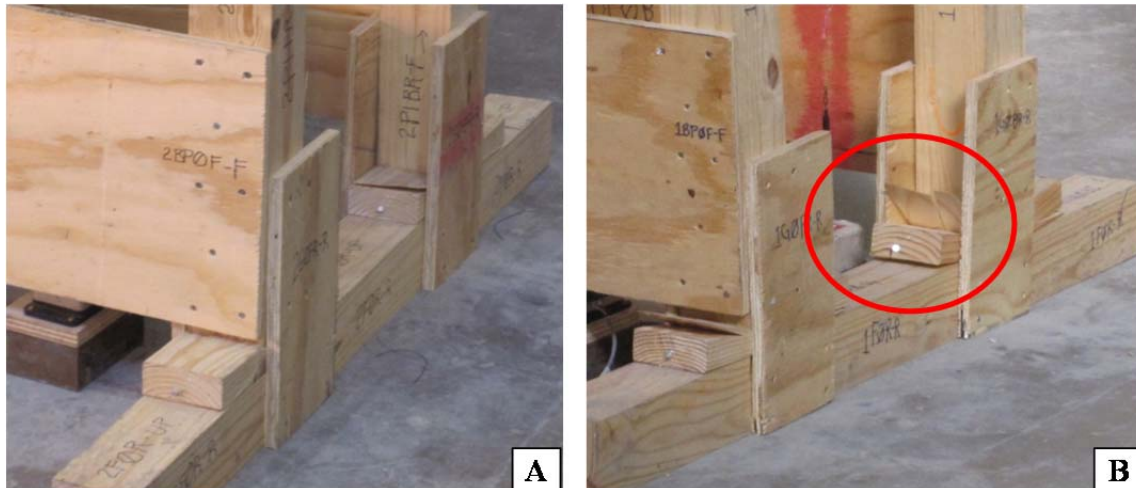
The wedges, located at the base of each of the four posts can be used as an emergency fuse. These wedges will often “cup” or bow upwards as the load in the post increases. The presence of and amount of cupping can alert US&R individuals that the shore is experiencing loading that may be approaching the capacity of the shore. Figure

4.13 shows an example of a cupped wedge, and also shows the inconsistency in the magnitude of wedge cupping.

Figure 4.13 Photographs of Cupping Wedges A) Initial Cupping Under Smaller Loads
B) Extreme Cupping Under High Loads

It can be seen in Figure 4.13-B that a set of wedges under one post can cup significantly more than under another post in the same shore. In some cases, cupping may not be significant in any set of wedges under extreme loading. These observations will be discussed in greater detail in Chapters 5 and 6.

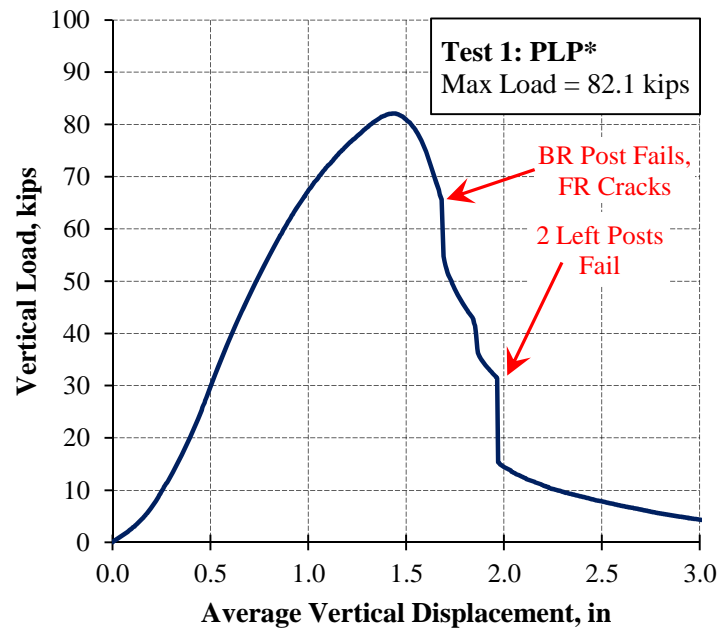
Figure 5.3 Load-Displacement Curve for Specimen 1

Prior to failure, all four posts began to bow outward towards the front. The first failure occurred at a knot in the back right post at approximately the midpoint between the intermediate braces at a total vertical load of 65kips. The front right post also cracked around a spike knot just above the lower intermediate brace at 65kips and progressively split as loading continued. At approximately 32kips, the two left posts simultaneously failed at knots. This load progression is presented using the load-displacement curve in Figure 5.3. Photographs of the failures are also provided.

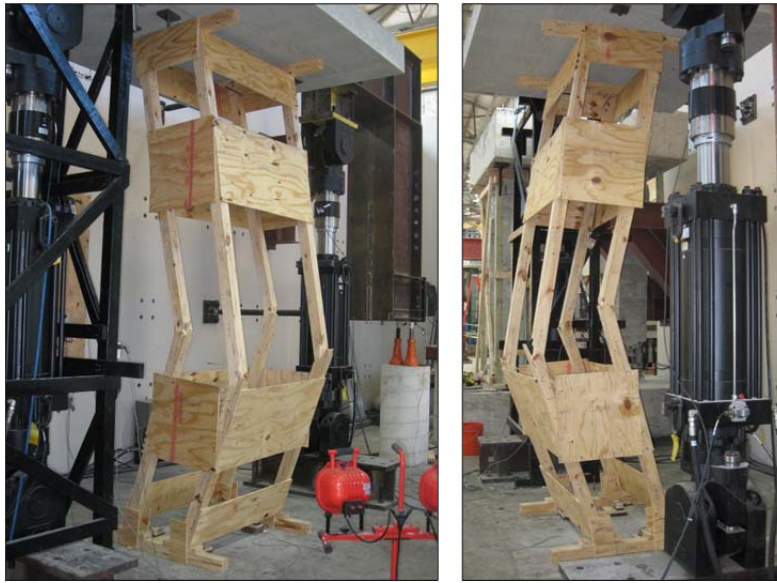
Figure 5.5 Final Failed Condition at the End of Test 1

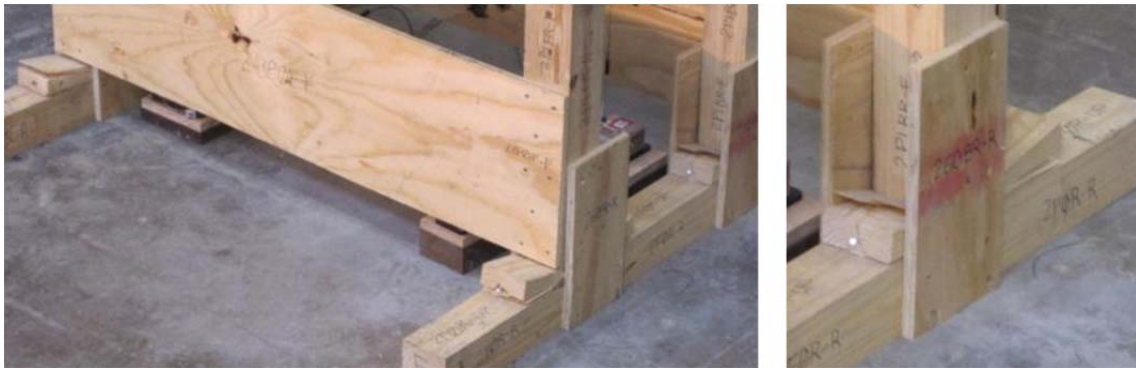
During testing, audible creaking and cracking of wood could be heard starting at 20kips and continuing to failure. These noises intensified in magnitude and frequency as the applied load approached the peak value. Cupping of the wedges initiated at around 65kips and widened as the test progressed. Cupping of each set of wedges was very uniform and consistent between all four sets. Figure 5.8 shows the performance of the wedges.

Figure 5.8 Test Specimen 2 Wedge Cupping

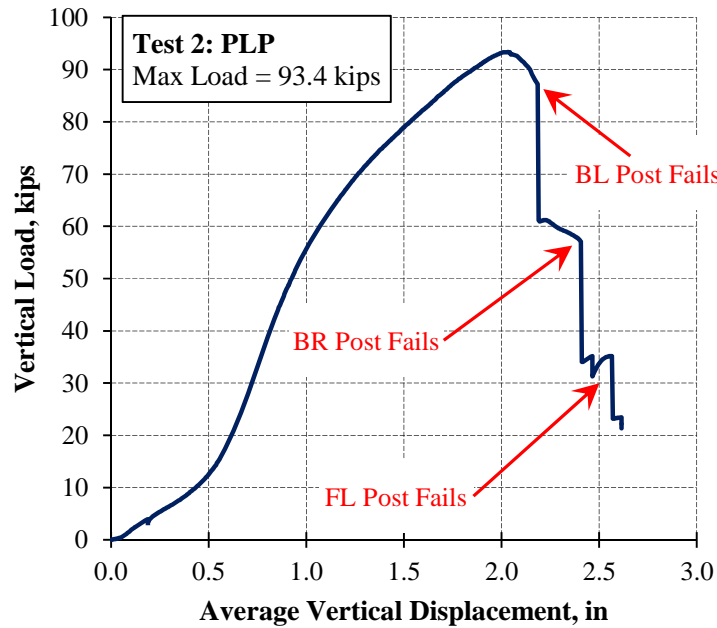
Figure 5.9 Load-Displacement Curve for Specimen 2

At 85kips, the two left posts were visibly bent in an ‘S’ shape, while the right posts remained relatively vertical. After the peak load of 93.4kips was reached, the back left post failed completely through the cross section in two locations, ejecting a roughly three foot long section. The back right post buckled at approximately 57kips in multiple locations, followed by the front left post at approximately 34kips. The load-displacement response is shown in Figure 5.9.

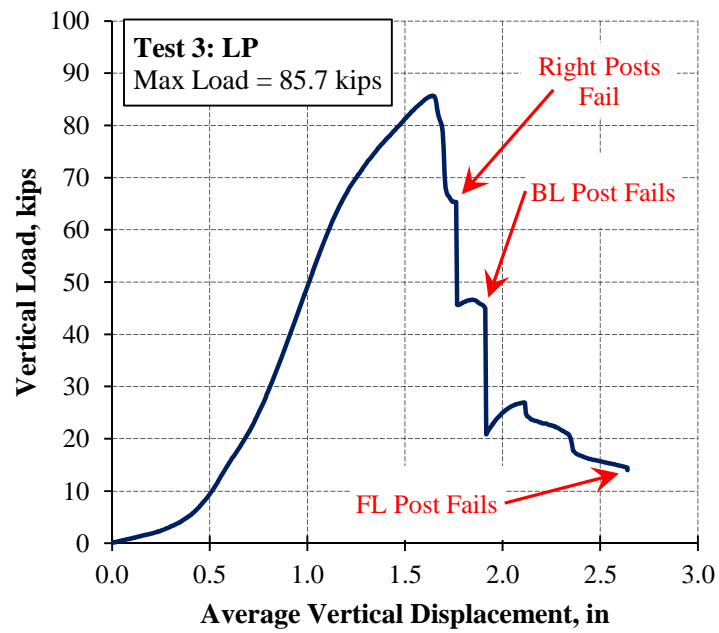
Figure 5.16 Load-Displacement Curve for Specimen 3

After reaching the peak load of 85.7 kips, the front right and back right posts began to deflect forwards to a significant degree. This action dramatically reduced the stiffness of the shore as the two posts began to buckle. At approximately 66 kips, both

The load-displacement plot is shown in Figure 5.16. Figure 5.17 shows a close-up view of each of the four post failures. Each failure occurred at a knot in the post.

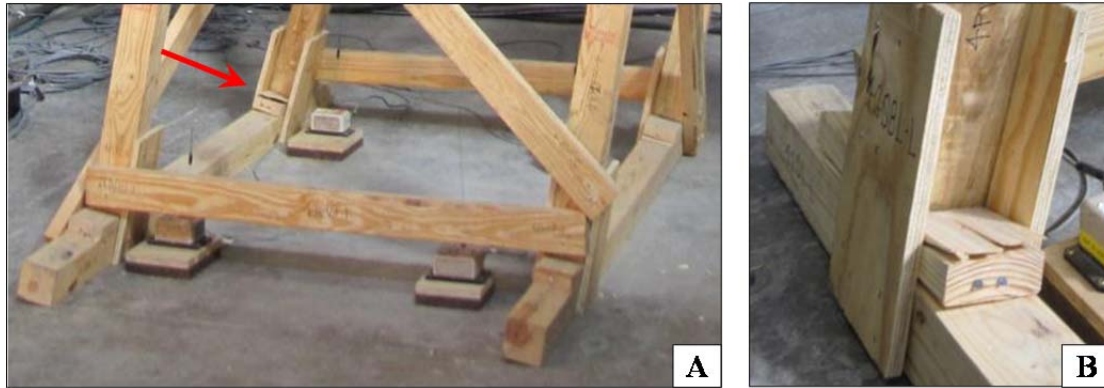
There were relatively no audible wood noises heard during testing prior to 70kips. These cracking and creaking sounds intensified from 85kips until failure. Cupping of the

wedges was very minor throughout the duration of the test. Only the back left set of wedges appreciably cupped, as shown in Figure 5.20.

Figure 5.20 Specimen 4 Wedges A) Wedges at Failure B) Back-left Wedge Cupping

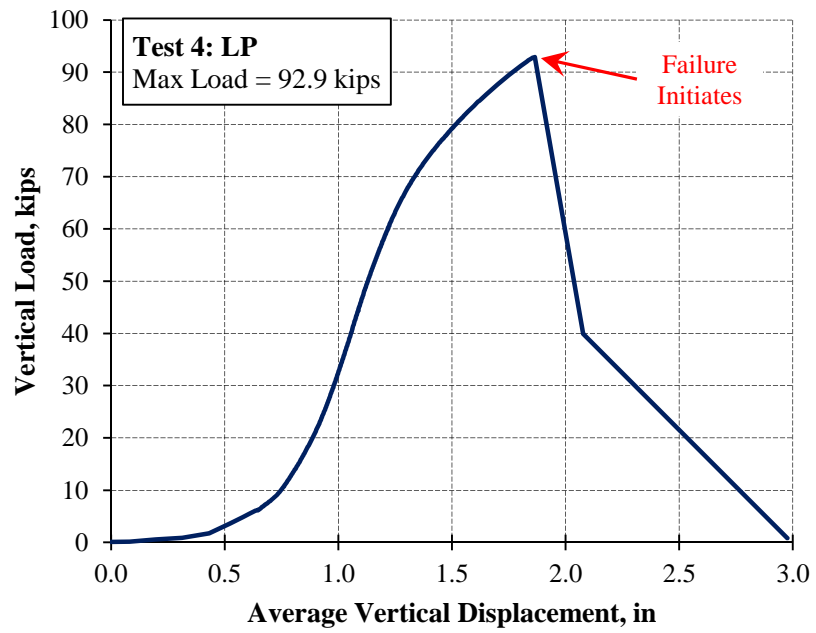
Figure 5.21 Load-Displacement Curve for Specimen 4

As the peak load was reached, the two back posts buckled to the right, followed closely by the buckling of the front two posts. The failure of all four posts occurred in approximately one second, in contrast to the progressive failures of the displacement-controlled tests. The load-displacement plot and post-failure photographs of test 4 are included in the following figures.

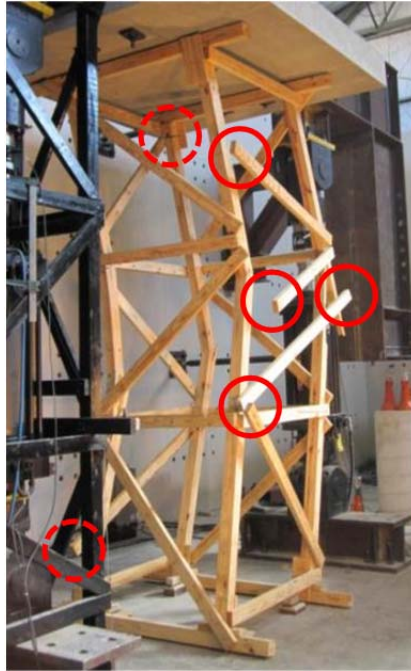
Figure 5.24 Locations of Connection Failures on Specimen 4

With the buckling action to the right, the majority of the braces on the front and back sides failed at their connections. All connection failures were characterized by nail withdrawal from the post, and did not include nail pull through by means of a split in the 2x4 brace, as was seen in Specimen 3. Complete brace connection failures included all of the diagonal braces on the front face, the second level horizontal brace on the front (4Hz2F), level 1 diagonal on the back (4D1B) and level 3 diagonal on the back (4D3B). Partial nail withdrawal locations were also observed on many of the other braces including those on the left and right sides. Figure 5.24 shows the six complete connection failure locations, and Figure 5.25 presents examples of these failures.

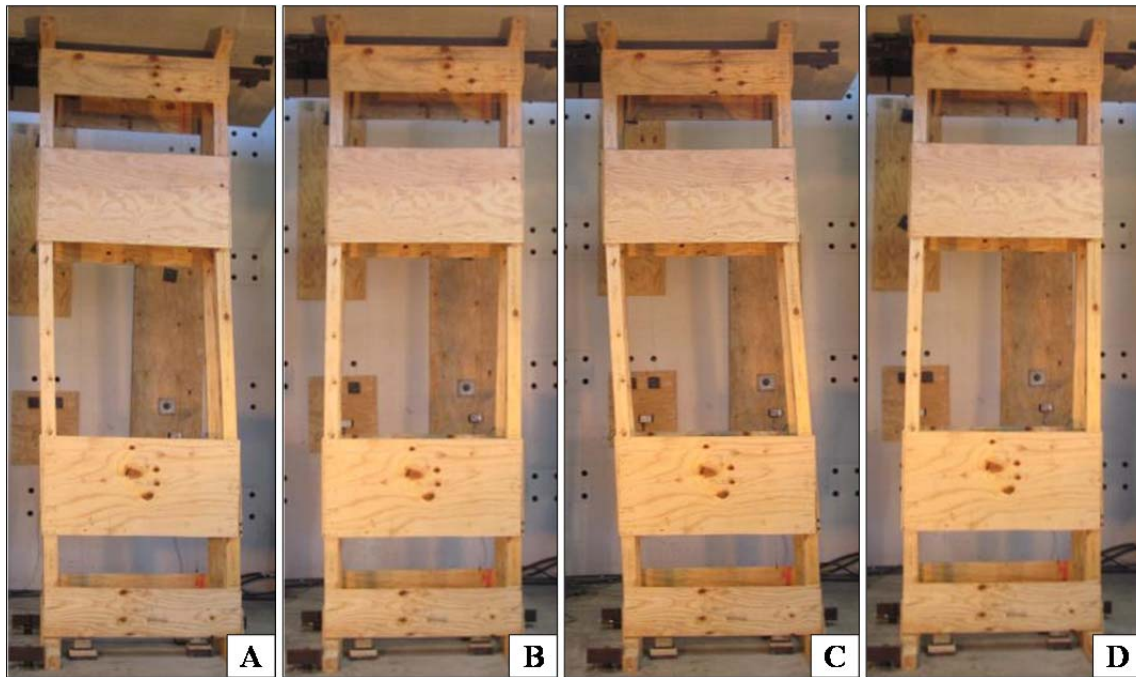
A series of four photographs showing the four lateral displacement amplitudes is provided in Figure 5.27. Double curvature in the posts can be seen as the top of the shore moved laterally while maintaining a level loading head. Steel lateral braces installed at the headers and soles prevented the shore from sliding during testing.

Figure 5.27 Specimen 5 Displacement Phases A) 2in Left B) 2in Right C) 4in Left
D) 4in Right

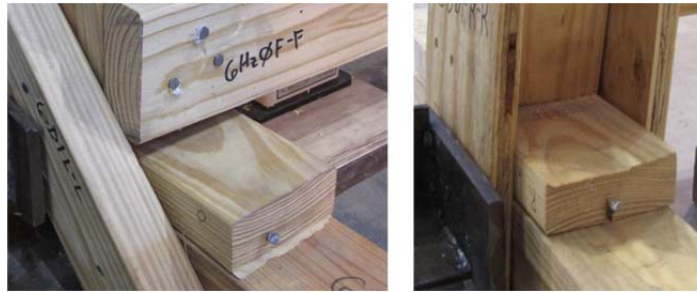
Wedge cupping was relatively absent throughout the entire loading sequence. Splitting of the wedges was also not observed, as was common in other tests. Figure 5.35 shows the condition of the wedges at the conclusion of the test.

Figure 5.35 Condition of Wedges after Loading

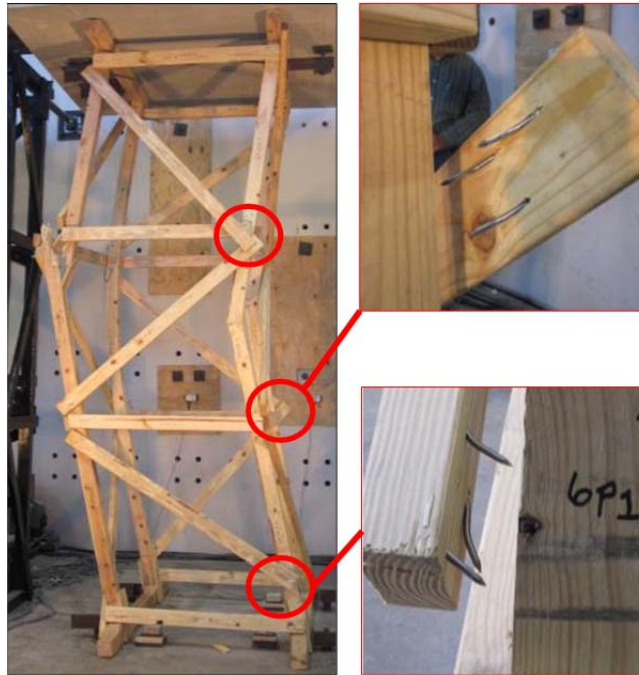
Three 2x4 braces failed via nail withdrawal from the post. These braces locations are shown in Figure 5.40. Numerous other braces experienced partial withdrawal failures, in particular, around the regions of post failure.

Figure 5.40 Brace Failure Locations

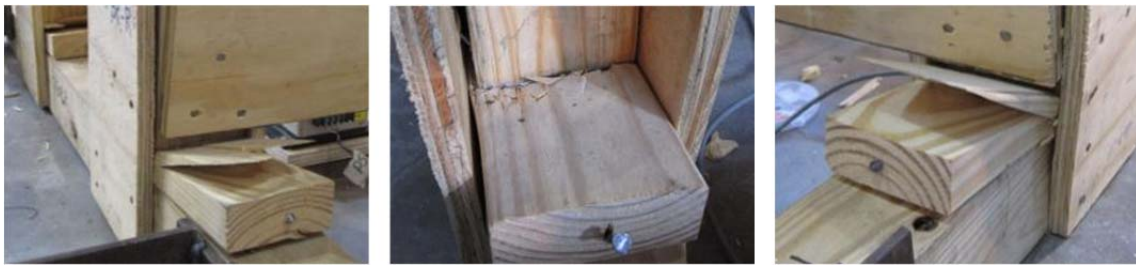
Wedge cupping was noticeable under all four posts, initiating at approximately 80kips. Splitting of the wedges was also observed, in particular, at the location of the toe-nail. Significant bearing of the post into the wedges was observed in the post-test autopsy, as seen in Figure 5.41.

Figure 5.41 Wedge Cupping and Bearing Under Posts During Loading

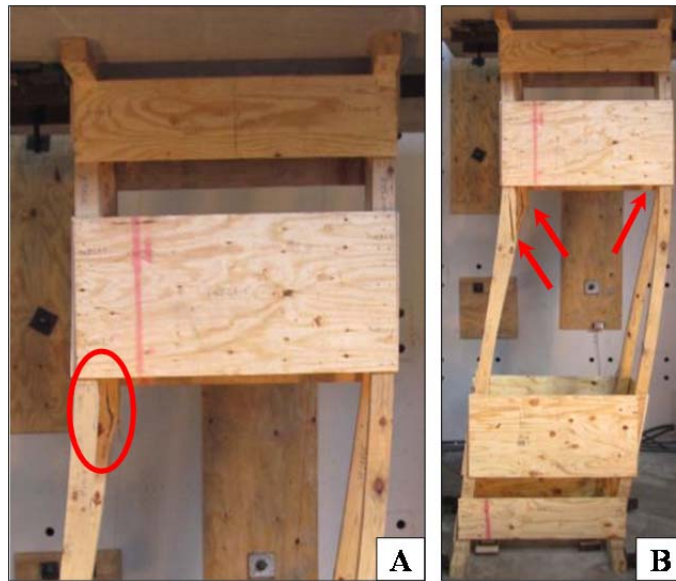
At approximately 14.9in of lateral displacement, the back left post split around a knot near the second level of bracing. The vertical load of 32kips was maintained after the split, and the full 15in. of displacement was attained. Therefore the displacement was held constant and vertical load was increased until complete failure of the shore was achieved. Shown in Figure 5.54 and Figure 5.55 are the vertical load-displacement curve and lateral load-displacement curve for specimen 9. The vertical load-displacement curve depicts both phases of the test, constant load during lateral movement and increasing load during constant 15in. displacement.

Once the 15in. lateral limit was reached the shore was vertically loaded while the 15in. lateral displacement was held constant. Just prior to reaching 45kips, the back right post began to split and fail within the second level brace region. As the loading was maintained, the splits in both the back right and back left posts increased in magnitude until the front left post failed, concluding the test. Figure 5.57 shows the initial failure at 14.9in. lateral deflection, and the final condition of the shore.

Figure 5.57 Post Failure Locations A) Initial Failure During Lateral Displacement B) Final Shore Condition

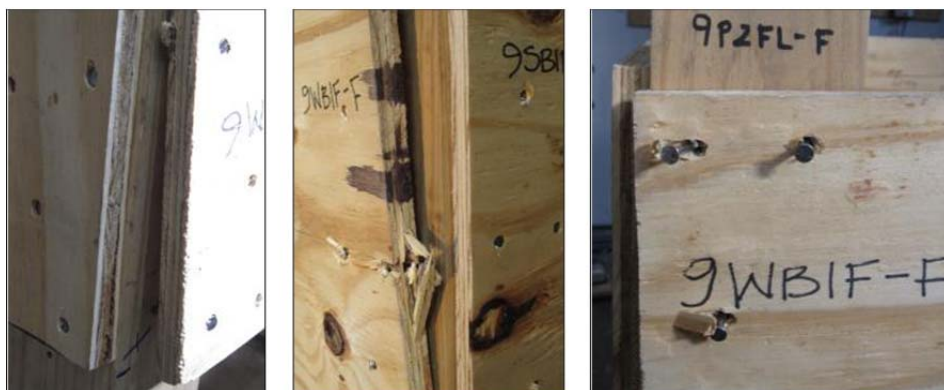
The plywood braces and their respective connections performed well. Only minor nail withdrawal was observed on the front and back braces (see Figure 5.59).

Figure 5.59 Photographs of Brace Connection Failures

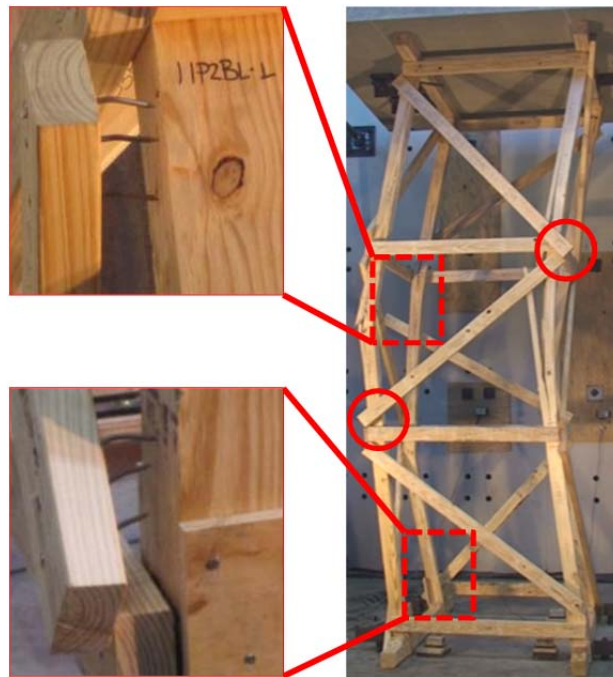
Diagonal brace failures occurred during the testing sequence both prior to and after the initial failure of the back right post. The top connection of the second level diagonal brace on the back of the shore pulled out prior to first failure as well as the bottom connection of the first level diagonal on the back face. Partial withdrawal of the bottom connection of the second level diagonal brace on the front was also observed prior to first failure. After first failure, the bottom connection of the third level diagonal on the front of the shore failed. Photographs of these brace failures are presented below.

Figure 5.73 Brace Connection Failures

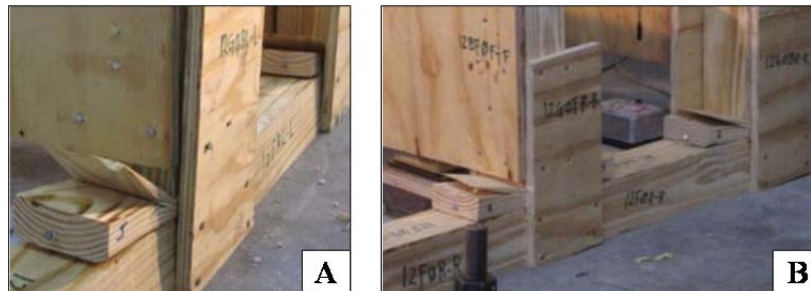
Wedge cupping was observed during loading. All four sets of wedges began noticeably cupping at approximately 60kips, and increased as loading continued. Each set of wedges cupped to a different magnitude, but all were clearly recognizable. Photographs of the wedges are provided below.

Figure 5.74 Wedge Performance A) Left Side B) Right Side

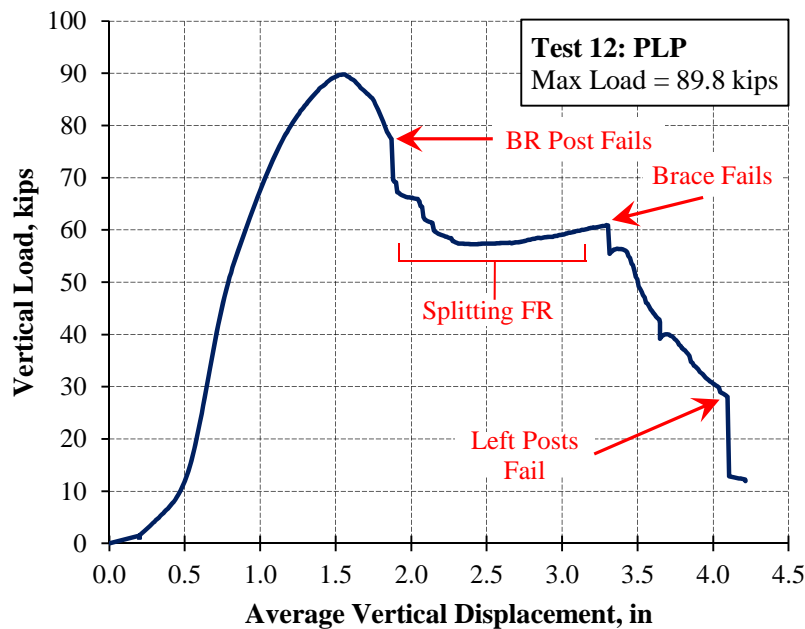
Figure 5.75 Load-Displacement Curve for Specimen 12

After reaching a peak load of 89.8 kips, audible sounds of cracking and distress were very frequent and very loud. The right side began to buckle towards the front, and initial failure occurred in the back right post at a load of 78 kips. Splitting of the front right post in the region of the second intermediate brace began at approximately 65 kips. The right side was noticeably bent forward, and considerable twisting of the plywood braces on the front, back and right side was observed. Also at this point, considerable bearing of the post and top plywood brace into the left header was witnessed. As seen in Figure 5.75, the capacity slightly increased before losing capacity at 60 kips, which correlated to the connection failure of the second intermediate plywood brace on the right side from back right post. Large deformations occurred as the tower tilted to the left, lifting the right footer completely off the ground. Final failure occurred at approximately 28 kips as the two left posts buckled to the left. The load-displacement curve for specimen 12 is presented in Figure 5.75. Also shown below are photographs of the progressive failures.

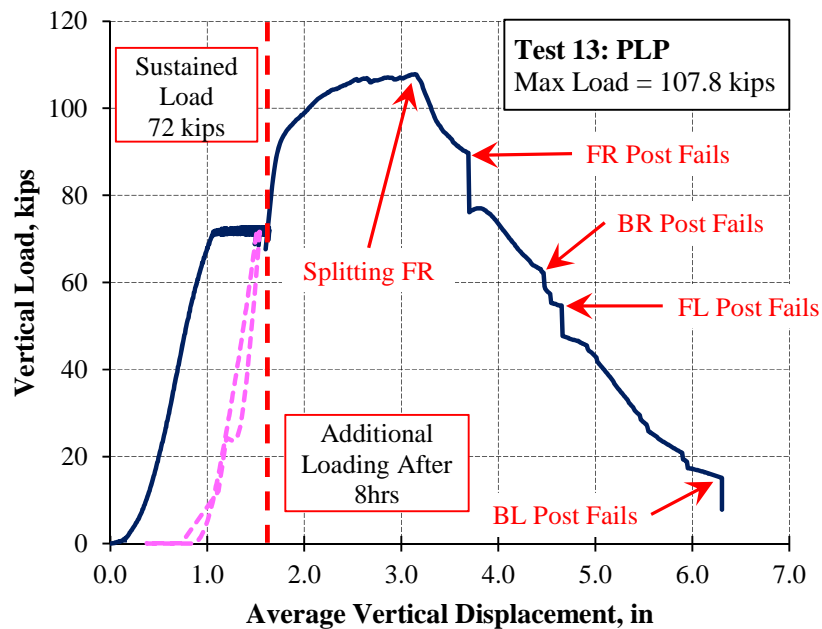
Figure 5.81 Load-Displacement Curve for Specimen 13

Loading of the specimen began at 9:00am and concluded at 5:00pm. At 2:00pm, an error occurred in the loading program controlling the actuators. The system was unloaded, re-equilibrated and the 72kip load reapplied. This unloading and reloading

period can be seen by the dotted magenta line on the load-displacement curve presented in Figure 5.81. Specimen 13 successfully completed the full 8hours under the sustained load of 72kips without any signs of failure. The total amount of vertical deformation under the sustained lateral load was 0.55in. Mild creaking sounds were heard throughout the test, but did not become serious.

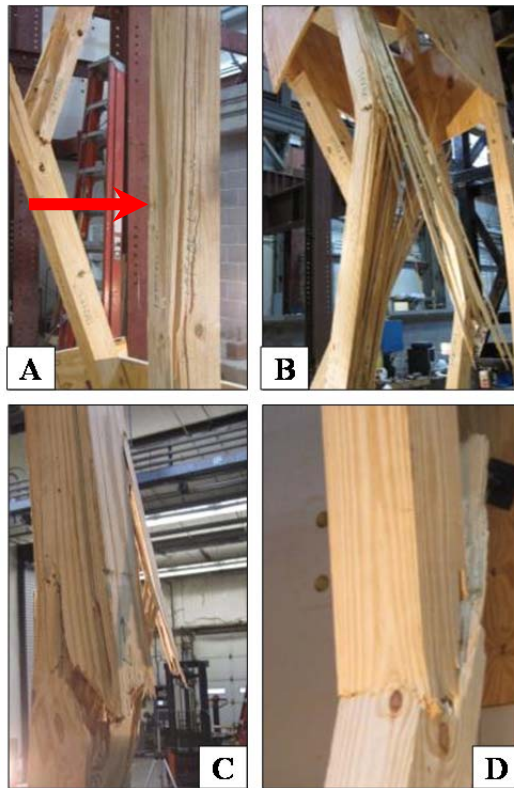
Figure 5.83 Post Failures A) Back Left B) Back Right C) Front Left
D) Front Right

As the peak load of 107.8kips was reached, bearing of all four posts into their respective headers was noticeable. This was followed by the progressive longitudinal splitting of the front right post. The front right post was the first to rupture at

approximately 90kips, followed by the longitudinal splitting of the back right post at 63kips and fracturing of the front left post at 55kips. After these three failures, the shore continued to fold inward on itself towards the back left post, lifting the front right post off of the footer and down from the header. The back left post split longitudinally with the tension face towards the back at approximately 16kips. The progressive failure of the shore is displayed in Figure 5.82 as well as detailed photographs of the failures in Figure 5.83.

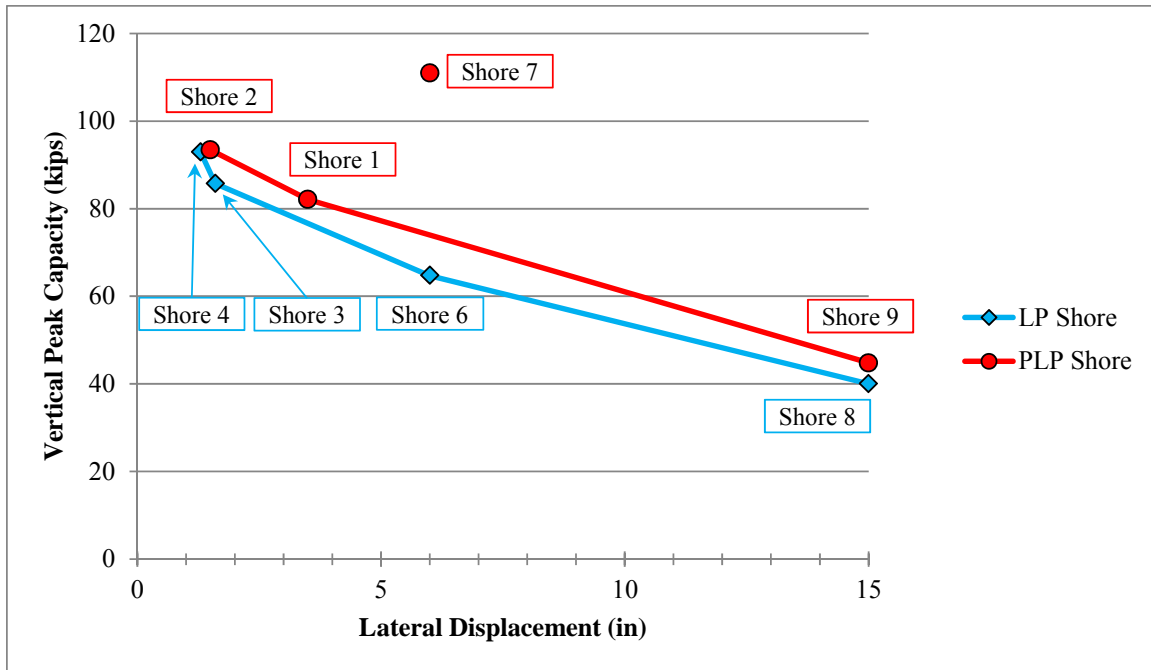
Figure 6.1 Lateral Displacement versus Peak Capacity

Considering the average vertical peak capacity of a shore without induced lateral displacement was 89kips, it can be seen that with the exception of shore 7, vertical load capacity was reduced with a larger lateral displacement. Figure 6.1 presents a plot of the lateral displacement versus the peak vertical capacity for both LP and PLP shores utilizing the data obtained from shores 1-4 and 6-9. The lateral displacement for shores 1-4 is the initial out-of-plumb value prior to testing.

As seen above, the PLP shore configuration maintained a higher vertical load capacity under lateral displacement than the LP configuration. This supports the US&R PLP design goal of providing a more robust shore. The test results also show that both LP and PLP towers still support a higher load than the design capacity of 32kips with up to a 15in. offset of the headers from the footers.

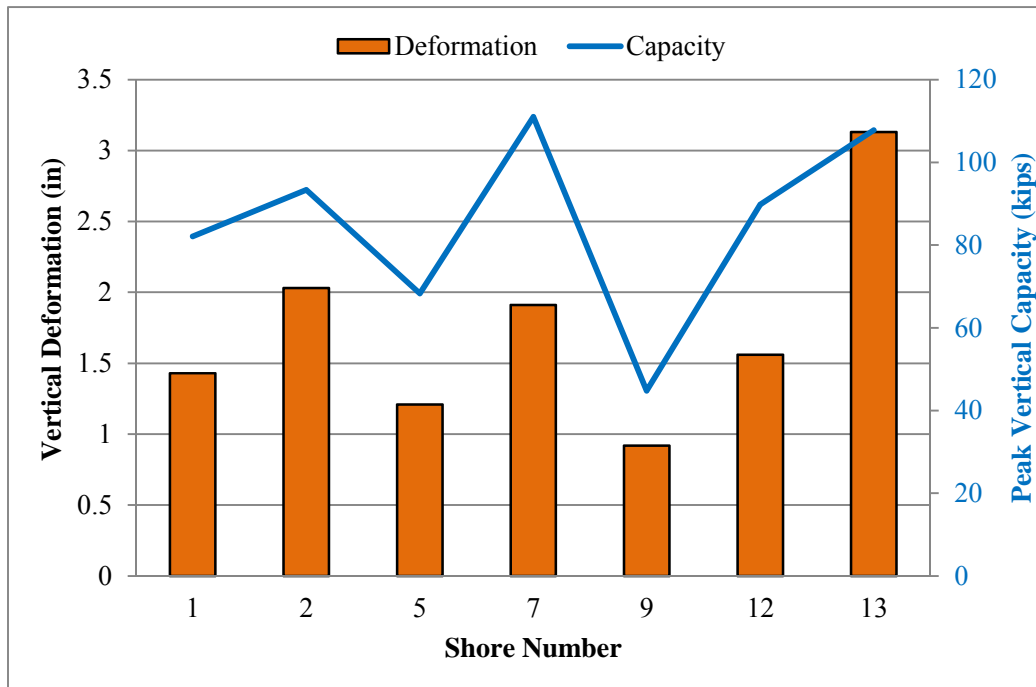
Figure 6.2 Vertical Deformation Comparison of PLP Shore Specimens

Regardless of the magnitude of the peak vertical load, shore 13 displaced over an

inch more (54%) than the next largest value, 0.55in. of which occurred solely during the 8-hr sustained loading phase. Even shore 7, whose peak vertical load was higher than shore 13, deformed 1.2in. less than shore 13 (see Figure 6.2).

Thus the presence and effects of creep on a shore over time can be substantial. This deformation may be of greater concern than the overall capacity of a shore under sustained loads given that shores in the field are often in service for many days. However, it should be considered that shore 13 was loaded with 72kips, over twice the design capacity, and lower sustained loads should result in lower creep deformations.

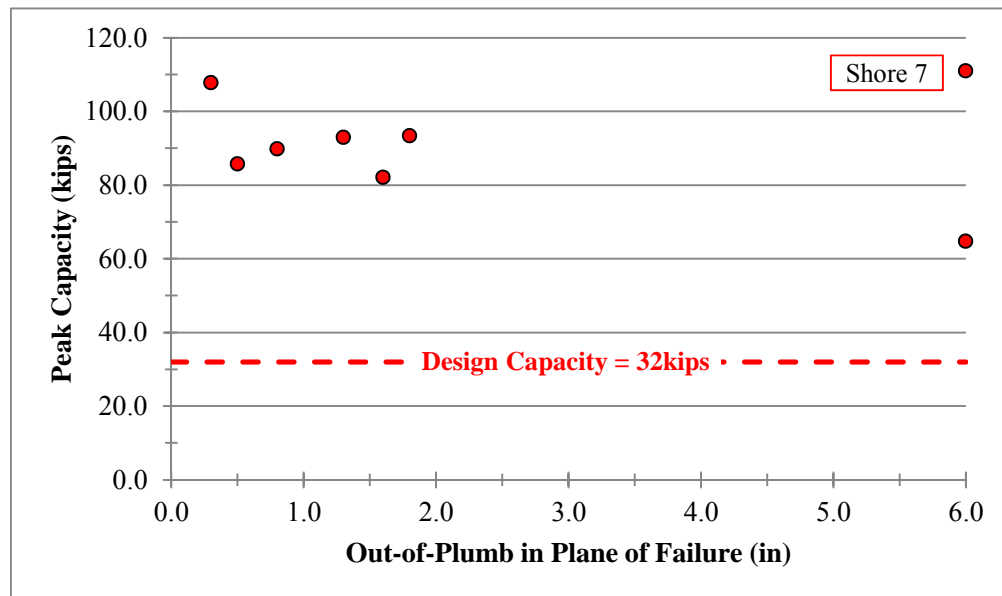
Figure 6.3 Peak Capacity versus Misalignment

The data in Table 6-8 is plotted in Figure 6.3 for the plane of failure. Excluding the outlier point from shore 7, it is evident that even up to an initial out-of-plumb of 6.0in., a shore can maintain a vertical load of twice the design capacity.

Realistically, a properly constructed shore should not exceed an initial out-of-plumb of 2.0in., especially if warping due to the drying of the wood prior to loading is not a factor. From the data, both the PLP and LP shores maintained a peak carrying capacity of over 80.0kips with up to a 2.0in. initial misalignment, a factor of safety of 2.5.

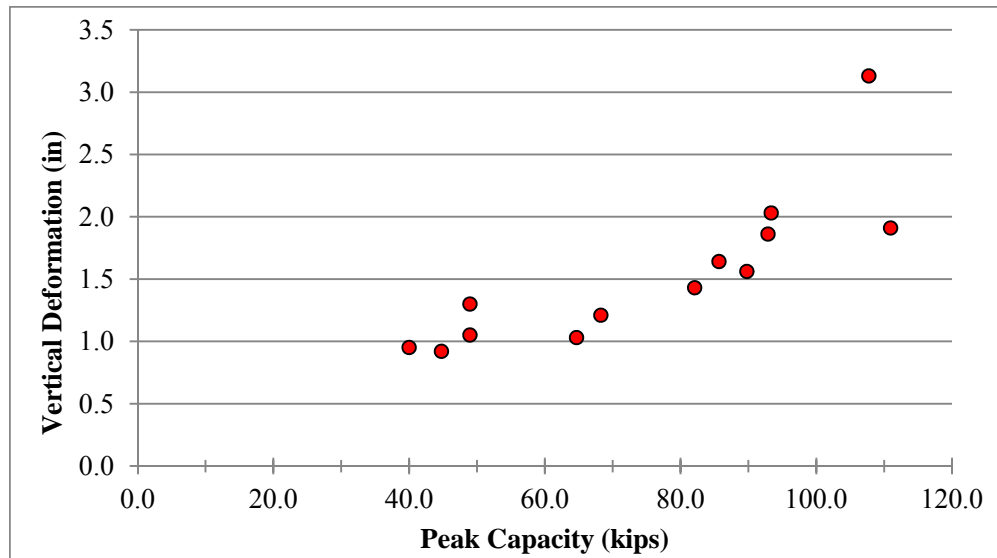
Figure 6.4 Vertical Deformation at Peak Capacity

The least amount of vertical deformation at peak capacity was 0.92in. during the 15in. lateral displacement test. While it is clear that the exact amount of displacement does not always approximate the load on the shore (shores 7 and 13), the two are related. Figure 6.4 is a graphical representation of the amount of vertical deformation to the peak load at which the deformation was recorded.

Figure 6.4 shows some relationship between the maximum load on the tower and the amount of vertical deformation the tower has undergone regardless of the horizontal displacement. Therefore a fuse that captures the amount of relative vertical displacement of the header to the footer may provide a more accurate and consistent means of early warning of failure. Load displacement plots for the entire testing sequence for each specimen are provided in *Chapter 5*.

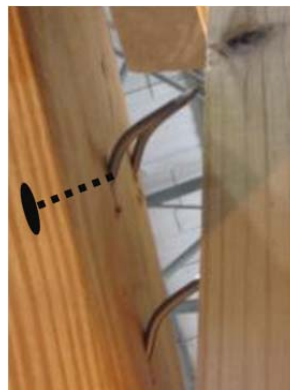
This type of nail failure was commonly observed in the post-test autopsies, but was not the only connection failure mode documented. Failure modes II, III_m and III_s were also observed as well as pullout and splitting of the brace. The exact initial failure modes of the braces were difficult to observe because most of the failed braces also eventually pulled the nails out of the posts, bending the nails. However, signs of double curvature that correspond to Mode IV were observed and an example is shown in Figure 6.6. All brace failures are documented in *Chapter 5* along with photographs of the nail failures.

Figure 6.6 Example of Yield Mode IV from Specimen 8
