Historic Preservation and Disaster Resilience:  
Flooding in Santiago de Querétaro, Mexico

Report

**Master of Science in Community and Regional Planning**

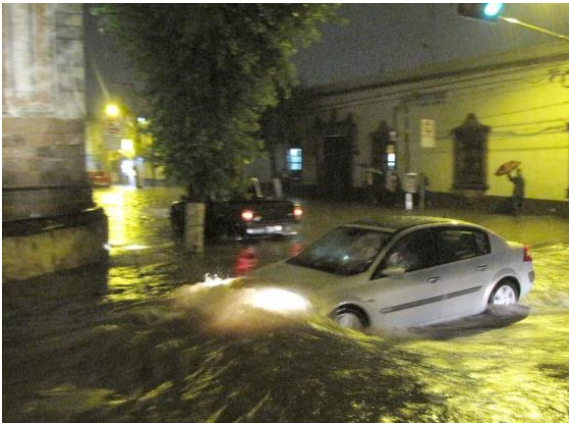
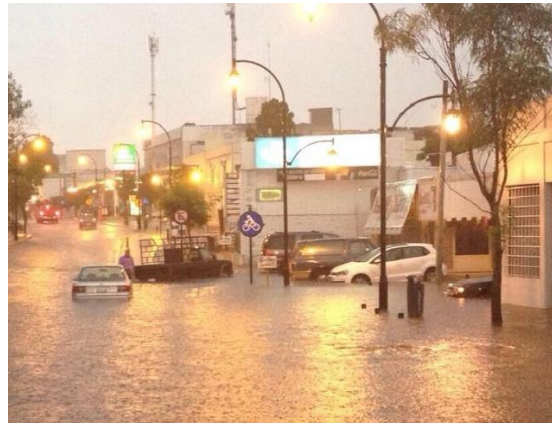
Figure 1-4: Flooding on Ezequiel Montes St, 2014

Figure 1-5: Flooding on Universidad Av, 2014

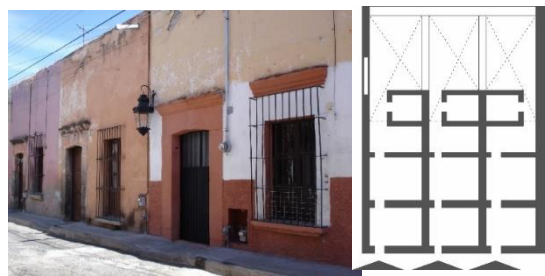
**Type Four:** These homes have one row of rooms with a courtyard and kitchen towards the rear of the home.

Figure 2-9: Type Four Home and Floorplan

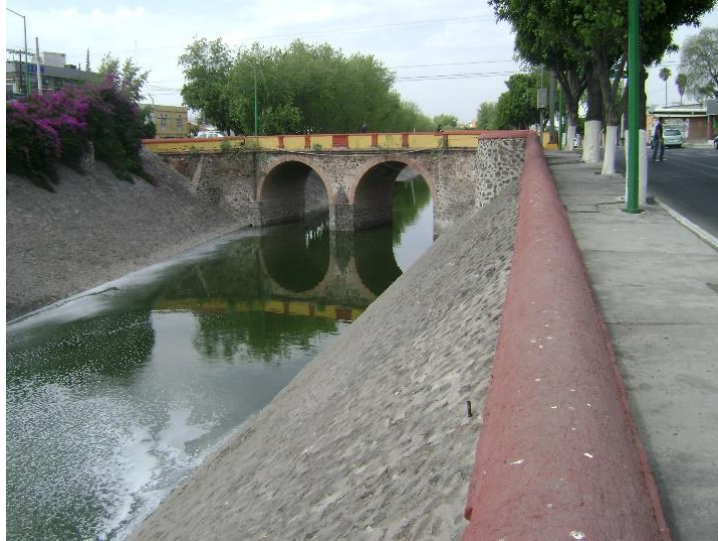
Figure 4-6: Hardscaped Portion of Querétaro River

The segment of the Querétaro River flowing through the urban area has also been channeled and cobbled in an attempt to improve flow, and control shifting (See Figure 4-6). In the Historic Center, Universidad Avenue follows the trace of the river on either side; the banks of the river in this area have been landscaped into a linear park (See Figure 4-7 and Figure 4-8)

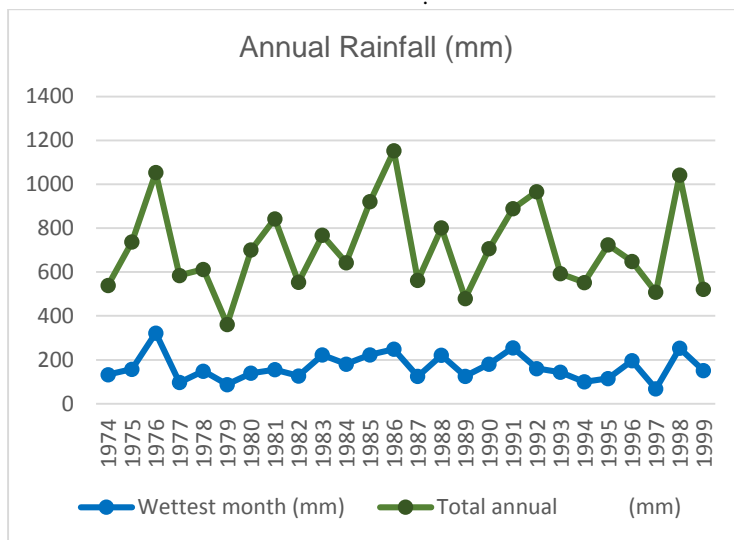
Figure 4-14: Annual Rainfall 1974-1999  
(Source: CNA, 2002)

Most heavy rain occurs in the wet summer season. Table 4-2 shows yearly recorded precipitation in millimeters from 1974-1999 and the total rainfall in millimeters for the wettest month in each year.

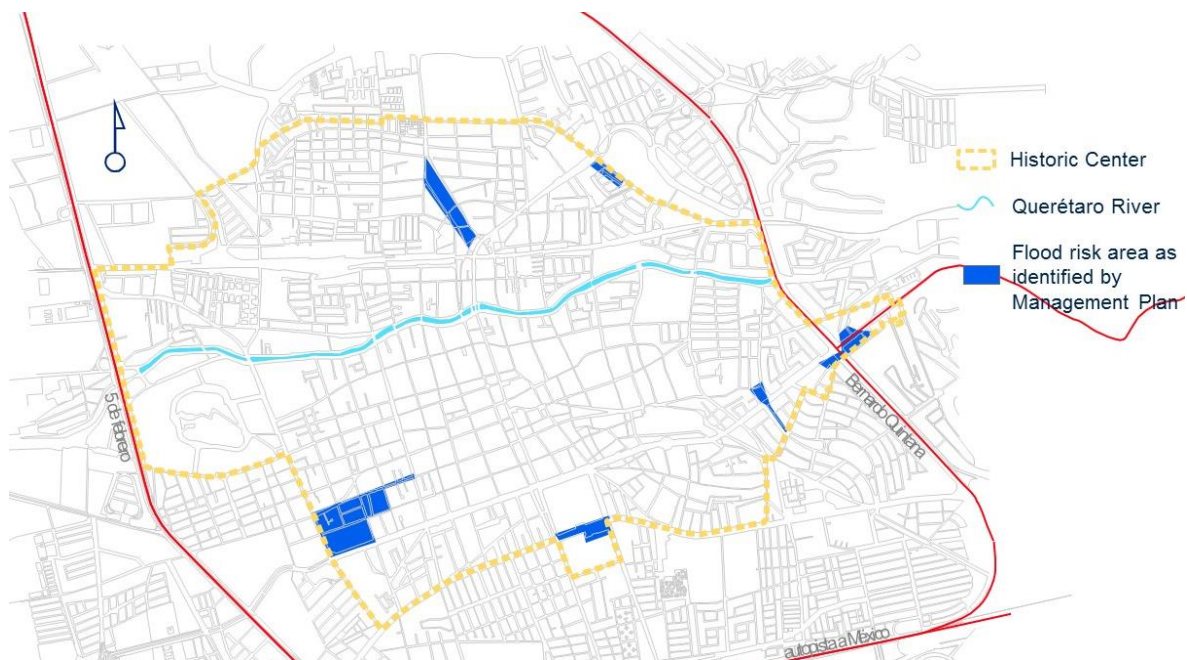
Figure 5-3: Areas at Risk of Flooding  
Source: Plan Parcial, 2005

The Historic Center Management Plan, using information acquired from the State Water Commission (CEA) has identified twelve areas of potential flooding. These include the intersections of Zaragoza Street with Juárez, Allende, Guerrero, Ocampo, Tecnológico, and Corregidora Streets. The entirety of the portion of the Querétaro River running through the downtown is identified as a risk area. Four other intersections: Esmeralda at Maestu, Los Arcos at Capuchinas, Felipe Angeles at Epigmenio Gonzalez and Psicometría at Trigonometría are listed as points at risk of flooding (Municipio 2006, Vol. III, p. 32).

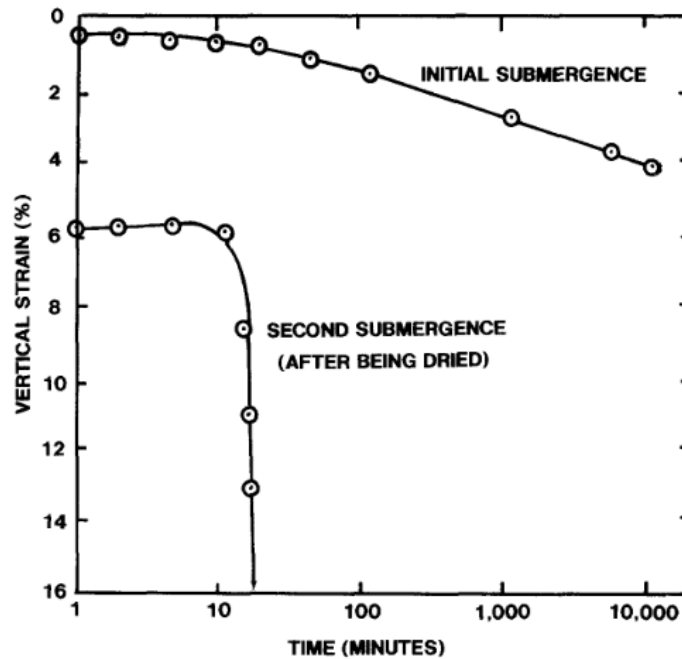
Figure 6-2: Vertical Strain on Submerged Adobe  
(Source: Day 1993)

Adobe is durable when well-maintained but, as its main ingredient is earth, can weather and collapse when uncared for. Furthermore, it is particularly susceptible to flooding. If exposed to running water, adobe walls are quickly eroded, compromising the structural integrity of the entire building. Long-term submergence causes the adobe to swell and become weaker as it absorbs the water (San Bartolomé, Cabrera, & Huaynate, 2012). Vertical strain on adobe doubles only after about ten hours (600 minutes) of initial submergence, making it apparently resistant to short-term first-time floods. Cycles of wetting and drying, however, cause the material to lose integrity as its earthen blocks swell, shrink, and break apart. Day's laboratory tests on adobe showed vertical strain on a sample piece of the material was sixfold after being submerged for seven days and left to dry. The sample disintegrated after only ten minutes of subsequent submergence (Day 1993, pp. 165-168; See Figure 6-2)

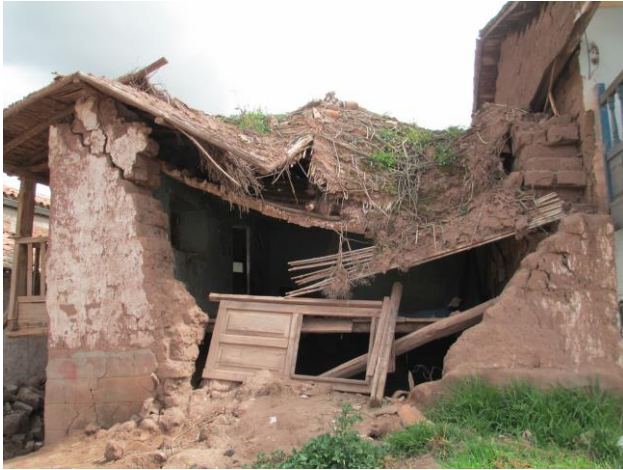
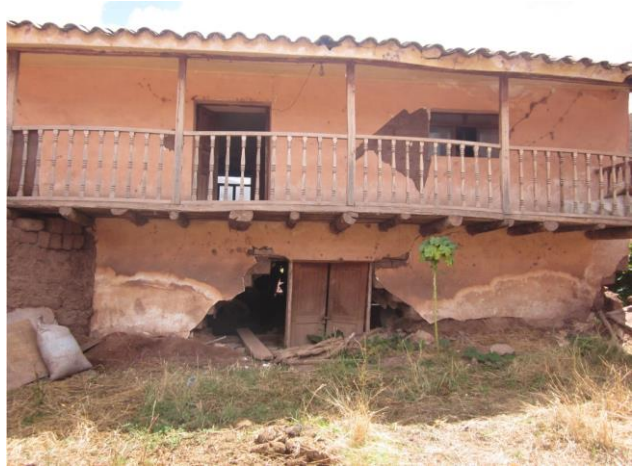
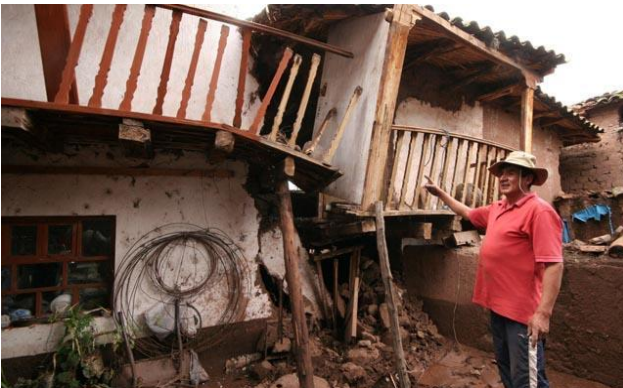
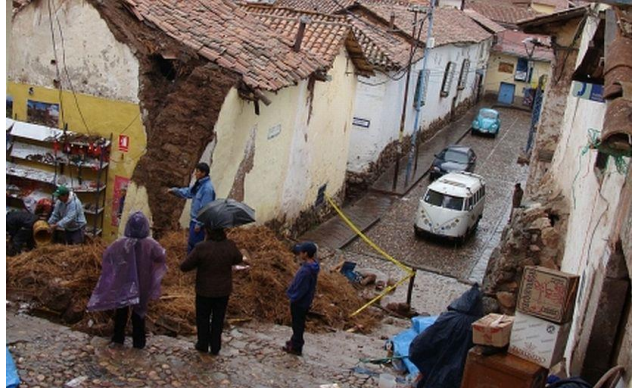
The adobe structures of Querétaro have remained intact so far, but it is useful to consider cases in which such structures have been affected to appropriately plan for a disaster resilient heritage zone. Cuzco, Peru has a significant inventory of adobe structures, plastered and unplastered, many of which were affected by flooding in 2010 and 2013 (Goshen College, 2010). Figure 6-5 shows a near complete collapse of a whitewashed unplastered wall after the 2008 floods outside of Cuzco. Figure 6-6 shows serious damage suffered by a plastered two-story adobe residence. The cracks in the plaster from swelling and unleveling are evident in the first and second stories. Figure 6-7 shows partially collapsed adobe homes as a result of soil and wall erosion during flooding. Figure 6-8 shows a partially collapsed wall in Cusco. Also evident is the loss of protective plaster and whitewash near the foundation of several buildings, attributable to water erosion and cracking due to swelling.

*Figure 6-5: Home Affected by 2010 Cusco Floods*  
(Source: Goshen College 2010)

*Figure 6-7: Home Affected by 2010 Cusco Floods*  
(Source: Goshen College 2010)

*Figure 6-6: Homes Affected by 2013 Cusco Flood*  
(Source: Cuatro casas 2013)

*Figure 6-8: Homes Affected by 2013 Cusco Flood*  
(Source: Cuatro casas 2013)

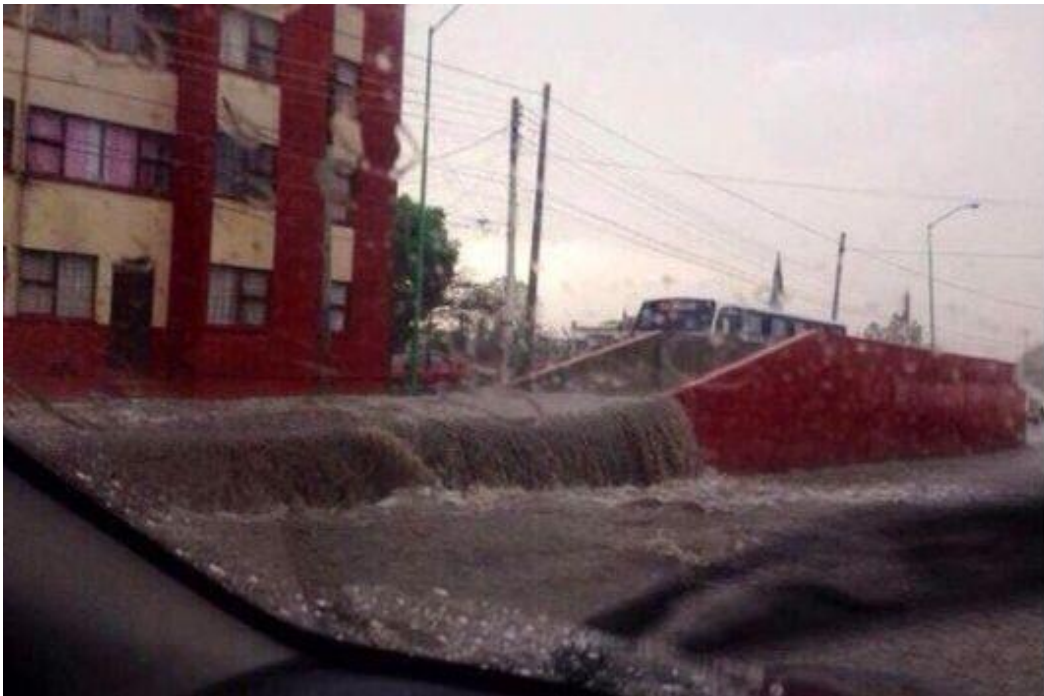
*Figure A-2: "El Arenal" Drainage Channel Overflowing*  
(Source: Evalúan daños)

Complete Phases I-III of stormwater management infrastructure in the historic center (See Figure 8-2: Improvements Proposed in Stormwater Management Plan). Also complete and re-evaluate effectiveness of metropolitan stormwater diversion networks (See Figure 4-10: Urban Drainage Infrastructure for the Metropolitan Area). Reinforce drainage channels to prevent further ruptures and seepages (See Appendix A).

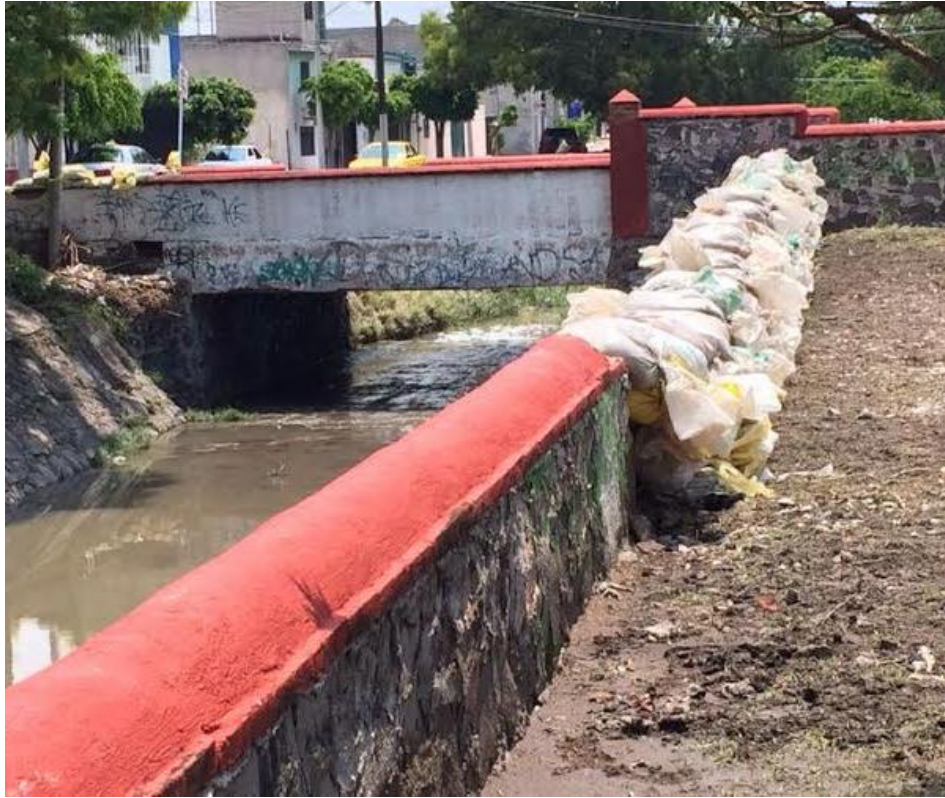
*Figure A-3: Ruptured Retention Wall on Río Querétaro*  
(Source: Torres & Benítez 2014)

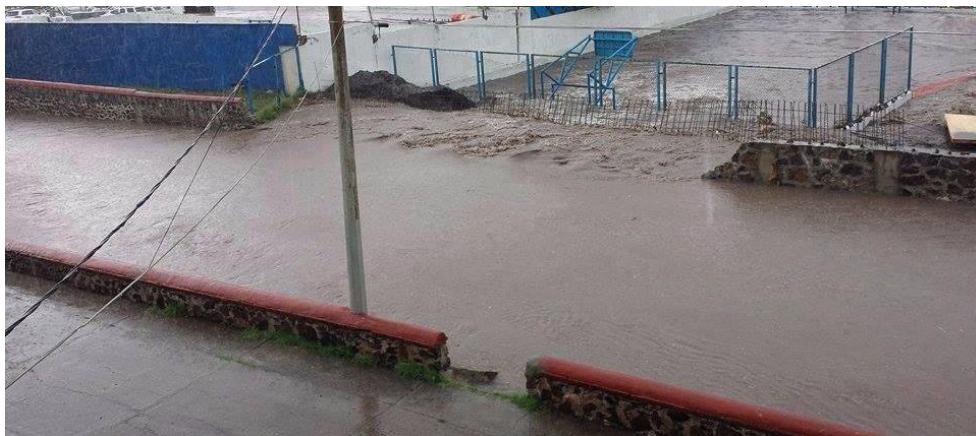
*Figure A-4: Ruptured Drainage Channel*  
(Source: Evalúan daños)
