“HERE TO STAY IN POWER”

Adaptive Reuse of Seaholm Power Plant at Austin, Texas as Austin Museum of Art

Report

Master of Science in Historic Preservation

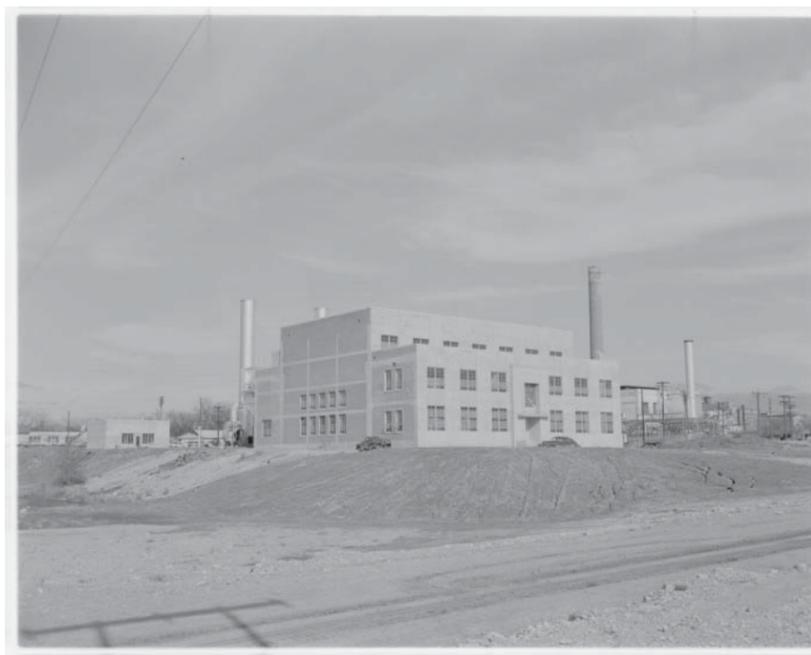
2. The first phase of Seaholm construction.

J.M. Odom of Austin was the contractor.^[3] A new power plant was crucial for two reasons: due to war shortages the city had not upgraded its facilities for almost a decade while the population had increased many folds and, with the advent of televisions, air conditioners, dishwashers and washing machines, the demand for electricity was greater than ever before. In 1950, the first phase of Power Plant No. 2 began. The second phase was finished in 1958. Five generators produced 120,000 KW of electricity.^[4]

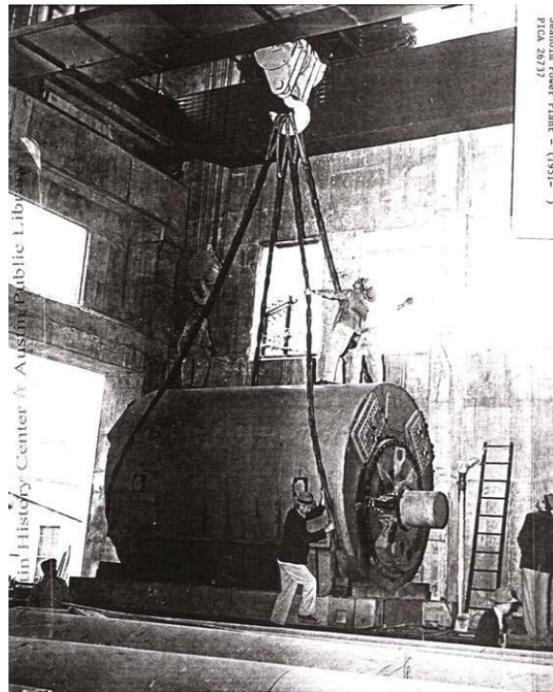
3. Interior - crane used for turbine installation.

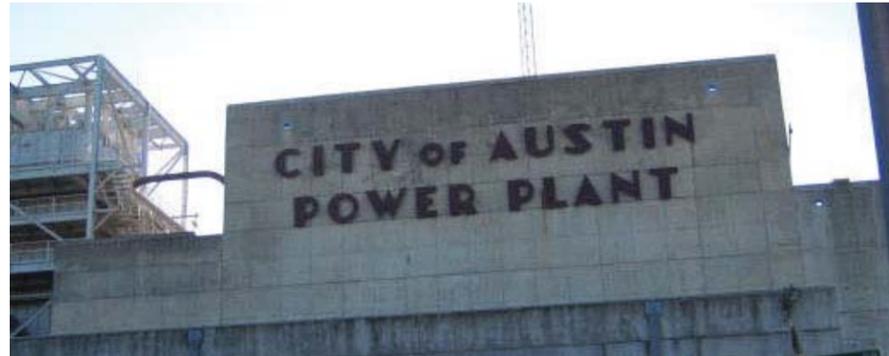
20. Art Deco Lettering on West Elevation

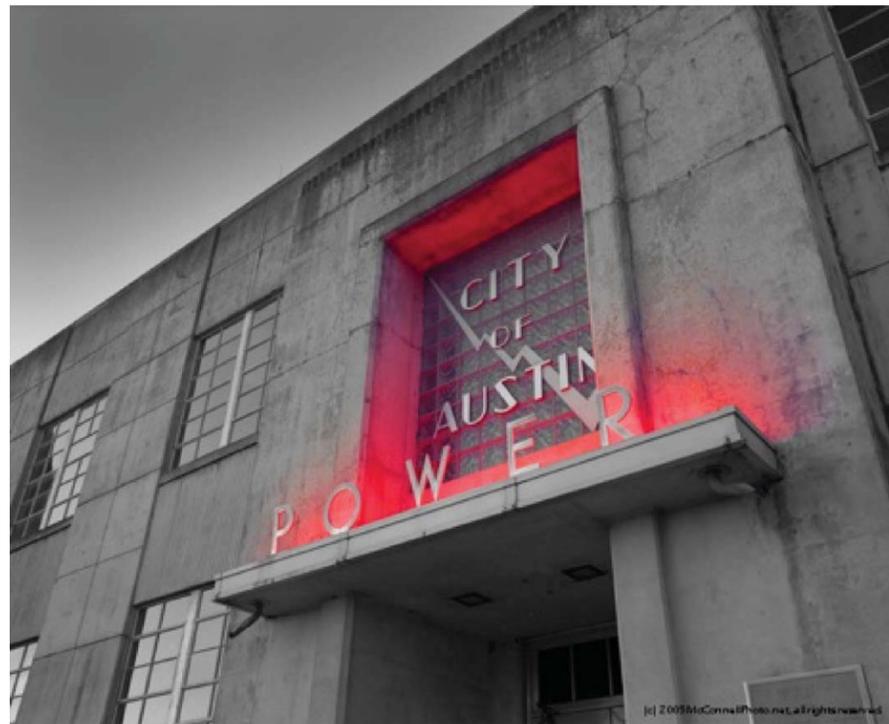
21.. Art Deco Signage and Lettering Above Entrances in South Elevation

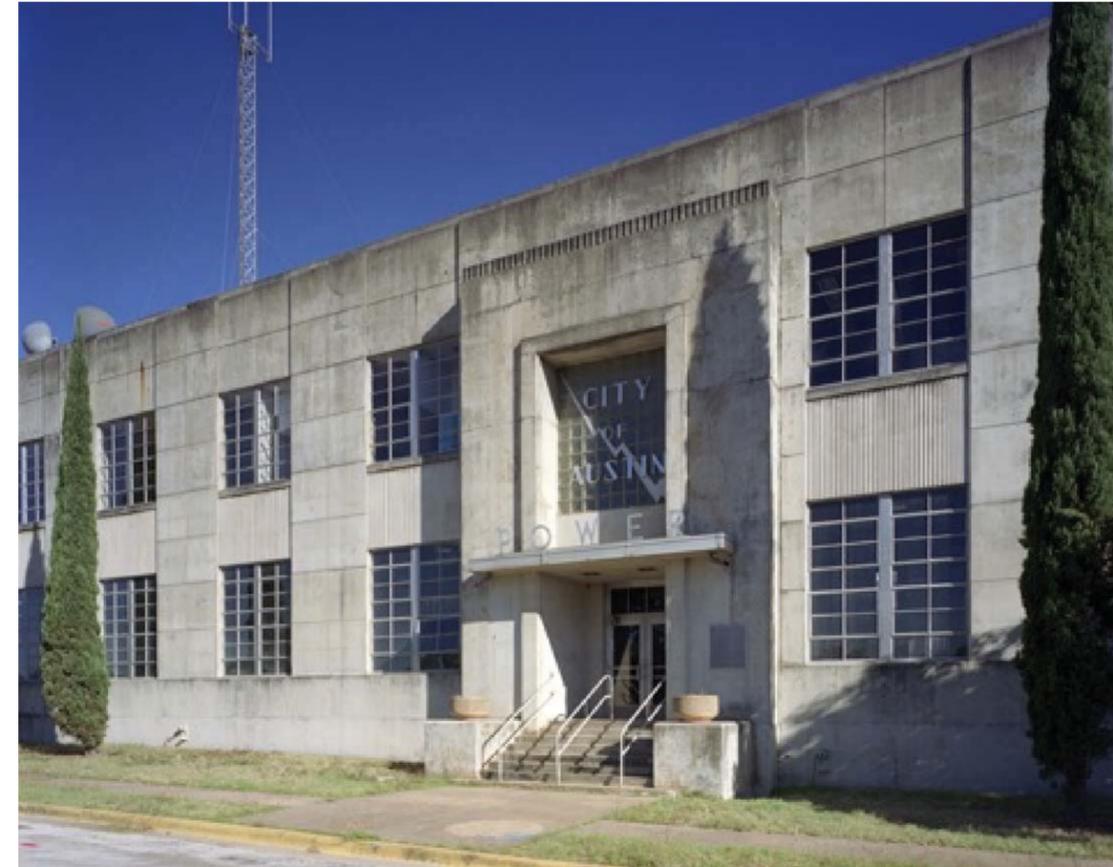
22.. South Elevation
Fluted Treatment of Concrete Panels Between Upper and Lower Level Windows
Corrugated Treatment of Trim on Top of the Entrance Surround
Concrete Urns on Either Side of the Steps
2x6 and 2x7 Awning-Type Windows
4 Foot x 4 Foot Scoured Concrete Facade

The whole structure is built with cast-in-place concrete. The external concrete façade is scored into 4 foot x 4 foot panels that sometimes have corrugated or flat rubbed surfaces. The texture of the plywood formwork applied during its construction gives the panels their unique character. The panels in between upper and lower windows have a fluted pattern on the concrete façade. The windows and doors are steel with transparent glass panes used in most of them. Glass blocks are also used in southern and eastern elevations. The boilers and other machinery are made of steel and the newly added covering is of sheet metal.

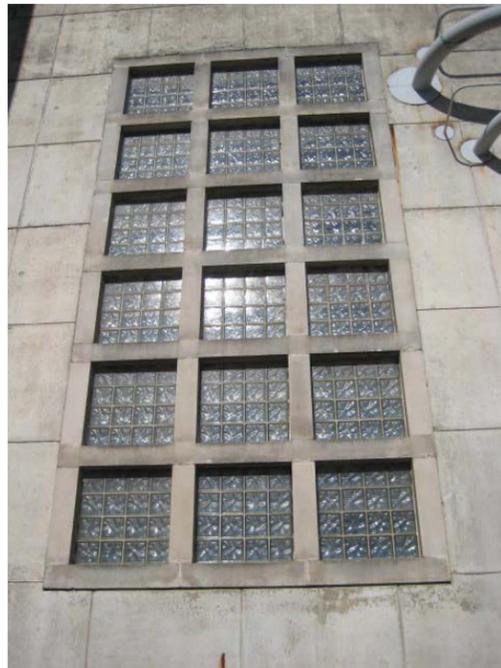
23. Floor -to- Ceiling Glass Blocks Fixed Window on East Elevation

The east elevation of the Seaholm Power Plant has a small building tacked on to the larger building. This elevation, like the south elevation is broken into a neat grid by windows. Towards the north, a floor to ceiling fixed window dictates the character of this elevation. This window is made up of a grid of glass blocks set against a concrete framework. The north elevation displays the industrial nature of the building. Only the entrance doors and the windows above it are visible on the northern façade as the boilers covered in sheet metal stand right in front of it. Therefore, northern elevation is defined by the five flue stacks and the sheet metal covered boilers and their associated machinery.

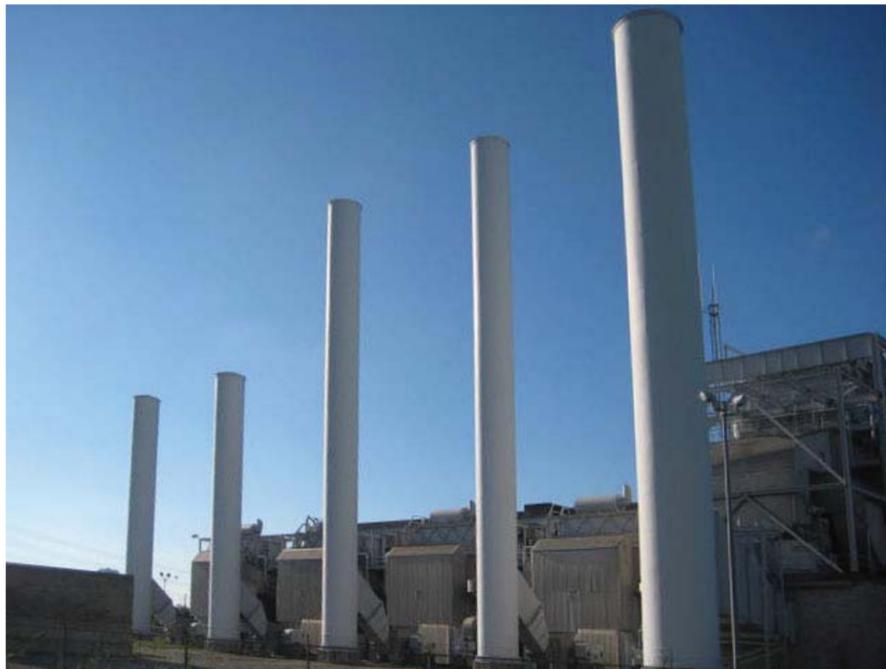
24. Flue Stacks in North Elevation

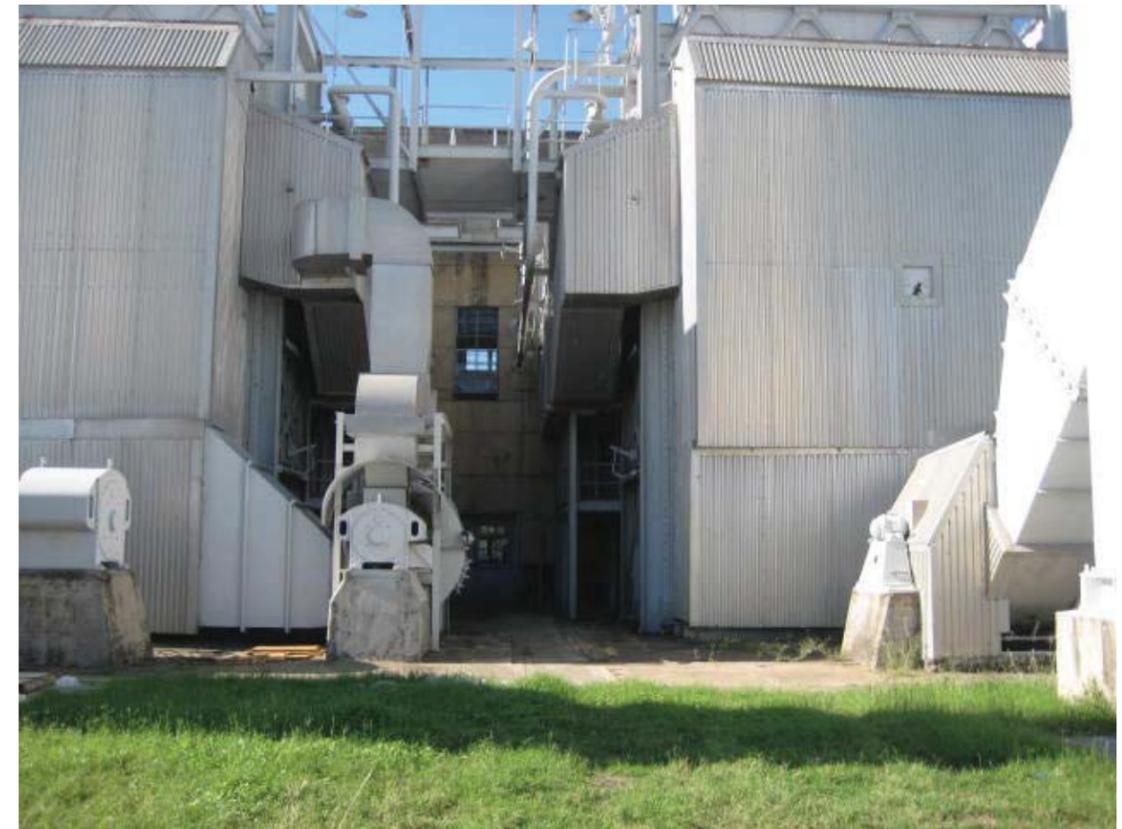
25. View from North
Boilers and Other Machinery Covered with Sheet Metal
Main Entrance Doors and Windows Above in North Elevation
Steel Overhead Walkway

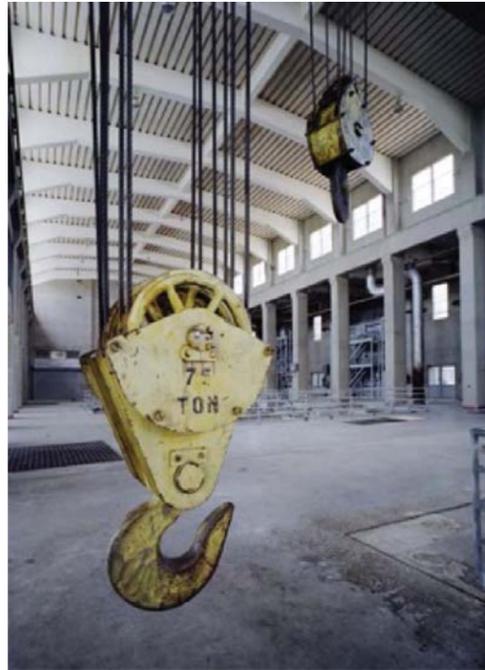
26. In-house Crane Used During Construction & Production Periods at Seaholm Power Plant - Fully Functional

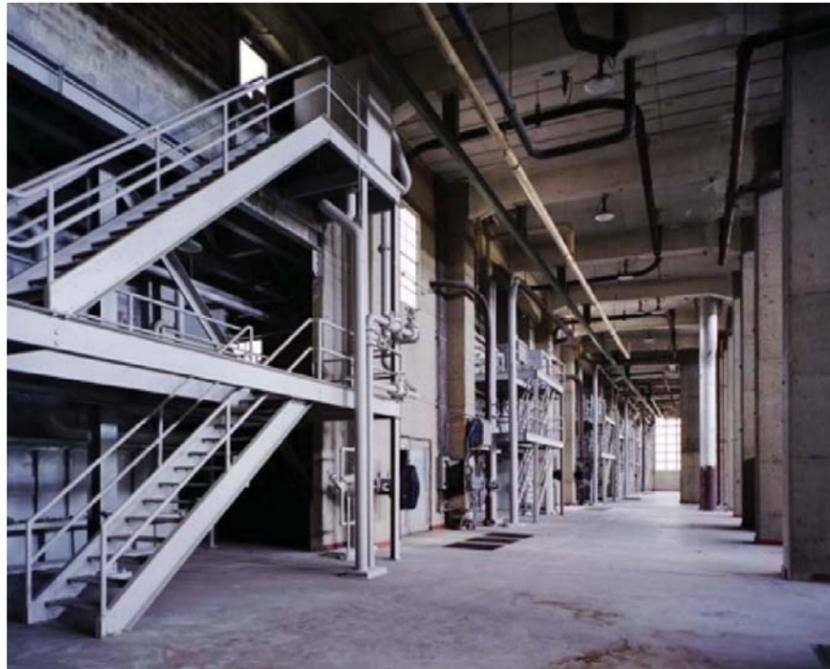
27. Double-Height Space on the Northern Side of Main Floor

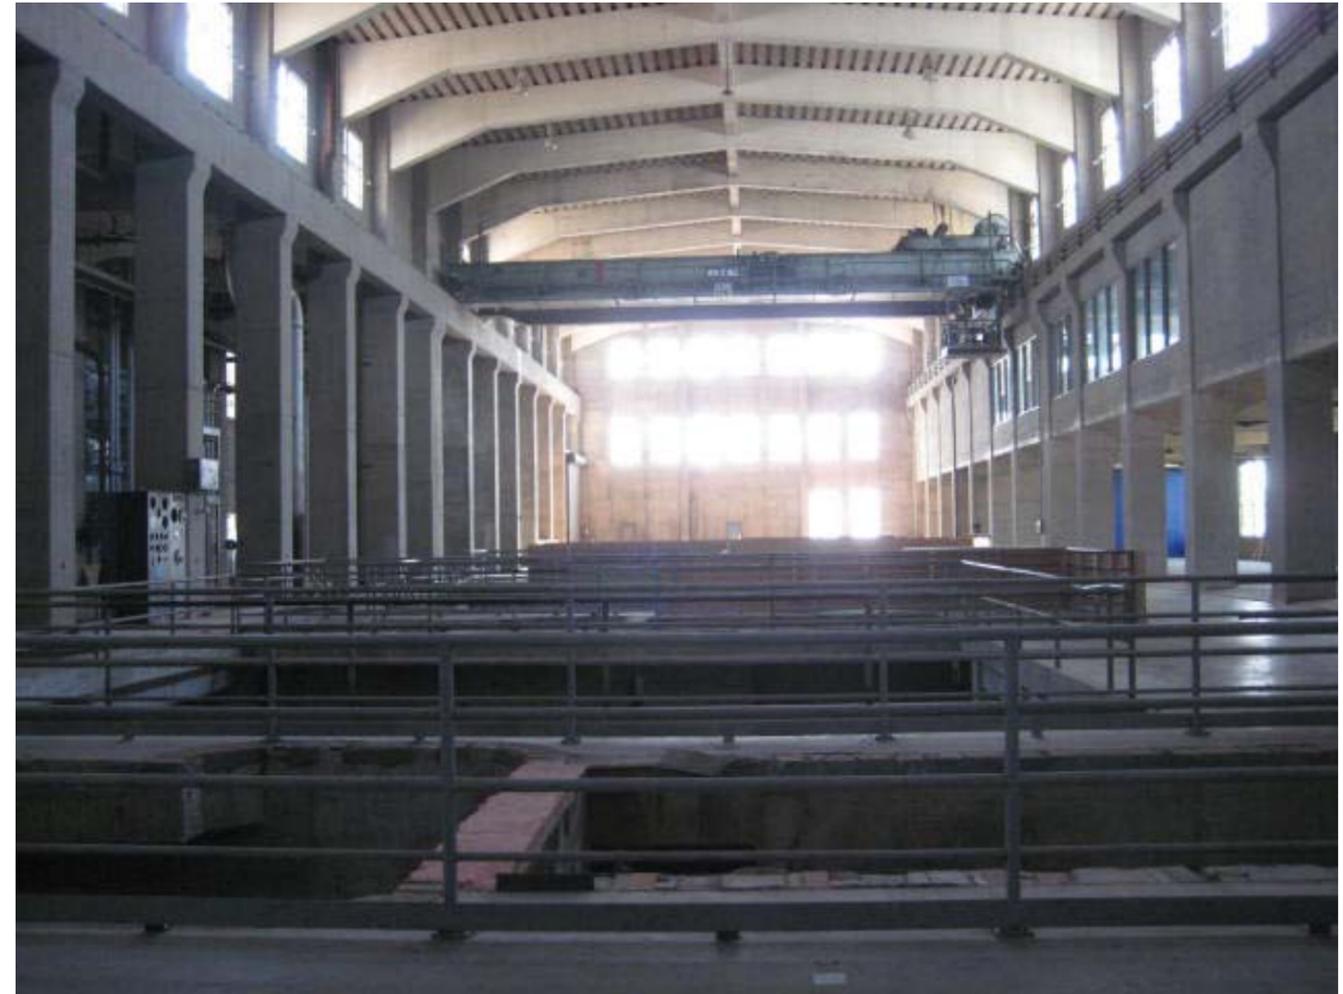
28. Main lobby area
Turbine Hall: Double-Height Main Floor Space
Multiple Floor Cut-Outs
Quality of Light
Column and Beam Design

The interior of the building is as special as its exterior even though the machinery has all been removed. The turbine hall is interesting in terms of its height, the quality of light, the floor slab cut-outs and its large expanse of space. Similarly the two floors below have varied quality to them. At least more than half of these floors have no natural light access. The floor cut-outs bring in diffused light from the turbine room windows down to the lower levels. At the lowest most level, the most interesting features apart from the quality of light are the water catchment areas and the view of the upper floors. The floor level in between the lowest floor and the ground floor is divided into two levels. The southern part of the floor is 3 feet lower than the northern half. They are connected to each other through a series of steps and metal grate walkways. Another important feature at this level are the circular holes in the wall that runs laterally through the middle of the floor which previously housed large pipes that carried natural gas. There are also a number of steel stairs and railings that enhances the industrial feel of the building.

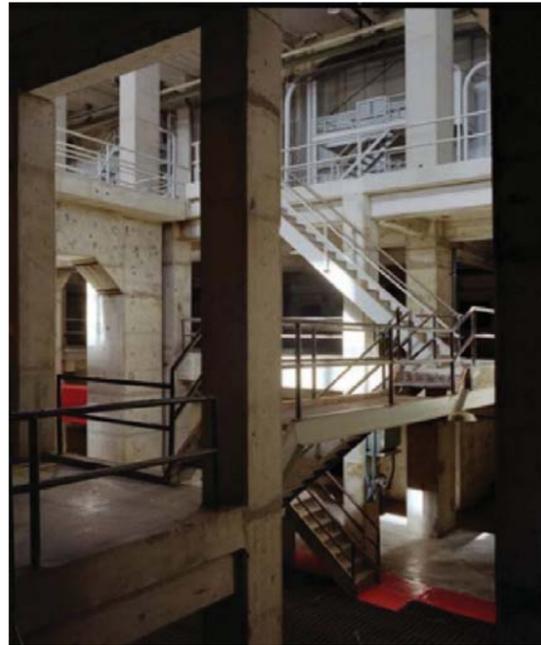
29. Lower floor view
Metal Grate walkway
Splash of Red Paint
Filtered Light

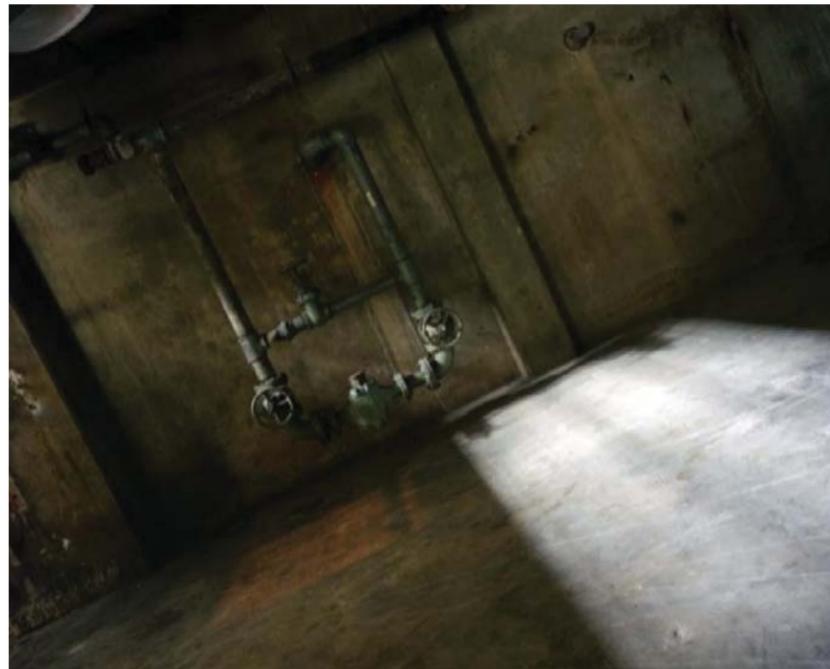
30. Various Mechanical Equipment Dispersed Throughout
the Building

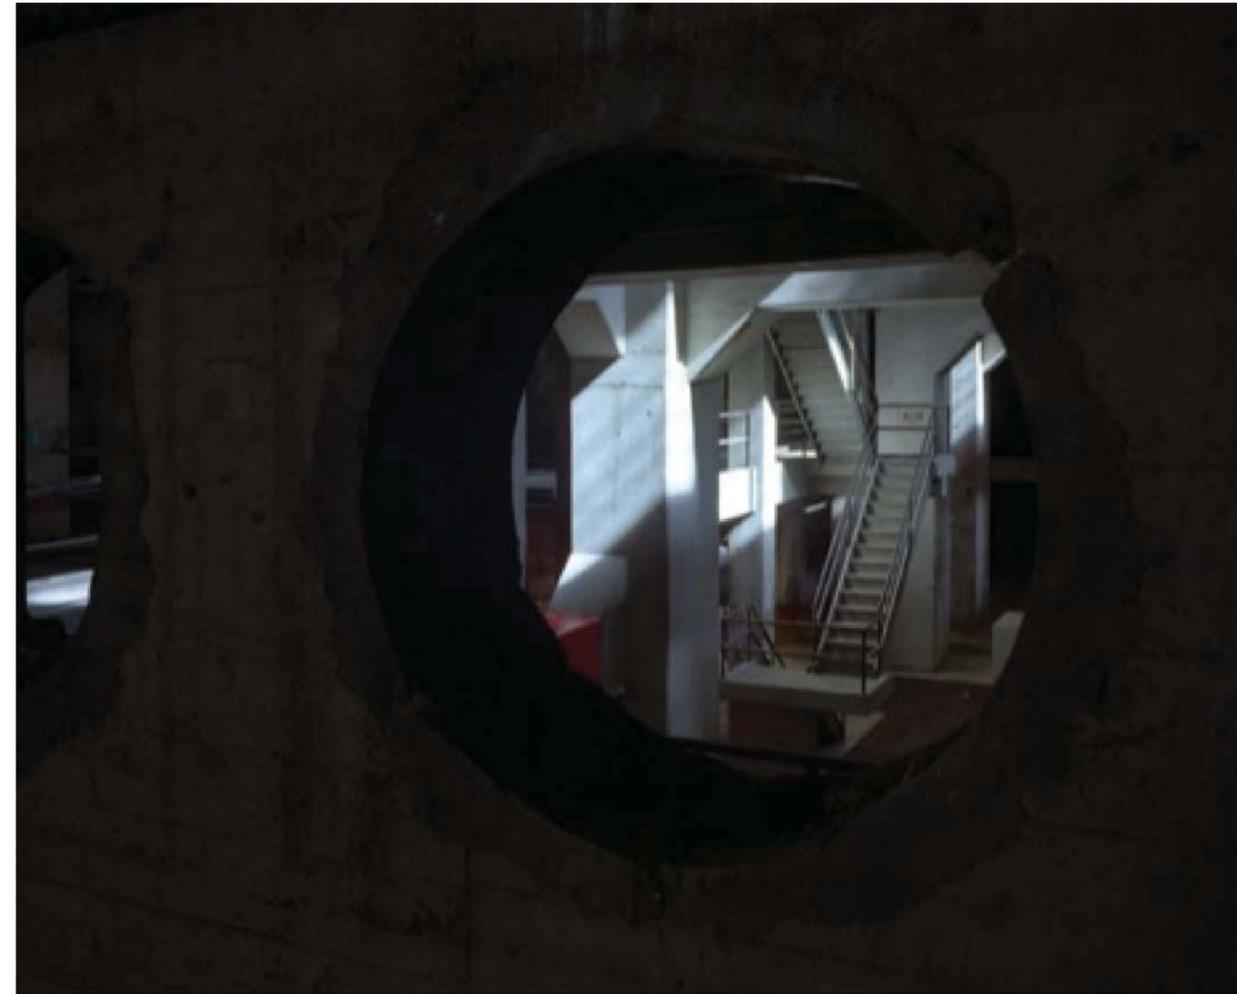
31. View through a Pipe Hole in the Wall
The Pipe Hole Original to the Building; Carried Boiler Pipes
Quality of Filtered Light

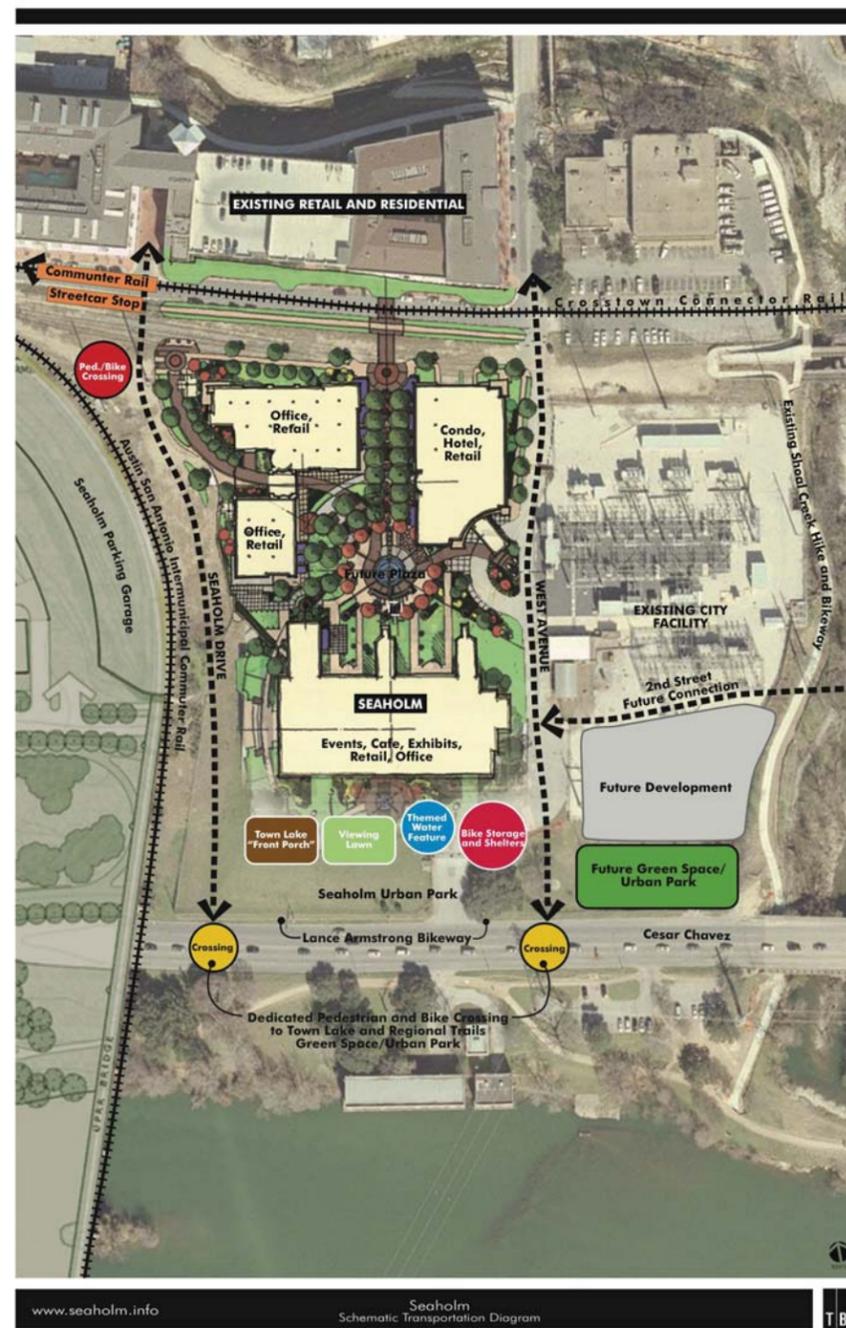
32. Seaholm District Plan

In 2000, urban design consultants ROMA was hired to develop a multitude of redevelopment plans for various pockets of Austin. Among these, was the redevelopment of Seaholm District. In collaboration with other entities both public and private a master plan was proposed and developed. Following are the recommendations made for Seaholm District in the master plan:^[9]

- Preserve Seaholm Power Plant as a prominent civic historic landmark with viable and complementary public-oriented uses. Reinforce the natural, visual and open space character of Town Lake and Shoal Creek.
- Ensure that adequate parking is provided for Seaholm.
- Extend roadways to improve local access to Seaholm and to create better linkages to the downtown and adjacent activity centers, and provide for improved bicycle and pedestrian circulation through the Seaholm district.
- Provide the development of an intermodal transit facility at the heart of the Seaholm district, accommodating city and inter-city buses, Amtrak and future light rail and commuter rail service.
- Promote the development and redevelopment of surrounding properties and the preservation of key resources to create a unique and vibrant mixed-use

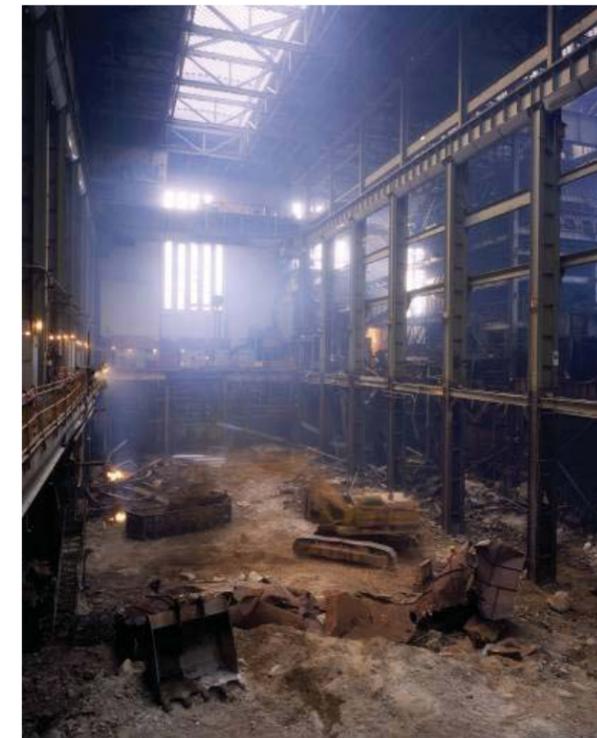
39. Turbine Hall during construction.

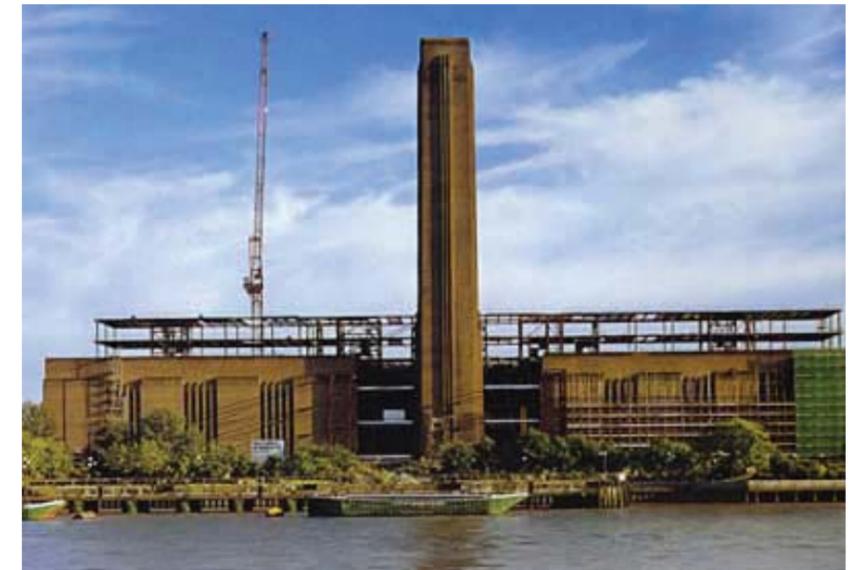
40. Reconstructing Bankside - Construction of “Light Beam”

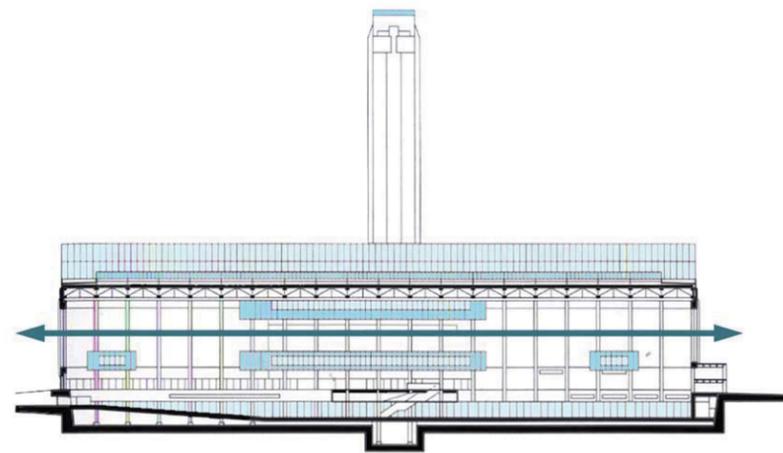
41. Sectional Organization Diagram

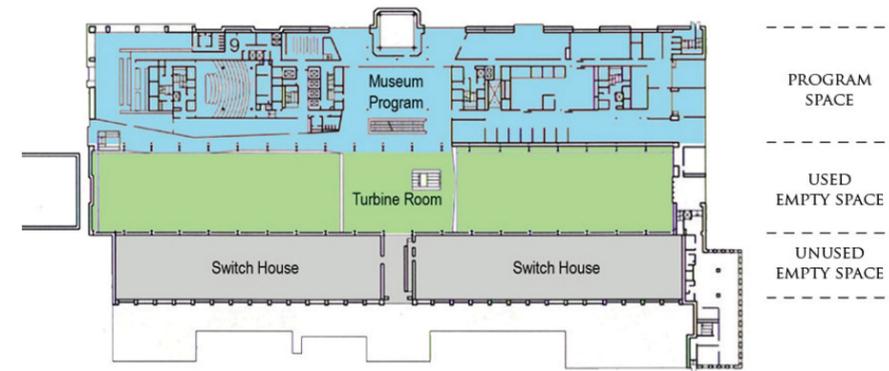
42. Horizontal Mapping Diagram

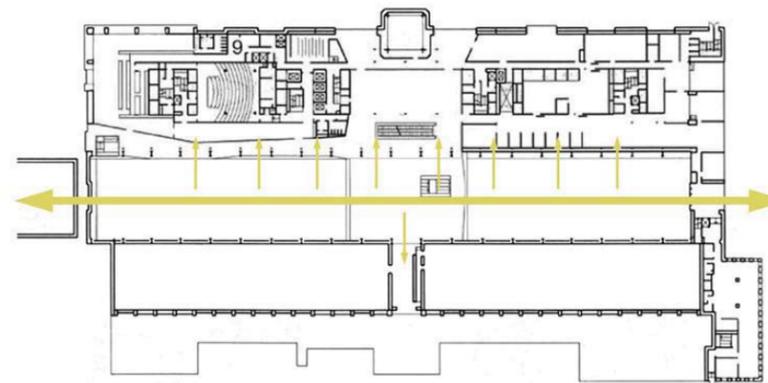
43. Planar Organization Diagram

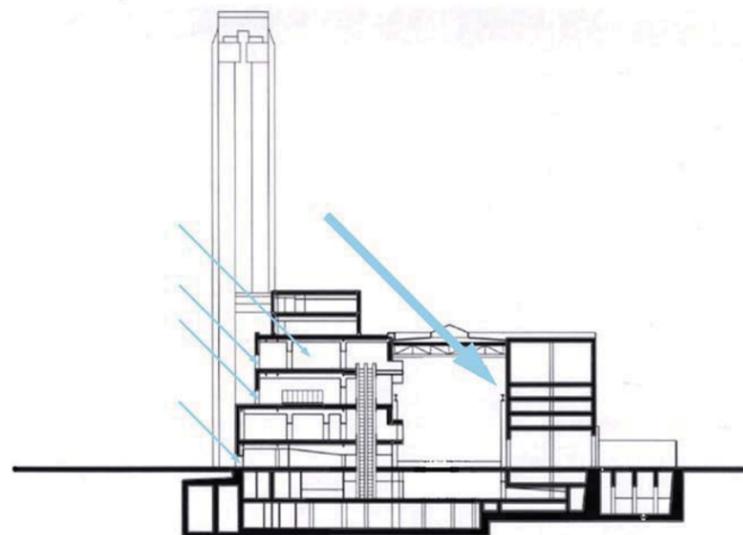
44. Circulation Axis Diagram

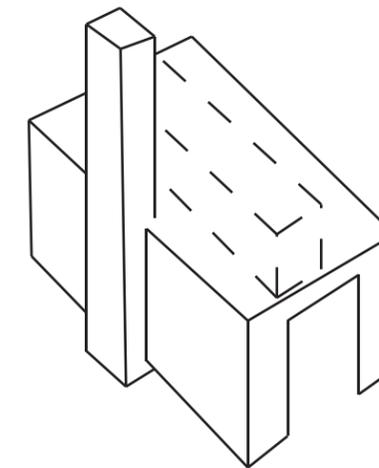
45. Lighting/Ventilation Diagram

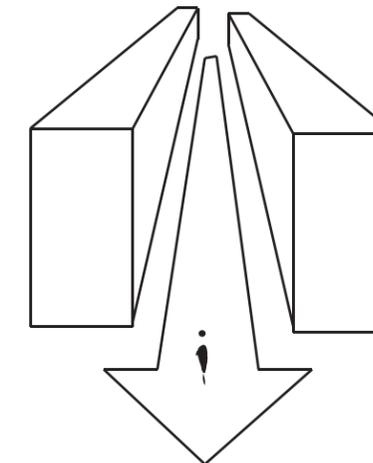
46. Retention of structure with highly visible modern structural-aesthetic addition.

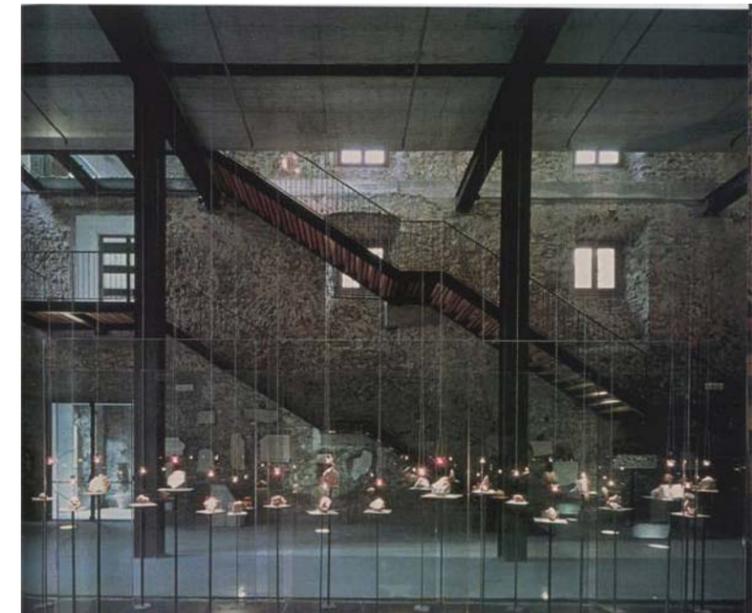
52. Scuderie Aldobrandini - Using vertical circulation elements as a tool to weave areas together.

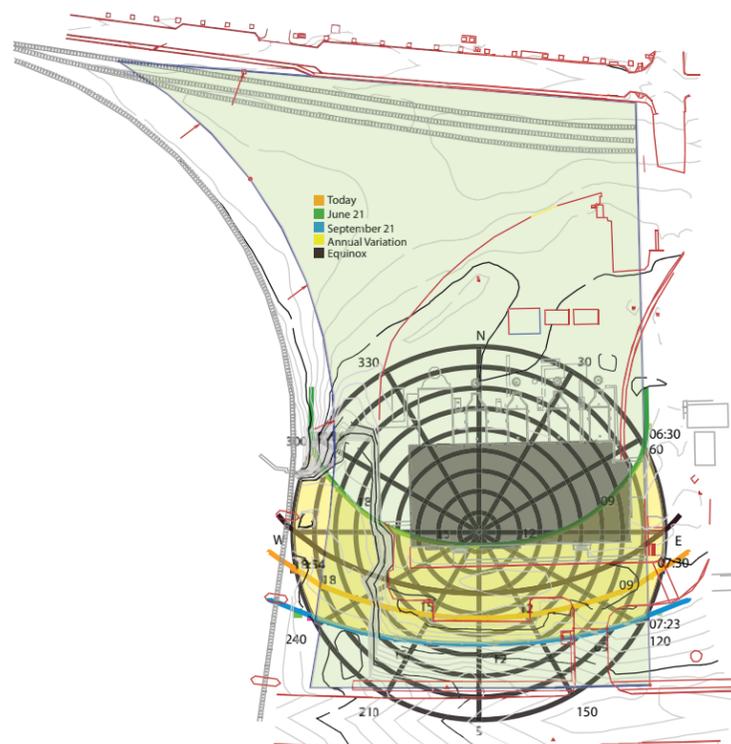
64. Sun Path Diagram

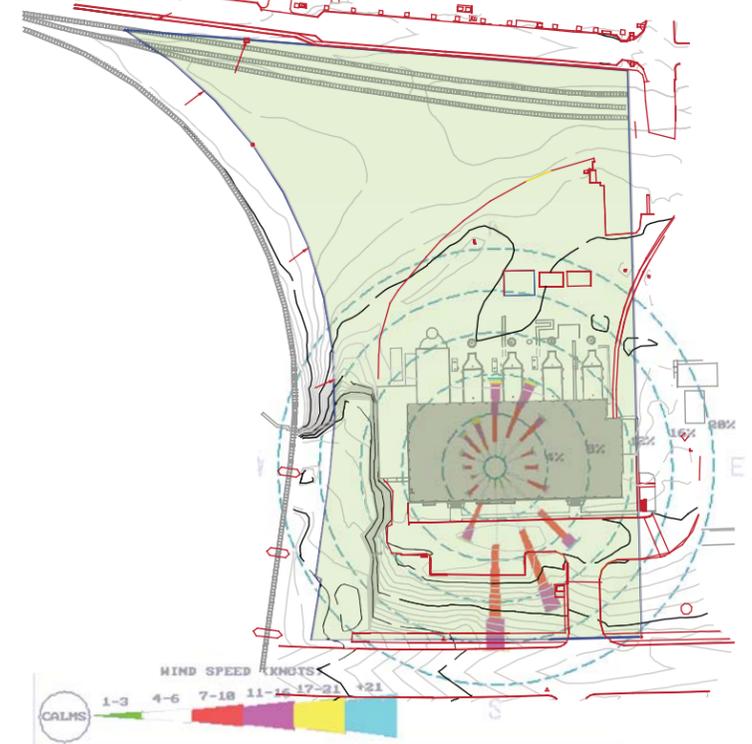
65. Yearly Wind Pattern Diagram

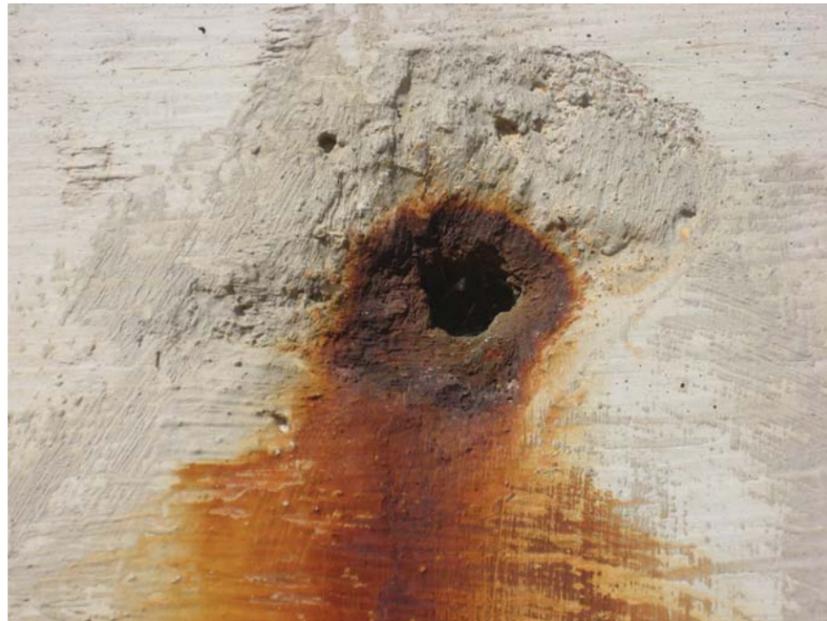
66. Concrete Metallic Staining - Staining of concrete due to corrosion of metals within the concrete or attached to it.

Note: In Seaholm these stains are either brown (from possible corrosion of reinforcement) or green (from oxidation of copper scuppers)

Another common condition seen on the building is metallic staining, brown in color. The stain appears to “ooze” out of the building. It can probably be attributed to corroded reinforcement within the structure. Since these staining occur at points where the reinforcement is exposed or very near the surface or through larger blow holes, it is possible that only the exposed reinforcement has undergone oxidation and thereby rust formation.

Green staining can be observed on concrete around the copper scuppers. It seems likely that these stains are a direct result of oxidation of the copper and subsequent staining.

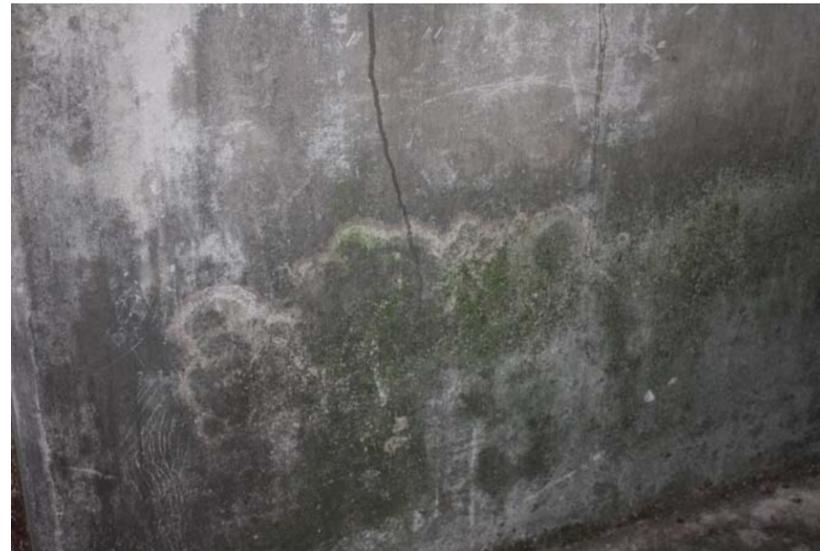
67. Biological Growth -Micro organisms of various colors and forms, living or dead, including fungi, algae, lichens or bacteria, that colonize on the surface or penetrate into cavities. Their growth is compounded by the presence of moisture and sunlight. Some organisms may penetrate several centimeters into the substrate. Biofilms are often dark-colored and, depending on the environmental conditions & substrate type, may form solid layers or films. In addition to aesthetic issues, micro organisms accelerate deterioration of many materials. Most biofilms hold in moisture, & some organisms produce acidic products of metabolism that are damaging to acid-sensitive materials.

The most rampant condition visible on the building is black and green staining on the surface that can be attributed to biological growth. The staining is visible on concrete as well as the stone sills and coping. The black staining is predominant all over the structure but is more concentrated at the parapet level, sills and just below the sills on the south elevation. Black staining that may or may not be biological growth can also be spotted on the add-on boiler room on its west elevation. The green staining is concentrated on the north elevation of the building from ground level to up to 4 feet above.

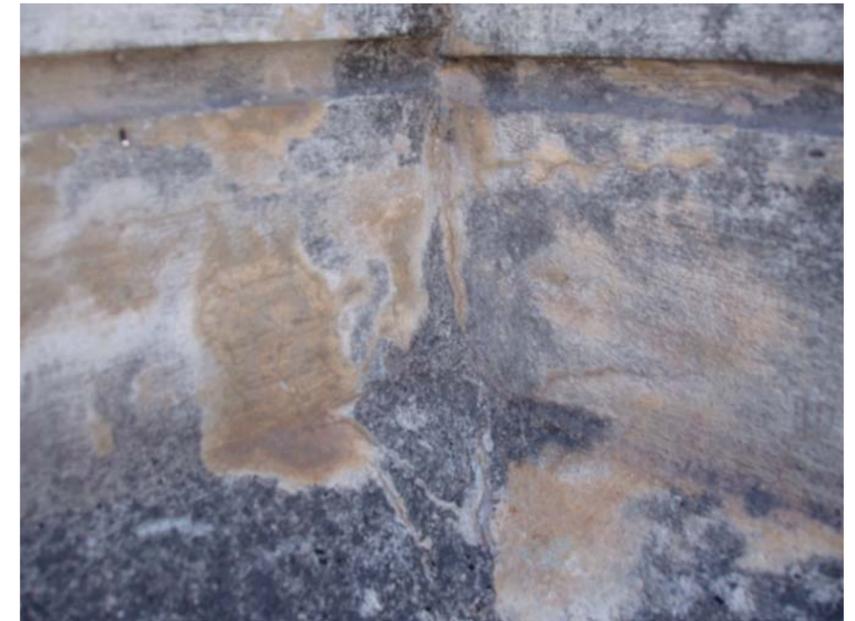
68. Brown Discoloration (May be Alkali-Silica Reaction) - Small to mid-size patches of brown and orange discoloration that appear almost like a crust.

Note: It is probable that this discoloration may be Alkali-Silica Reaction (ASR) which is the reaction between alkalies (sodium and potassium) in Portland cement and certain siliceous rocks or minerals present in some aggregates. The products of the reaction may cause abnormal expansion and cracking of concrete in service.

Brown discoloration of concrete can be observed on the entrance pilasters, on the smaller building to the east from ground level to 6 feet above ground level. Sporadic occurrences can also be spotted on the south and north elevations. These appear to have similarities

with a condition called Alkali-Silica Reaction found in concrete. ASR is the reaction between alkalis (sodium and potassium) in Portland cement and certain siliceous rocks or minerals present in some aggregates. The products of the reaction may cause abnormal expansion and cracking of concrete.^[21]

Overall Seaholm appears to be in good condition. The appearance of brown discoloration if positively identified as ASR would require immediate attention and repair. Other primary concerns are staining possibly due to corrosion of reinforcement and biological growth. The appearance of multiple cracks, spalling, staining and discoloration in the smaller part of the building on the east side has led the author to conclude that this part of the building may have used left over materials or materials that were lower in standard than ones used in the other parts of the building. The clerestory window areas in elevation and roof were not accessible for this project. A more detailed assessment including these areas is advised.

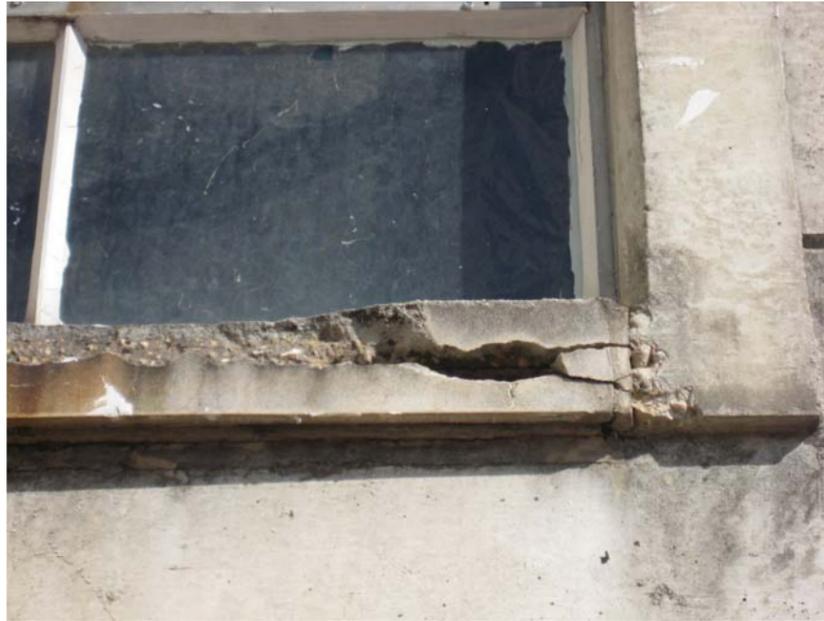
69. Structural Cracking - Structural cracking is cracking that not just appears on the surface but is spread through the whole volume of the material.

A couple of instances of cracks that go deeper into the structure appear on the concrete surfaces. Two on the smaller east side building one at the parapet level and another on the southern sill appears to go through the entire volume of material. The crack at the parapet level adjacent to the scupper may have been due to mechanical damage as there are wires that wrap around it.

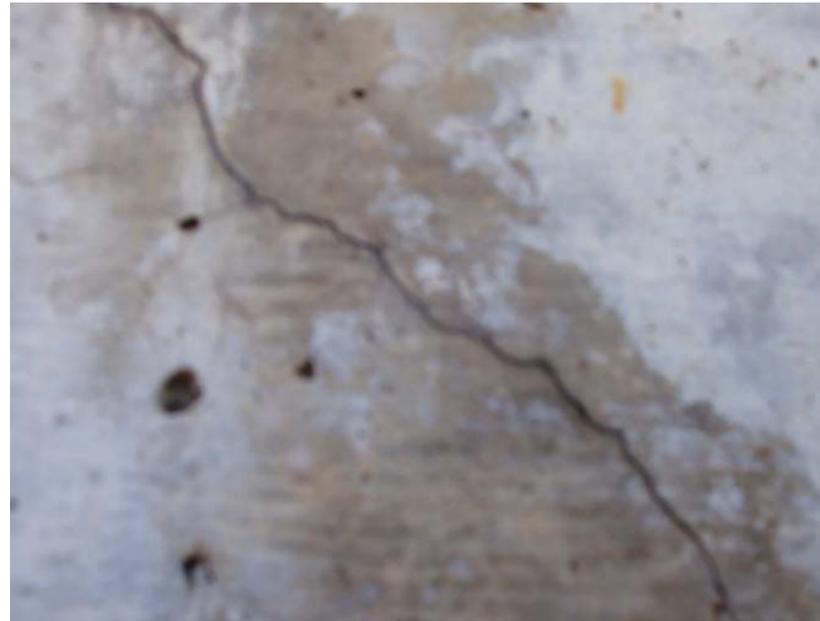
70. Surface Cracking - Cracking that occurs in the surface of fresh concrete soon after it is placed and while it is still plastic.

Horizontal and vertical surface cracks can be observed over the concrete mostly on the south and east elevations. Surface cracks also appear on the stone sills and coping.

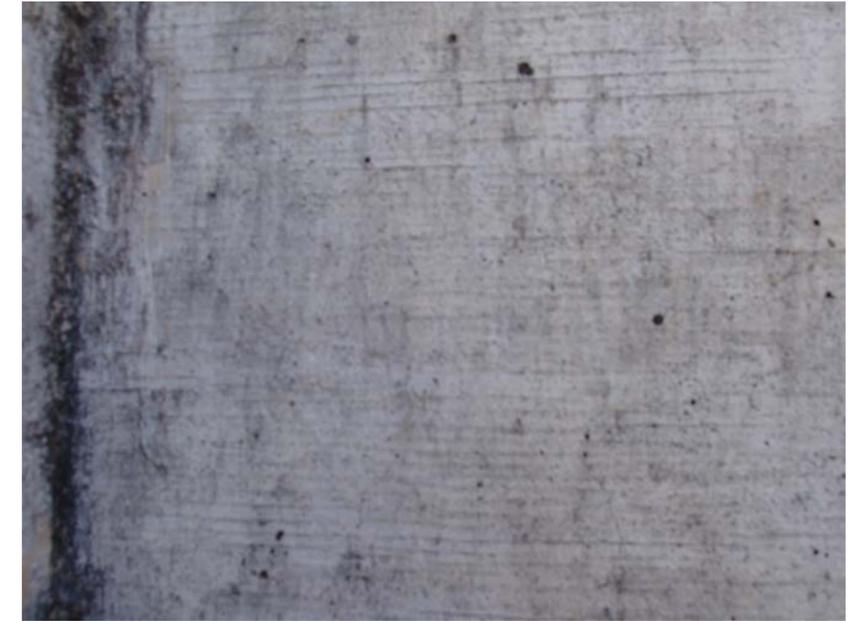
71. Crazing - Crazing is the development of craze cracks, a system of fine random cracks in a concrete surface.

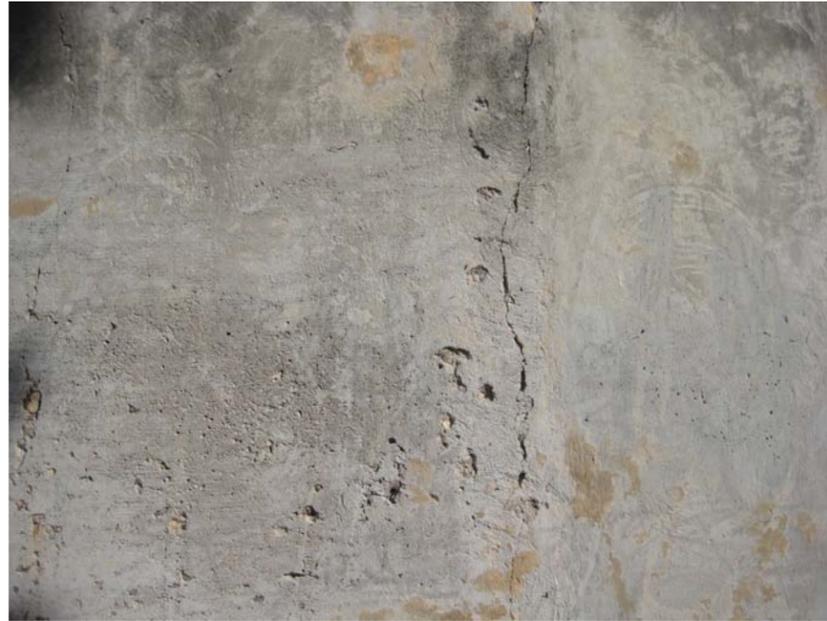
72. Blow Holes - Bug holes (blow holes) are small regular or irregular cavities, usually not exceeding 15 mm (0.6 in.) in diameter, resulting from entrapment of air bubbles in the surface of formed concrete during placement and consolidation.

Presence of small regular or irregular cavities can be observed on concrete. These holes result from entrapment of air bubbles in the surface of formed concrete during placement and consolidation.^[22]

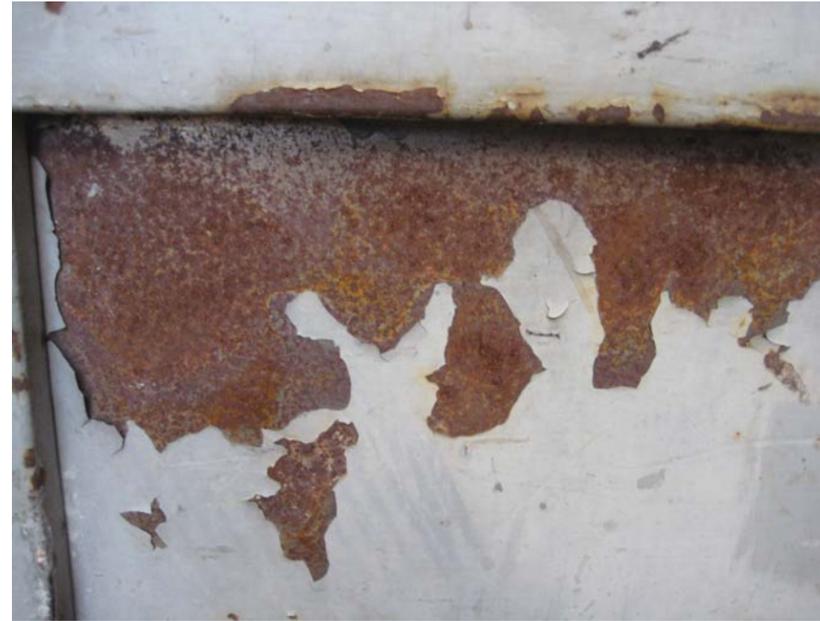
73. Corrosion of Metals - A condition resulting from the exposure of some metals to oxygen and water. With iron-containing metals, the result of this oxidation is called rust. The formation of corrosion products often involves a substantial increase in volume, which can lead to breakage, failure or inoperability.
Note: In the case of Seaholm, corrosion of equipment parts can be attributed to the peeling away of paint layer that exposed the metal substrate to atmospheric conditions and resulting in corrosion.

The steel used in the machinery is corroded especially at ground level and at joints.

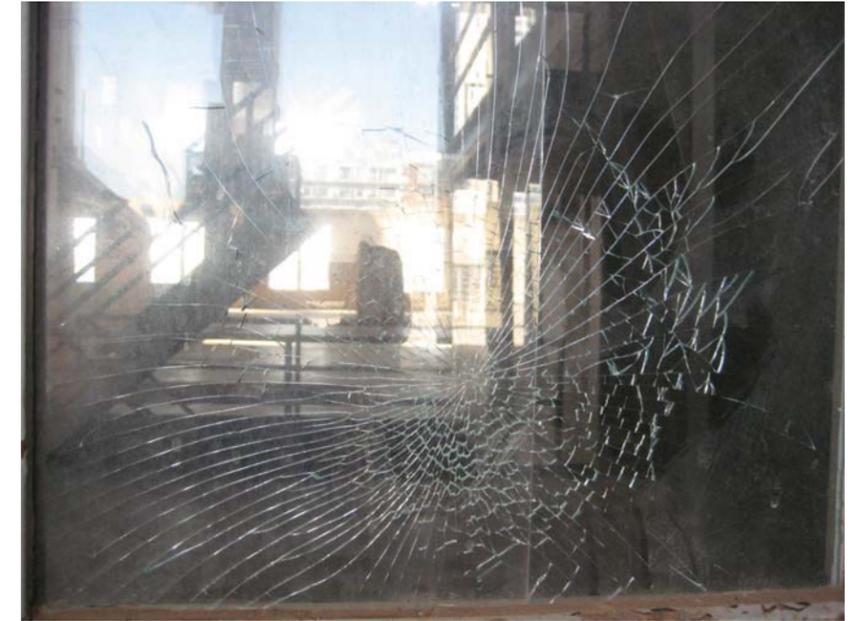
74. Cracked Glass - Glass that has received a severe blow and disintegrated from its original appearance is called cracked glass. This may be due to mechanical, human-induced damage or due to excessive temperature change and/or weathering.

There are cracked glass panes on windows on all sides and the north elevation doors.

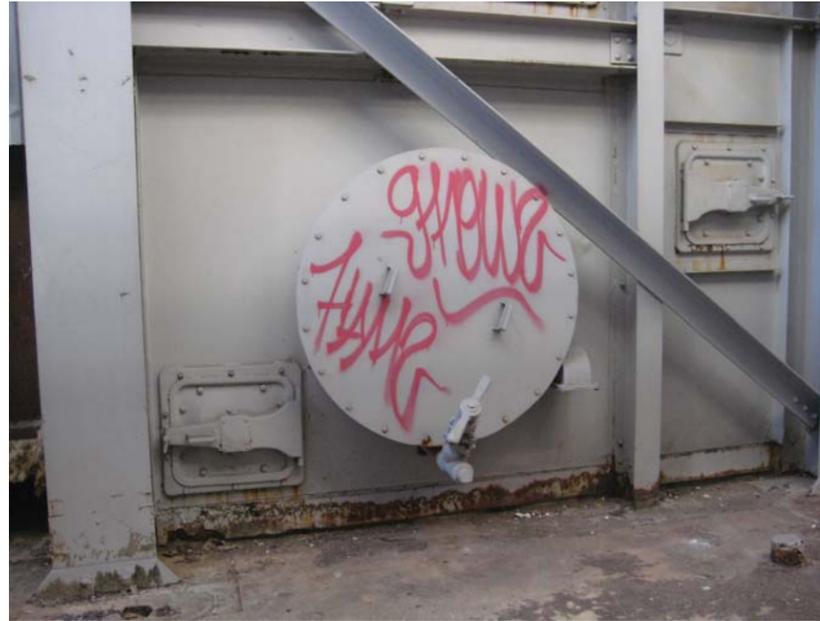
76. Graffiti - Graffiti is an anthropogenic condition which is the deposition of paint, ink, or similar matter on the surface of a material.
