“HERE TO STAY IN POWER”

Adaptive Reuse of Seaholm Power Plant at Austin, Texas as Austin Museum of Art

Report

Master of Science in Historic Preservation

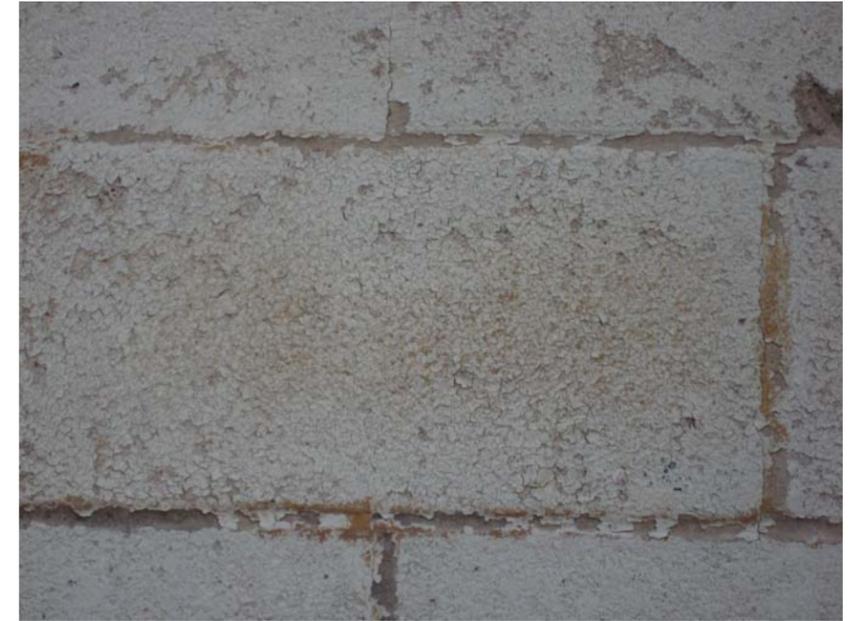
77. Peeling Paint - Loss of paint adhesion often resulting in deterioration or damage to the underlying substrate.

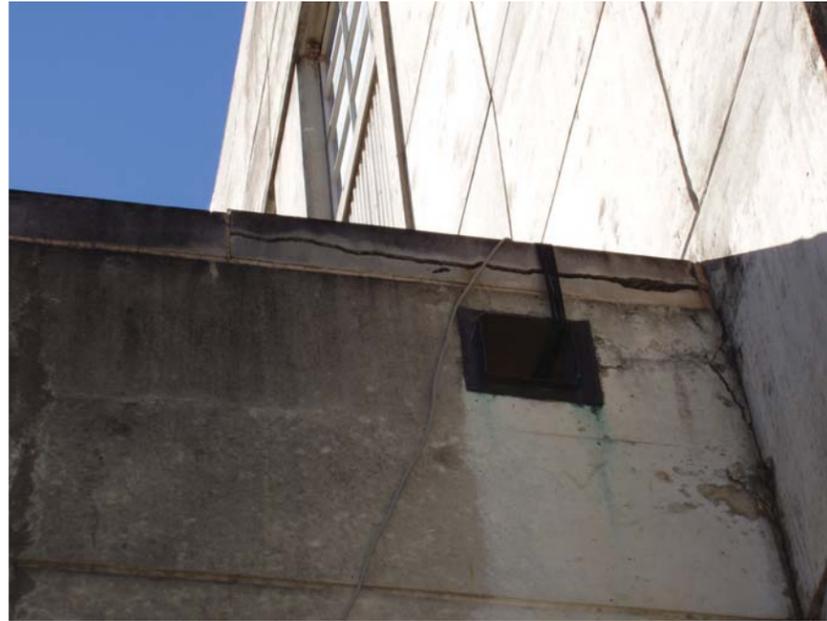
78. Green Staining - Copper when exposed to air gets oxidized, the result of which is green-colored stains on the substrate or on the material attached or closest to it.

Green staining can be observed on concrete around the copper scuppers. It seems likely that these stains are a direct result of oxidation of the copper and subsequent staining.

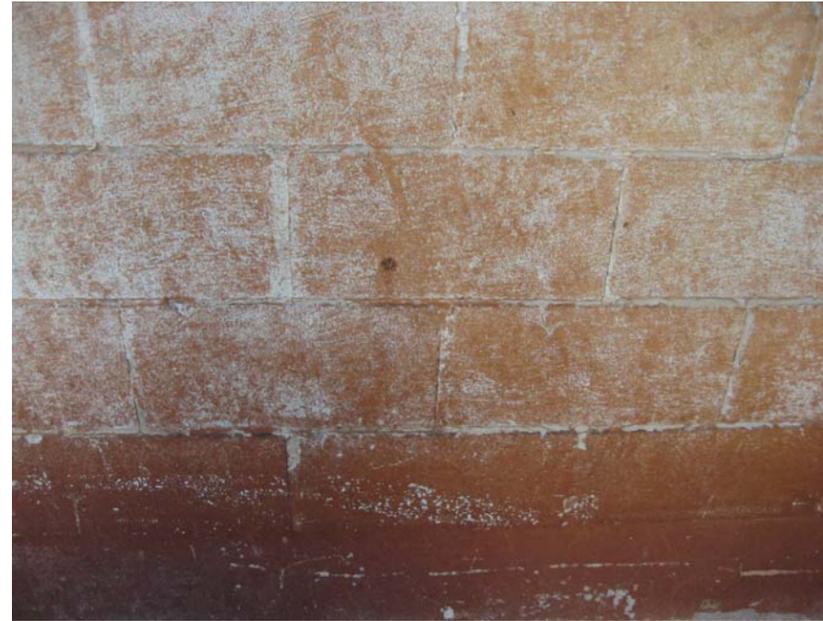
79. Orange-Brown Discoloration - The orange-brown discoloration of the whitewash paint is possibly due to presence of elements in the paint that when exposed to air gets oxidized. It may be a ferrous element that oxidizes to form rust or other elements like lead that undergoes oxidation.

There is black staining on the CMU that can be attributed to biological growth. The black staining is predominantly seen at the coping level. There is also orange-brown staining that appears from ground level to 4 feet above ground level on the north elevation of the add-on boiler room. This staining may be due to occurrence of oxidizing elements in the paint covering CMU.

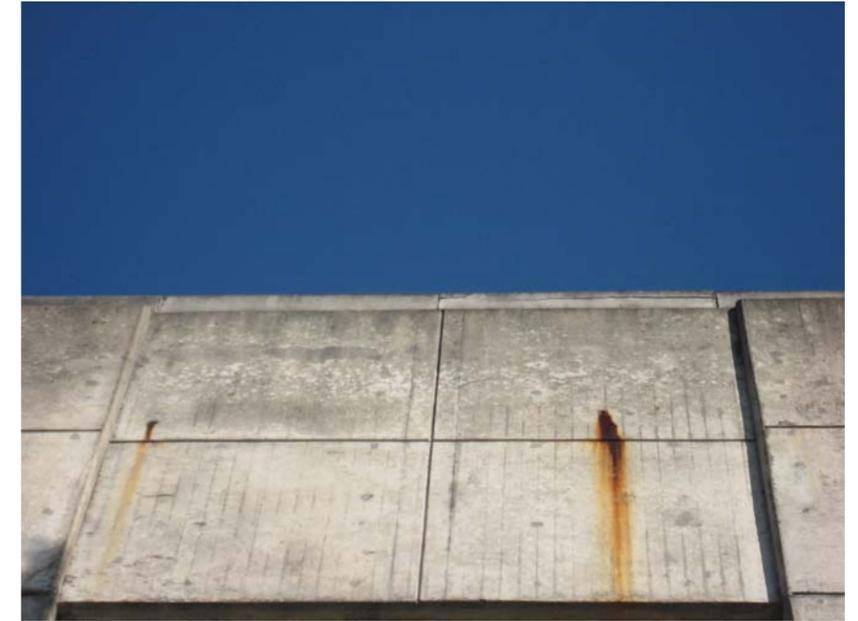
80. Exposed Reinforcement - When reinforcement are laid too close to the surface without enough concrete covering, it leads to easy exposure due to factors like natural weathering and mechanical damage. Once exposed it may result in the corrosion of the reinforcement.

There is evidence of exposed reinforcement that may have been a result of weathering on some of the panels in the south elevation. These are high up in the elevation and not readily accessible. Therefore the nature of this condition have not been completely ascertained.

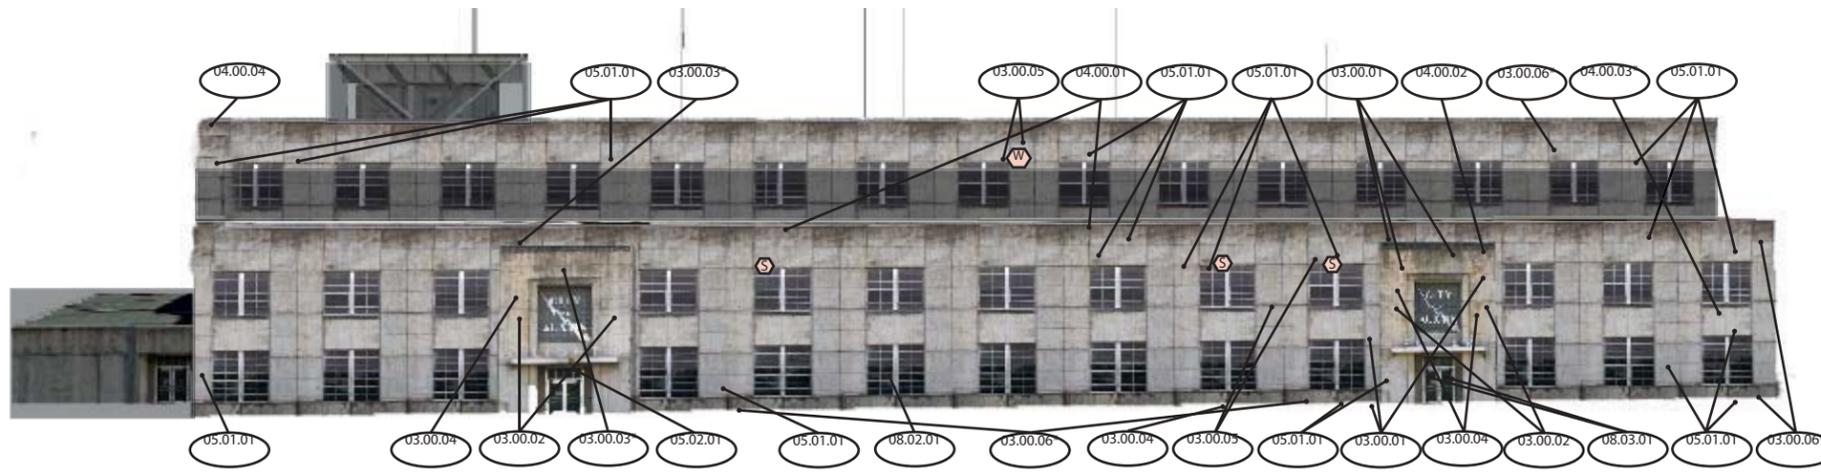
South Elevation

Original architect: Burns & McDonnell
 Construction date: 1950-1958
 Drawing by Google Sketch Up Network
 [Repositioned by author]

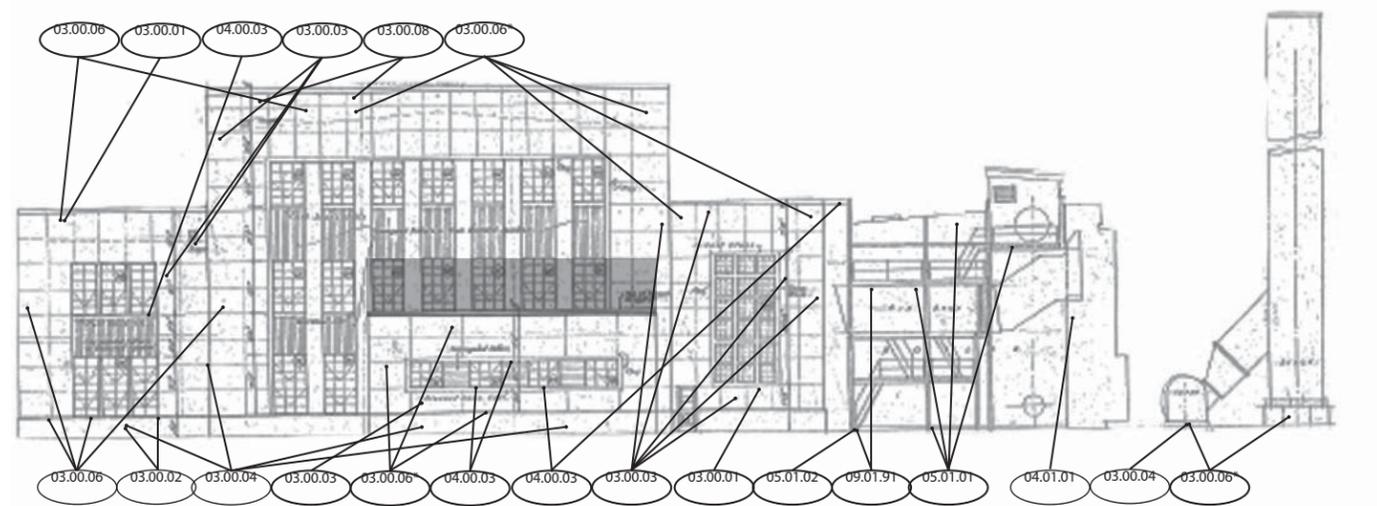
East Elevation

Original architect: Burns & McDonnell
 Construction date: 1950-1958
 Drawing by Google Sketch Up Network
 [Repositioned by author]

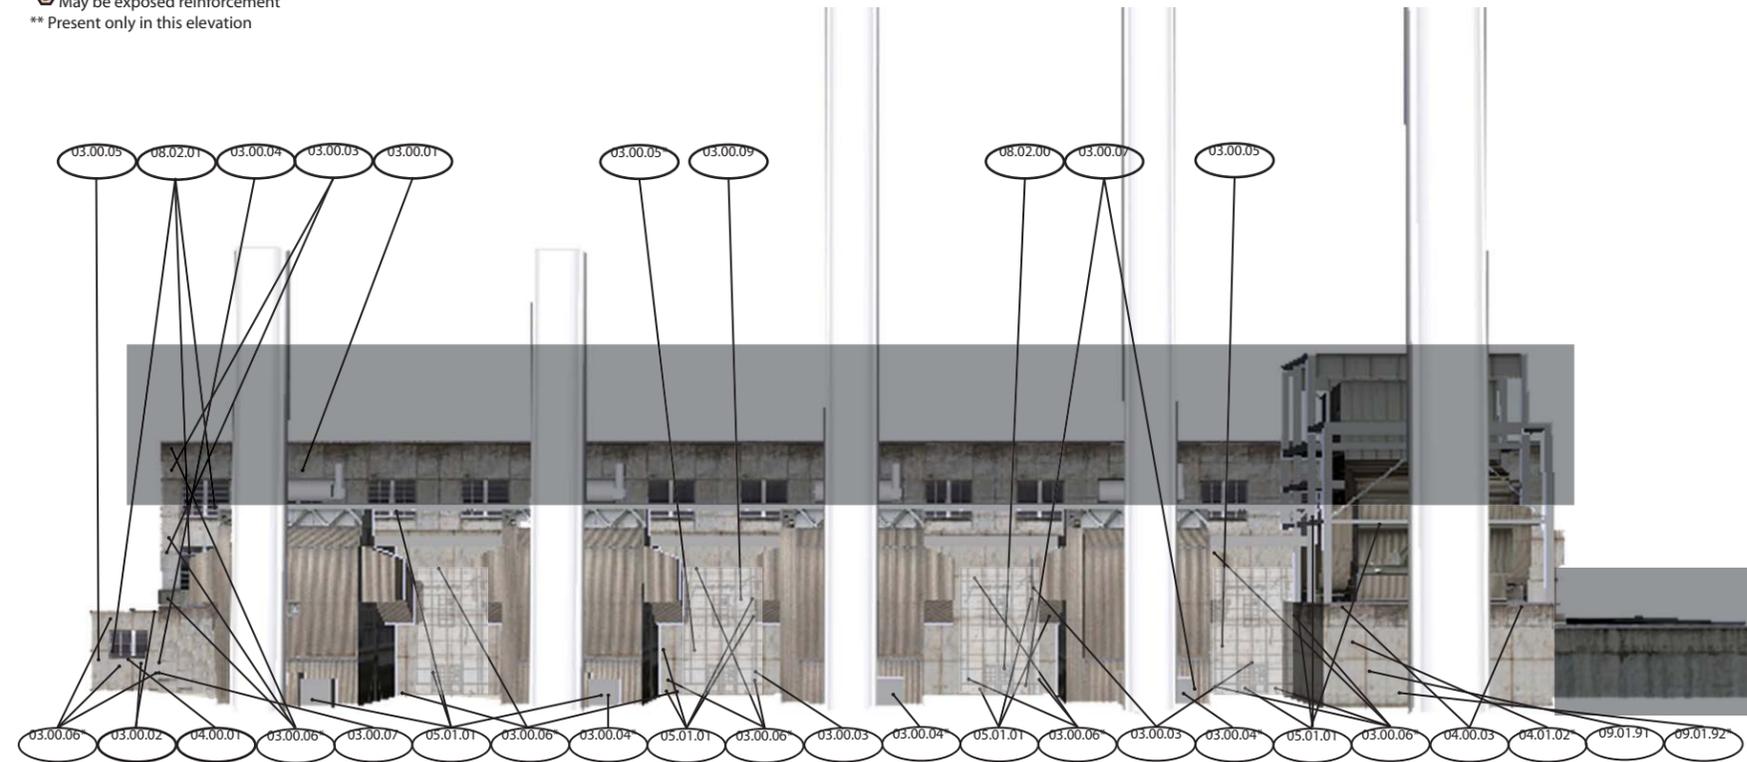
North Elevation

Original architect: Burns & McDonnell
 Construction date: 1950-1958
 Drawing by Google Sketch Up Network
 [Repositioned by author]

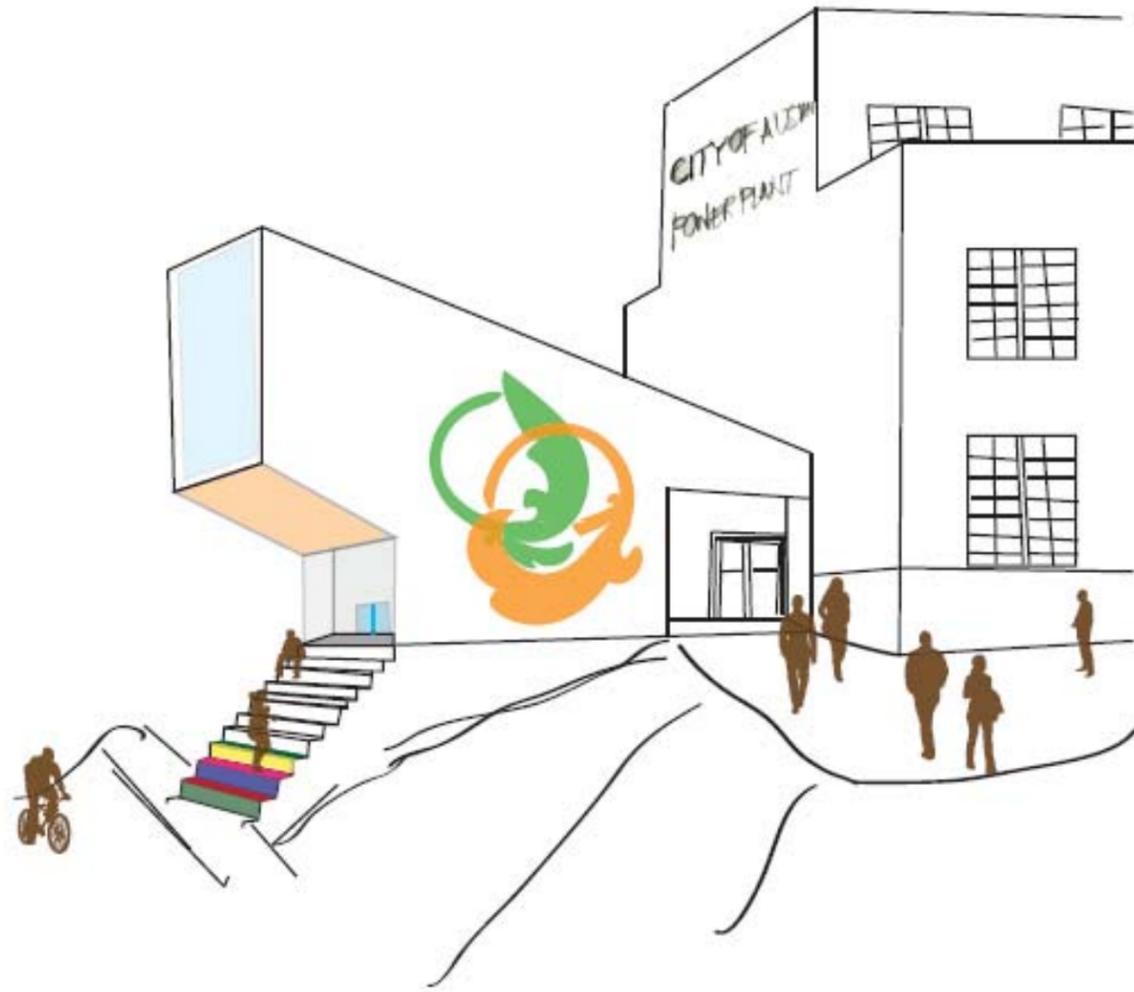
81. One of the Initial West Entry Options

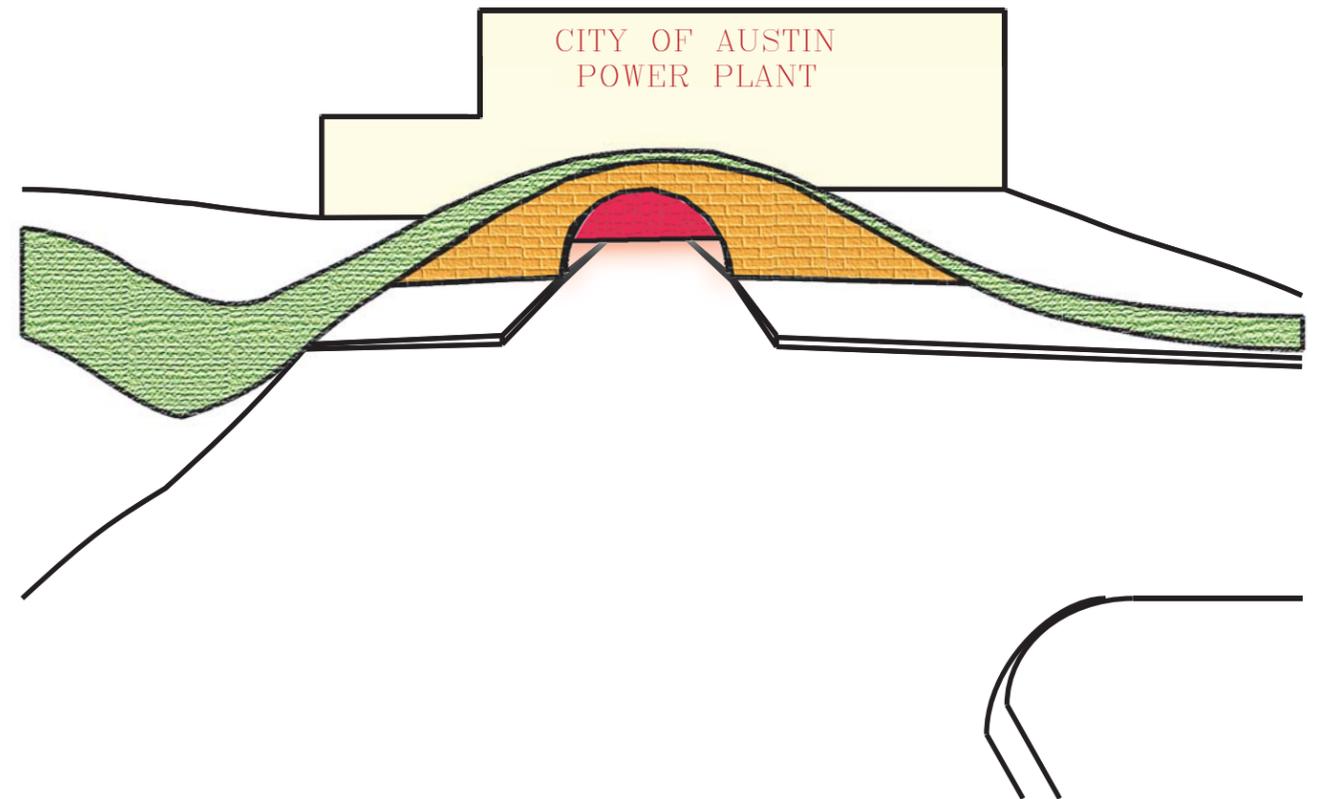
82. One of the Initial West Entry Options

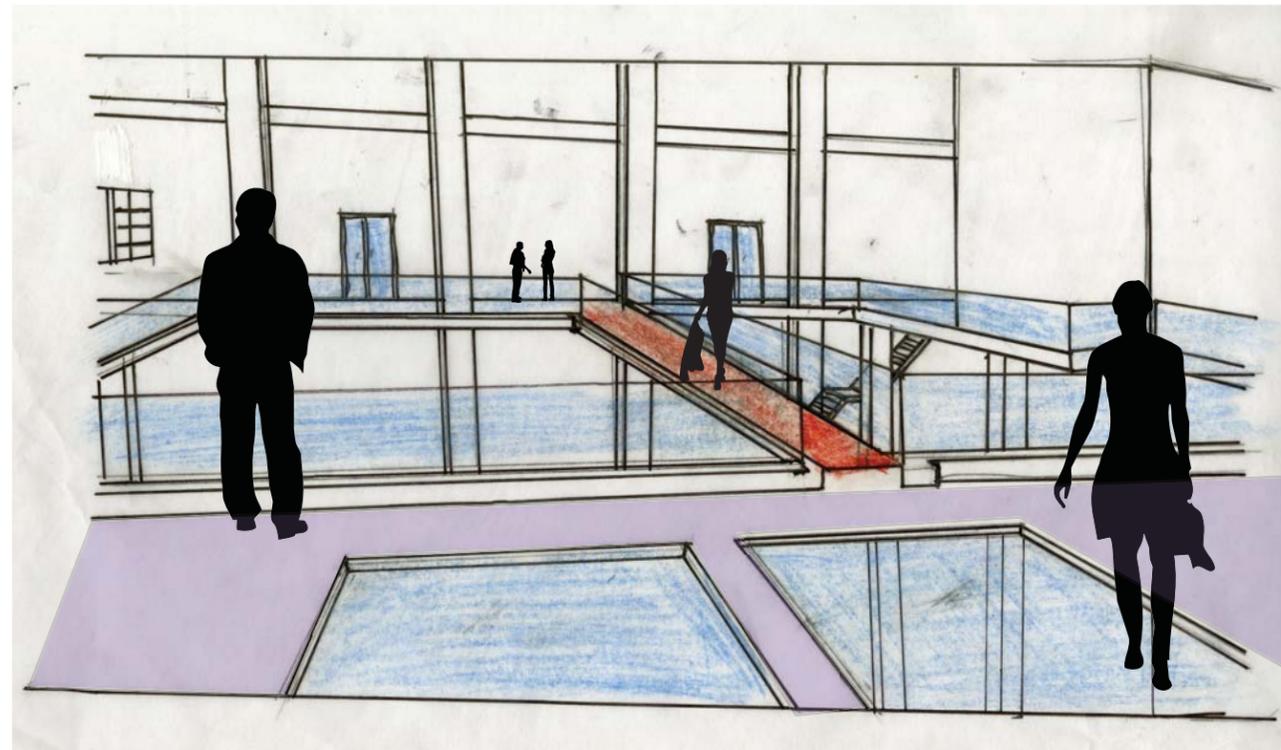
83. View from North-side pedestrian entrance.

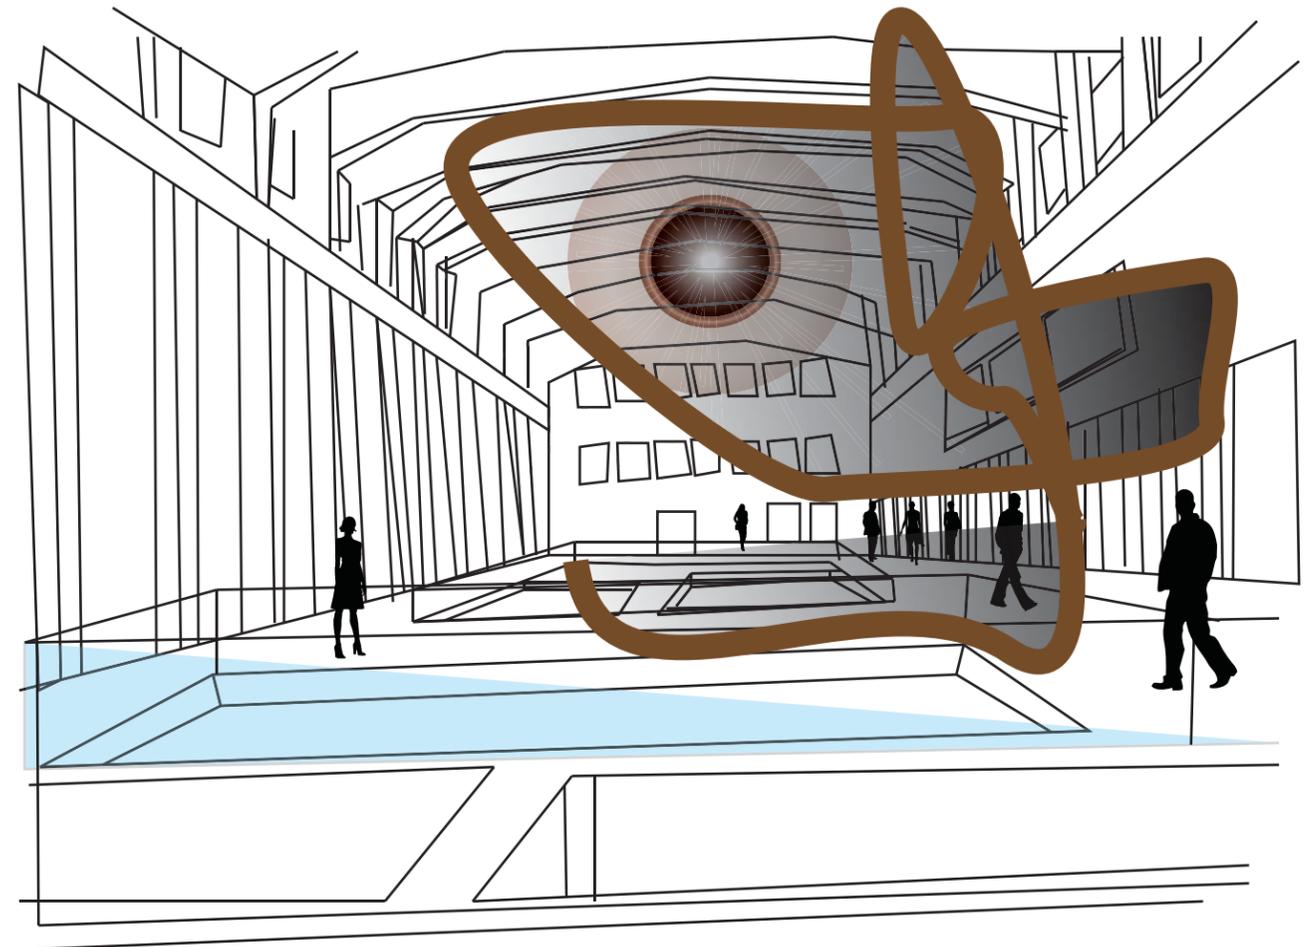
84. Main lobby area.

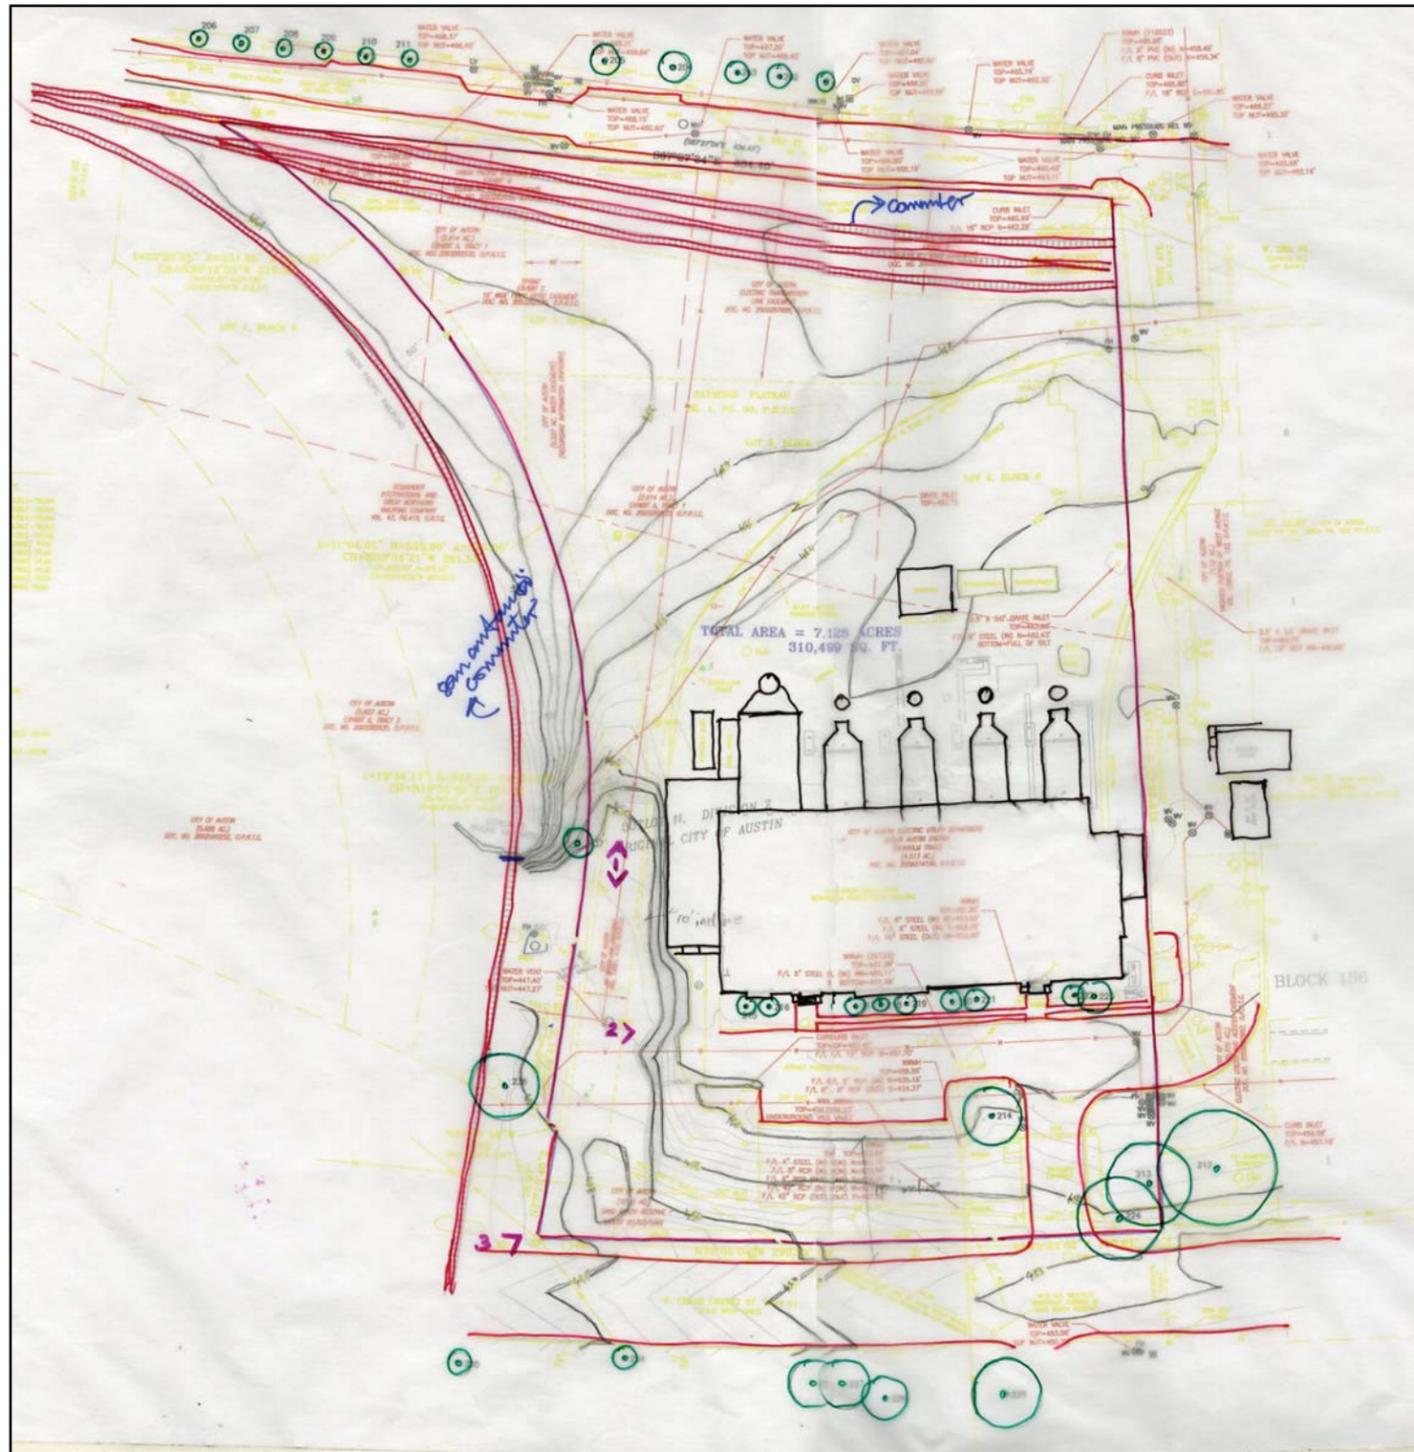
88. Site Plan (Scale 1' = 1/64")

Much thought has been provided to the entrance placement to the site and the building. The allotted parking spaces to the west of the building (close to Lamar Blvd.), future rail transit corridors to the east, nearby flood plains to the south and the need for a service-entrance/elevations were the major factors in consideration.

To this effect, it was concluded that multiple numbers and levels of entrances were required for easy site access and to maintain and ease of flow of traffic within the building. The south side entrances that were historically the main entrances have been transformed in character to work as administrative/retail storage entrances and as fire exits. The close proximity of the southern entrances to flood-plains was a decisive factor in this design decision. Due to ease of access by foot, bus and in future by rail, the northern entrances stood out as possible main entry into the building. As such the main orientation of the building has reversed. The parking spaces to the west required the building to have an easy access from the west elevation that is closest to the parking area. A new entrance that is connected to the street level by a nominally steep ramp is therefore designed. This entrance is placed on the lower level floor plan, whose wall were below ground level before the new entrance design. The traditional service entrance on the north side is retained as is. The entrance door on the extreme north of the building is re-designed as a fire exit and a new door on the east elevation (least visible) has been provided for additional fire exit requirements.

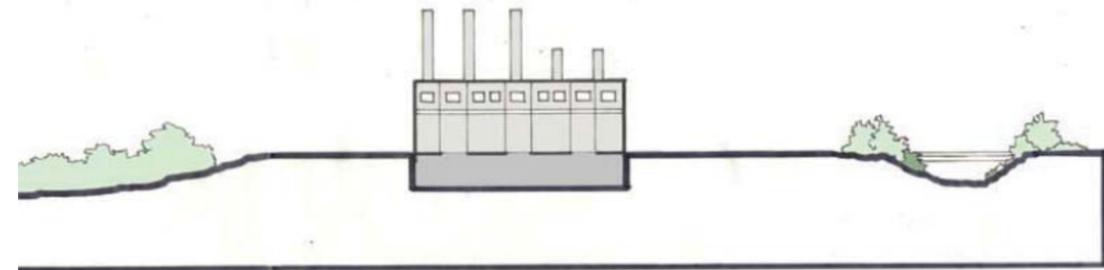
89. West-East Site Section (Scale 1' = 1/64")

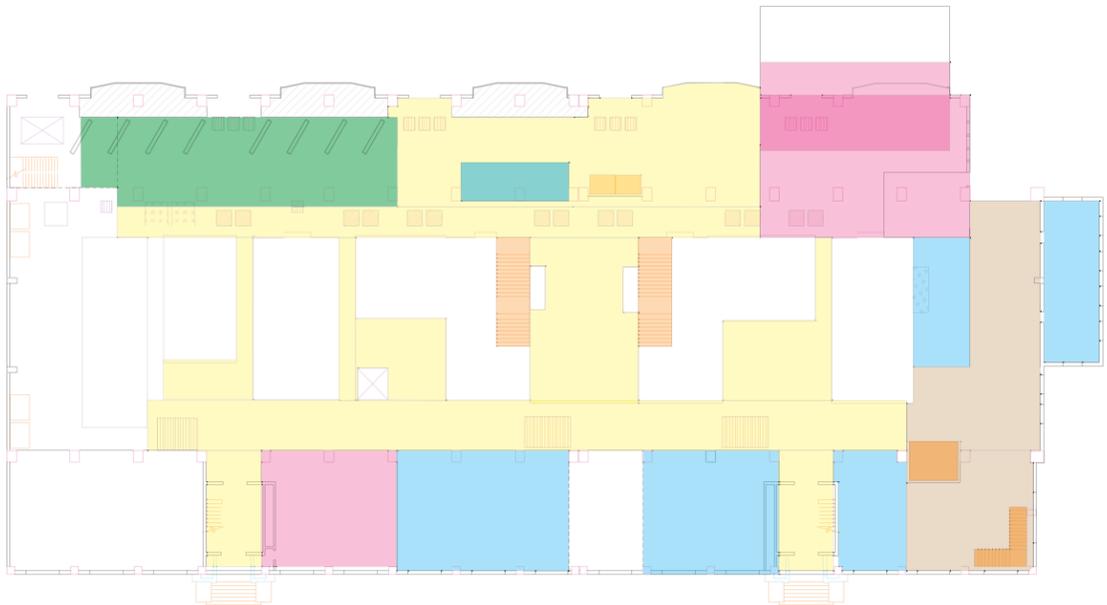
- circulation space - atrium - lobby
 - exhibition space
 - office (when grey - art handling/storage)
- education lab - family
 - retail - cafe - wine bar
 - vertical circulation

90. G+0 Space planning

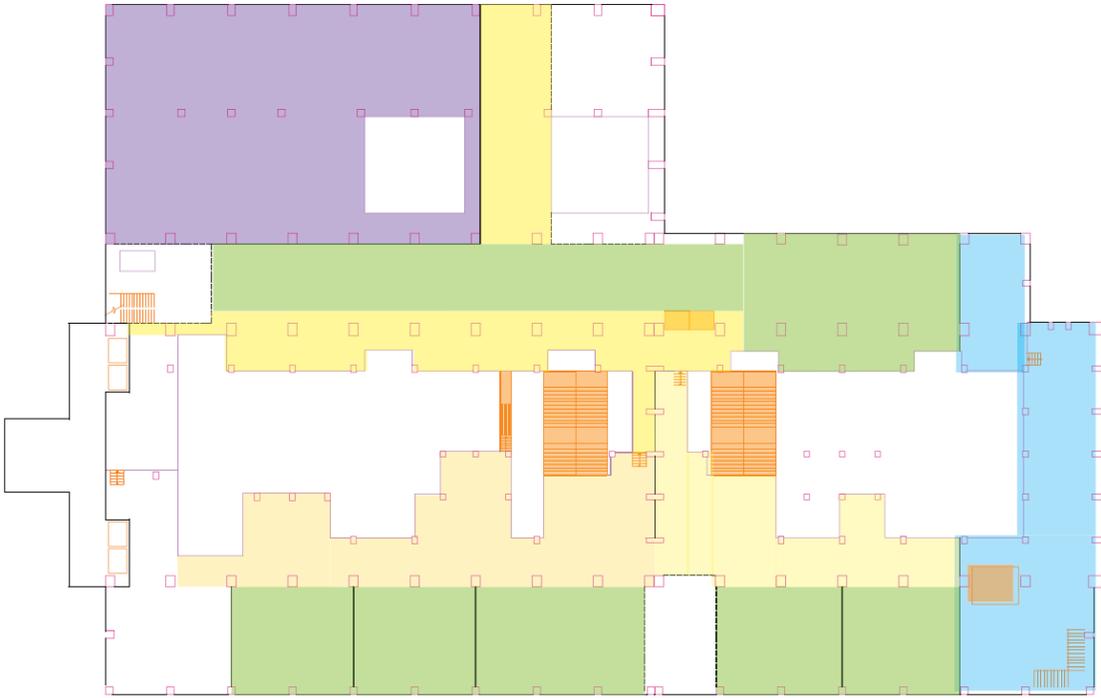
91. G-1 Space planning

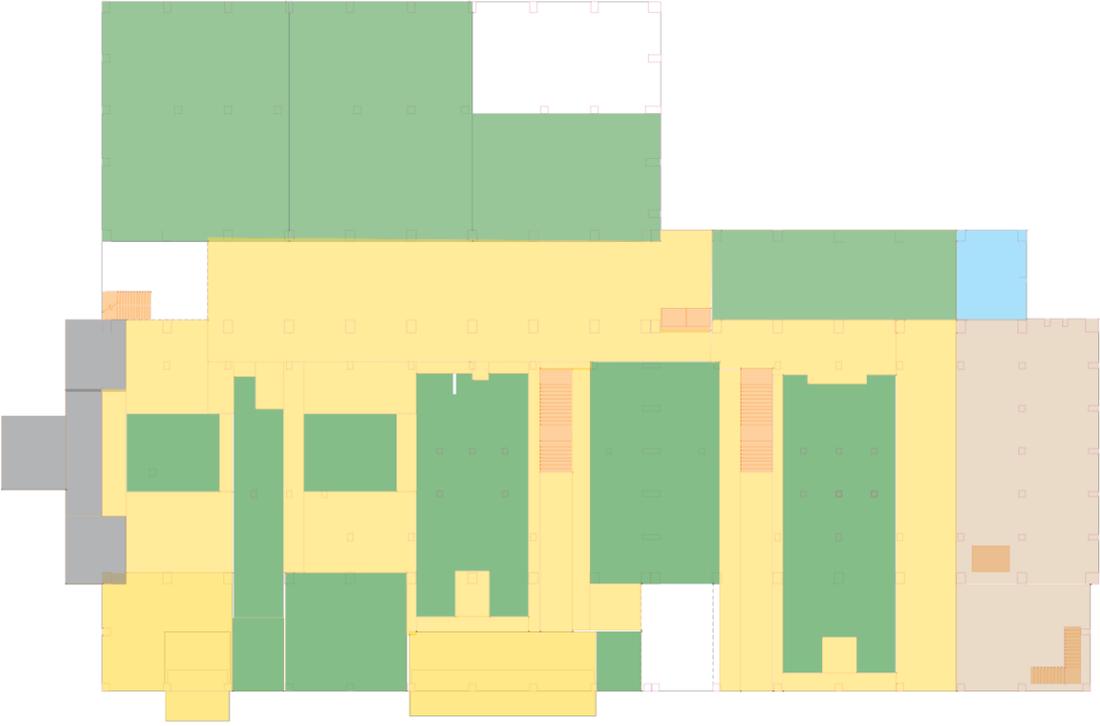
92. G-2 Space planning

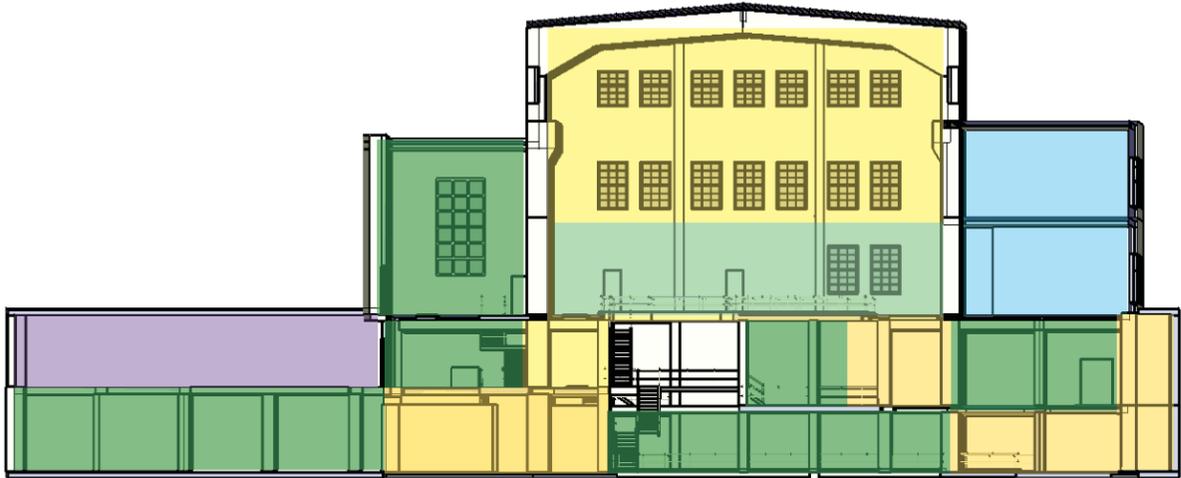
93. N-S Section thru the middle

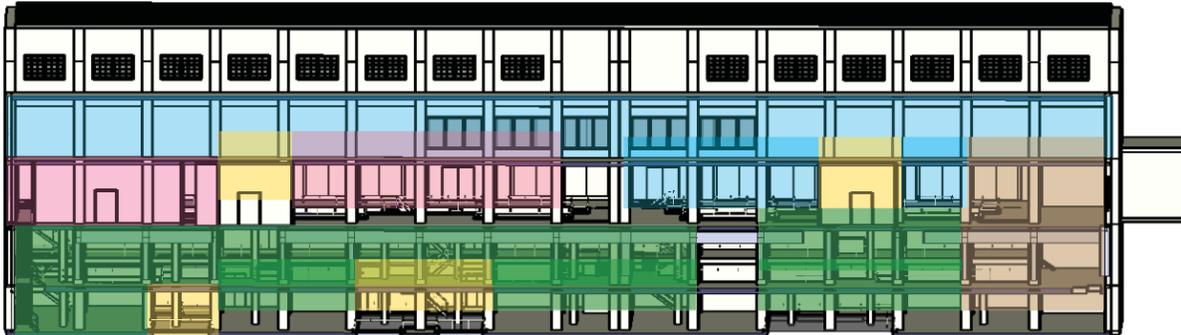
94. E-W Section thru south side office block

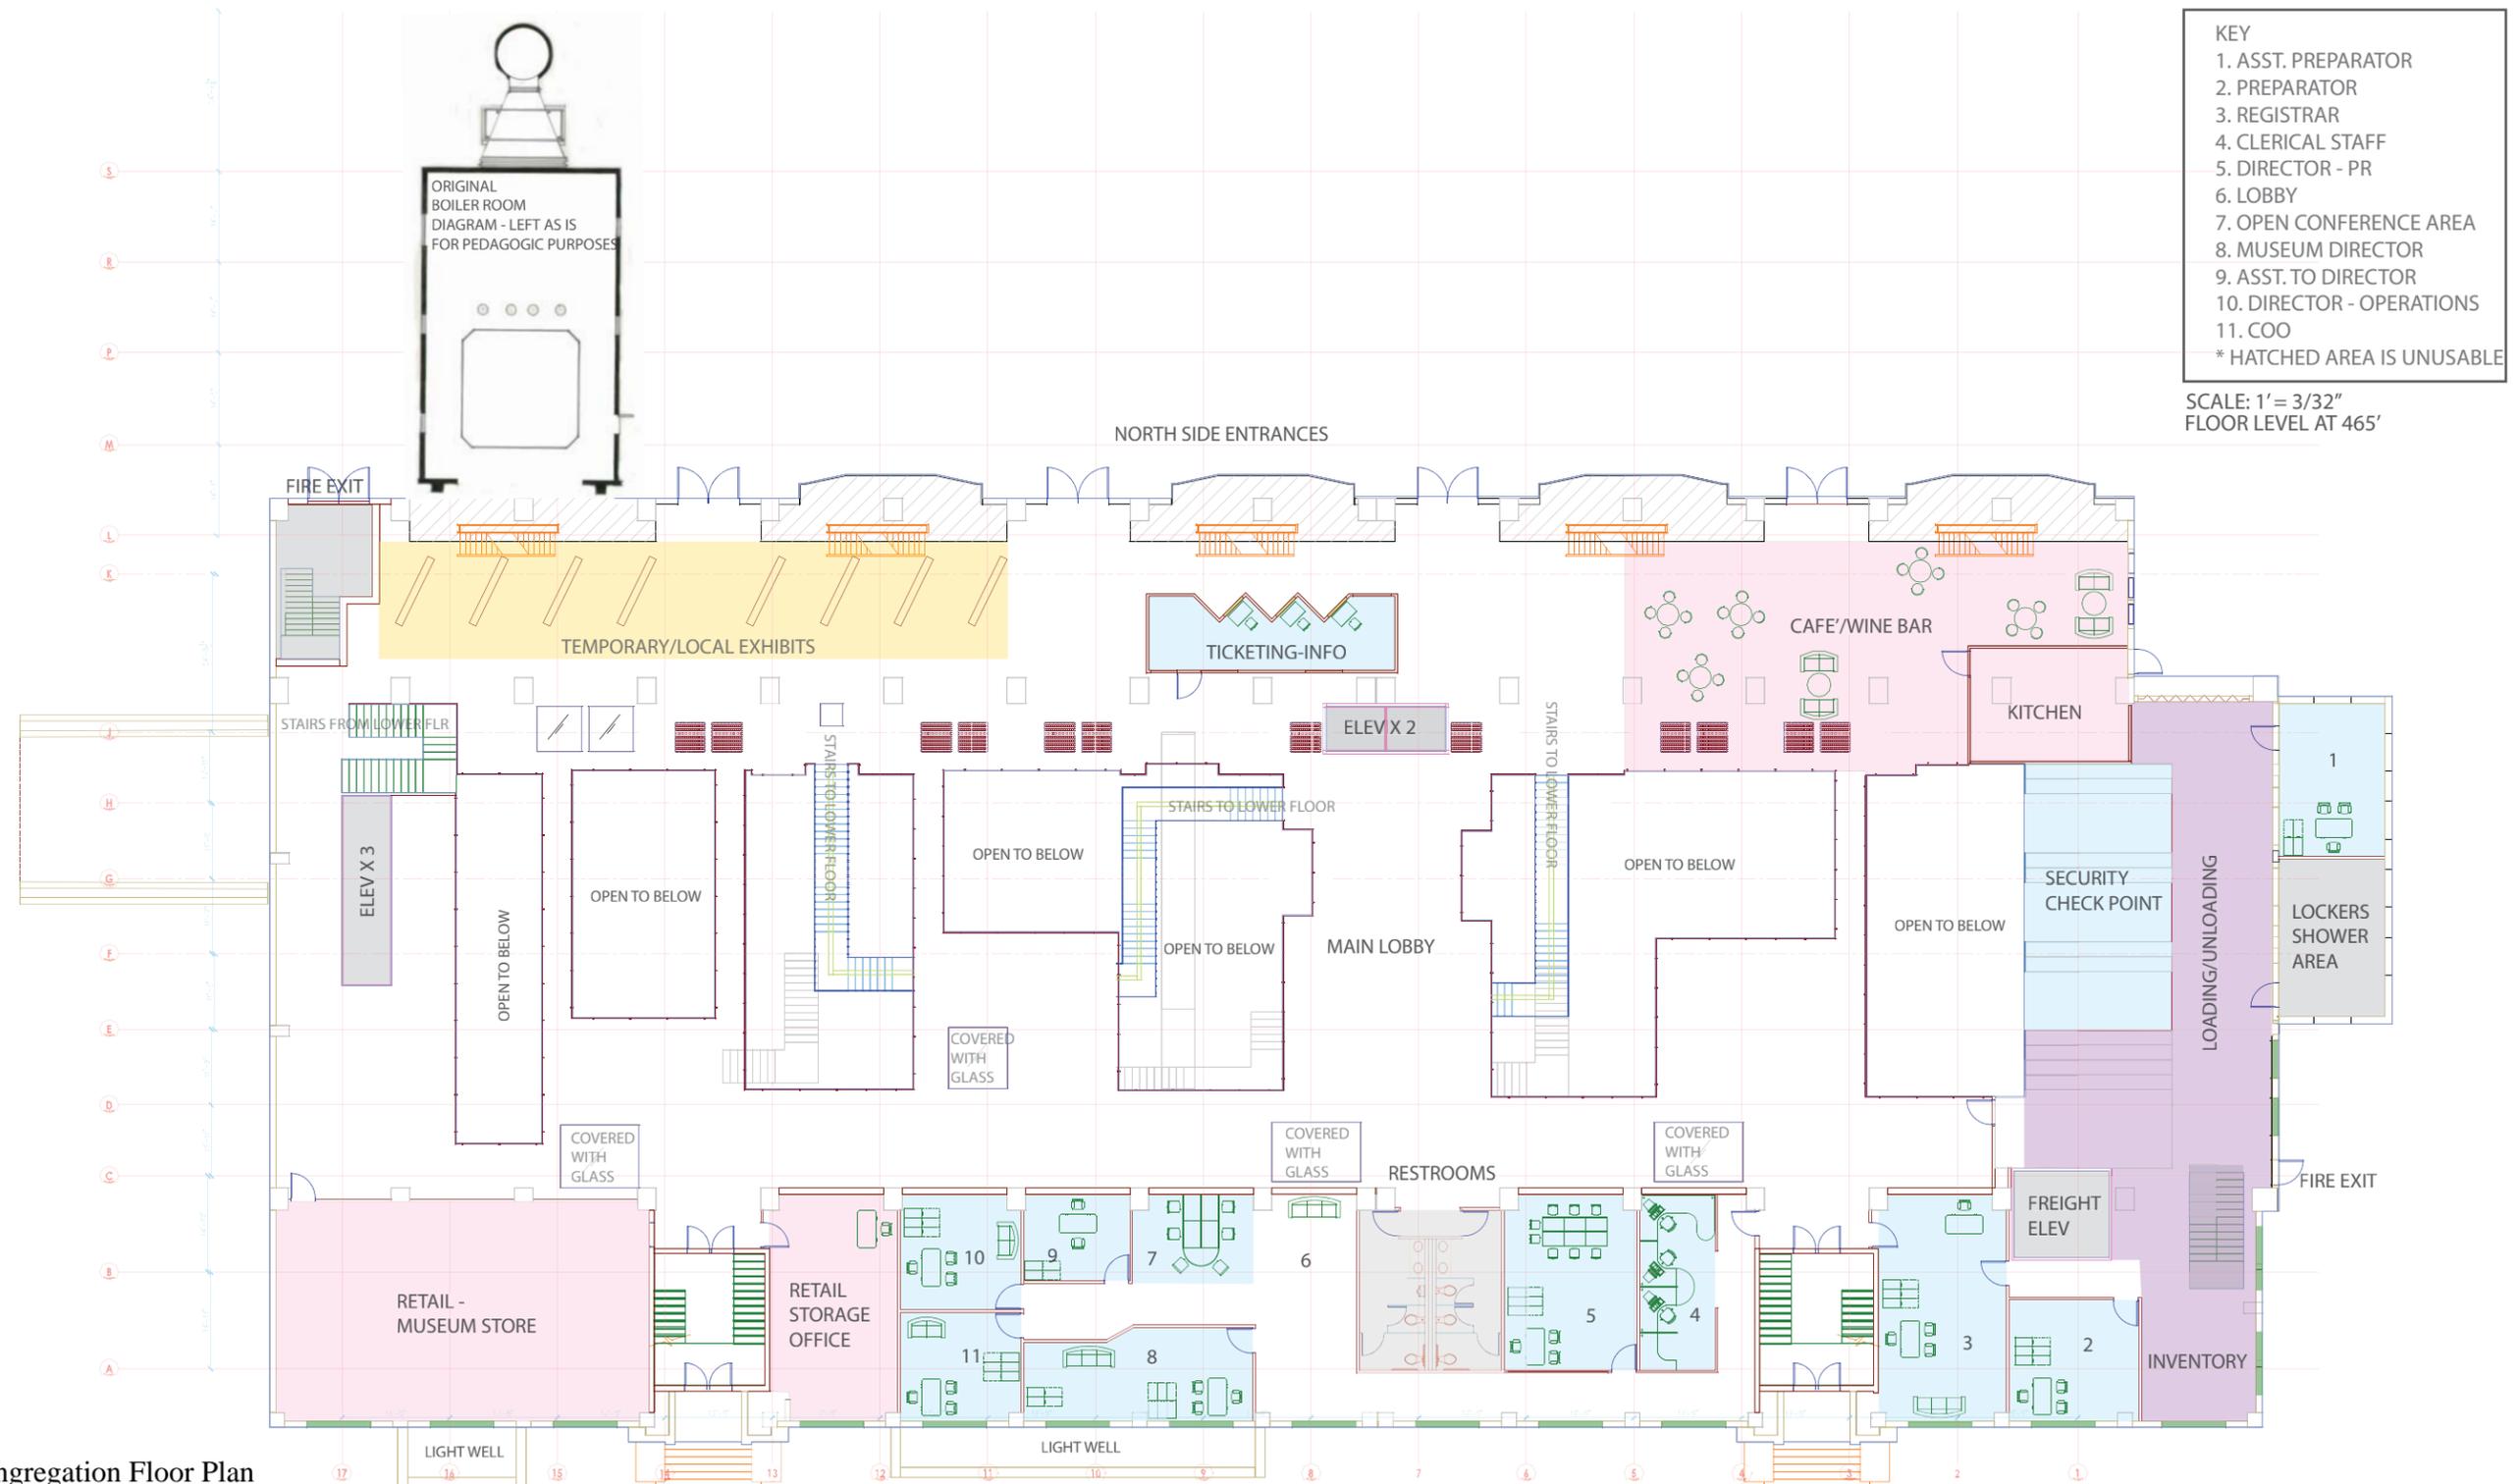
97. Congregation Floor Plan

SCALE: 1' = 3/32"
 FLOOR LEVEL AT 453' (North)
 FLOOR LEVEL AT 450' (South)
