“HERE TO STAY IN POWER”

Adaptive Reuse of Seaholm Power Plant at Austin, Texas as Austin Museum of Art

Report

Master of Science in Historic Preservation

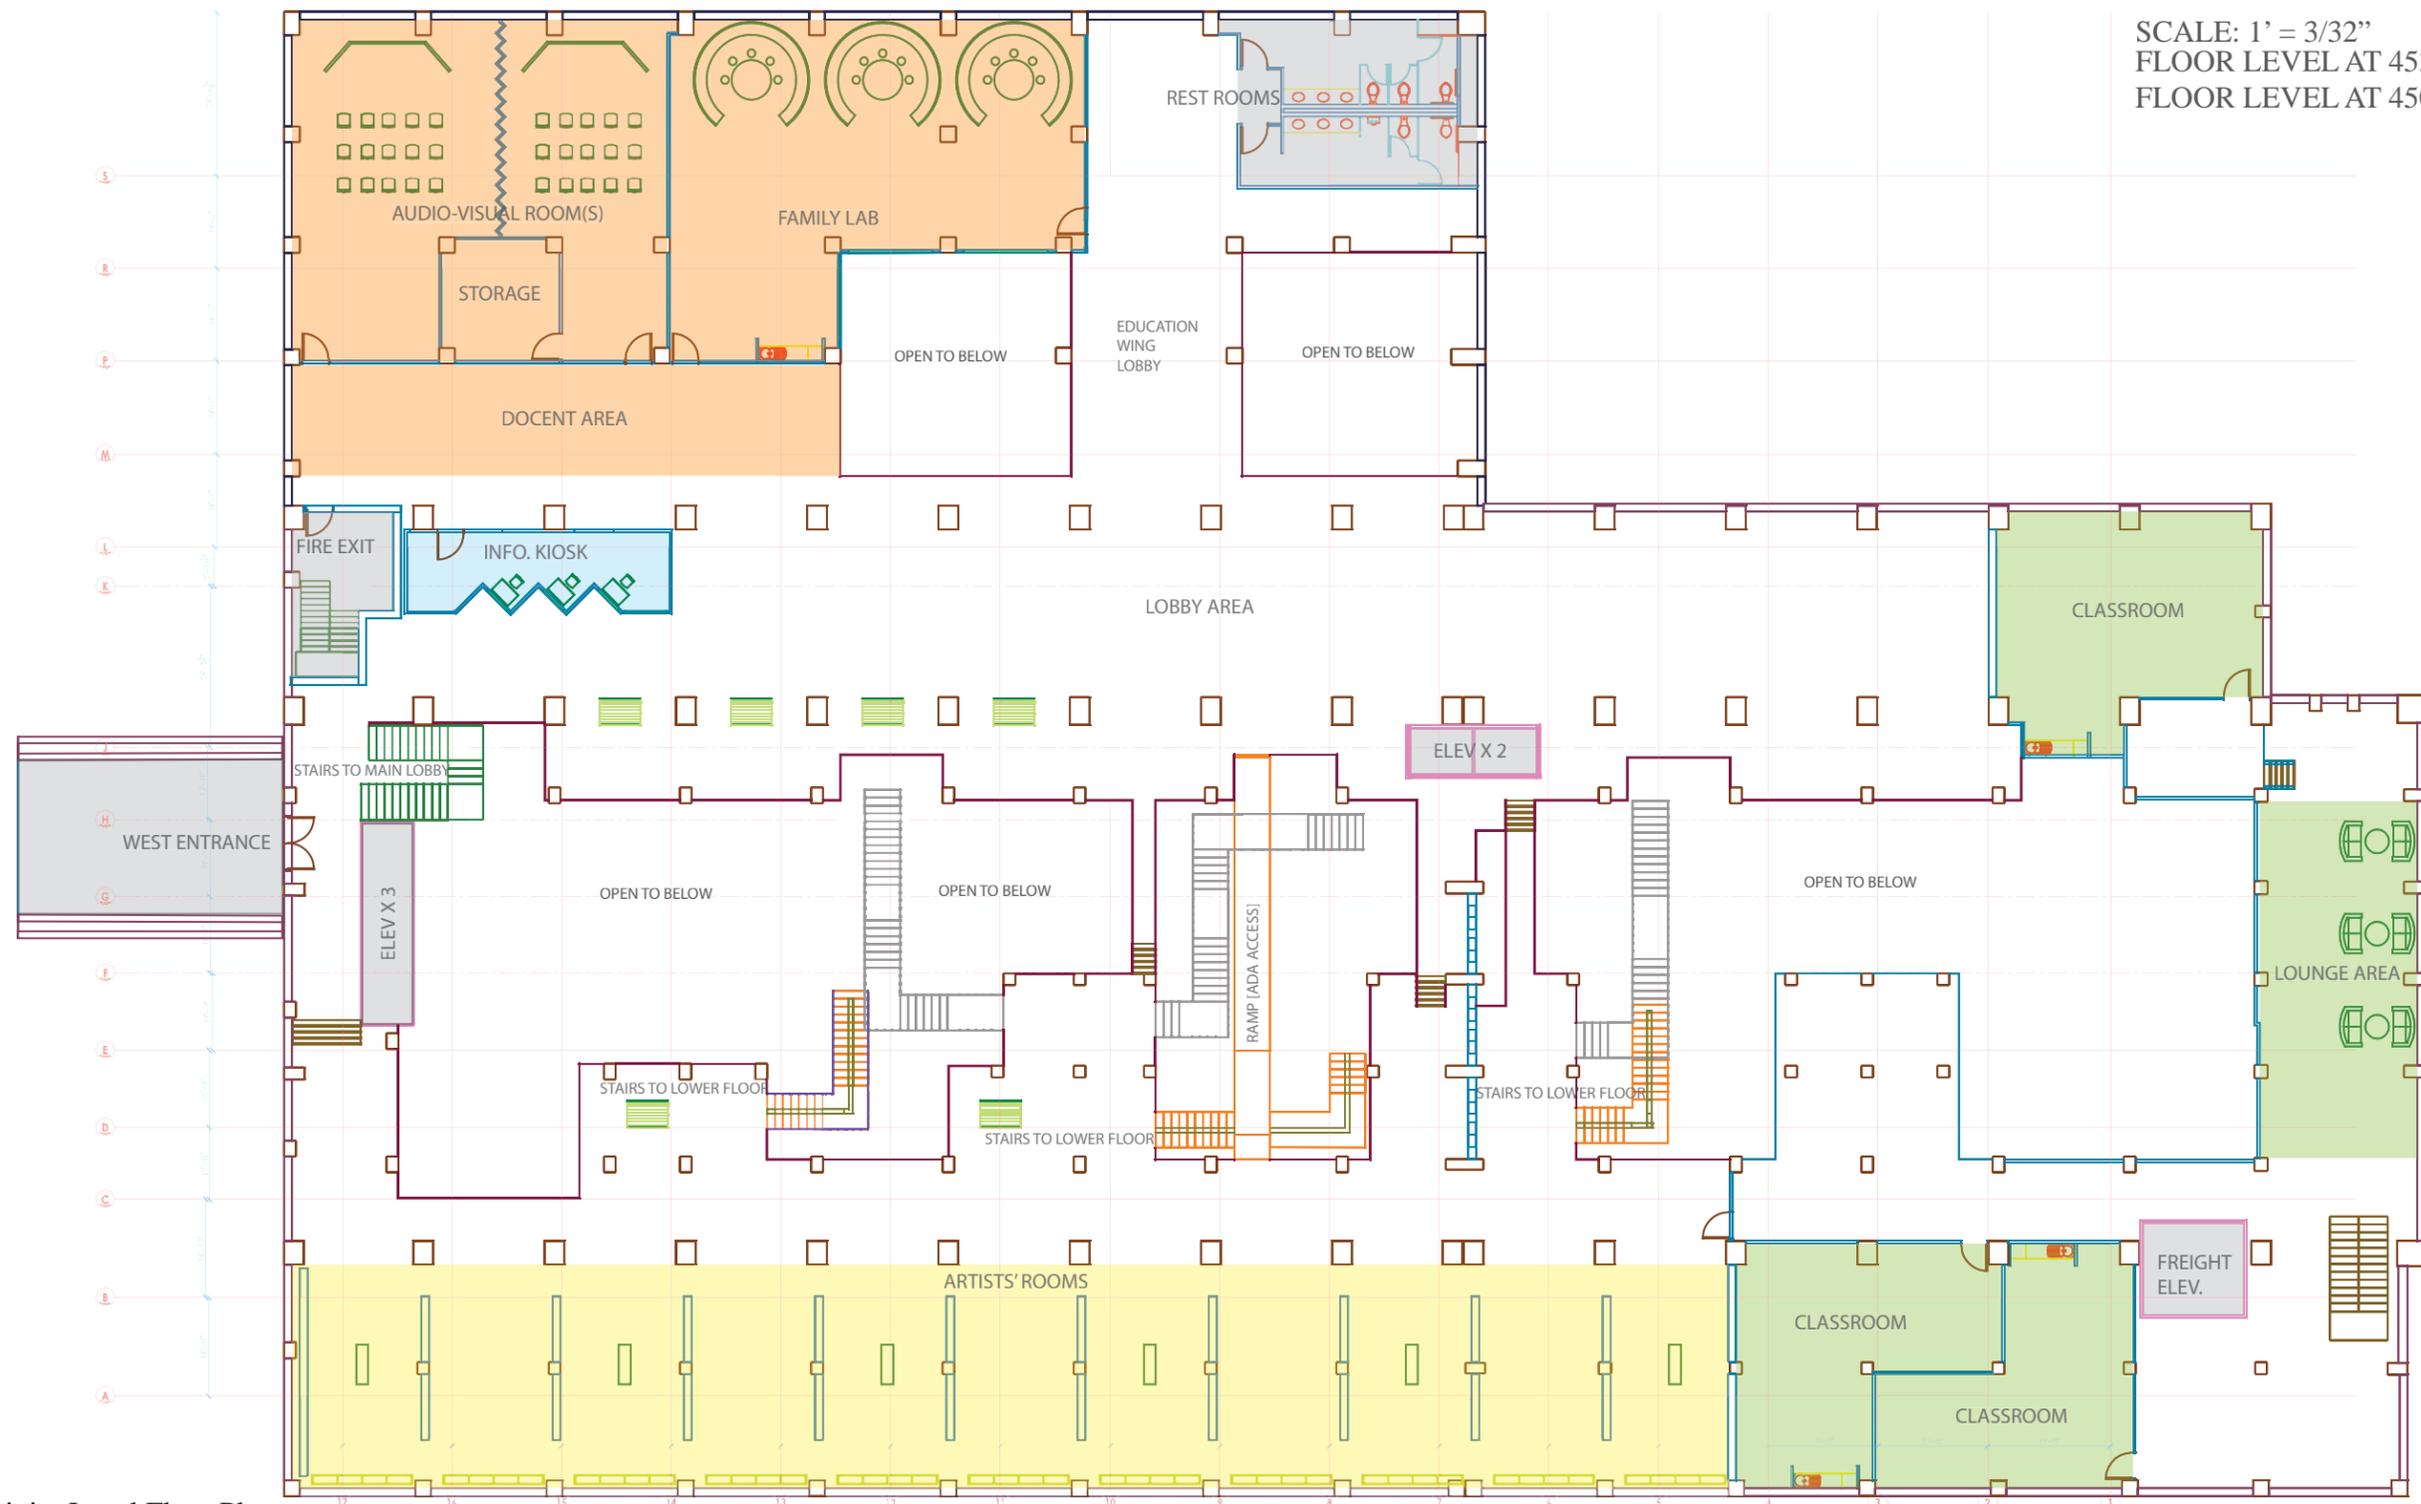
98. Activity Level Floor Plan

SCALE: 1' = 3/32"
FLOOR LEVEL AT 439'

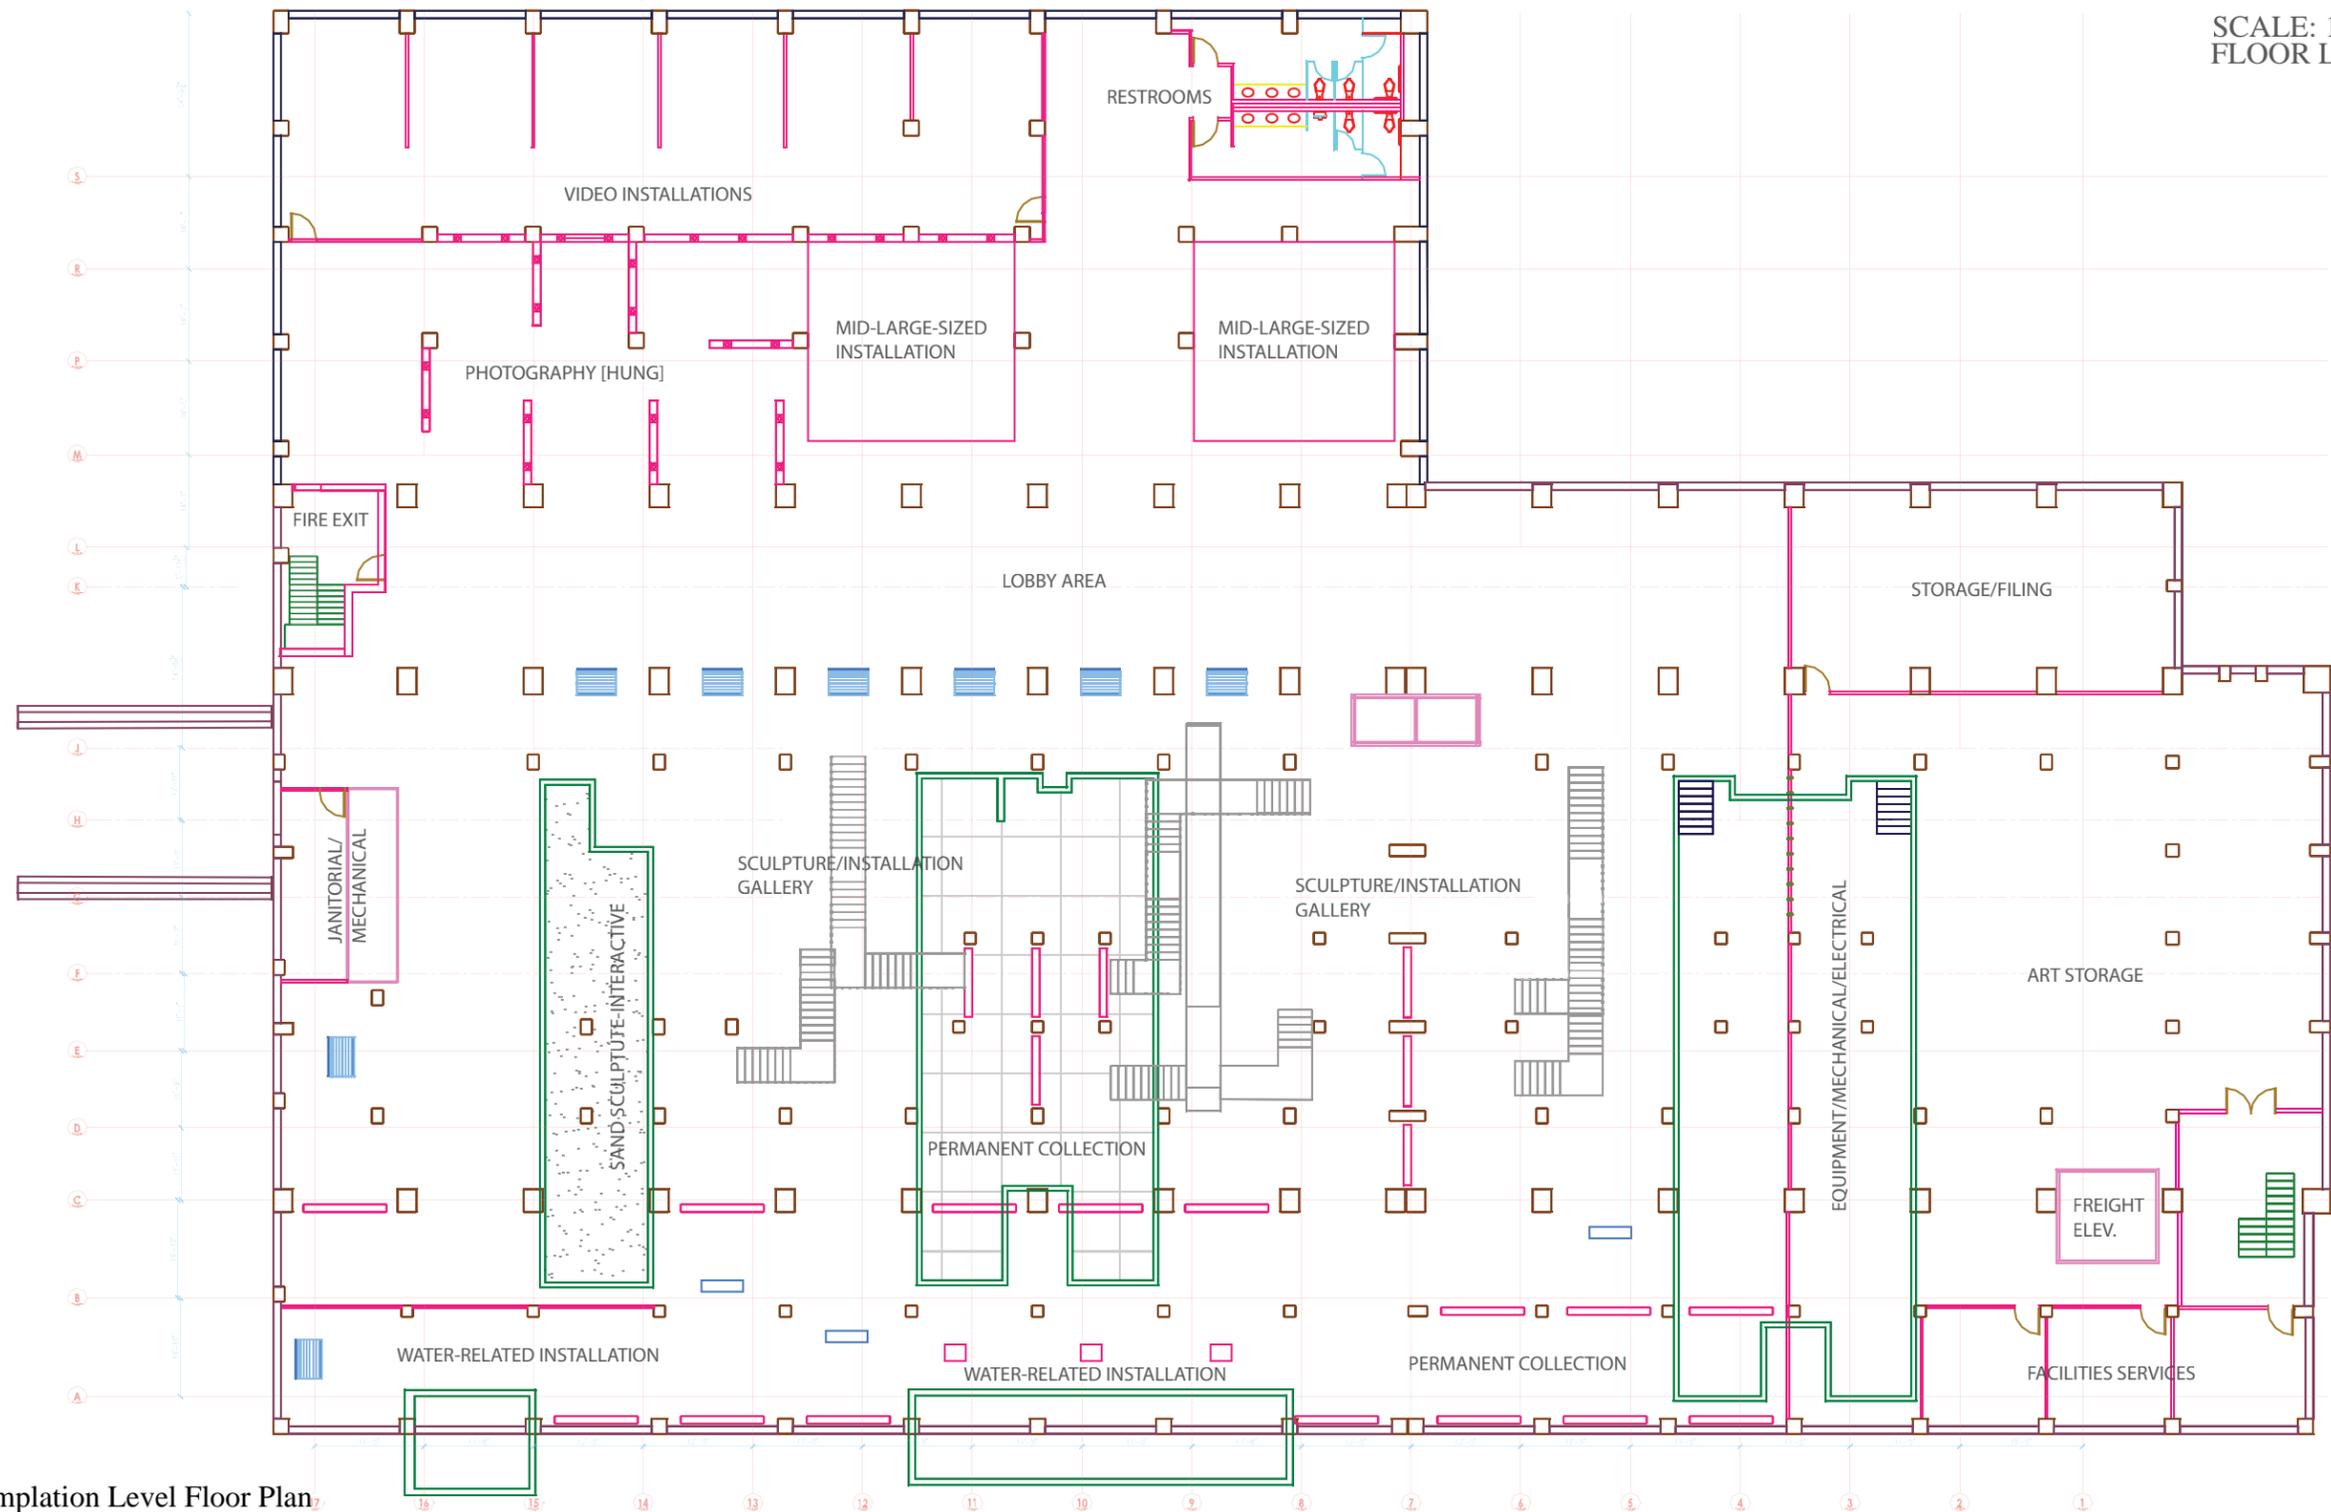
99. Contemplation Level Floor Plan

SCALE: 1' = 3/32"
FLOOR LEVEL AT 481'

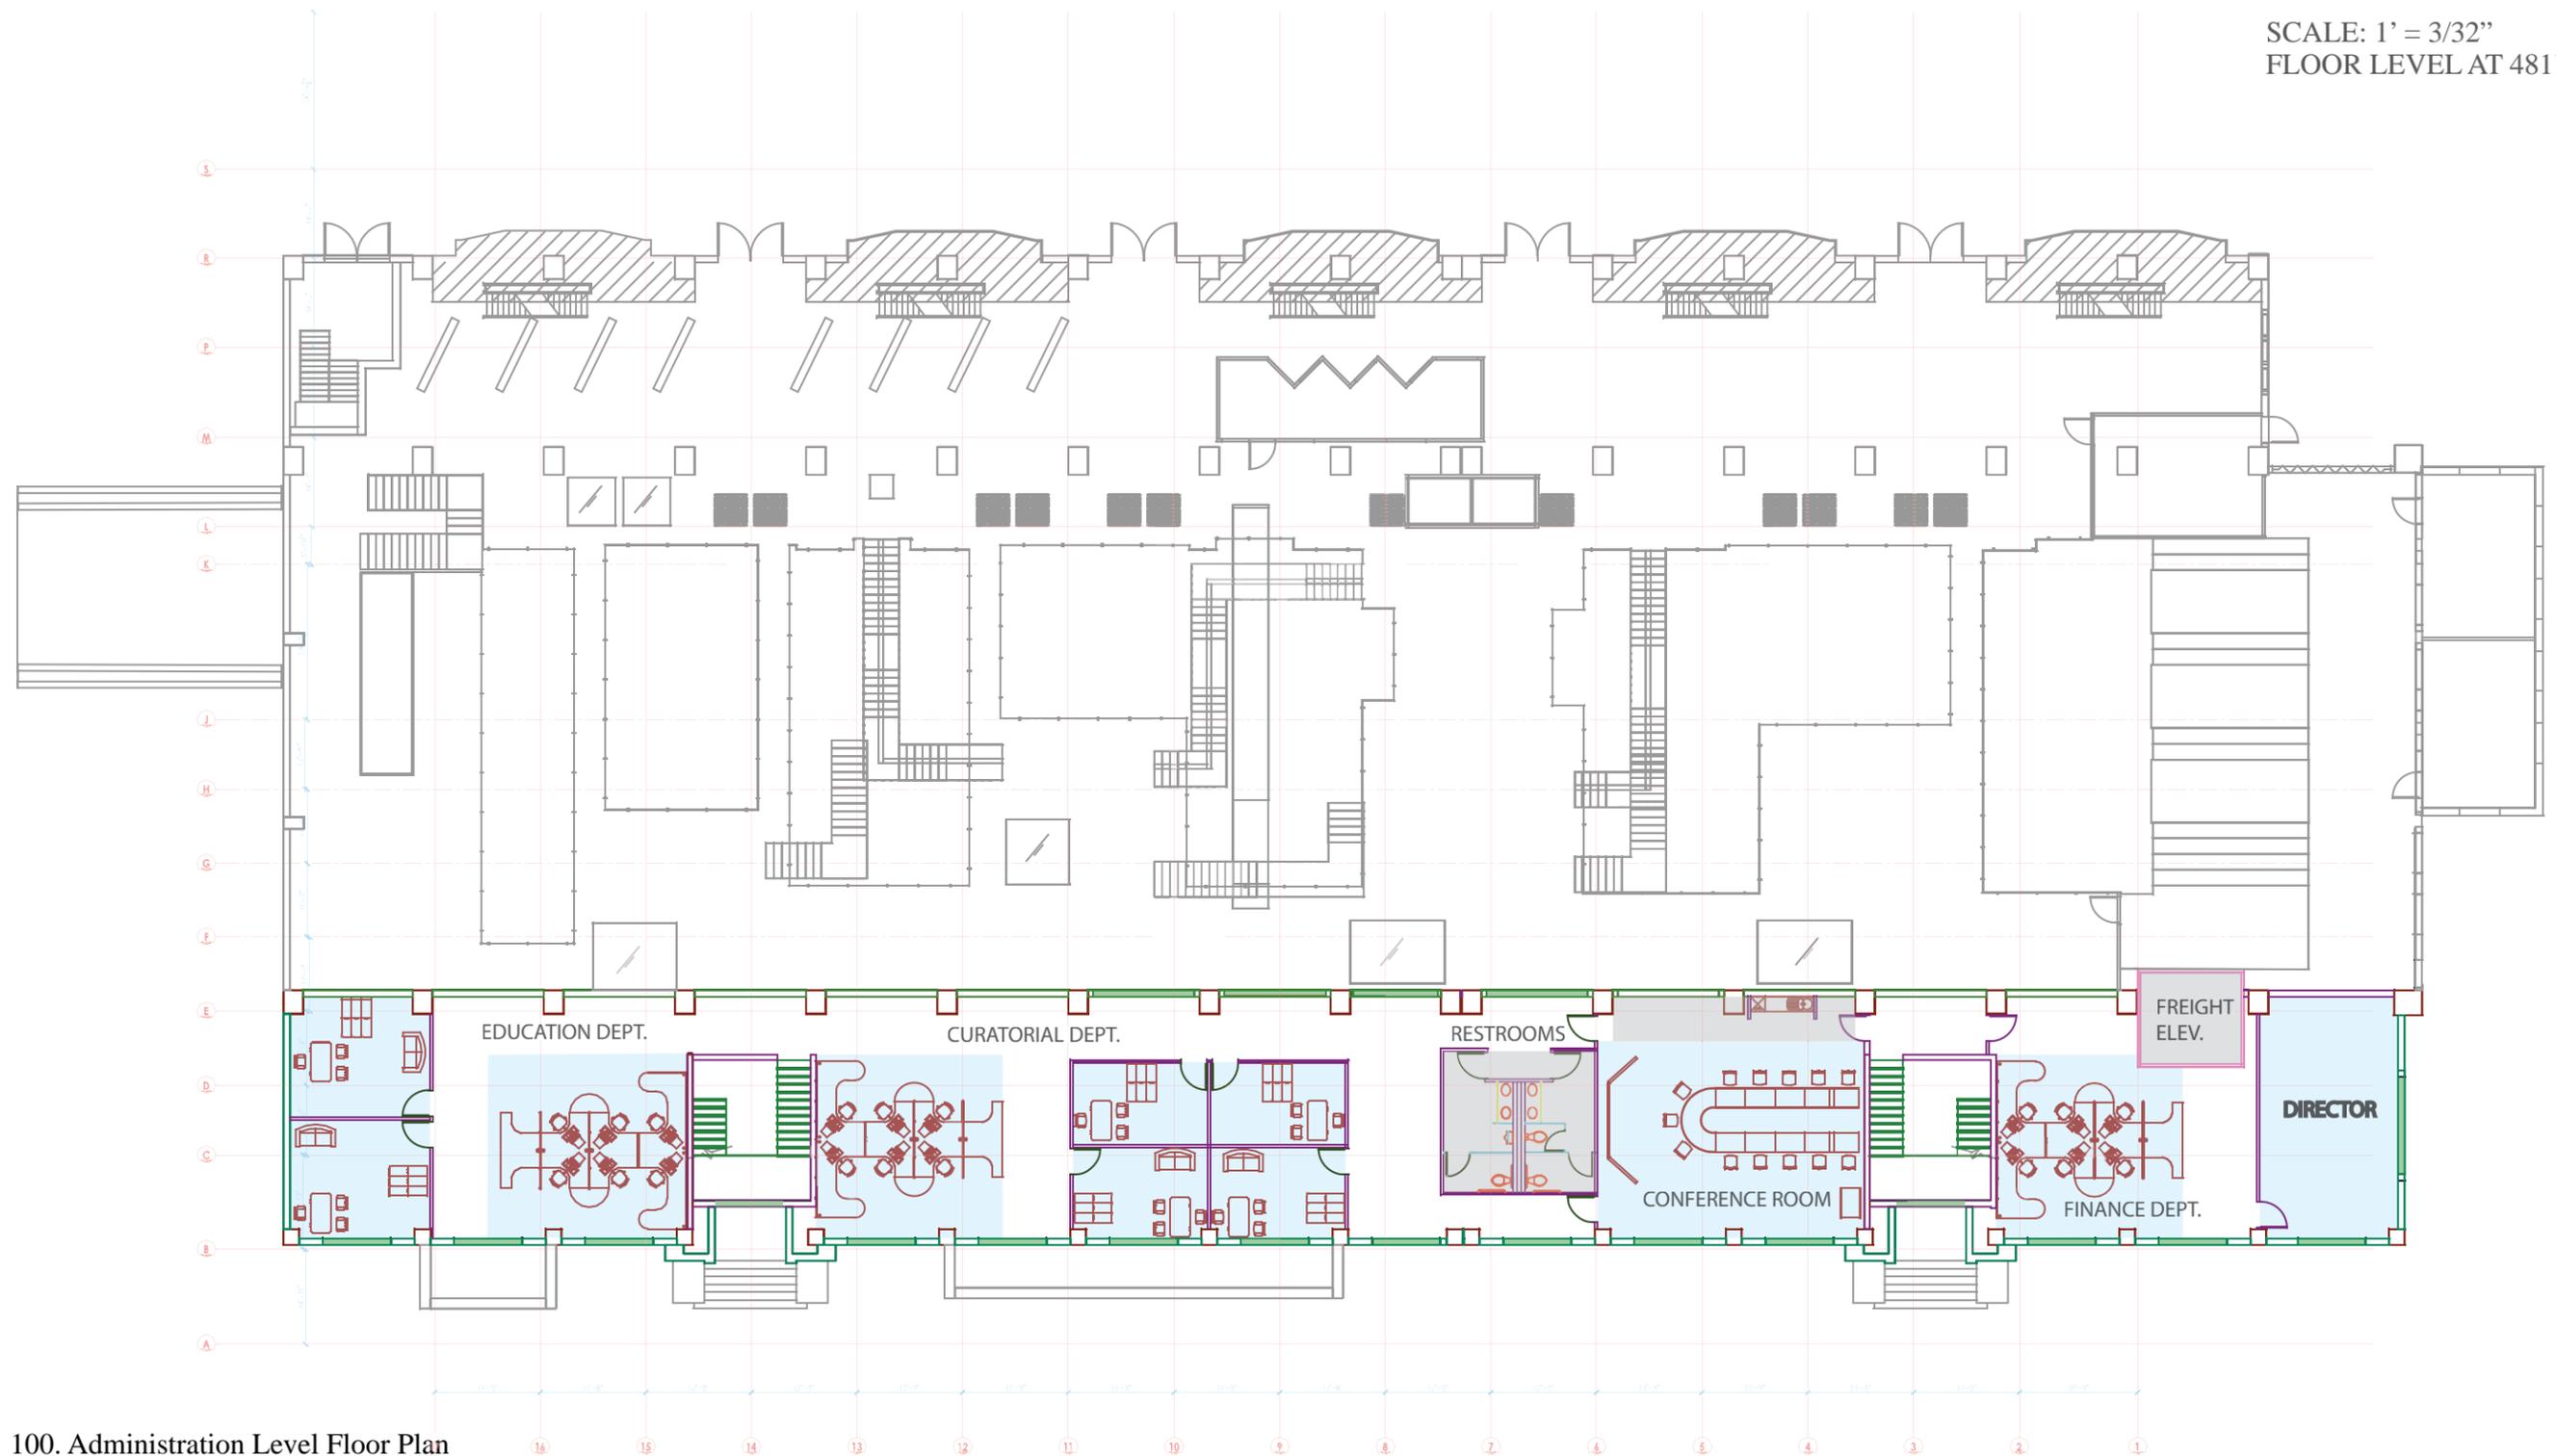
100. Administration Level Floor Plan

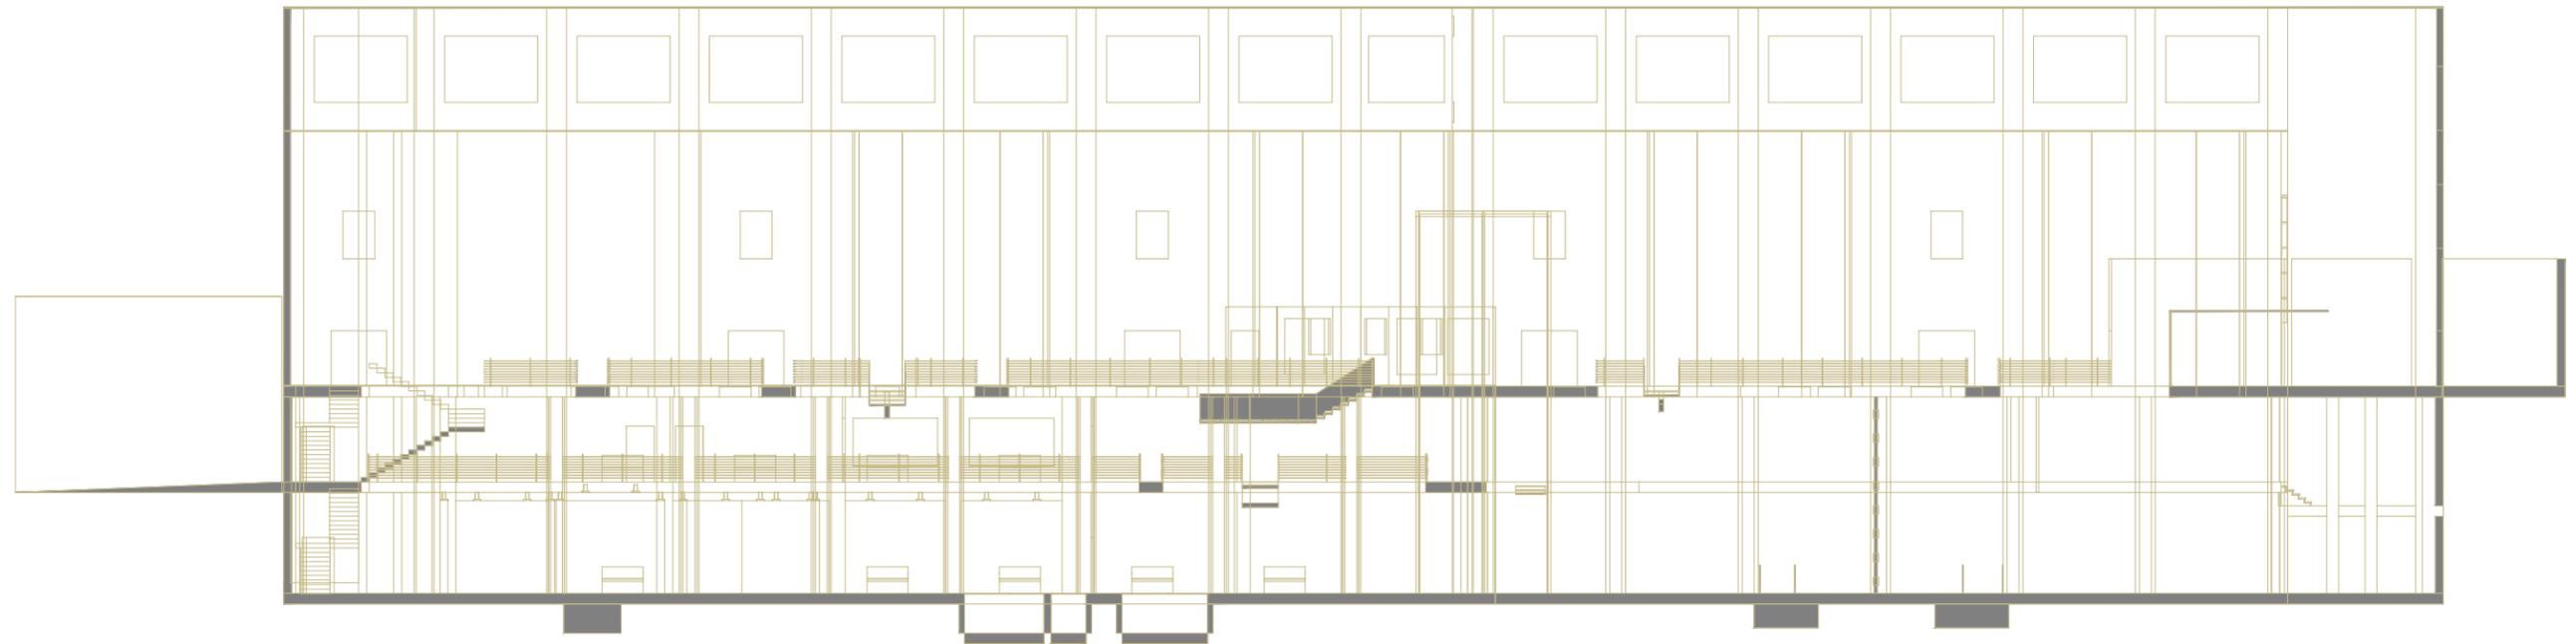
101. Section looking north through the new west-side entrance.

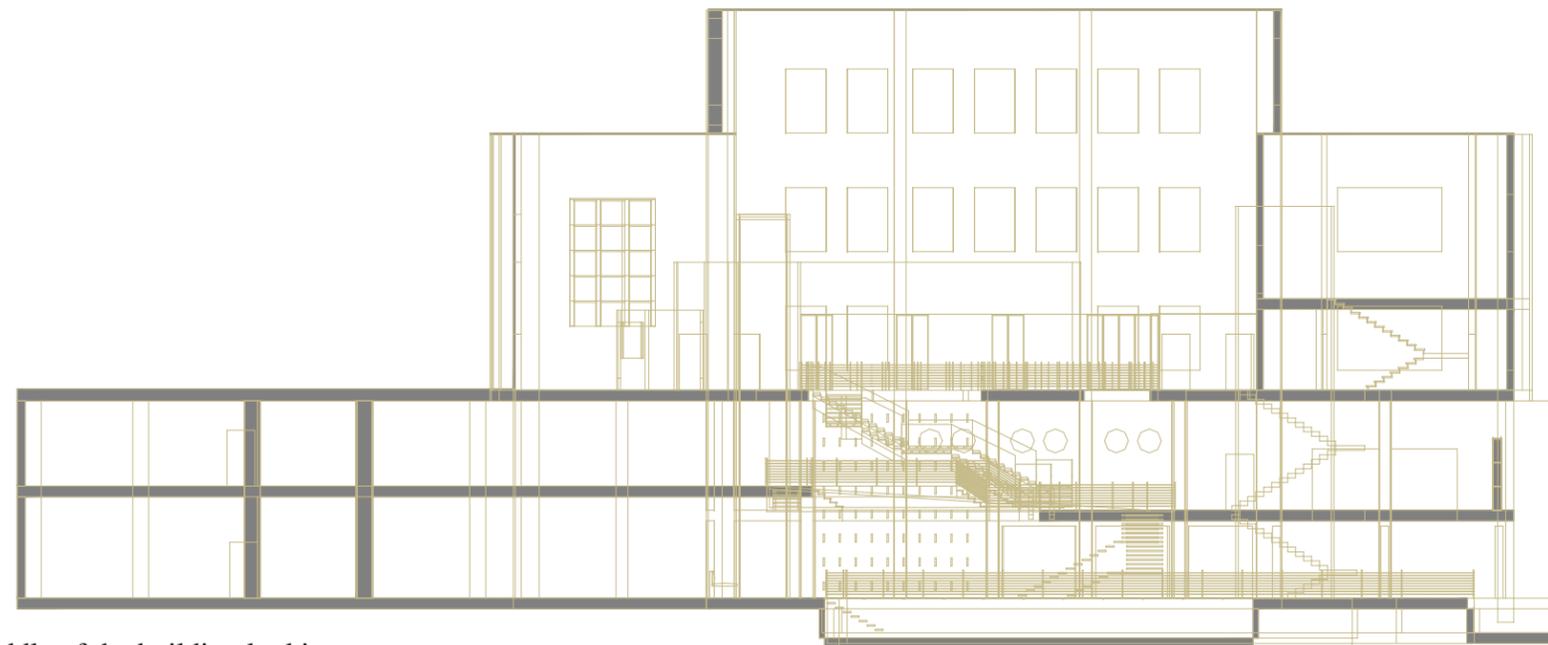
102. North-South section through the middle of the building looking east.

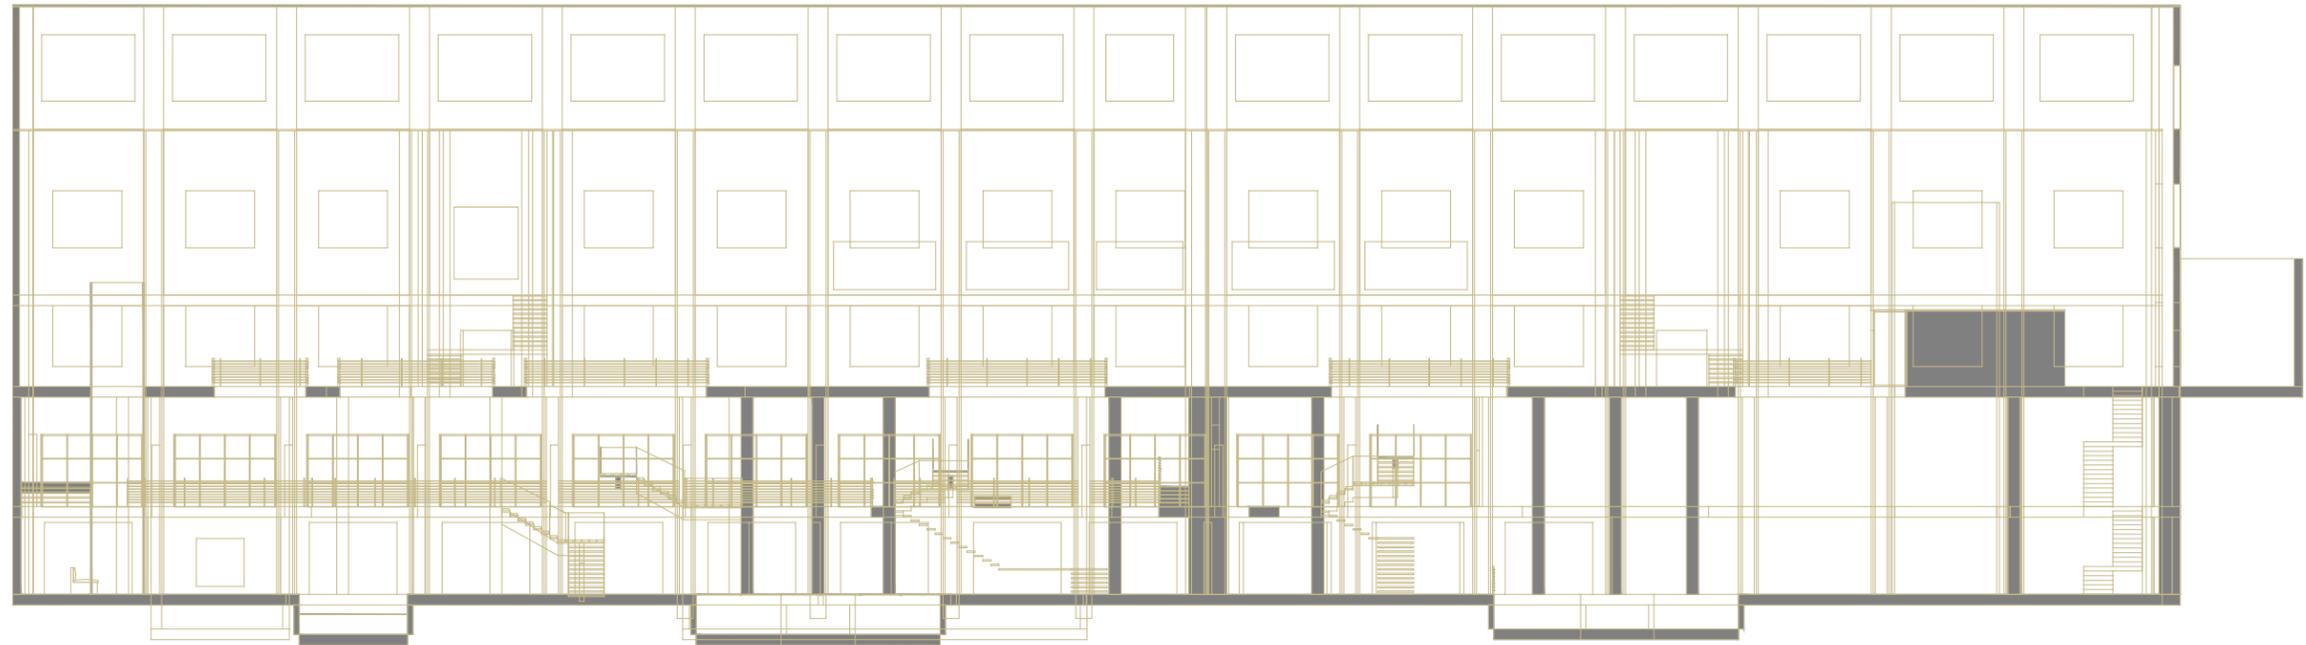
103. East-West section looking south through the middle of the building.

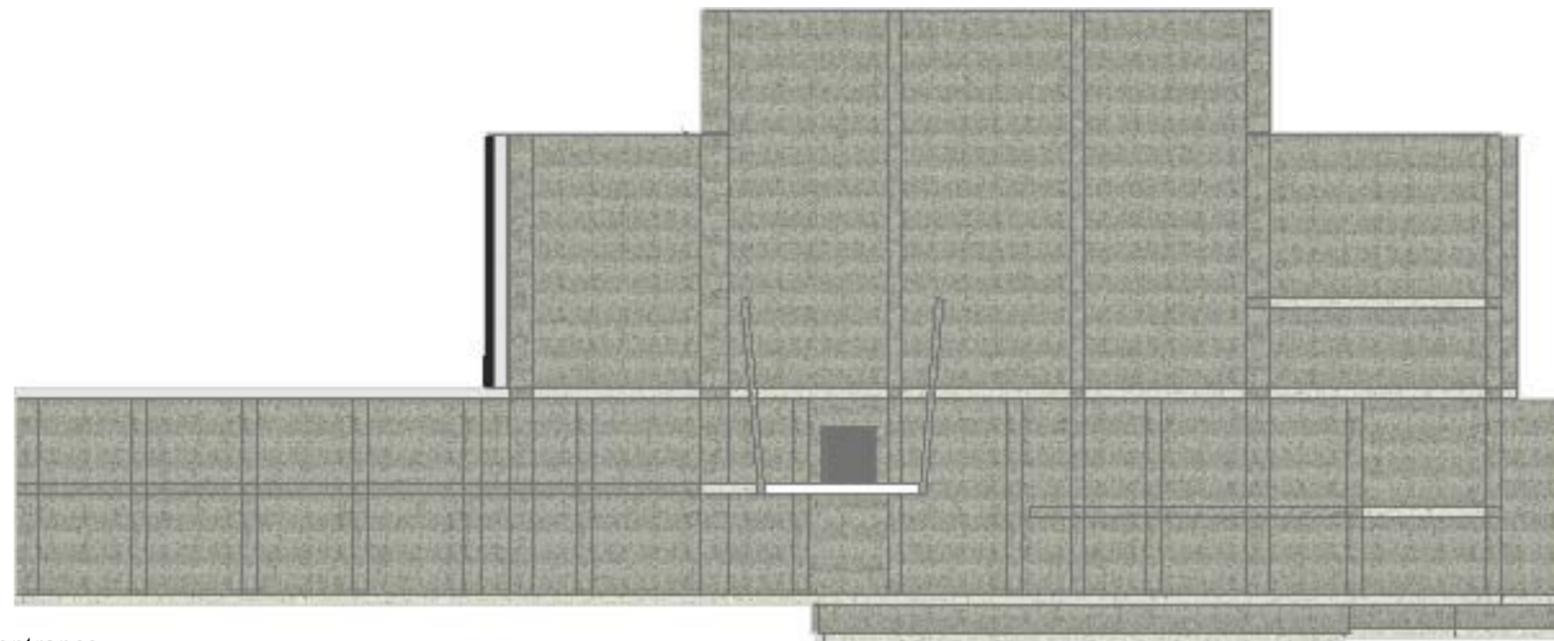
104. West elevation with the new entrance.

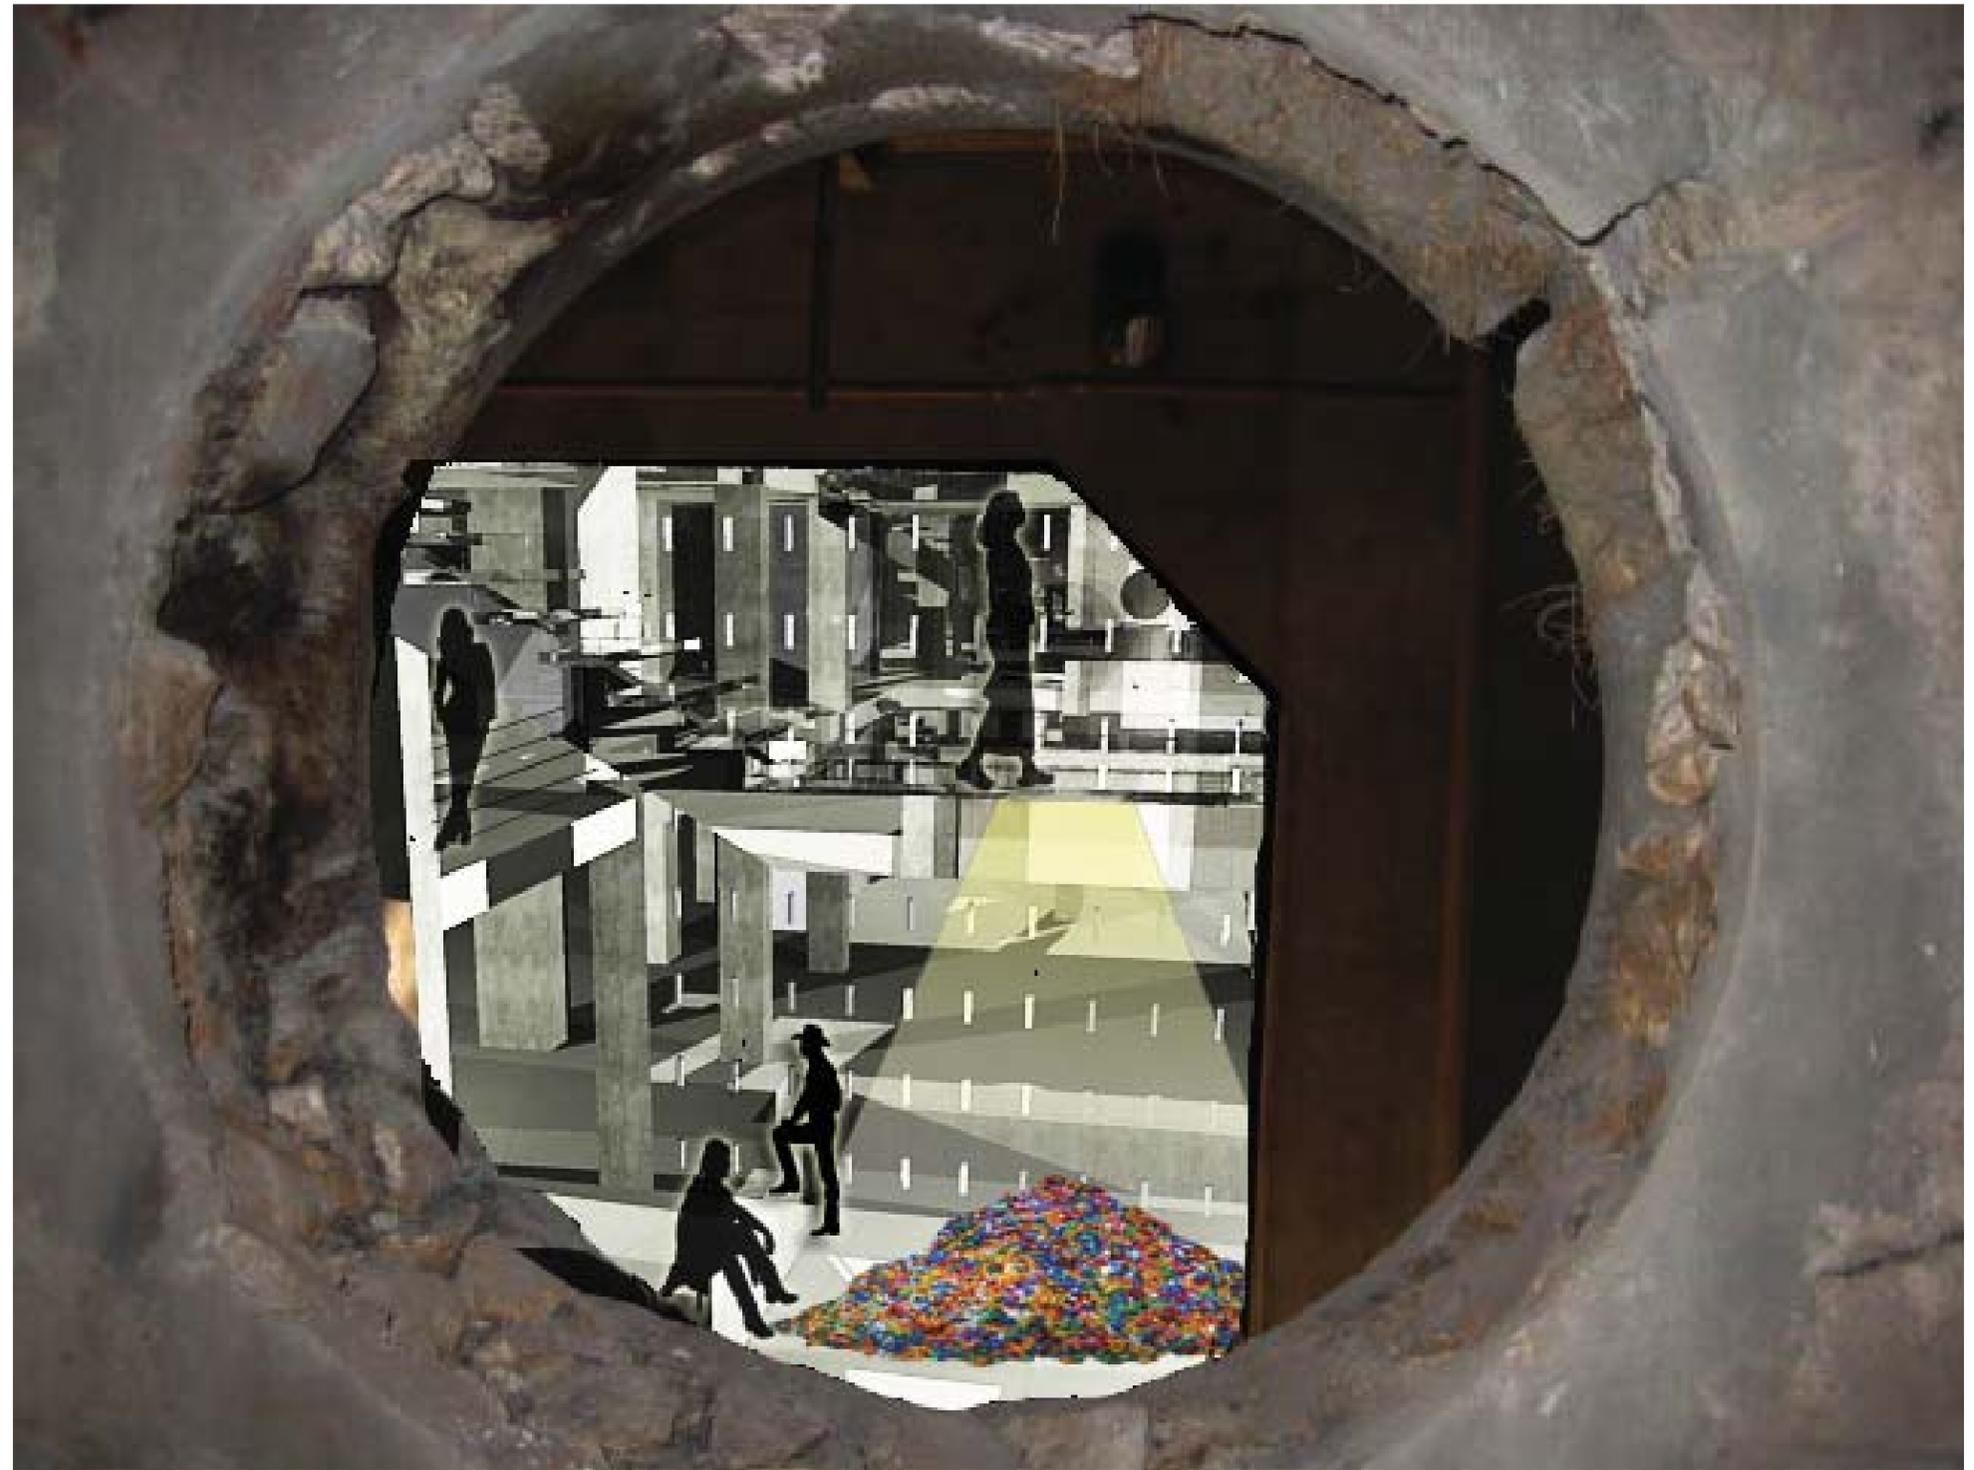
108. View through pipe hole at the Activity Level.

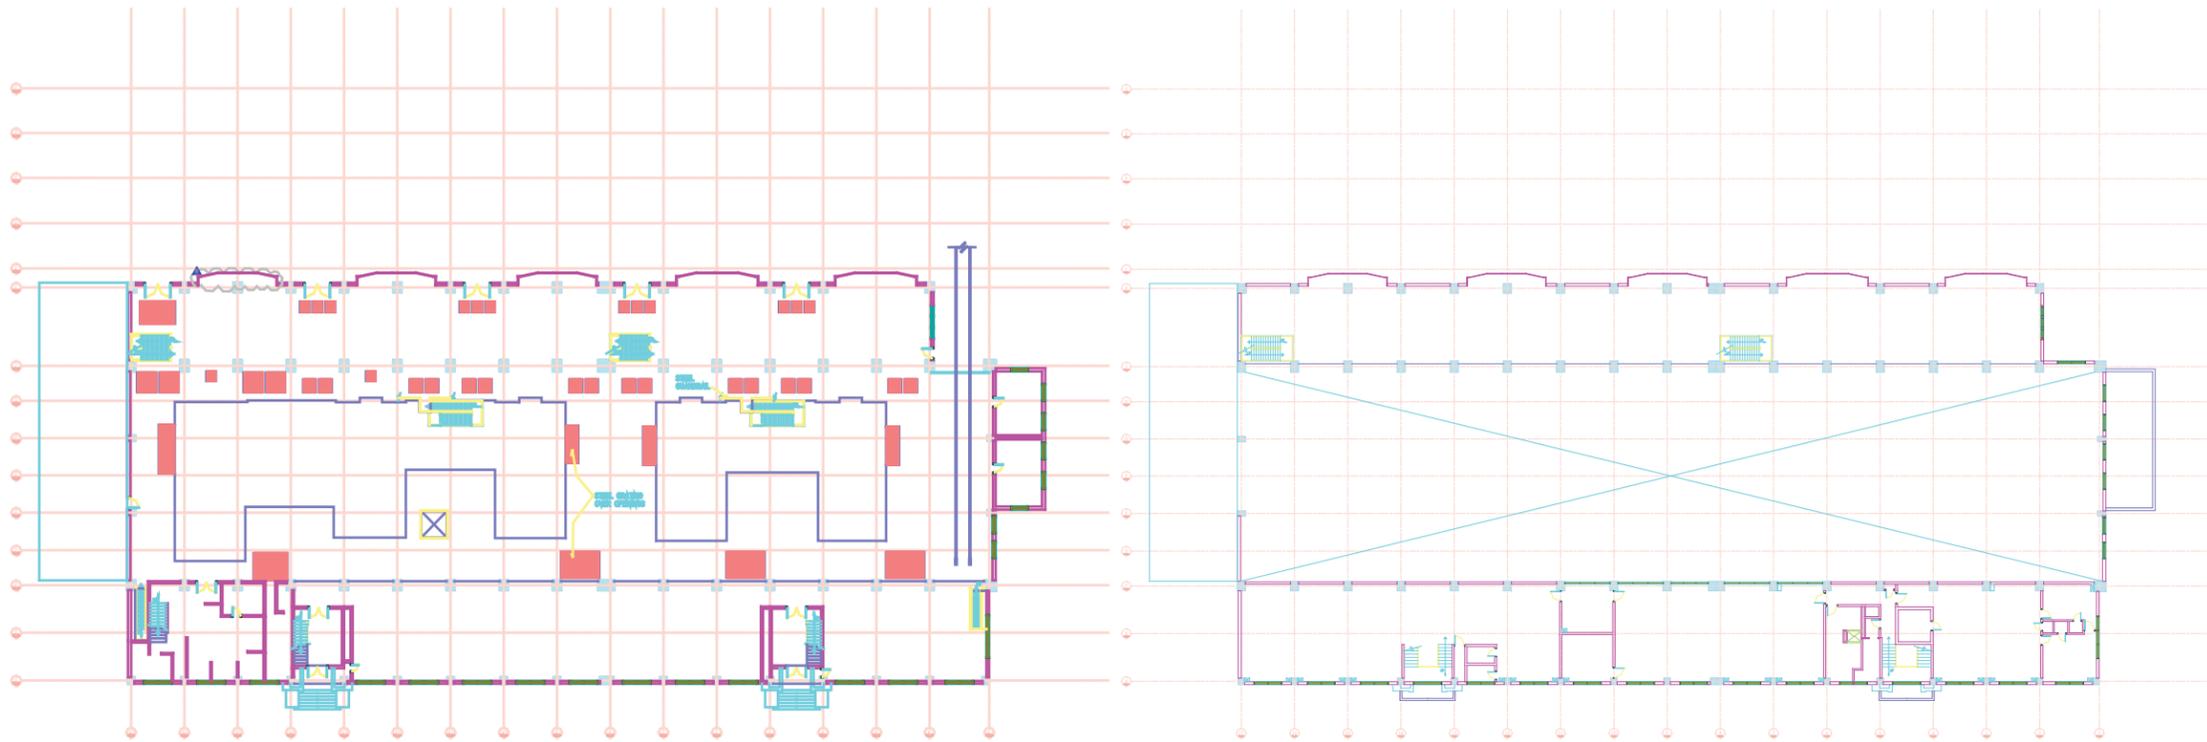
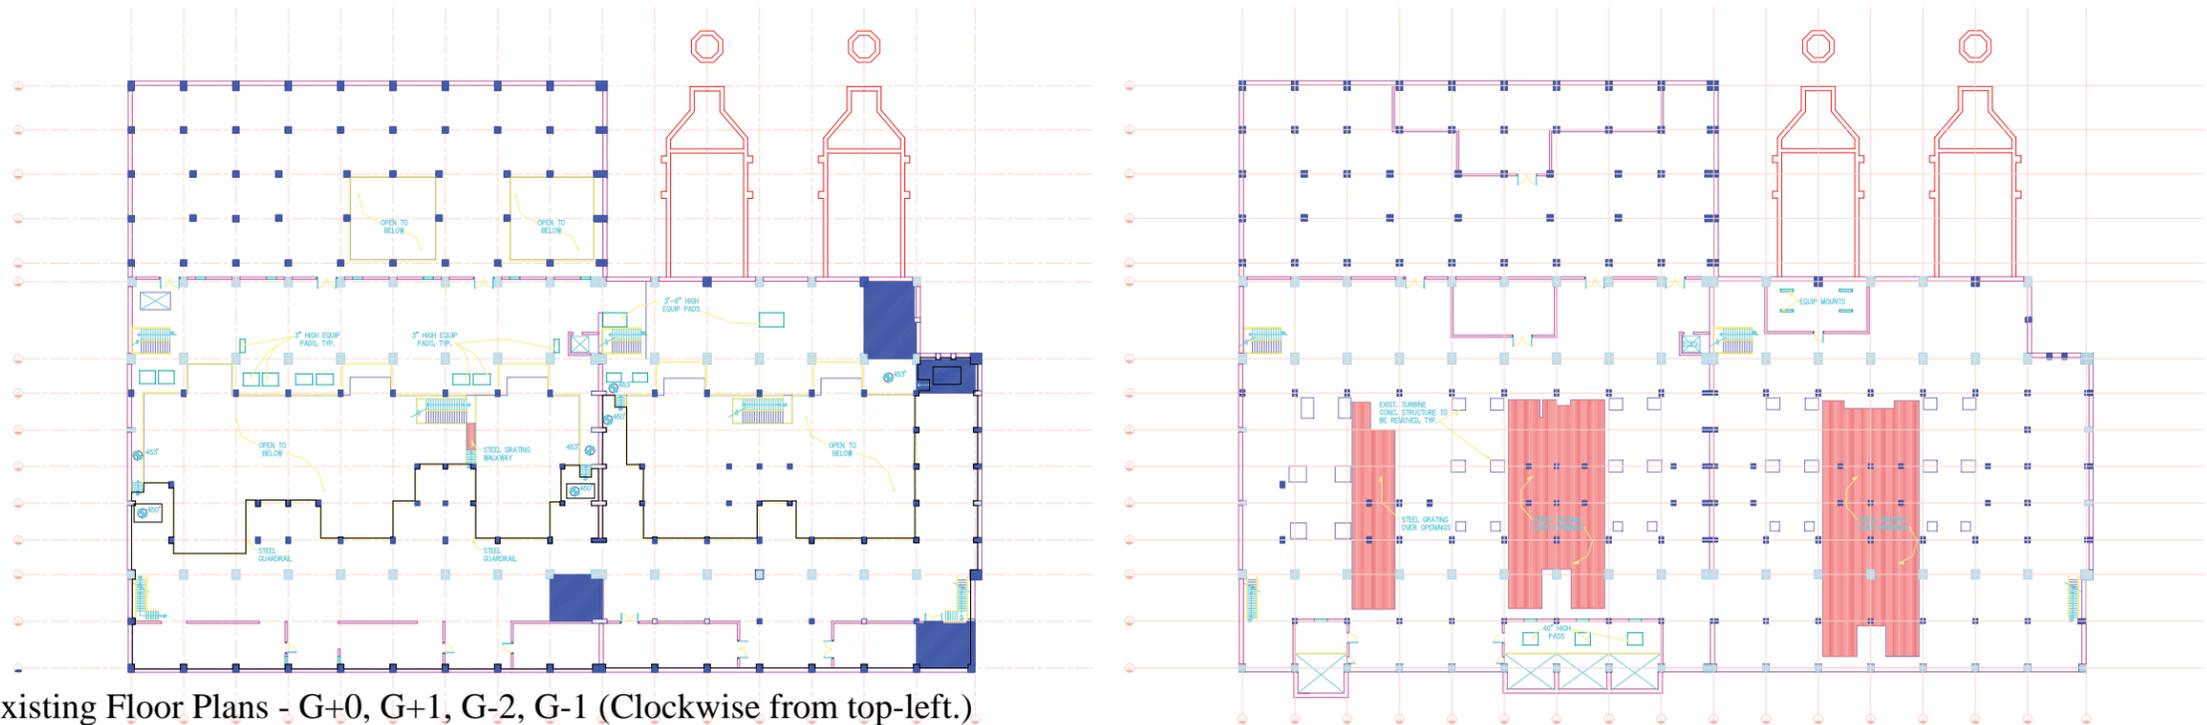
Appendix A: Existing Floor Plans - G+0, G+1, G-2, G-1 (Clockwise from top-left.)
