Technical Report

CRWR 263

CHARACTERIZATION OF HIGHWAY RUNOFF IN THE AUSTIN, TEXAS AREA

CENTER FOR RESEARCH IN WATER RESOURCES

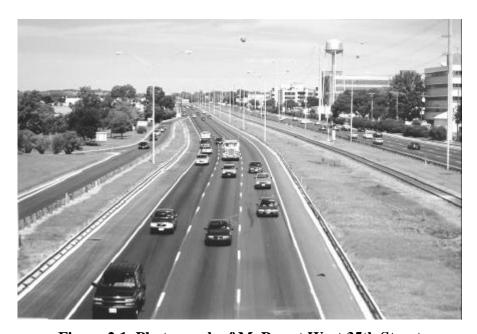
Figure 2.1 Photograph of MoPac at West 35th Street

MoPac at West 35th Street is a high traffic site located in central Austin (Figure 2.1). The land use of the area is mixed residential and commercial. Samples were collected from a storm drain inlet located along the gutter of a curbed section of the three southbound lanes. The catchment covers an area of 5,341 m² which is 100% asphalt. The average daily volume of traffic at this site was approximately 60,000 vehicles per day, ranging from a maximum of 6,000 vehicles per hour to a minimum of about 100 vehicles per hour. Induction coils installed in each lane of traffic recorded traffic counts during each rainfall event.

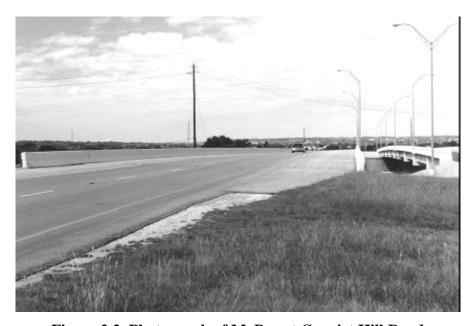
Figure 2.2 Photograph of MoPac at Convict Hill Road

MoPac at Convict Hill Road is a low traffic site located on the southwestern edge of Austin (Figure 2.2). The land around Convict Hill Road is mostly residential and rural property. Runoff was collected from the down spout of the northbound lanes of the MoPac overpass over Convict Hill Road. This outfall drains 526 m² of bridge deck, which is 100% asphalt paved and has two lanes of traffic and wide shoulders. One meter high concrete barriers are located along each side of the roadway. The average traffic count in April 1995 was approximately 8780 vehicles per day, ranging from less than 10 vehicles per hour to nearly 1400 vehicles per hour.

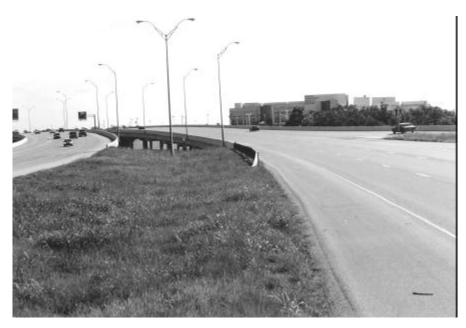
Figure 2.3 Photograph of MoPac at Walnut Creek

The Walnut Creek site is located in north Austin and consists of a combination of paved highway and grassy shoulder and median (Figure 2.3). The land use classification of the area is mostly commercial and high density residential. Water was collected from a 10.46 ha (104,600 m²) area. Approximately 37.6% of the drainage area is paved with asphalt and consists exclusively of the six north- and south-bound lanes of MoPac. No curb or gutter was installed and the highway runoff drains into a large grassy median. Runoff from the median enters a 1.22 m diameter storm sewer system through drop inlets. In April 1995, approximately 47,000 vehicles per day were recorded for this section of MoPac. The hourly traffic counts ranged from about 100 to 3600 vehicles.

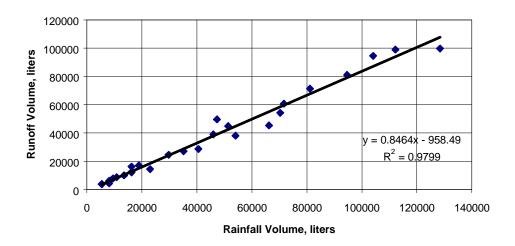
Figure 2.4 Runoff Coefficient for MoPac and West 35th Street

Water level was read from a bubbler tube located at the bottom of the curbing system before the water entered the catchment inlet. A rating curve was developed for this location by discharging water from a fire hydrant approximately 100 meters upstream of the level measuring location. The water was discharged at metered flow rates to construct the rating curve. The water elevation recorded at different flow rates by the flow meter allowed the development of an accurate relationship between water level and flow rate. The flow meter was active at this site for more than one year. Monitoring flow rates of numerous storms produced an average runoff coefficient of about 0.90 which is consistent with values commonly reported in the literature for 100% impervious surfaces. The runoff coefficient calculations are shown in Figure 2.4.

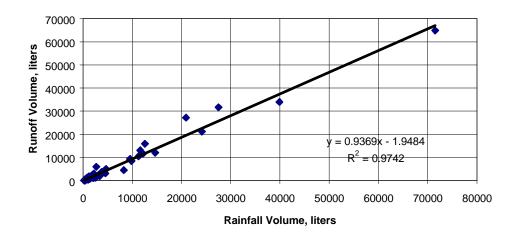
Figure 2.5 Runoff Coefficient for MoPac at Convict Hill Road

An identical weir was calibrated at the Center for Research in Water Resources (CRWR) laboratory. The observed discharge of the 30 degree section was almost identical to that predicted by the formulas. The recommended length and weir elevation of the collection box were limited by the height of the down spout at the base of the bridge support and the concrete pad that was located below it. However, the consistency of the results and the resulting runoff coefficient indicated that the system employed was reliable and yielded accurate flow data. The runoff coefficient calculated in this manner was about 0.94. The runoff-rainfall relationship is shown in Figure 2.5.

Runoff discharge at the Convict Hill Road site was measured using a weir installed on a collection box at the base of a 6-inch diameter down spout. The weir was a compound weir, consisting of three sections: a bottom section which was 20.32 cm high with 30 degree throat, a middle portion which was 4.83 cm high with a 90 degree cross section and a top section which was a rectangular weir which had 5.33 cm sides. Depth of water in the collection box was measured and the discharge was calculated from a rating curve for each section.

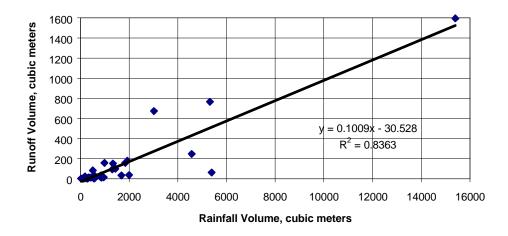
Figure 2.6 Runoff Coefficient for MoPac and Walnut Creek

The rainfall runoff relationship is shown in Figure 2.6. The larger scatter of the points is the result of the large percentage of the area which is grass covered and where the initial moisture content of the soil strongly influences the volume of runoff. The average runoff coefficient for this site was approximately 0.10, which is in the expected range of values for a site of these characteristics.

Samples were collected by an automatic sampler from the 1.22 m diameter outfall of the system prior to the discharge entering Walnut Creek. Flow in the storm sewer system at Walnut Creek was calculated using the Manning formula for pipe flow. The slope of the pipe (S), the roughness coefficient (n), the diameter of the pipe (D), and the depth of water in the pipe (d), were used to calculate the flow rate using:

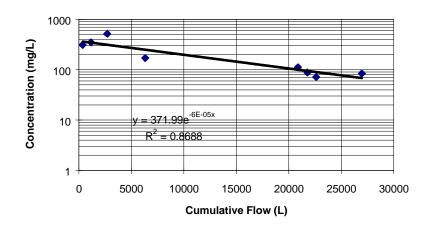
Figure 3.1 Washoff of TSS at 35th Street, 10/29/93

The first flush effect was more evident at West 35th Street than at Convict Hill Road or Walnut Creek because the concentrations of the constituents were higher at West 35th Street and changes were more evident. A first flush was most pronounced during short storms with fairly constant rainfall intensities. For longer events, changes in traffic volume, rainfall intensity and other variables reduced the magnitude of the first flush. Vehicles acted as a continuing source of pollutants during storm events, so complete washoff never occurred. For all storms monitored at this site the percentage of total mass

discharged at any point in the storm was only slightly higher than the percentage of the total runoff volume at that point. A more detailed description of the first flush effect at 35th Street is contained in CRWR Technical Report #264 (Irish et al, 1995).

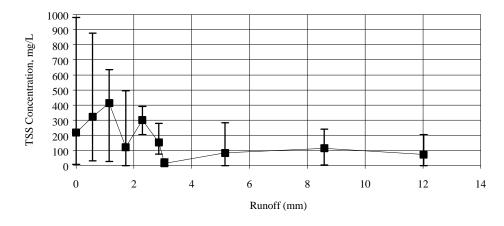
Figure 3.2 TSS Washoff Pattern at Convict Hill Road Site

At Convict Hill Road most sample collection was limited to the first 12.1 mm of runoff, because of the requirements of the NPDES permit and the rainfall characteristics in the Austin area. This limited the evaluation of the first flush characteristics at this site. Higher concentrations were recorded during approximately the first 3 mm of runoff for most constituents; however, the concentrations quickly became approximately constant for the duration of the sampling period. The typical pattern is shown in Figure 3.2 for TSS. Since the concentration of TSS stabilizes at approximately 100 mg/L, significant loading continues for the duration of the sampling period.
